BOTANICAL STATEMENT

ZWARTFONTEIN DAM

Proposed enlargement of an existing dam on Portion 8 of the Farm No. 792 and
Remainder of the Farm Zwartfontein No. 792 (Malmesbury), Swartland Local
Municipality, Western Cape Province.

June 18, 2020

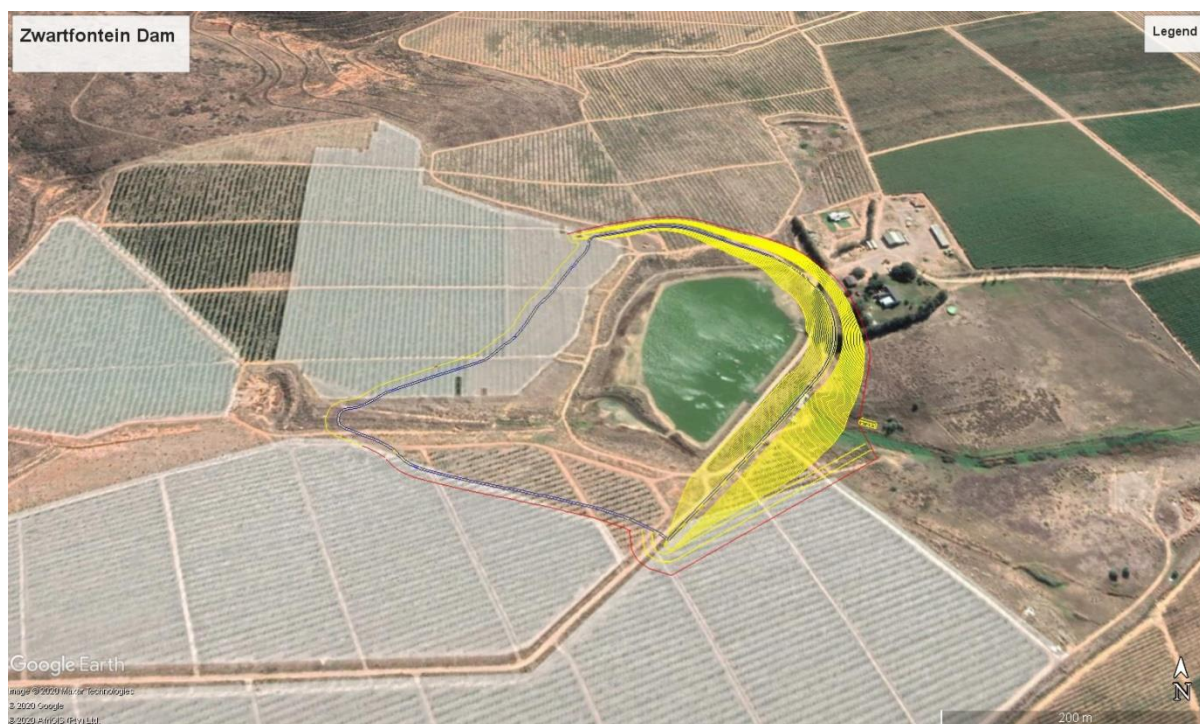
Figure 3: The Zwartfontein Dam, showing the dam wall location (Red) and the area that may be affected (blue dotted line)

Figure 3 shows the existing dam and illustrates the approximate footprint enlargement. It also shows the areas that will be impacted by the proposed footprint.

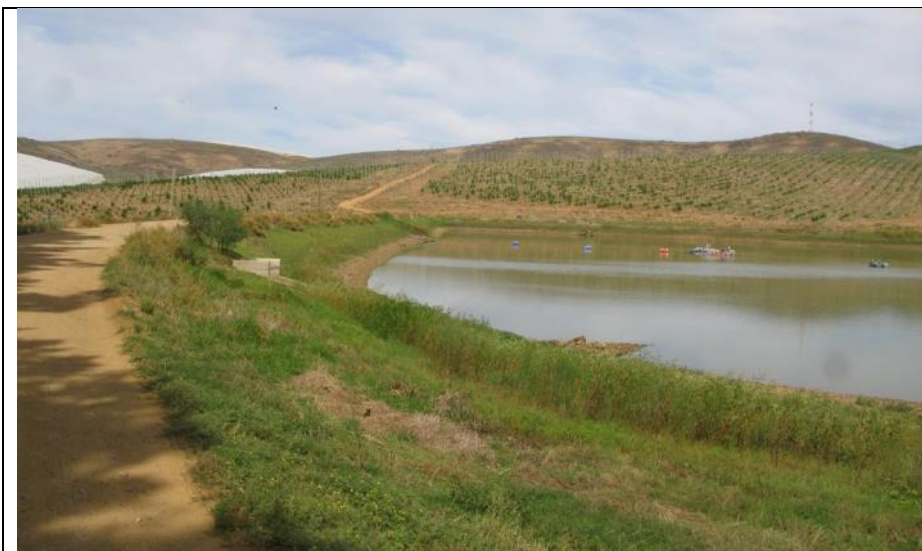
Photo 1:

The site visit confirmed that the small edge of vegetation that can still be observed next to the dam is in fact degraded veld, which only now only supports hardy weeds and shrubs and perennial grasses finding some shelter and water within the excavated edge of the original dam. In fact, apart from a small section at the back of the dam (Photo 2), most of this area was most likely part of the originally excavated area that would have been left stripped of topsoil and any remaining indigenous vegetation (Refer to Photo 1).

Looking over the existing dam wall from east to west. Note the degraded vegetation along the dam slopes.

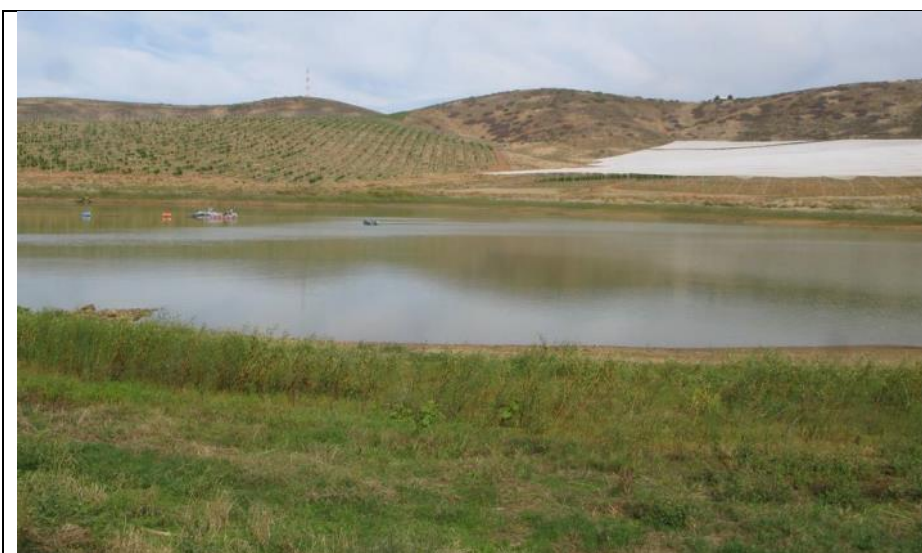
Photo 2

Looking over the middle of the dam from east to west. Again the degraded weedy vegetation should be noted along the dam wall. It is expected that in these areas all the topsoil was removed when the original dam was build.

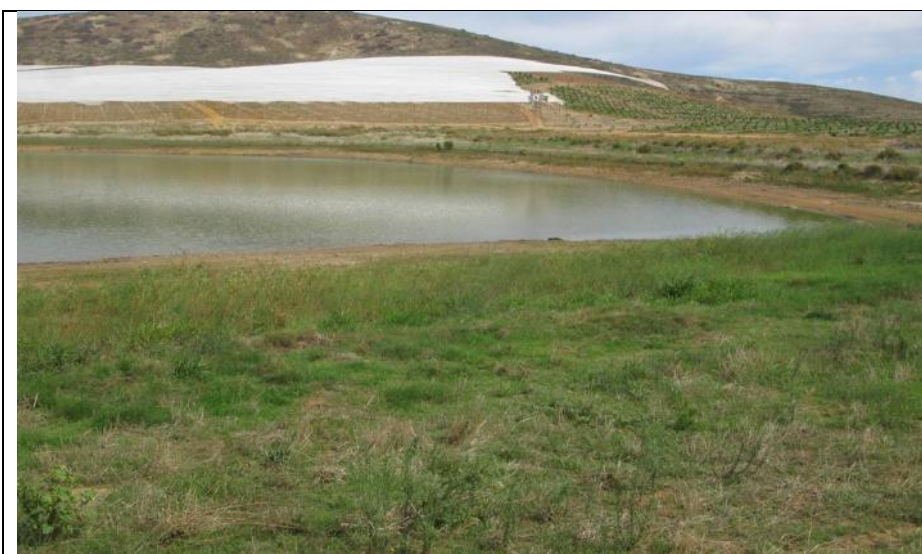
Photo 3

Looking at the bottom part of the dam (from southeast to northwest over the dam. Note the slightly better vegetated area to the back of the dam (Refer Photo 4).

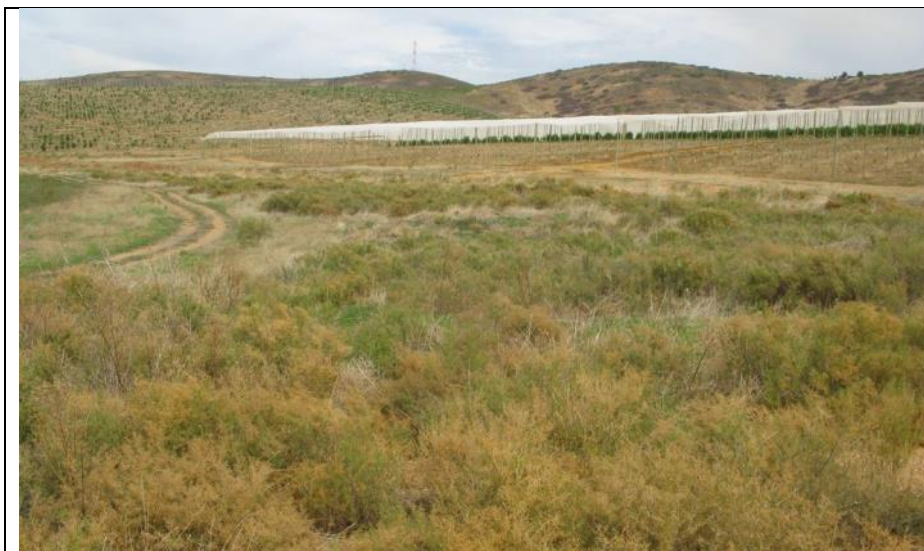
Photo 4

Looking from east to west over the bottom part of the dam, again showing the slightly better vegetated area. This area was basically dominated by *Galenia africana* and *Salsola kali*, other shrubs like *Stoebe* and *Eriocephalus* scattered in between.

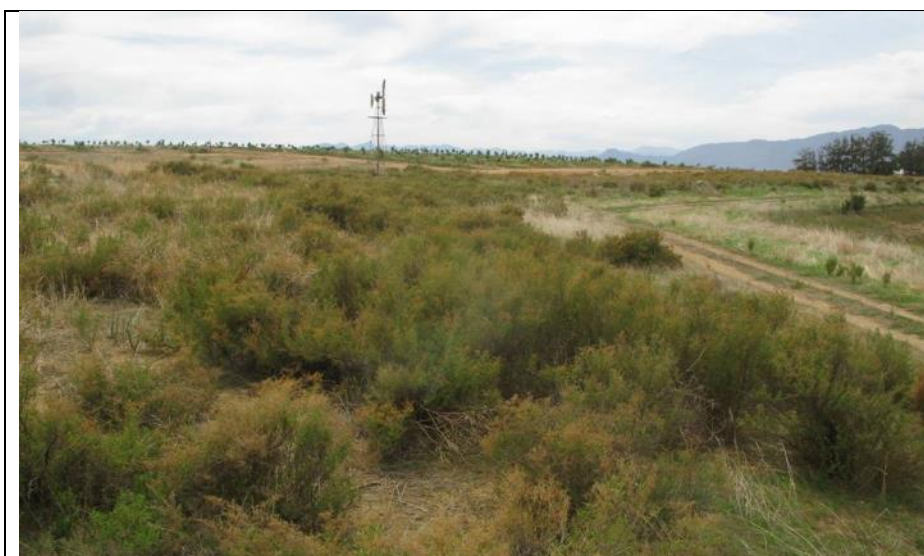
Photo 5

Looking from west to east over the bottom part of the dam. Again showing the *Galenia* dominated disturbed veld.

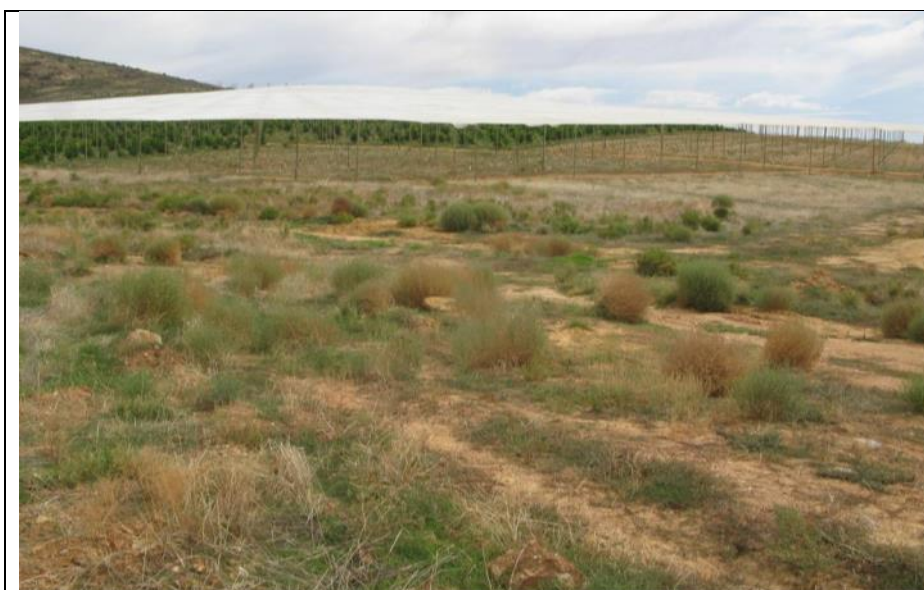
Photo 6

Showing the *Salsola kali* dominated remaining veld to the west of the dam. Again it is clear that this area were subject to heavy disturbance in the past. It is almost certain that all topsoil were removed in this area during the construction of the original dam.

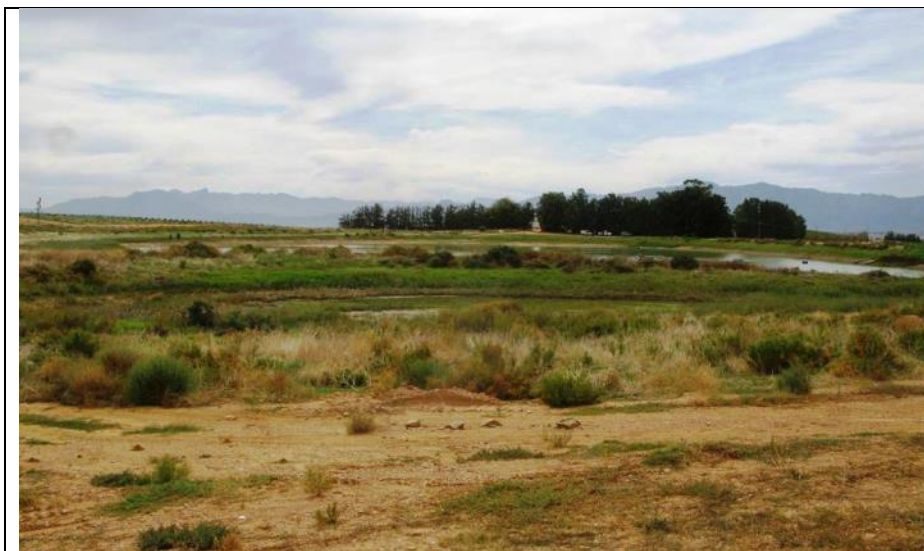
**Photo 7**

The south western corner of the dam where the CBA and ESA has been identified. Again the vegetation can only be described as transformed, with only hardy weedy and alien invasive species remaining.

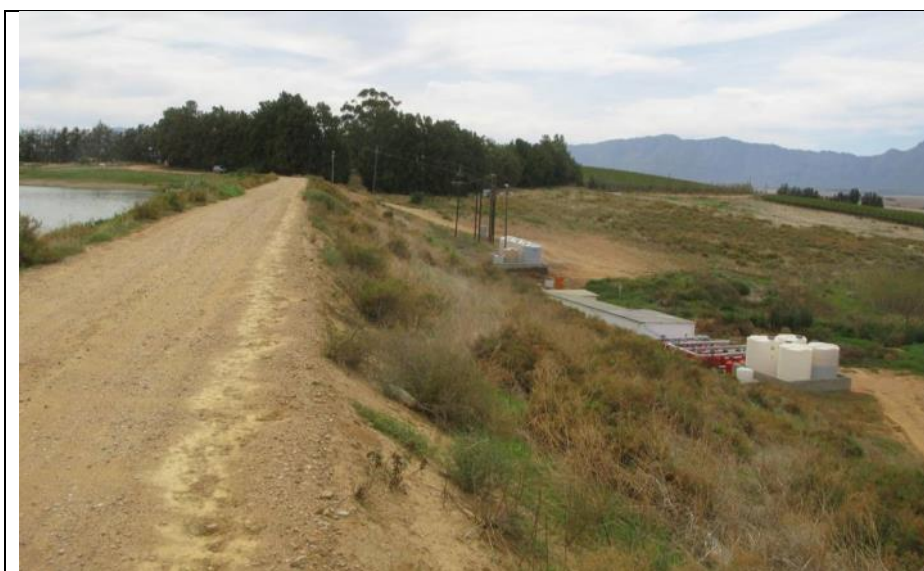
**Photo 8**

A view over the dam wall looking from west to east.
