WATER USE LICENSE APPLICATION FOR THE ESTABLISHMENT OF A NEW VINEYARD AND AN IRRIGATION HOLDING DAM ON TURKSVY FARM, UPINGTON

### **FRESH WATER REPORT V2.3**

A REQUIREMENT IN TERMS OF SECTION 21 OF THE NATIONAL WATER ACT JANUARY 2021

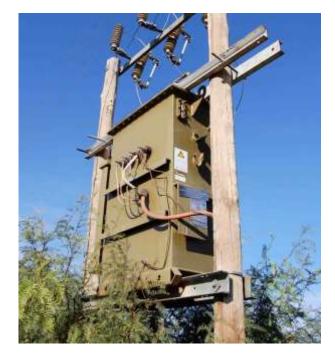
Figure 4 Transformer

The pump is electrically driven from a transformer on the river bank (Figure 4). The pole on which the transformer rests does not have the usual sign plate with a number.

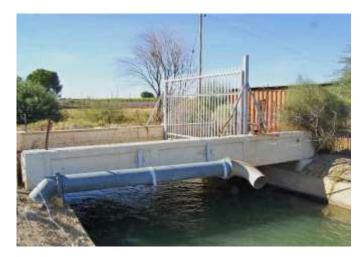
Figure 5 Point of discharge

The point where the water is dropped into the irrigation canal is shown in Figure 5.

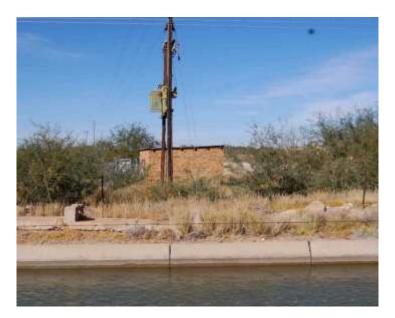
Figure 6 Abstraction point

The point where water is taken out of the canal is shown in Figure 6.

The pump to take water out of the canal is located in a pumphouse on the bank of the canal (Figure 6). Its electrical supply is from a transformer on the poles of which the numbers are shown in Figure 7. The water from the pumphouse is delivered into Turksvy Farm's irrigation system (Figure 8).

Once the new furrow has been constructed, this pump and its transformer will be decommissioned.

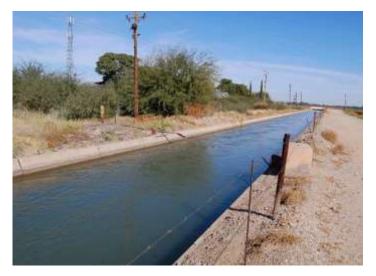
Figure 9 Proposed point of new furrow abstraction

The new furrow will be constructed on or near the following point on the canal:

28°27'35.08"S 21°16'51.96"E

The canal at this point is shown in Figure 9.

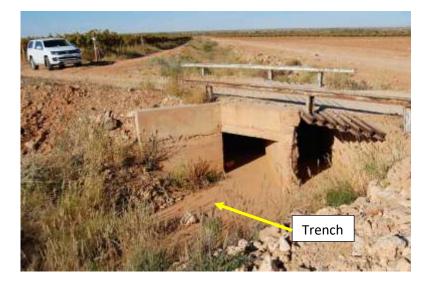
Figure 12 Culvert

In two places culverts (Figure 12) have been constructed out of the trench underneath the access road to the vineyards. From these culverts storm water is drained with perpendicular trenches through the vineyards to the large natural main drainage line at the south western boundary of the vineyards.

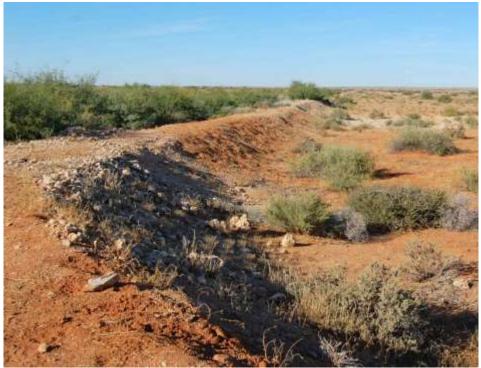
Figure 13 Berm

The south eastern end of the vineyards are demarcated by a berm. (Figure 13). This berm serves the same purpose as the trench, to cut off storm water out of the catchment. When constructed, the berm was meant to divert storm water around the vineyards, but this did not happen. Instead, storm water broke right through the berm to leave a wide gap (Figure 14). The current owner decided not to maintain the berm, but rather let the storm water through in its natural flow path and to contruct the new vineyards around the drainage line.

Yet, it was strong enough to punch a large gap right through the berm on Turksvy Farm.

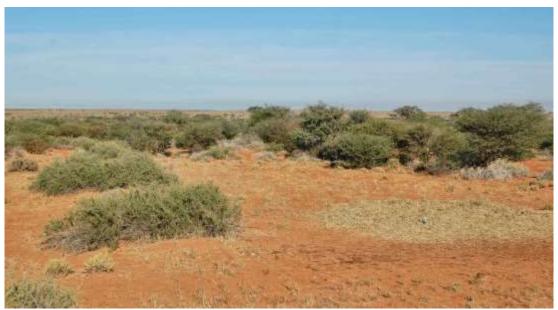
Figure 15 Vegetation on the drainage line upstream of the gap

The drainage line that goes through the vineyard area of Turksvy Farm, next to the plot that is still to be developed, is still covered with a dense stand of natural vegetation (Figure 15 and 16), such as swarthaak *Senegalia mellifera* and kameeldoring *Vachellia erioloba*. This renders the drainage line with a particular conservation value. The preservation of this drainage line would contribute to decision-making and a positive outcome for the proposed farming opportunity.

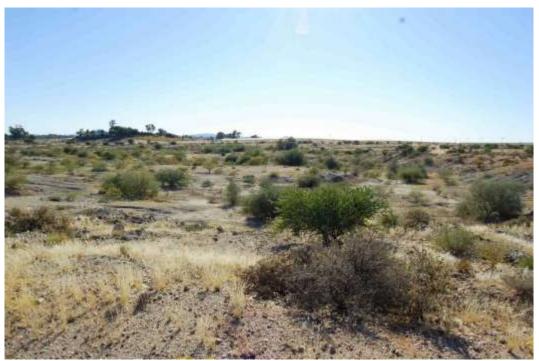
Figure 17 Location of holding dam

The small holding dam will be constructed in a depression that is deemed to be a borrowing pit for road building. A shallow scrape has been left, with the regrowth of some vegetation (Figure 17).

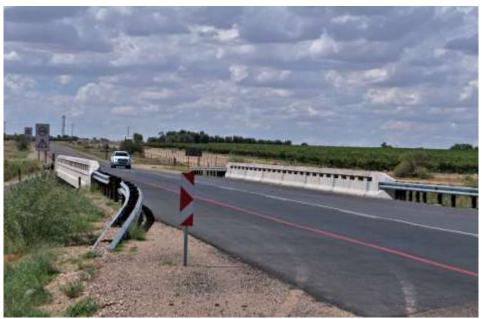
Figure 20 Trunk Road Bridge

Where the main drainage line from the sub-catchment passes underneath the N10 Trunk Road (Figure 20, bridge), it forms a large *Phragmitis* reed bed on both upstream and downstream of the bridge (Figure 21 and 22). Naturally, prior to human impact, this reedbed probably was absent, with a mostly dry and tree lined drainage line. The reeds established itself because of agricultural return flow and storm water as well as sewage spills out of Louisvale.

Upstream from the bridge on the left is the large Turksvy Farm vineyard. On the right is the informal settlement of Louisvale. Downstream from the bridge the agricultural development is extensive.

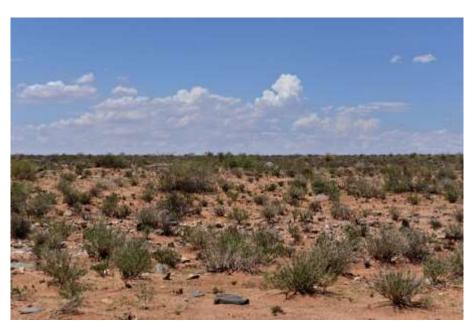
Figure 23 Upper part of sub-catchment

The upper part of the sub-catchment is largely natural (Figure 23), but closer to Louisvale it is entirely transformed into a dumping site for building rubble and other waste (Figure 24). The area is defaced by large quantities of litter. It was hard to see any conservation value in this area.
