BOTANICAL STATEMENT (Revision 1)

JADE HILLS DAM

**Proposed development a new dam and the re-development of existing agricultural land
on Portion 26 Of The Farm Stink Fontein 383, Ceres.
Witzenberg Local Municipality, Western Cape Province.**

12 February 2021

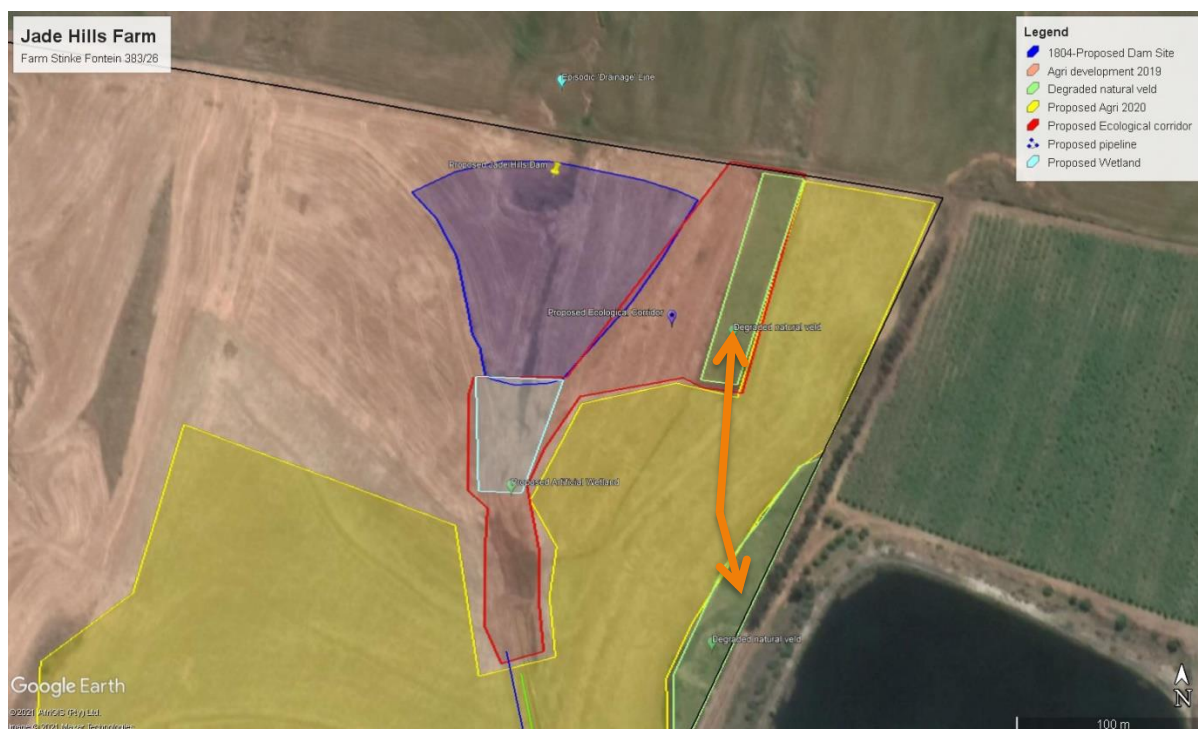
However, just east of the proposed new dam site, and along the eastern boundary of the property (marked by the arrows in Figure 6) two areas of degraded natural veld remains, protected within two rocky areas or ridges. Even though it was burned, many indigenous species could be identified. Some were re-sprouting, some were just re-emerging and some can be identified from remains. Both these area will not be impacted by the proposed development footprint and should be considered for protection as part of the proposed new ecological corridor and wetland area that is proposed as part of the development plan.

Figure 6: Google image, showing the proposed dam, cultivated land surrounding the dam and the two rocky ridges

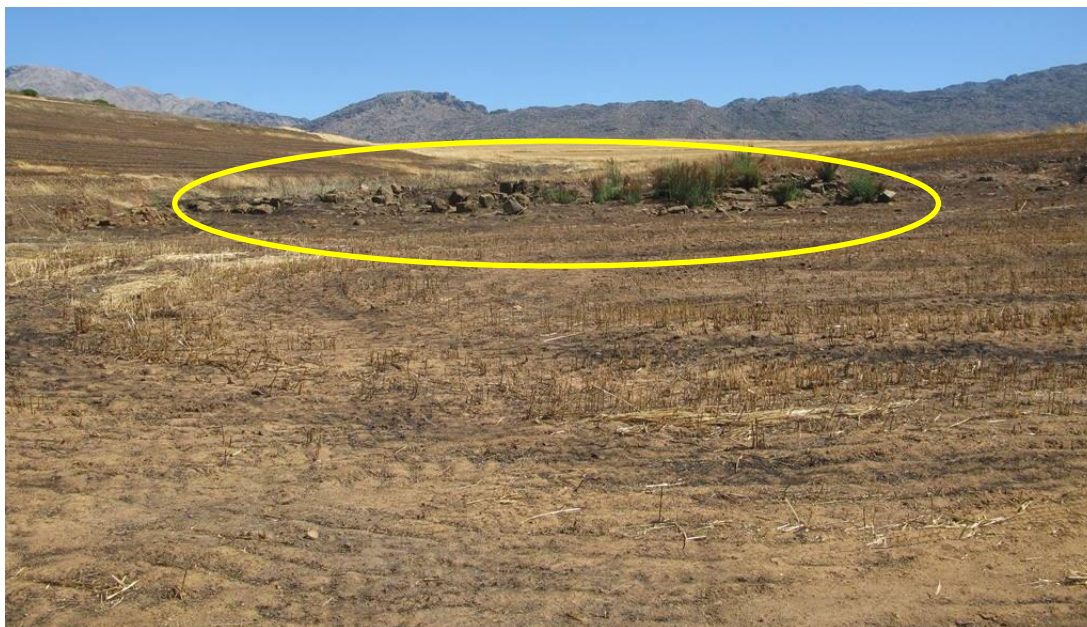
No natural vegetation was encountered on the site or its immediate surroundings, apart from a few hardy species (e.g. *Asparagus* species and *Montinia caryophyllacea*) that persisted in a small rocky outcrop within the proposed dam footprint (Refer to Photo 1). Because of the recent fire, it was not easy to identify many of these plants past genus level.

Photo 1: The proposed dam site, looking from the bottom of the small valley to the top of the proposed dam (Note the small remaining rocky patch within the dam, which supported the only remaining indigenous species within the proposed dam site, as discussed above).

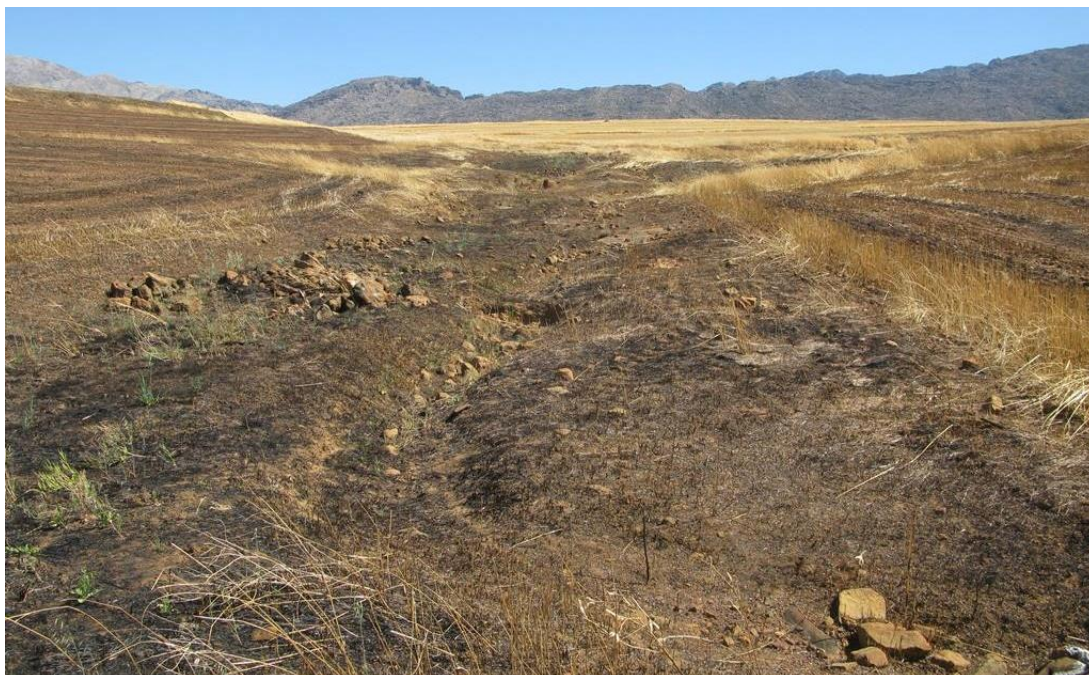
Apart from the above, no other natural vegetation remained within the proposed footprint (Refer to Photo 2-4). Photo 2 shows the small valley bottom seasonal water course associated with the ESA in Figure 4 (WCBS, CBA map). Although the fire had burned away any remaining plant species it is clear that the small stream had

not supported any significant shrub or tree species, in fact it seems as if any previous riparian vegetation had been replaced by a grassy cover.

Photo 2: The small seasonal valley bottom water course entering the dam (note the disturbance and absence of any riparian vegetation)

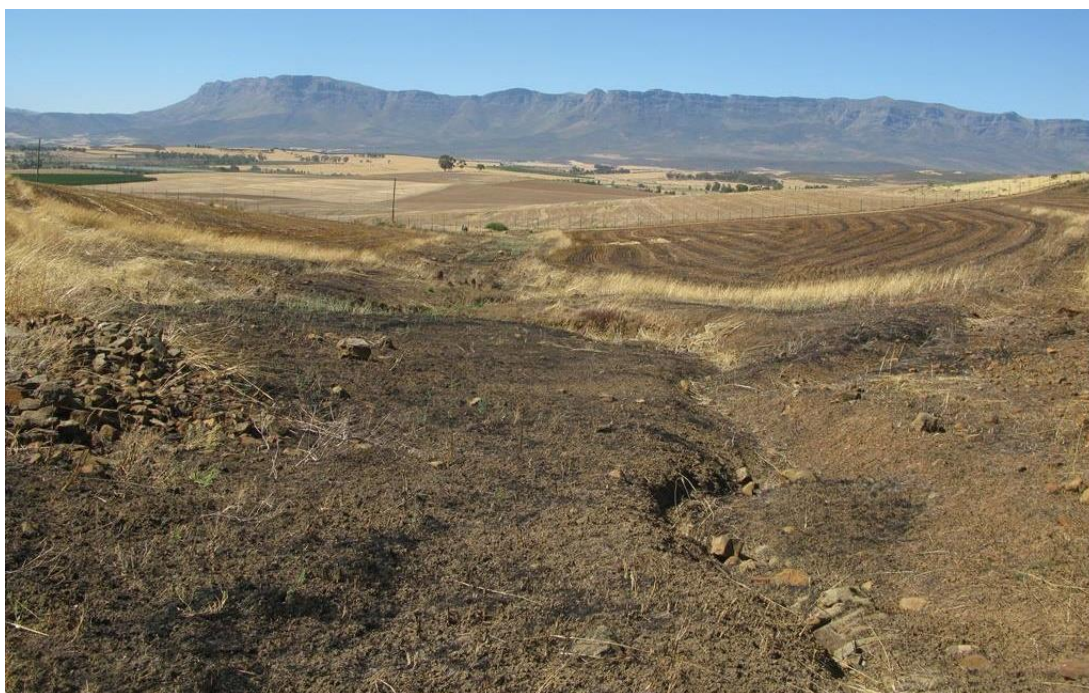
Photo 3 was taken from the inlet of the proposed new dam, down into the small valley that will become the dam (looking from south to north).

Photo 3: Looking over the proposed dam from north to south

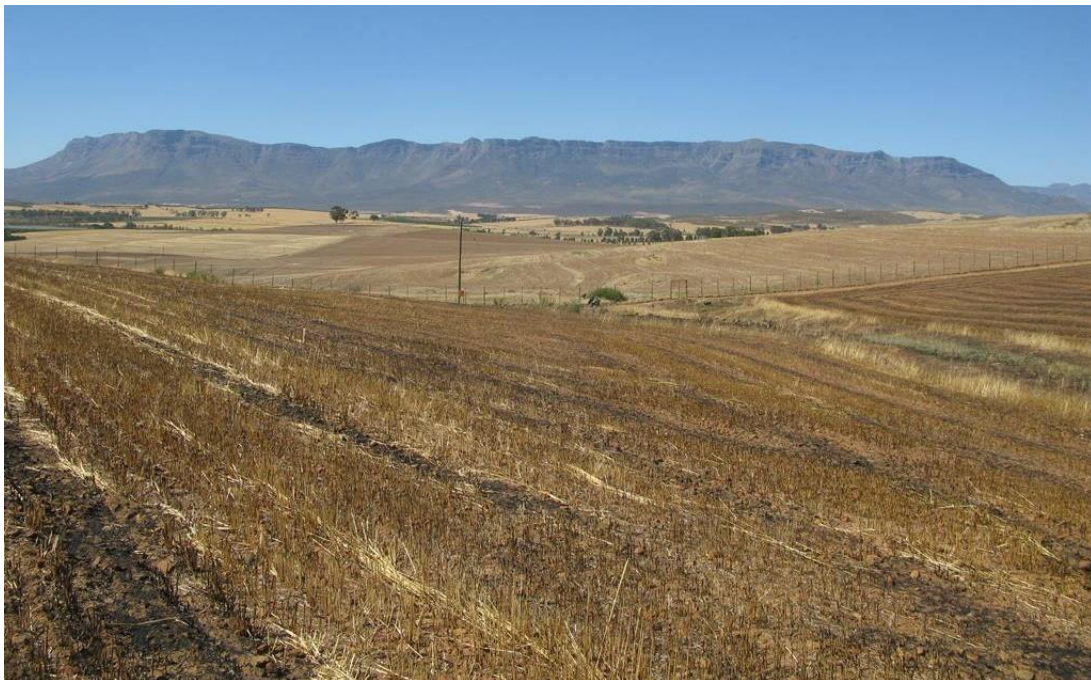
The following photos all show the degraded status of the proposed dam site. Photo 1, 2, 4 & 5 shows the proposed dam site from all the angles.

Photo 4: Looking over the proposed dam from the western embankment

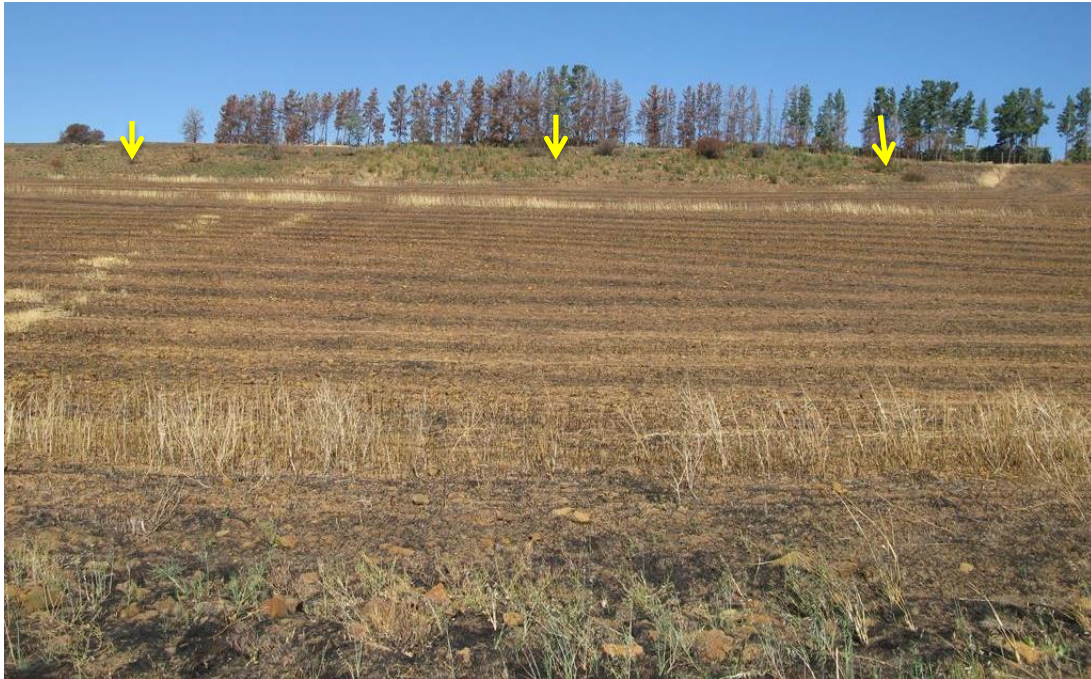
Photo 6 & 7 shows the rocky ridge to the east of the proposed dam. Although a recent fire temporarily removed most of the vegetation cover it was still easy to determine that the vegetation supported by this ridge is be mainly indigenous. Because of the fire it was difficult to identify any plants further than genus level with any certainty.

Photo 6: The rocky ridge with remaining natural vegetation, to the east, and outside of the proposed footprint of the dam

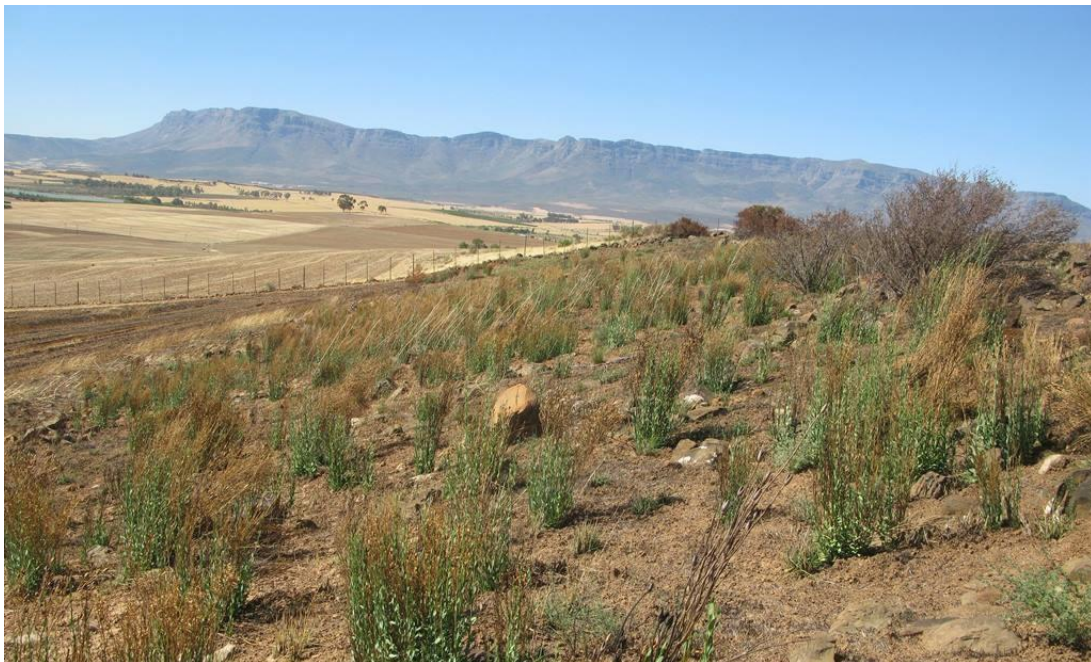
The vegetation of the rocky ridge seems to have been (and still are) dominated by *Montinia caryophyllacea* (the common pepper bush), which can be seen re-sprouting in Photo 7. Other species observed includes a number of bulb species, *Searsia glauca*, *Asparagus* species, *Galenia africana* and *Stoebe* cf. *plumose*. All of these plants are either hardy shrubs or pioneer species.

Photo 7: The remaining vegetation on the rocky ridge

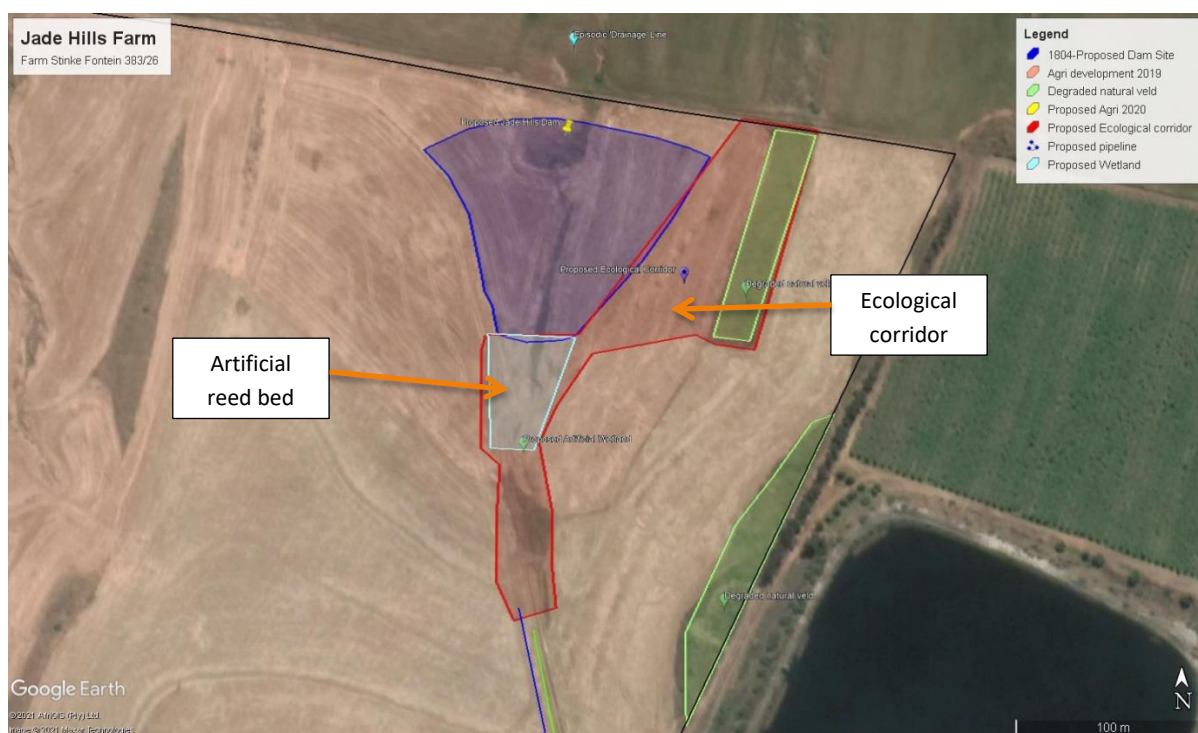
Figure 7: Sensitivity map showing potential positive spin-offs as recommended above

- A suitably qualified Environmental Control Officer must be appointed to monitor the construction phase.
- Both areas of degraded natural veld indicated in Figure 7 (underneath) should be protected as remaining natural veld (Figure 7).
- Before any work is done the site and access routes must be clearly demarcated (with the aim at minimal width/smallest footprint).
- Lay-down areas or construction sites must be located within already disturbed areas or areas of low ecological value and must be pre-approved by the ECO.
- All areas impacted as a result of construction must be rehabilitated on completion of the project.

- An integrated waste management approach must be implemented during construction.
- It is recommended that a small artificial wetland is established where the small seasonal stream enters the dam and that all water from the Water Scheme are pumped to above this wetland, so that it will also enter the dam through the wetland. This inlet should then be planted with reeds like *Phragmites australis* and / or *Typha capensis*, which will over time, establish itself in a dense stand, which will help to clean the incoming water before it reaches the dam. Properly designed and managed farm dams can attract a variety of birds, insects and animals to the area and so contribute to conservation of biodiversity (Refer to Figure 7 underneath).

- A second potential positive spin-off could be to incorporate the remaining natural veld on the rocky ridge to the east of the dam within the dam site itself, by fencing it in with the dam, or by refraining from cultivating the land between the dam and the rocky ridge, so that a slightly larger natural corridor can be

established linking the artificial wetland with the remaining natural veld and with the dam (Refer to Figure 7).
