**FRESHWATER RESOURCE VERIFICATION FOR THE
PROPOSED JADE HILL DAM, ON THE FARM
STINKFONTEIN 26/383, CERES, WESTERN CAPE**

EnviroAfrica cc

January 2019

Prepared by:	Scientific Aquatic Services
Report authors:	C. du Preez K. Marais (Pri. Sci. Nat)
Report reviewer	S. van Staden (Pr. Sci. Nat)
Report Reference:	SAS 219013
Date:	January 2019

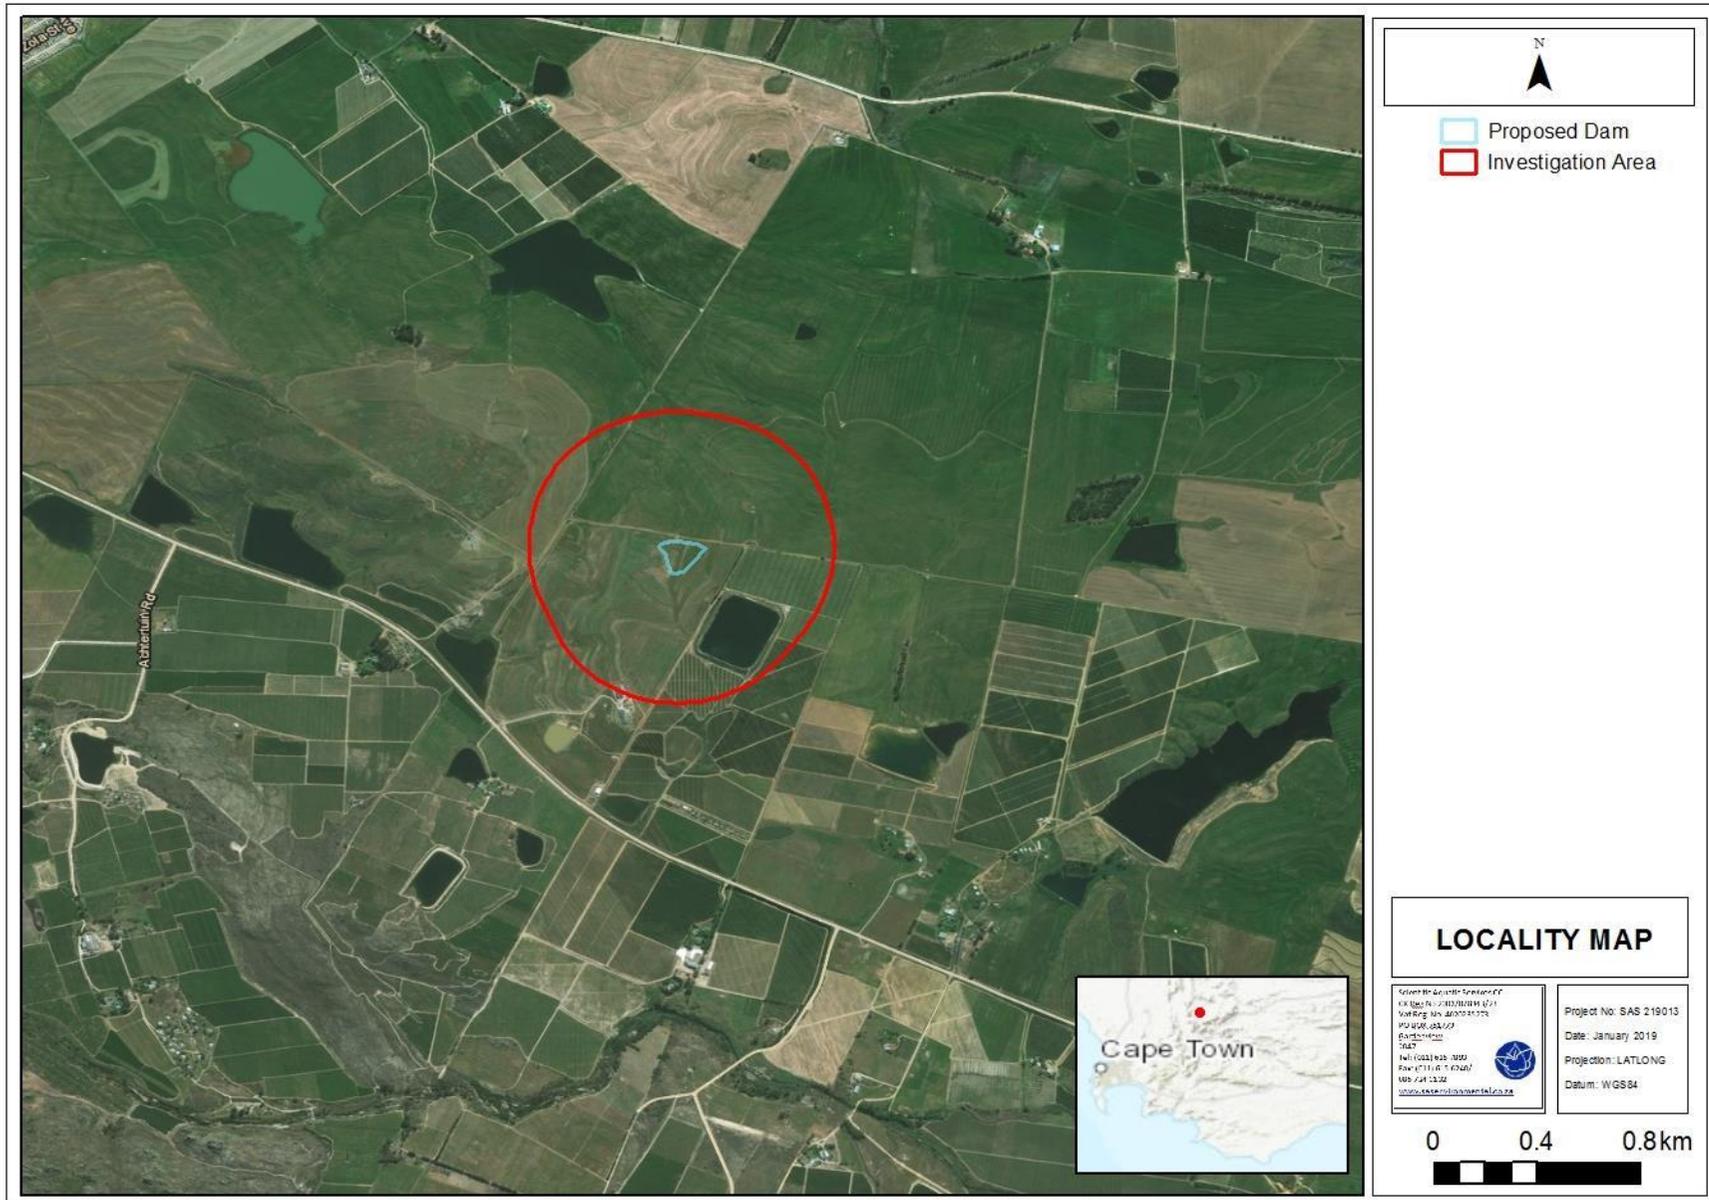
Figure 1: Digital satellite image depicting the footprint area of the proposed dam in relation to the surrounding areas.

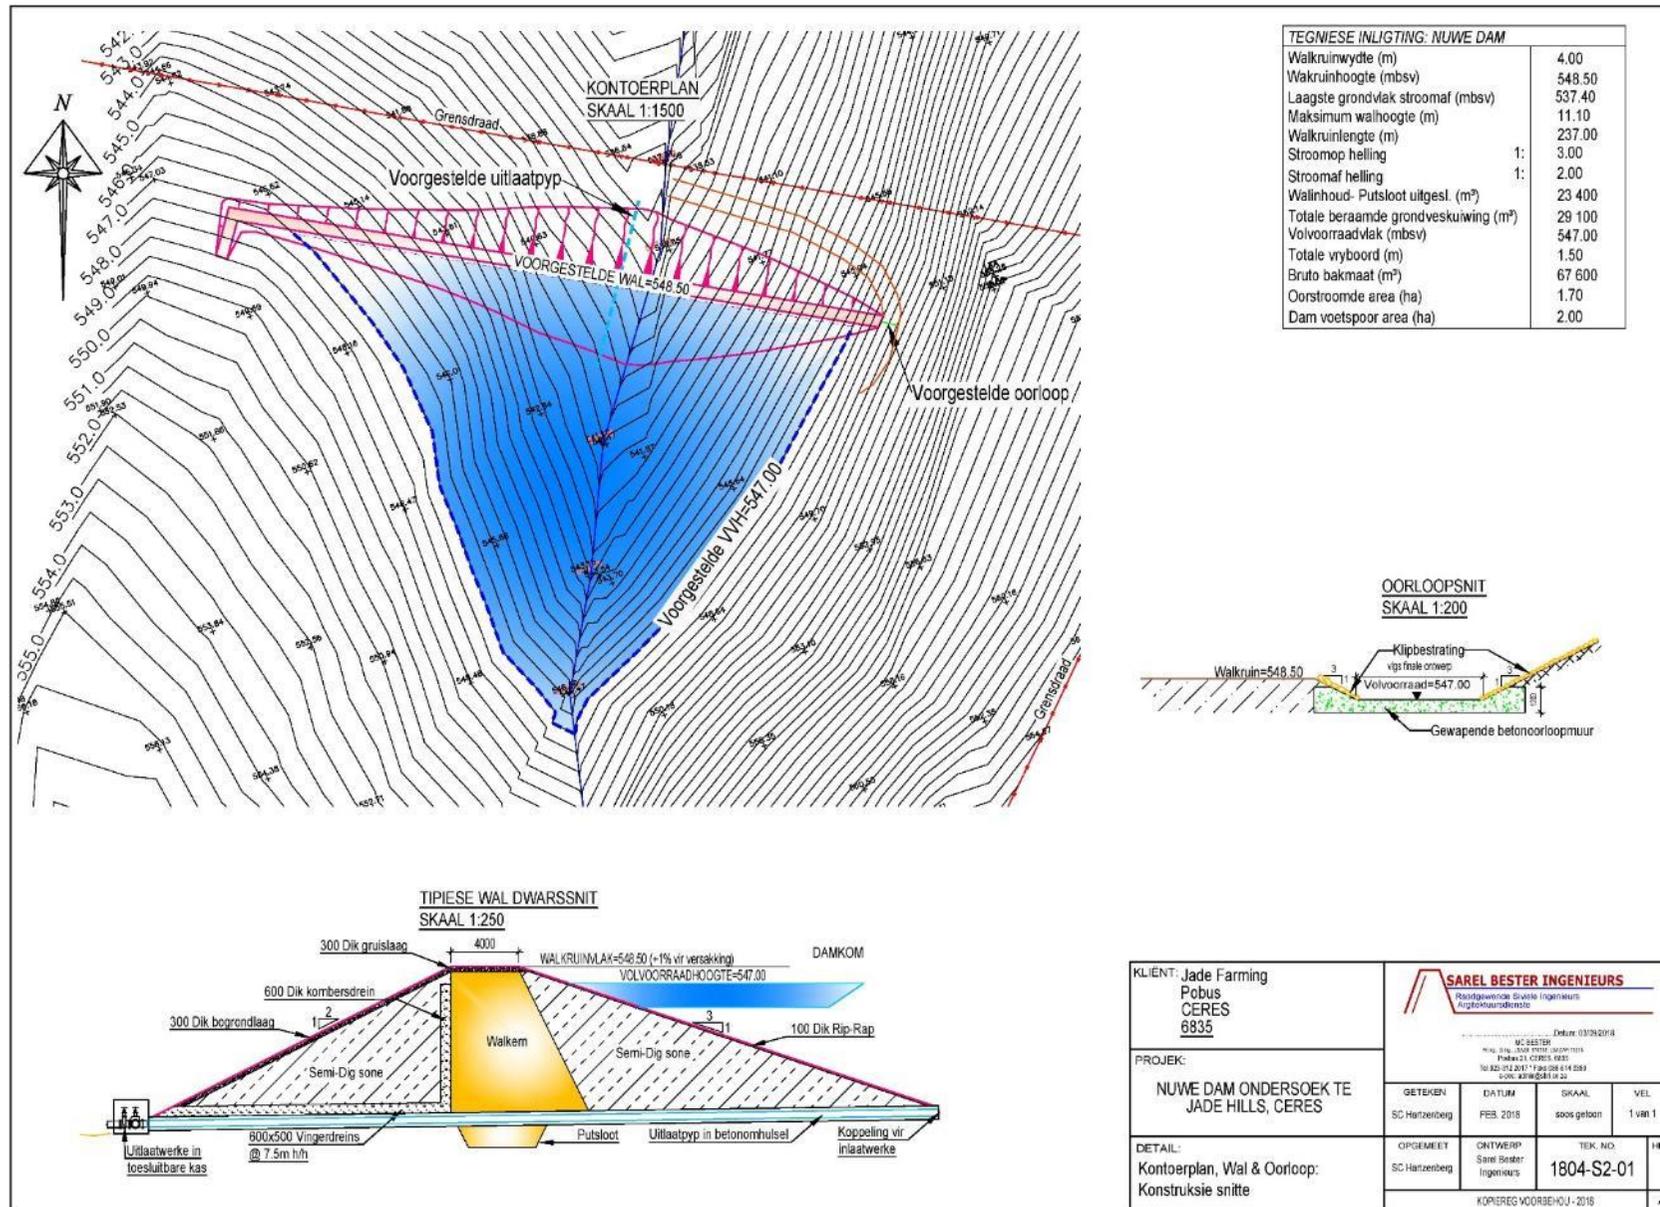
Figure 3: Proposed design drawing of the Jade Hill dam and associated dam wall (Sarel Besters Ingenieurs, 2018).

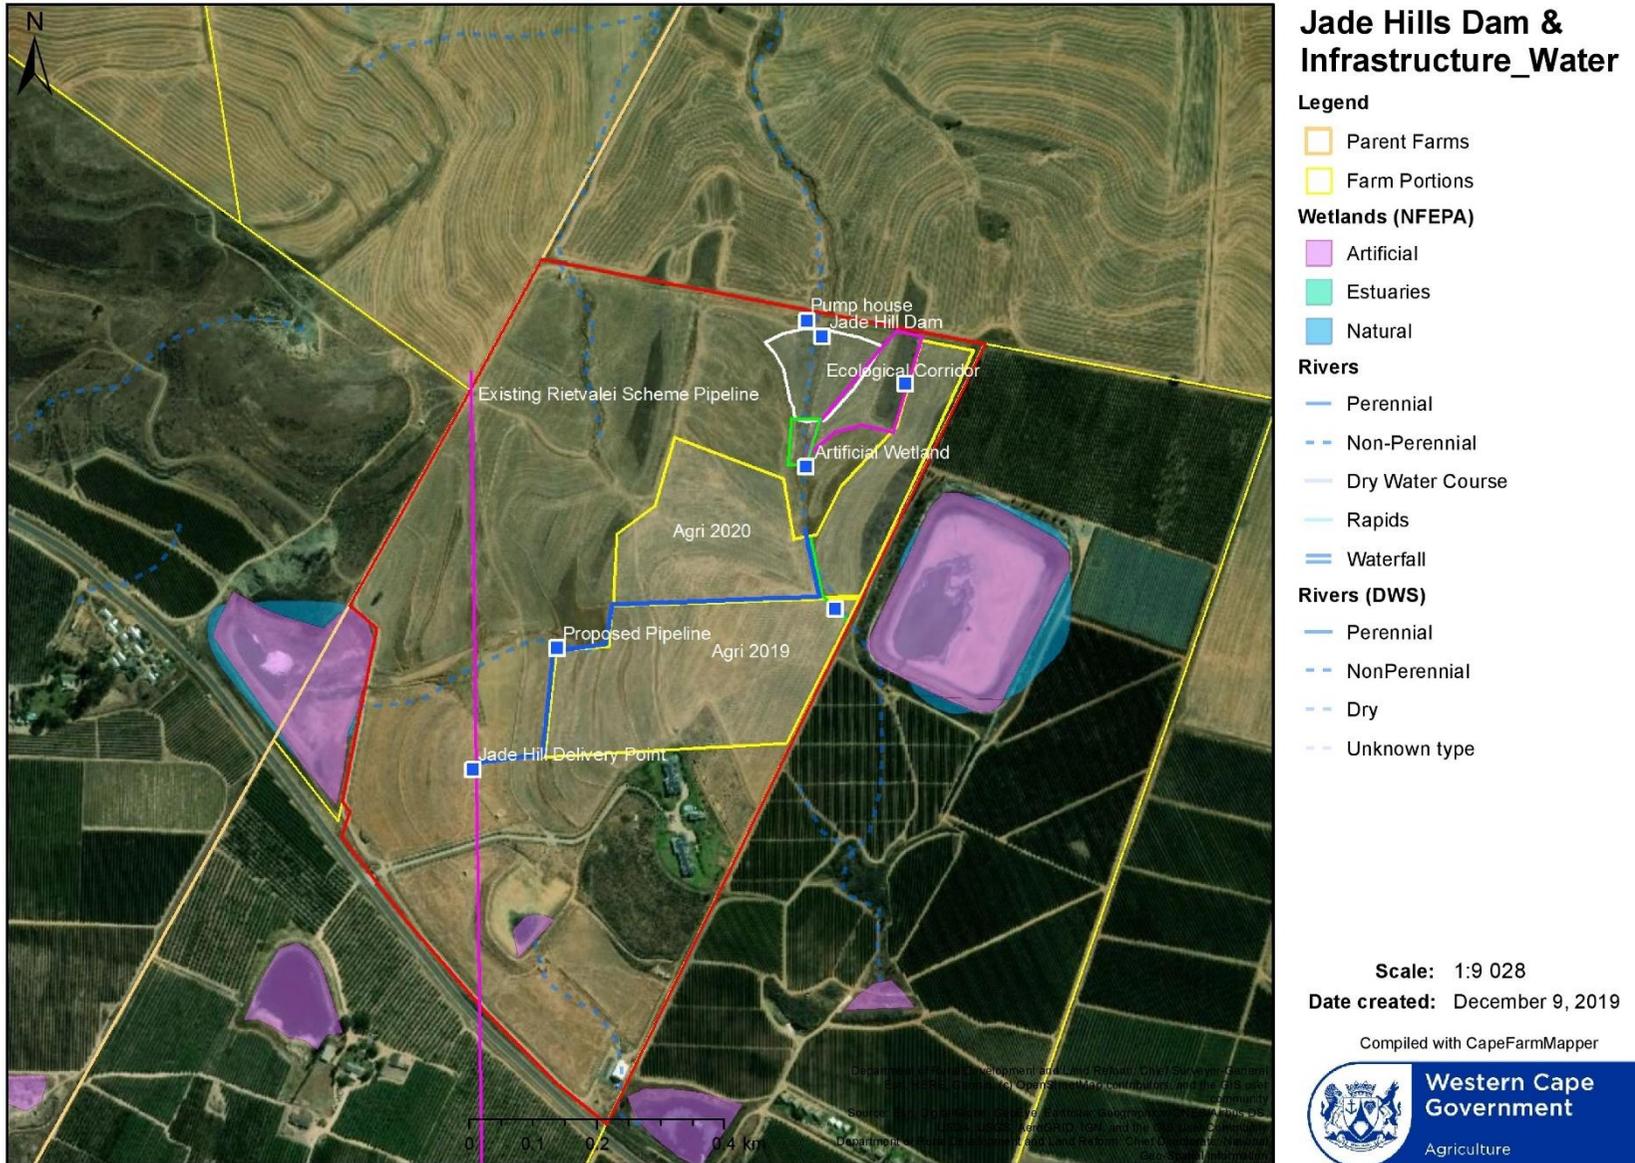
Figure 4: Infrastructure proposed as part of the Jade Hill dam development (white outline). The blue line depicts the proposed abstraction pipeline connecting to the Rietvallei irrigation scheme pipeline (the existing pipeline is indicated by the pink line) (EnviroAfrica, 2019).

On review of the location of the proposed dam, the surrounding area has primarily been transformed by agricultural activities, including the construction of other dams within the drainage features of the region as a whole. This can be seen in the historical imagery dating back to 1942 when compared to the most recent digital satellite imagery (2017) (Figure 5). The transformation of the surrounding areas to cultivated fields has also significantly modified the movement of surface water through the landscape (Figure 4).

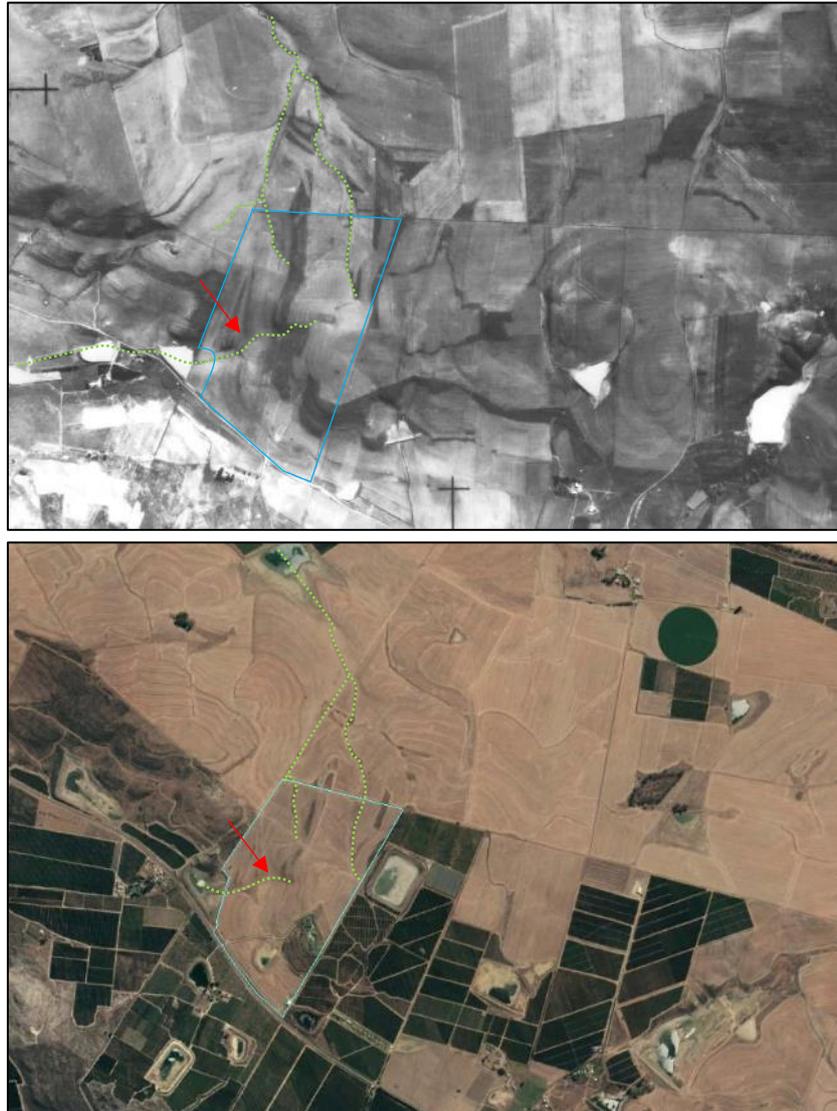
Figure 5: (Top) Historical imagery (circa 1942) of the farm on which the proposed Jade Hills dam would be developed, compared to the most recent satellite imagery (circa 2017). The blue outline indicates the boundary of the farm and the green dashed line indicates the surface flow paths. Take note that the surface flow path in the south western portion of the farm (as indicated by the red arrow) has been altered by surrounding agricultural activities.

- a. Based on the most recent digital satellite imagery of drainage line 2 (Figure 5 and 6), it presents with similar digital characteristics as that of the drainage line within the dam footprint, except that drainage line 2 is narrower and its catchment seemingly smaller.

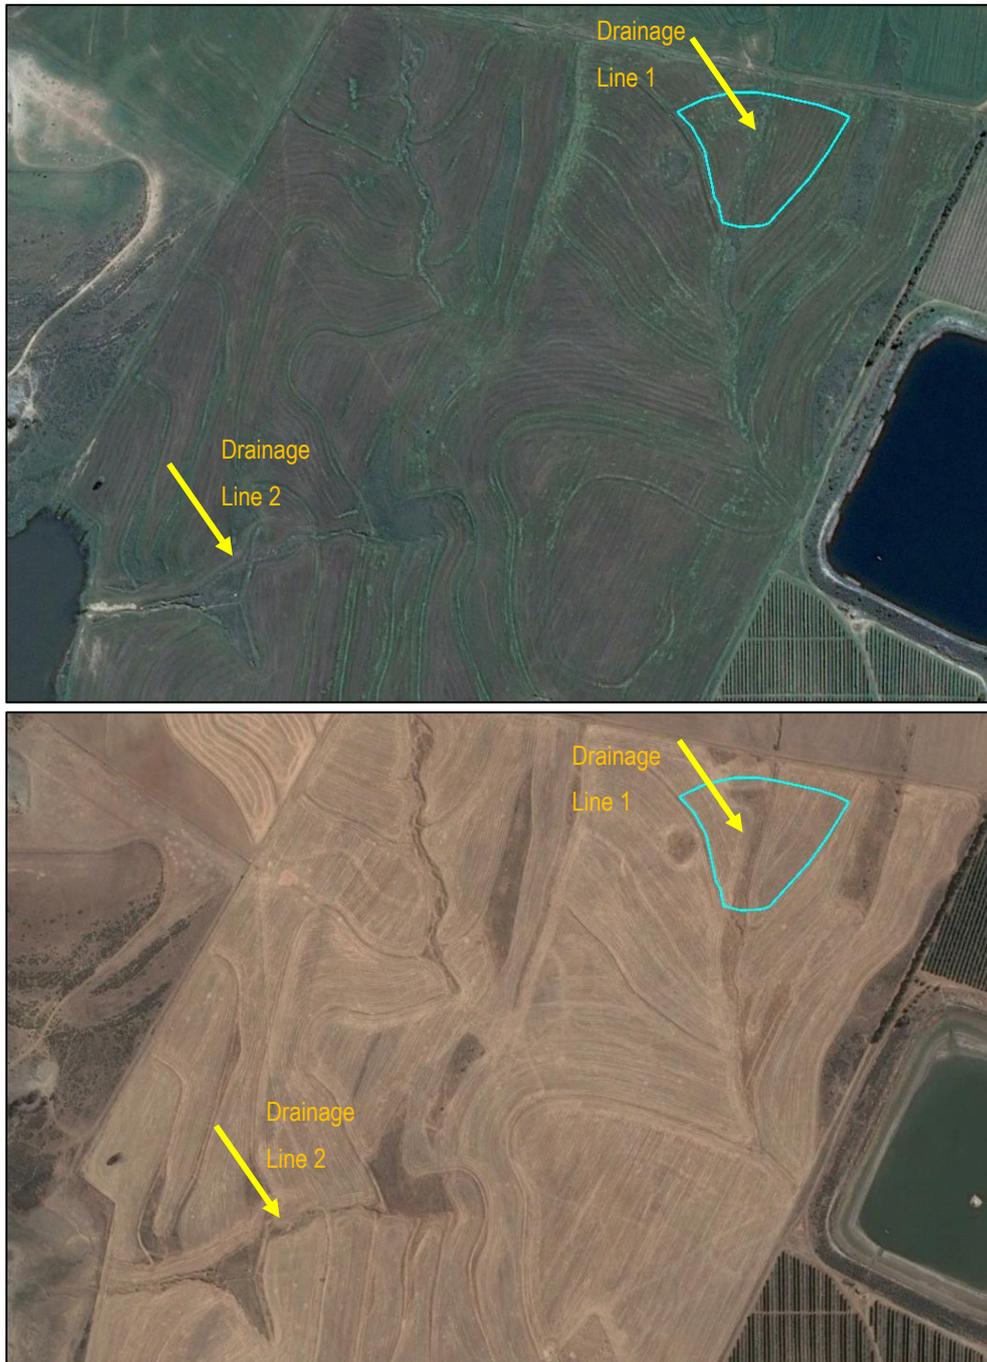
Figure 6: Digital satellite imagery from 2013 (Top – wet season) and 2017 (Bottom – dry season), shows an area with a different digital signature than that of the surrounding area (indicated by yellow arrows). These areas correspond to the drainage lines as identified within the historical imagery (Figure 5).

Furthermore, on comparison of the digital satellite imagery available between 2013 and 2017; imagery from 2013 (just after the wet season) (Figure 6) indicates a pronounced wetness digital signature of the drainage line within the footprint area of the proposed dam (hereafter referred to as 'drainage line 1') and a drainage line located south west of the footprint area (hereafter referred to as 'drainage line 2'), correlating to a surface flow paths identified in the historical imagery (Figure 5). After a period of drought in the Western Cape, and imagery of the dry season (December 2017), an area distinctly different to that of the surrounding area, is visible (Figure 6).

7. Based on the description of drainage line 1 associated with the proposed Jade Hills dam development above and its digital satellite signatures (Figure 6), the drainage lines in the investigation area (west of the proposed dam, as presented in Figure 14) could be considered to have similar on-site characteristics as the drainage line associated with the proposed Jade Hills dam footprint. These drainage lines were not assessed on site (only considered as part of the desktop assessment as they are within the 500m investigation area), but since the drainage line south west of the proposed dam (drainage line 2) may potentially be crossed by the proposed abstraction pipeline (Figure 4), it must be considered as part of this watercourse verification report.

- b. From digital satellite imagery (Figure 6) it can be seen that the local catchment of drainage line 2 has been transformed by cultivation and there are also no distinct changes in structure from the vegetation in drainage line 2 to that of the surrounding area. Based on this, the functioning and ecological condition of drainage line 2 is expected to be similar to that of the drainage line 1. As such, drainage line 2 may function as a waterway, through episodic conveying of water, and therefore potentially enjoys protection in terms of the National Water Act, 1998 (Act No. 36 of 1998), if a 1:100 floodline is present. To accurately determine the ecological condition and functionality of drainage line 2, it is recommended that it be verified during an on-site verification assessment.

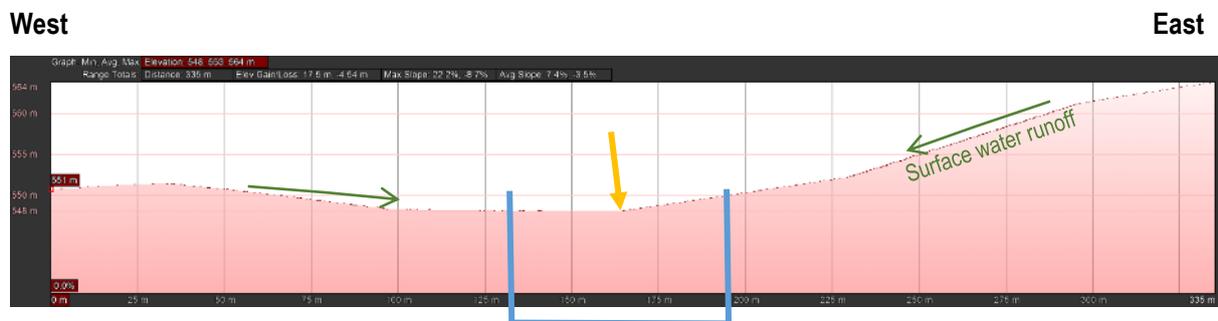
Figure 7: The elevation profile of the proposed Jade Hills dam, indicating the position of the dam (blue lines) and the locality of the drainage line (yellow arrow) relative to the elevation of the surrounding area.

An elevation profile (Figure 7) generated for the footprint area of the proposed dam using Google Earth, shows that the proposed dam would be located within a footslope position (in a south to north direction), but located in a valley area between sloped areas, west and east of the proposed dam area. Based on this, the topographic setting of drainage line 1 (as indicated in Figure 7) within the landscape, indicates that water would drain into this area of lowest relief and drain further in a northerly direction. The drainage line is further identifiable on the 1:50 000 topographical map provided in Figure 2.

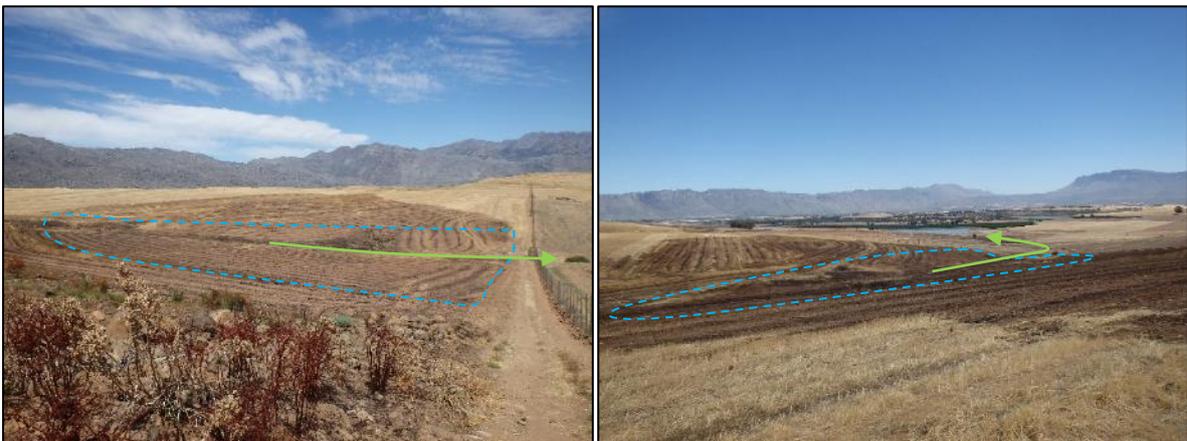
Figure 12: The blue line indicates the approximate extent of the footprint area of the proposed dam. The landscape position changes from a footslope (right) into a valley bottom position (left), draining in a south to north direction (green arrow).

1. The footprint area of the proposed dam is located within the footslope position in the landscape, changing into the valley bottom position just north of the proposed dam area (Figure 12). The proposed dam area has been burnt and cultivated.

2. An episodic^[1] drainage line was identified to be located in the footprint area of the proposed dam (Figure 12). This drainage line is referred to as drainage line 1. This feature is considered to be degraded as it has no natural riparian vegetation remaining and very few vegetation species were present (vegetation had not recovered after the area was burnt). An erosion gully was present within the drainage line, of which the depth thereof was more incised in the downstream reaches. The natural compaction and rocky nature of the soil (strong soil structure)

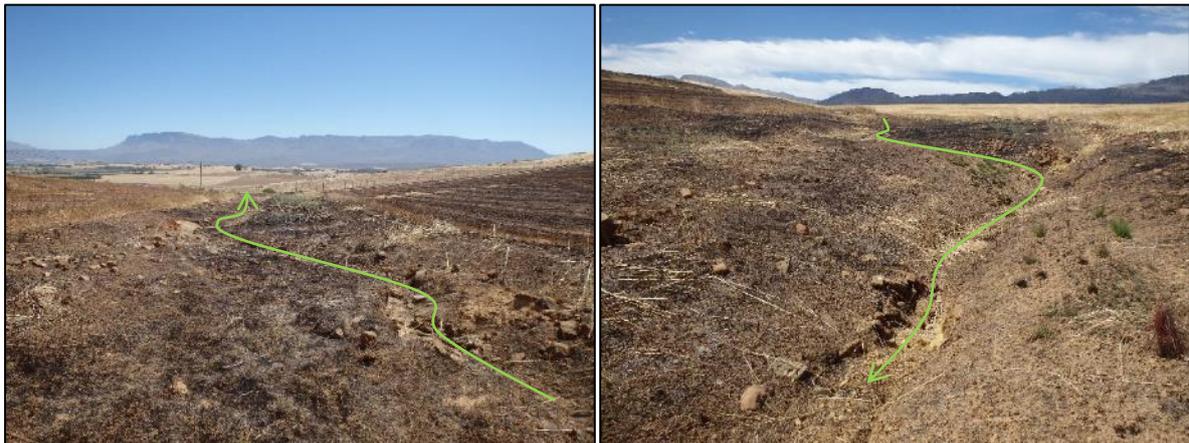
Figure 13: Photographs of the drainage line located within the footprint area of the proposed dam. The drainage line has an eroded gully, which varies in depth between its upstream and downstream reaches. This drainage line and the general surrounding area is rocky, and it is evident that some of the rocks removed from the surrounding cultivated areas have been placed within the drainage line. (*The green arrow indicates the direction of drainage).

prevents exacerbation of erosion, but due to the removal of the vegetation in the surrounding area and the degradation thereof in the drainage line, the depth of the erosion gully is deeper in the downstream reaches of the drainage line in the investigation area. This drainage line enters a dam located approximately 930m north of the proposed dam area. No other wetlands were found to be located within the footprint area of the dam nor the investigation area. The wetland flat identified by the NFEPA Database (Figure 10) to be located within the investigation area was identified as a dam located south-east of the proposed dam area. The locality of the drainage line in relation to the footprint area of the proposed dam and its investigation area is presented in Figure 14.

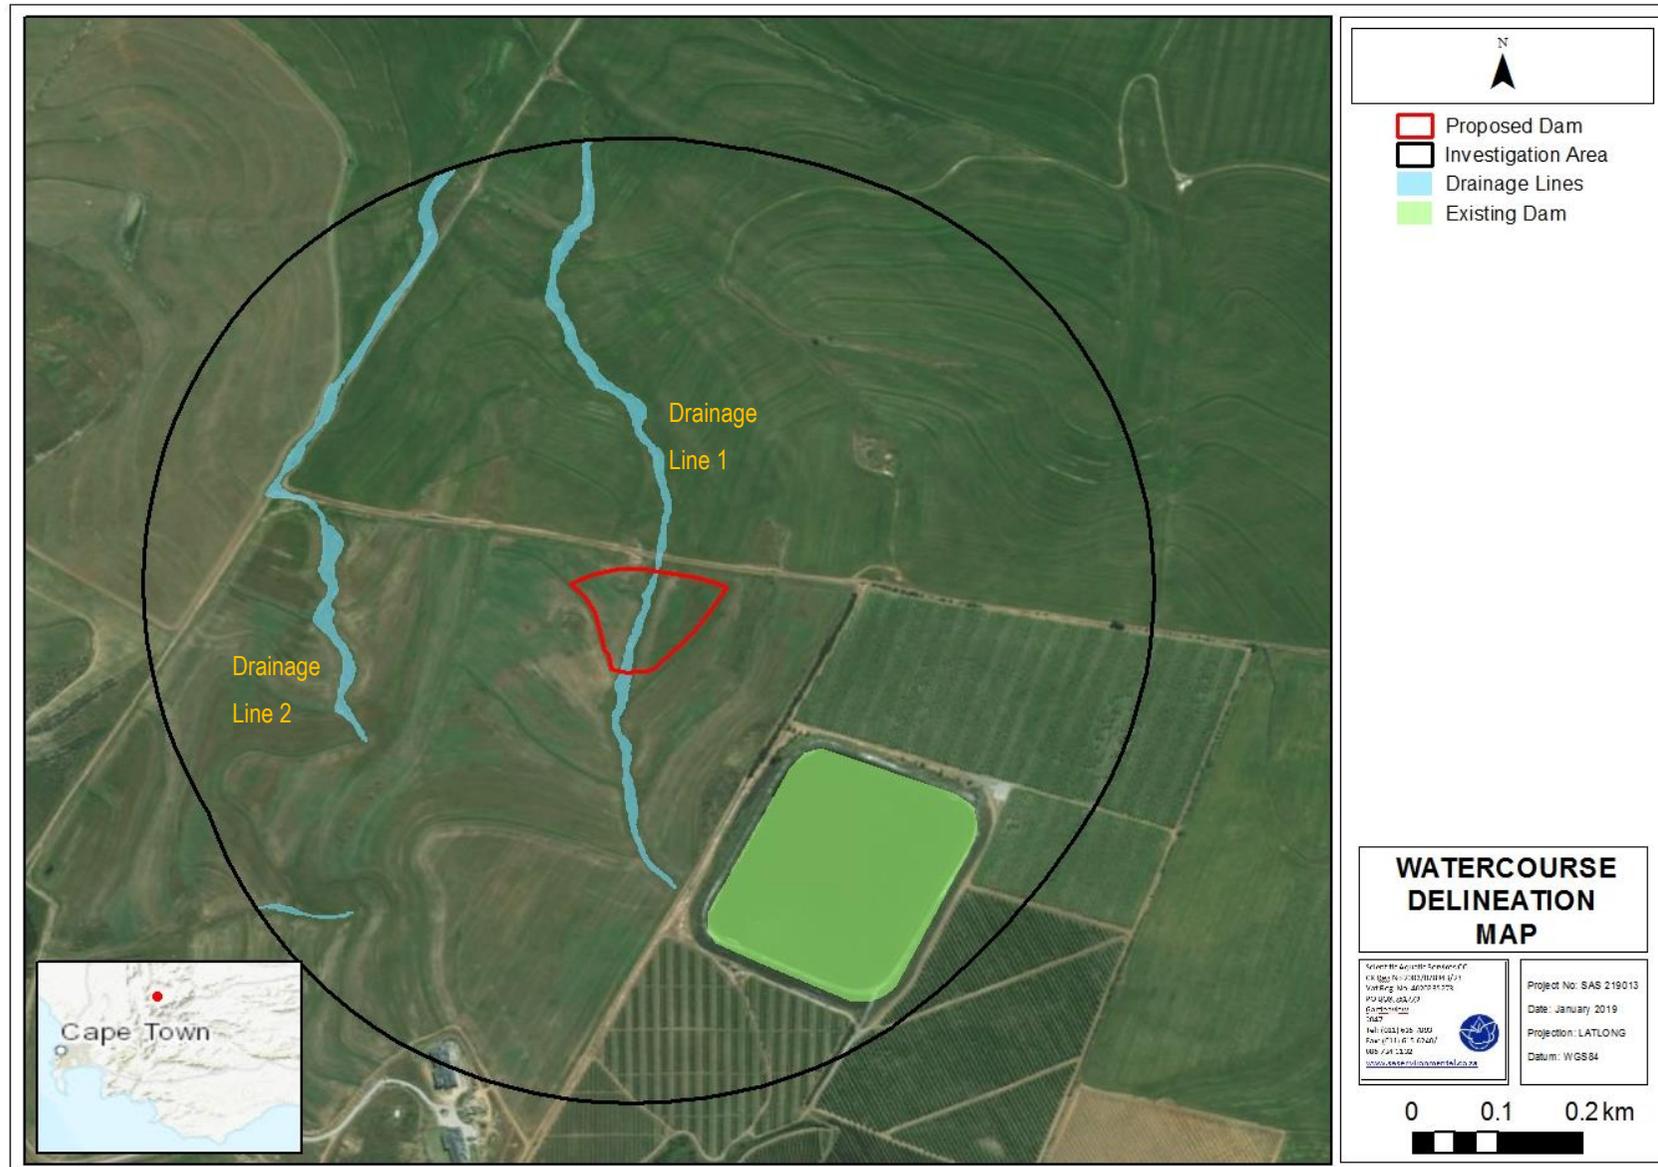
Figure 14: The delineation of the drainage line located within the footprint area of the proposed dam, in relation to its investigation area.

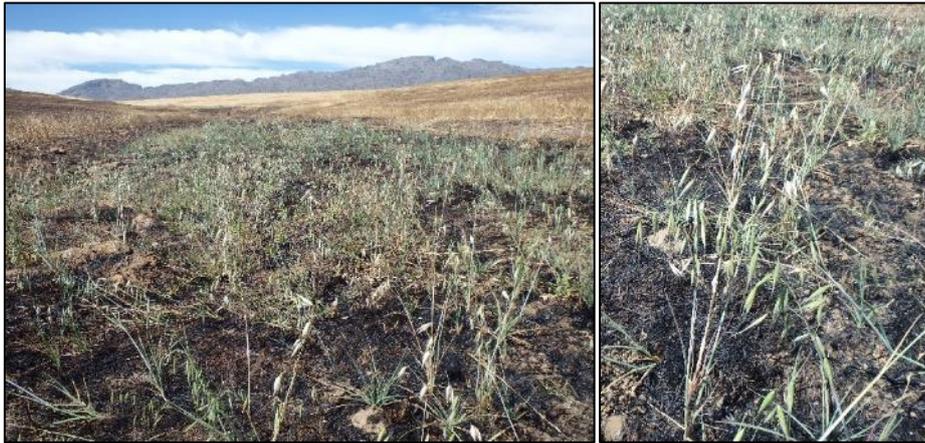
Figure 15: The grass species *Avena fatua* was found to be the dominant vegetation species during the time of assessment, with no other natural riparian vegetation identified.

Despite the vegetation component of the drainage line being significantly disturbed (mainly due to the surrounding cultivation activities), no remnants of sedges or any other type of indicator watercourse vegetation could be identified. The drainage line is mostly dominated by grass species, specifically *Avena fatua* (wild oats), a common weed species occurring in areas of disturbance (Figure 14).

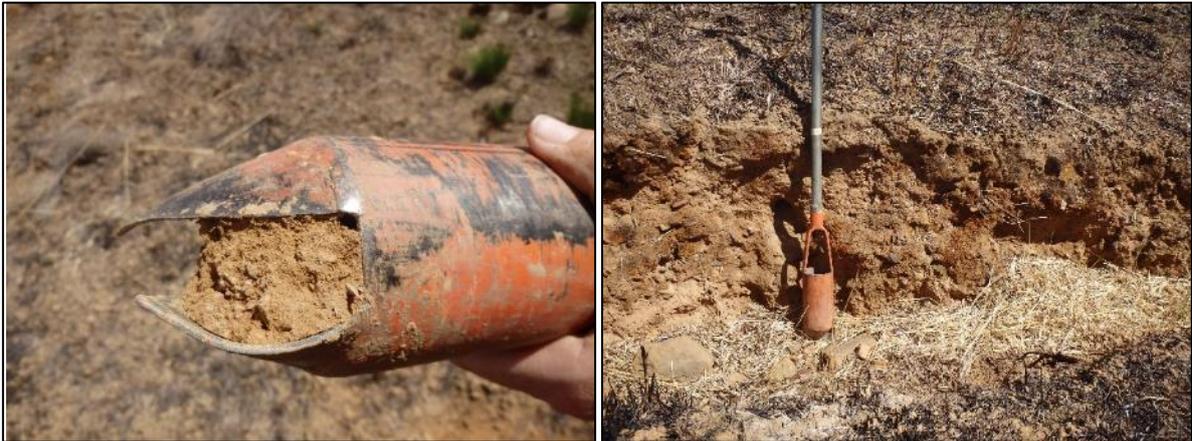
Figure 16: (Left) A hand auger sample, indicating uniform soil colour and strong structured soil. (Right) The soil profile of the erosion gully is rocky did not show any variation in colour or structure.

The soil profile associated with the drainage line was investigated using a hand auger (Figure 16). Due to the rocky nature of the area, it was only possible to auger to a depth of 20cm. This auger sample was uniform in colour (orange/brown) and did not show any redoximorphic features such as mottling or gleying (which is caused by prolonged saturated conditions in the soil and the subsequent development of anaerobic conditions). Upon investigation of the soil profile of the erosion gully, no variation in soil characteristics were evident (Figure 16), only indicating that the drainage line is composed of shallow compacted, strong structured soils on a hard bedrock (to which the gully has eroded to). Nevertheless, during the event of rainfall, surface runoff would enter the drainage line, in which water would then be conveyed into the larger downstream area which enters a dam approximately 930m north of the proposed dam area.

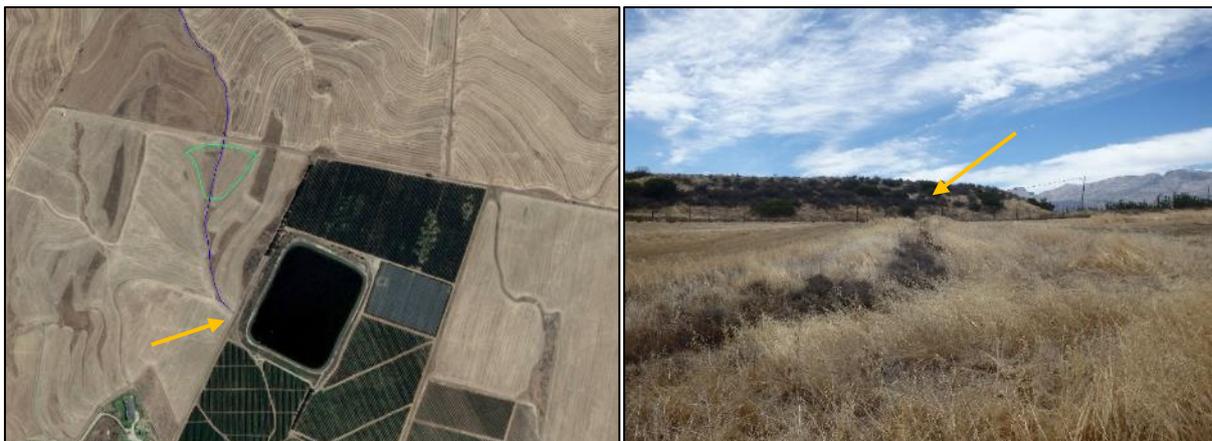
Figure 17: (Left) Digital satellite imagery indicating the most upstream point of the drainage line (yellow arrow) relative to the dam. (Right) It is clear that the drainage line is located just downstream of the dam, however, no evidence of seepage from the dam was evident.

4. This drainage line is expected to have surface water present only during and immediately after rainfall events, in which water would be present for a few days (if not shorter) and conveyed to the downstream dam. During the site visit, it was evident that the most upstream point of this drainage line is directly below an existing dam (upstream and south-east of the proposed dam area) (Figure 17). No evidence of an outlet from the dam or visible seepage into the drainage line was evident, but it is possible that if the dam reaches full capacity, spill over water would be conveyed within the drainage line.
