Fresh Water Report

Proposed enlargement of the dam

Farm Zwartfontein 792, Malmesbury Version 2.1

June 2020

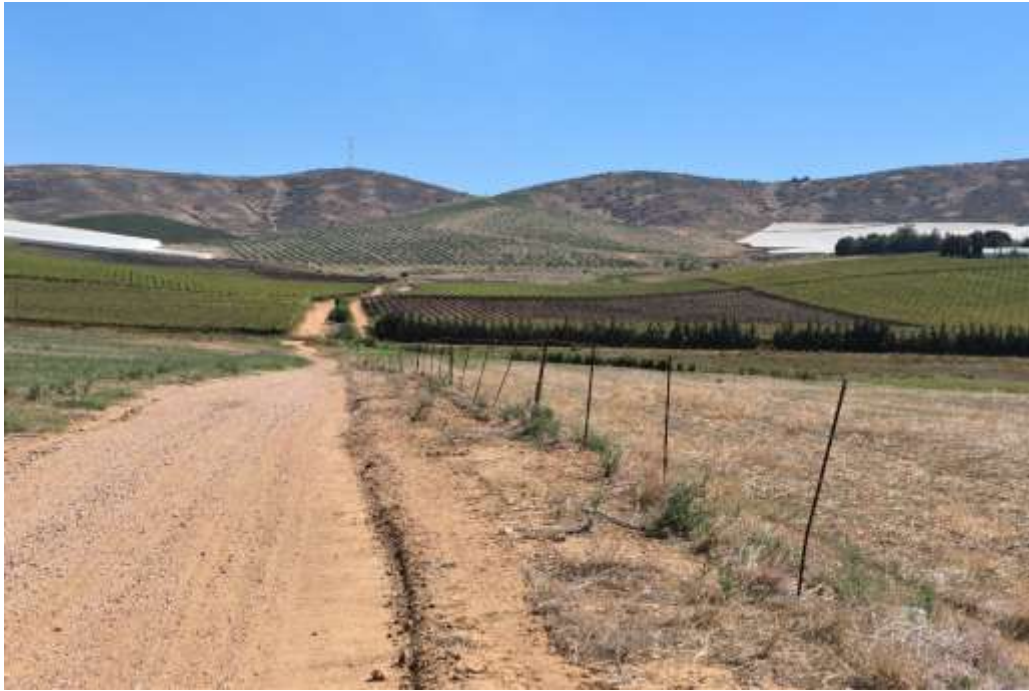
Figure 4 Hills above the dam

It rises on the hill above the sub-catchment (Figure 4). The drainage line upstream of the dam takes the shape of wide valleys with no discernible drainage line and with the same vegetation as elsewhere on the hill. The drainage line downstream of the dam (Figure 5) has been engineered into a straight agricultural return flow furrow all the way down to its confluence with the Berg River.

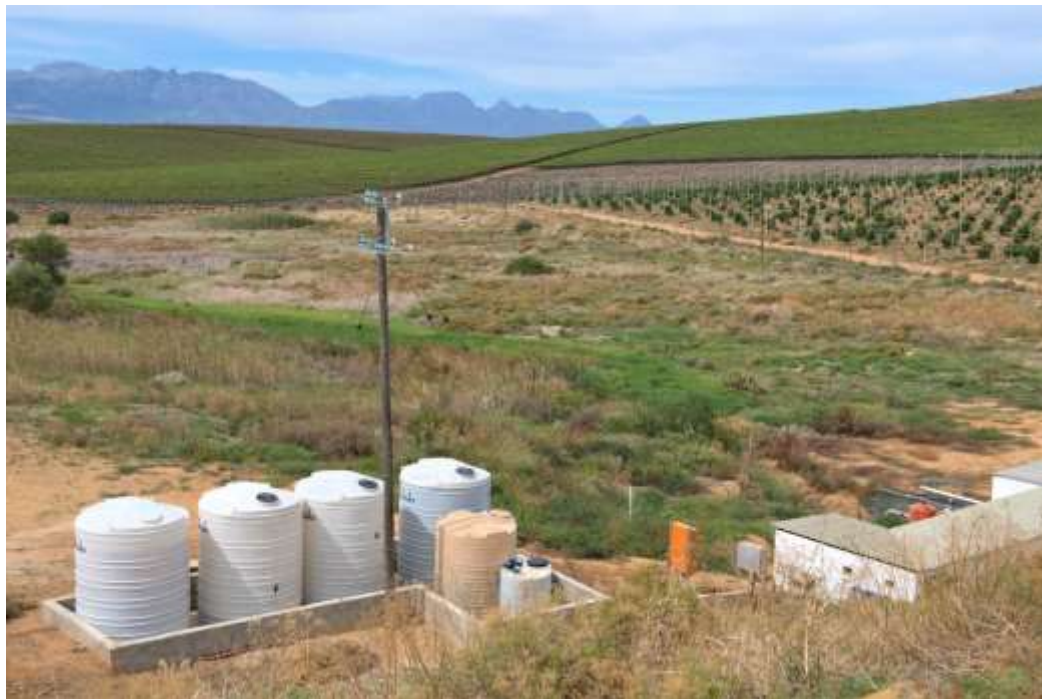
Figure 5 Drainage line below the dam

The land below and adjacent to the dam (Figure 5) has not been transformed into a vineyard and still bears some natural characteristics. The drainage line is overgrown

with reeds. At the end of this reach it makes a right angle turn, which was filled with water at the time of the site visit. This reportedly is seepage from the dam and possible agricultural return flow.

A catch pit has been constructed, together with a pump, to return most of this seepage back into the dam. The tanks containing fertiliser are positioned at the toe of the dam, together with the pumps driving the irrigation system on the farm (Figure 5).

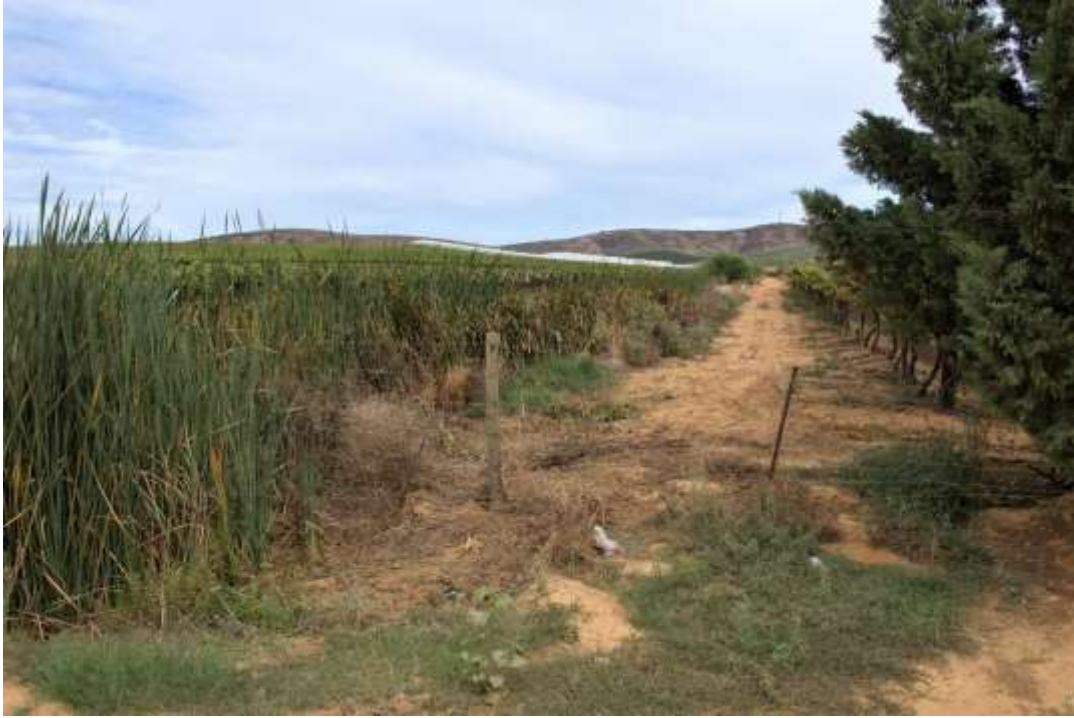
Figure 6 Drainage line in the vineyards

A second reach of the drainage line (Figure 6), now a straight canal, passes through the vineyards and a third diagonally across a large wheat field (Figure 7) and into the Berg River. The entire canal was overgrown with reeds, which were thick among the vineyards and sparse over the wheat field.

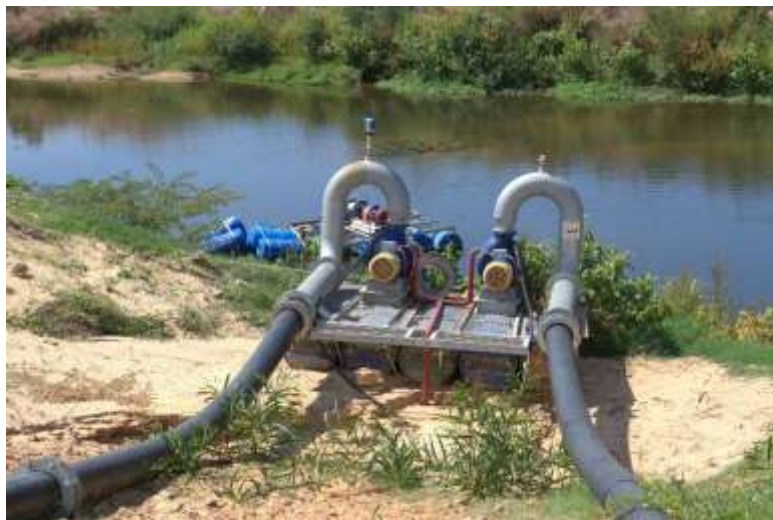
Figure 8 Pump

The sampling site was chosen where the pump (Figure 8) was located in the Berg River to abstract water for the farming operation.

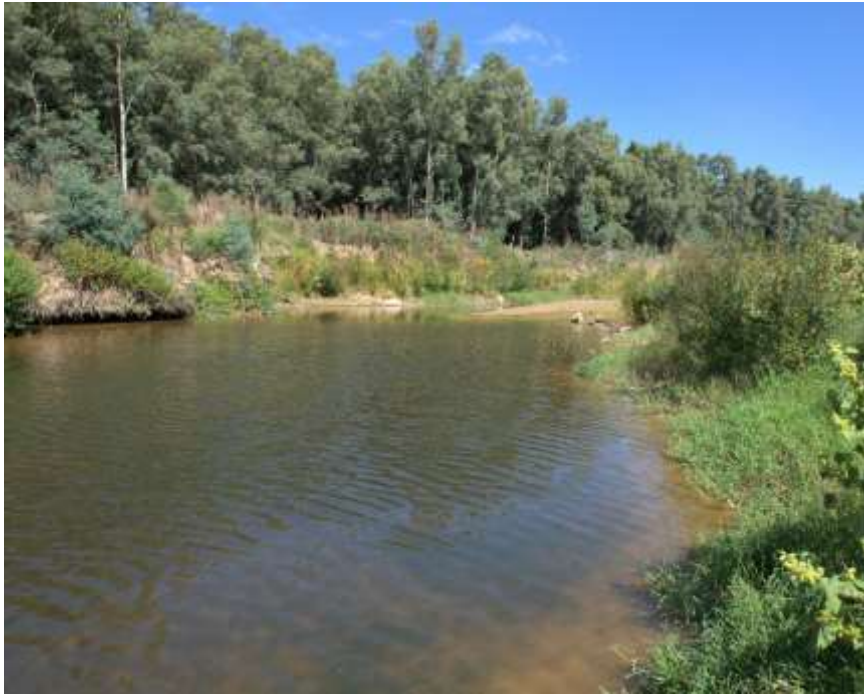
Figure 9 Upstream end of the pool

The river here was shallow, less than a metre deep, some 15m wide, slow moving, pool-like. The river was narrow upstream from the pool, perhaps a metre wide and the water was moving fast, more than 1ms^{-1} (Figure 9).

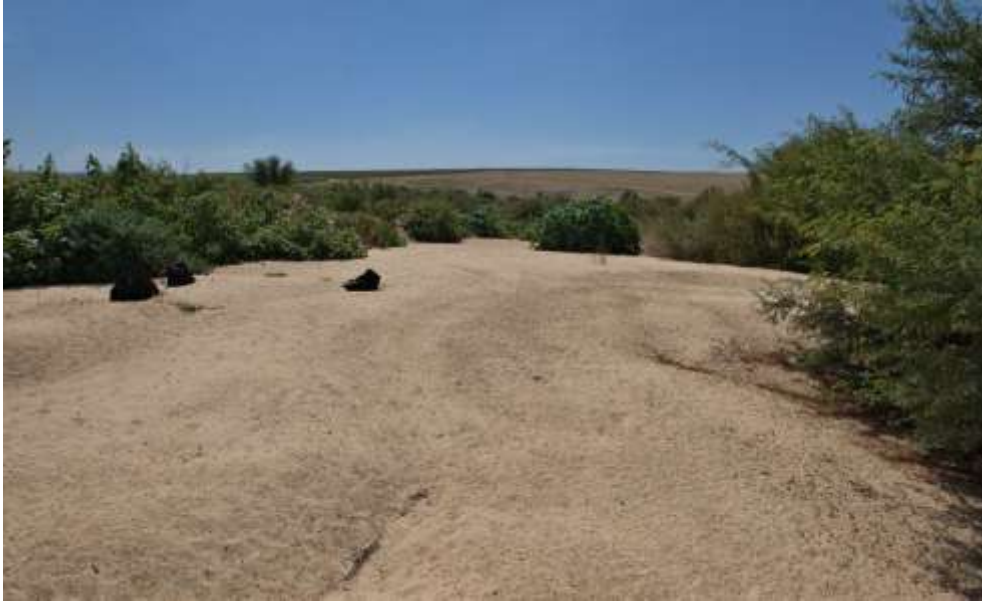
Figure 10 Sand deposits

The river was incised, with steep banks, with the Karoo shale base exposed in places. During floods sand is deposited high up the banks. The banks are erodible, but then mobilised sediments are deposited all along (Figure 10). The riparian zone seemed most dynamic, with material eroded and deposited as floods pass through during the winter rainy season. Erodibility is enhanced by agricultural practices close to the river banks.
