**GEOTECHNICAL CONDITIONS ON PLOT 2642
BOEGOEBERG SETTLEMENT AND PORTION 14 OF
THE FARM BOEGOEBERG SETTLEMENT 48: A
REPORT FOR THE EXPANSION AND
FORMALISATION OF OPWAG COMMUNITY**

2020/J09/MCP_01

PREPARED BY : CEDARLAND GEOTECHNICAL
CONSULT (PTY) LTD

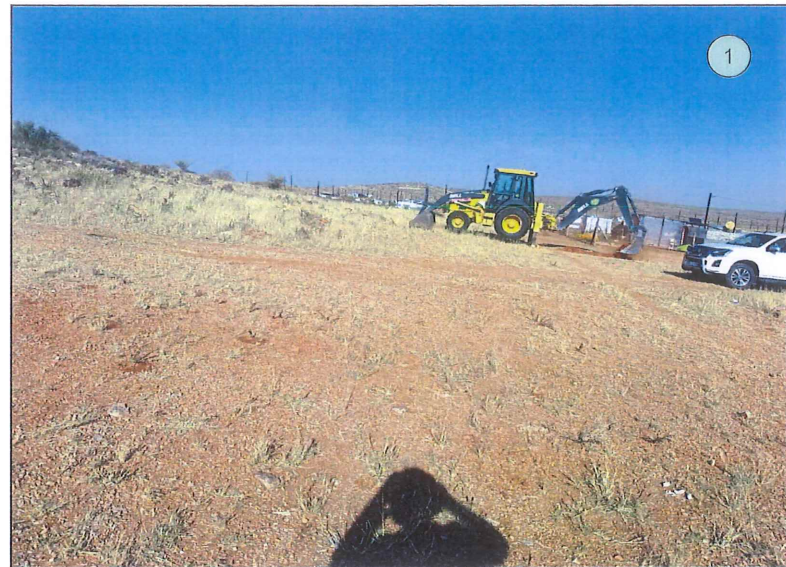
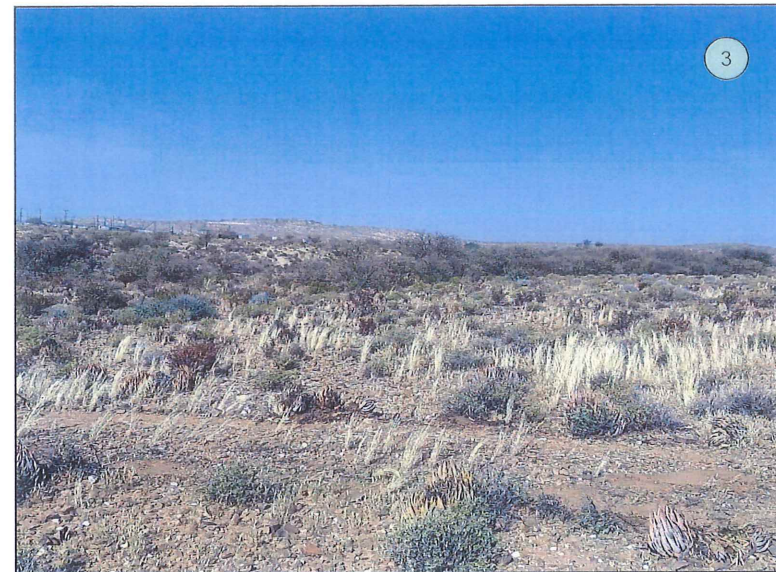
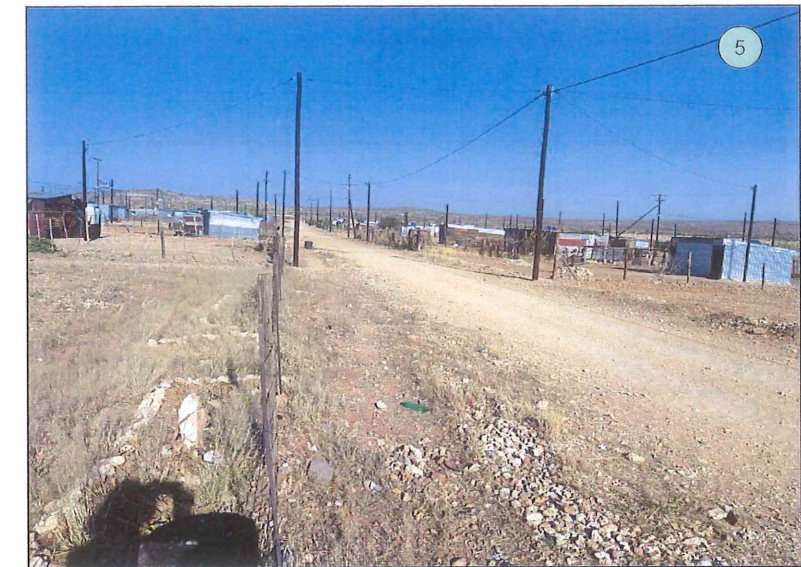
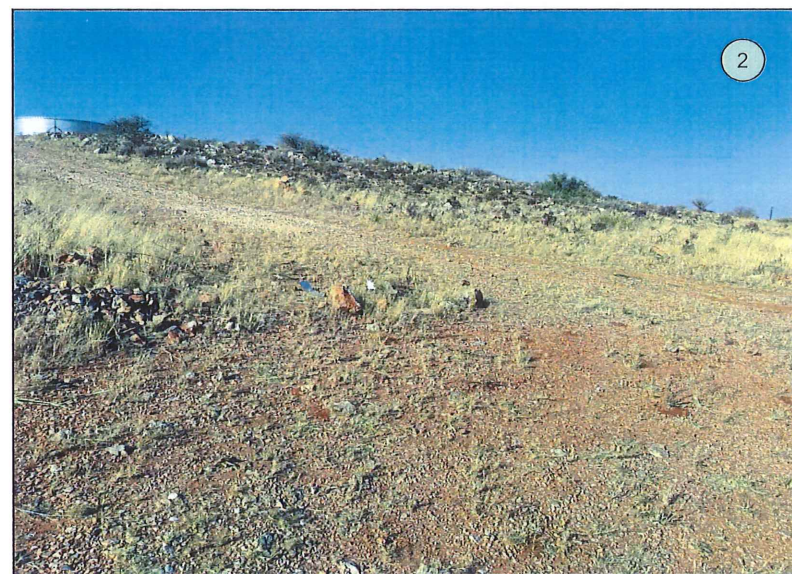
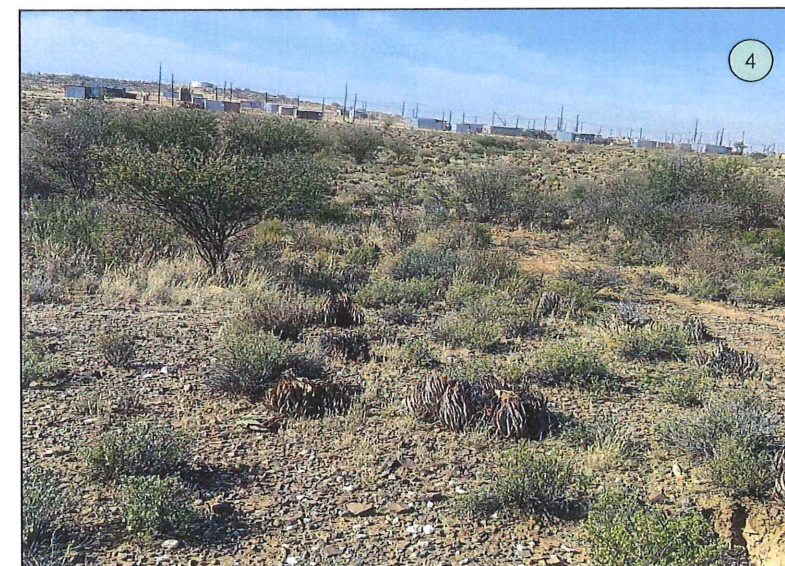
PHOTO 1: VIEW OF AREA BETWEEN VILLAGE AND QUARTZITE RIDGE TO THE NORTH EAST THEREOF. SURFACE SOILS OF COLLUVIAL SANDS.

PHOTO 2: VIEW OF AREA BETWEEN VILLAGE AND QUARTZITE RIDGE TO THE NORTH EAST THEREOF. SURFACE DEPOSITS OF QUARTZITE BOULDERS AND OUTCROPS OF QUARTZITE

PHOTO 5 : CONDITIONS IN THE VILLAGE OF OPWAG

Site conditions are illustrated on Photo 1 : Site Conditions.
