**SOUTH AFRICAN FRUIT EXPORTERS (PTY) LTD**

## **Fresh Water Report**

**Proposed new dam for**

## **Farm Bonathaba, Malmesbury**

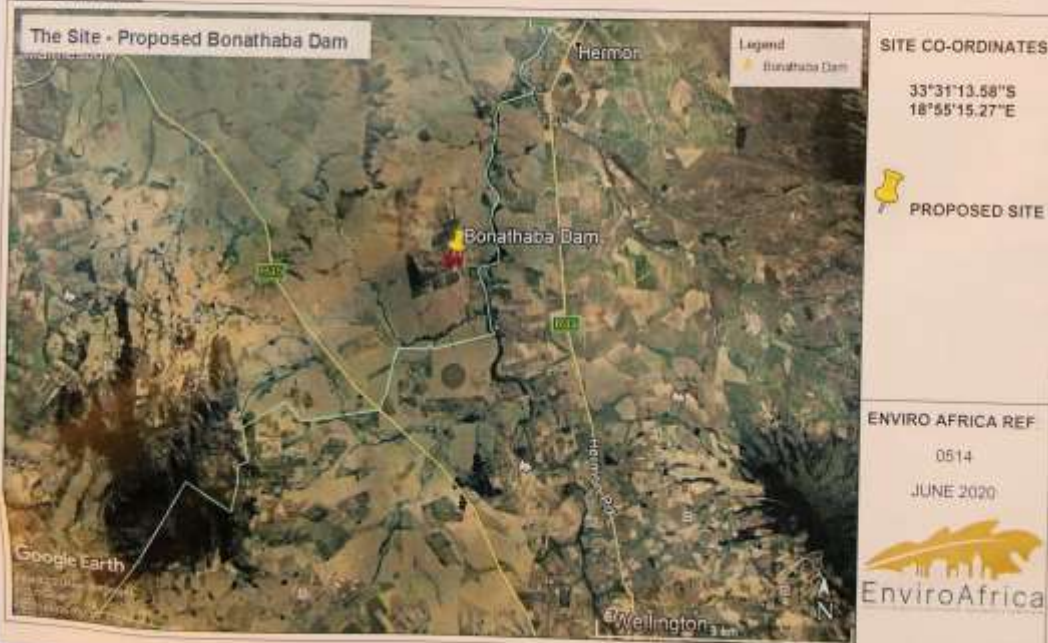
Figure 1 Public Participation

**PROPOSED DEVELOPMENT OF AN INSTREAM DAM ON PORTIONS 2 AND 3 OF FARM NO. 1100, BONATHABA, MALMESBURY, WESTERN CAPE**

Bonathaba has appointed Enviro Africa to conduct the legally required EIA for the envisaged farm dam, along with the public participation (Figure 1).

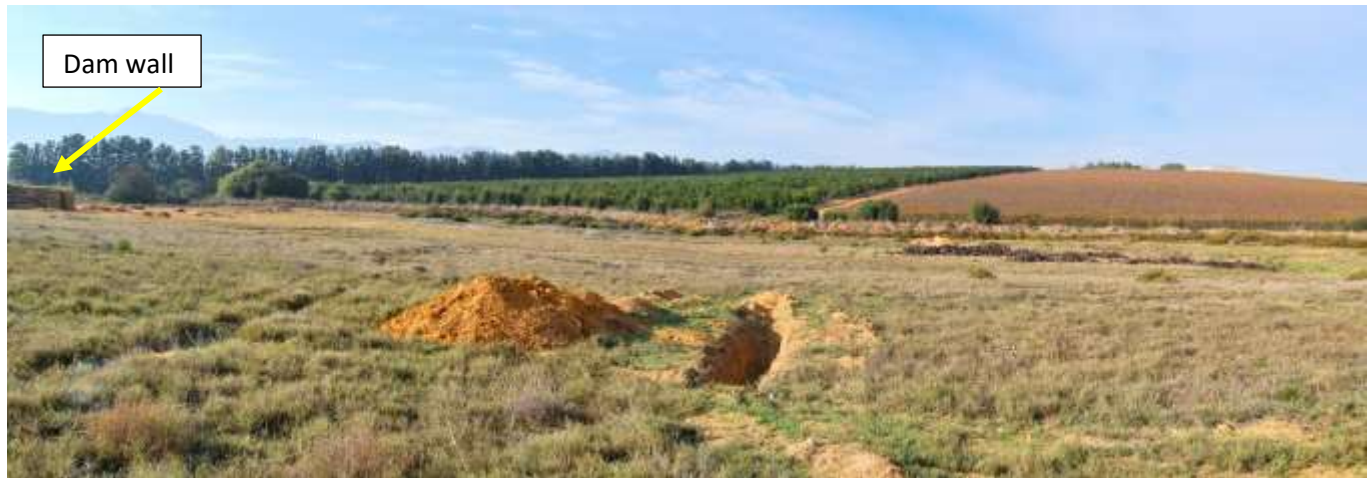
**Figure 3** Dam site

The dam site is shown in Figure 3.

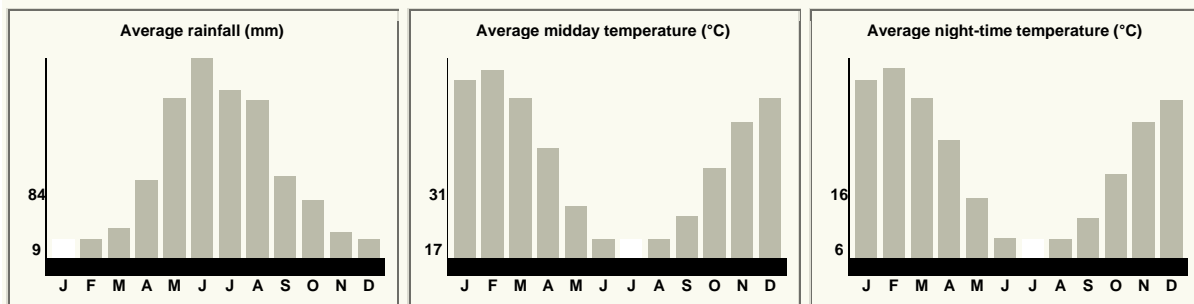
**Figure 5 Hermon Climate**

Hermon normally receives about 471mm of rain per year and because it receives most of its rainfall during winter it has a Mediterranean climate. The chart below (Figure 2, lower left) shows the average rainfall values for Hermon per month. It receives the lowest rainfall (9mm) in January and the highest (84mm) in June. The monthly distribution of average daily maximum temperatures (centre chart below) shows that the average midday temperatures for Hermon range from 17.3°C in July to 30.2°C in February. The region is the coldest during July when the mercury drops to 6°C on average during the night. Consult the chart below (lower right) for an indication of the monthly variation of average minimum daily temperatures.

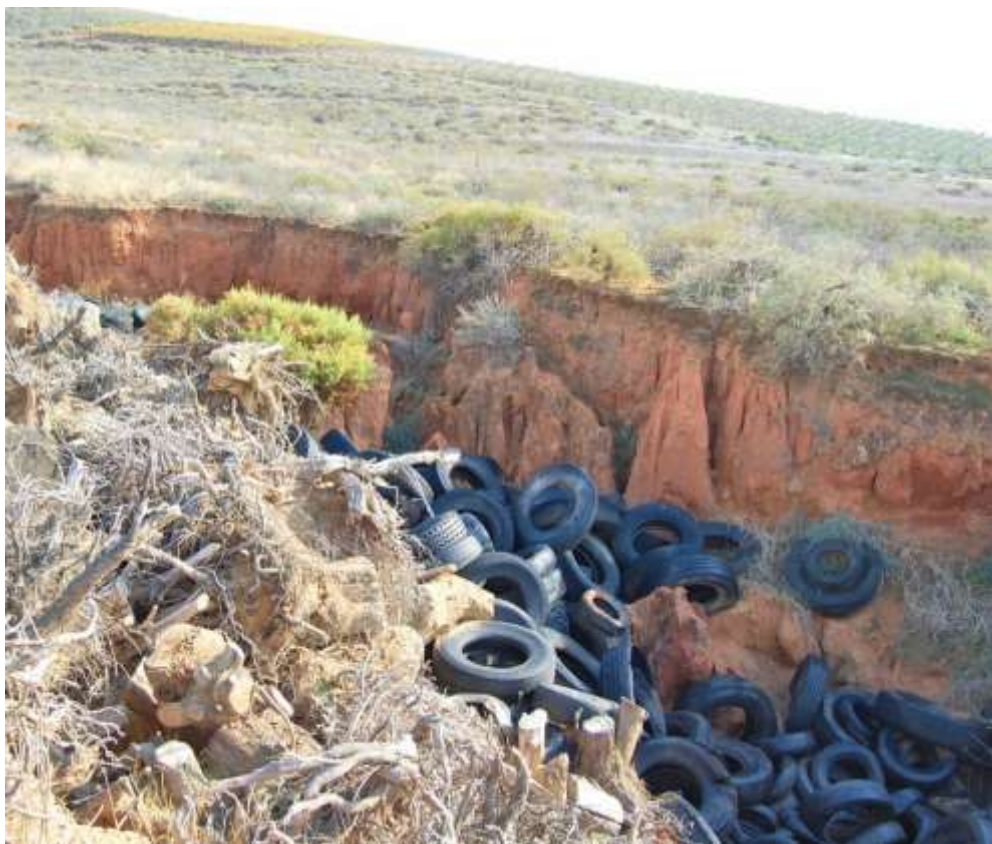
**Figure 9** Erosion control

The current effort of controlling erosion with old tyres and building rubble (Figure 9) is definitely not adequate.

It makes economic sense to investigate the erosion potential and to subsequently design an erosion control system. This would comprise of a combination of upstream

smaller dams, walls, canals, levies and other hard structures directed at slowing down the flow, settling out of mobilised sediments and preventing further erosion. This will have to be designed and overseen by a professional person with experience in the control of erosion.

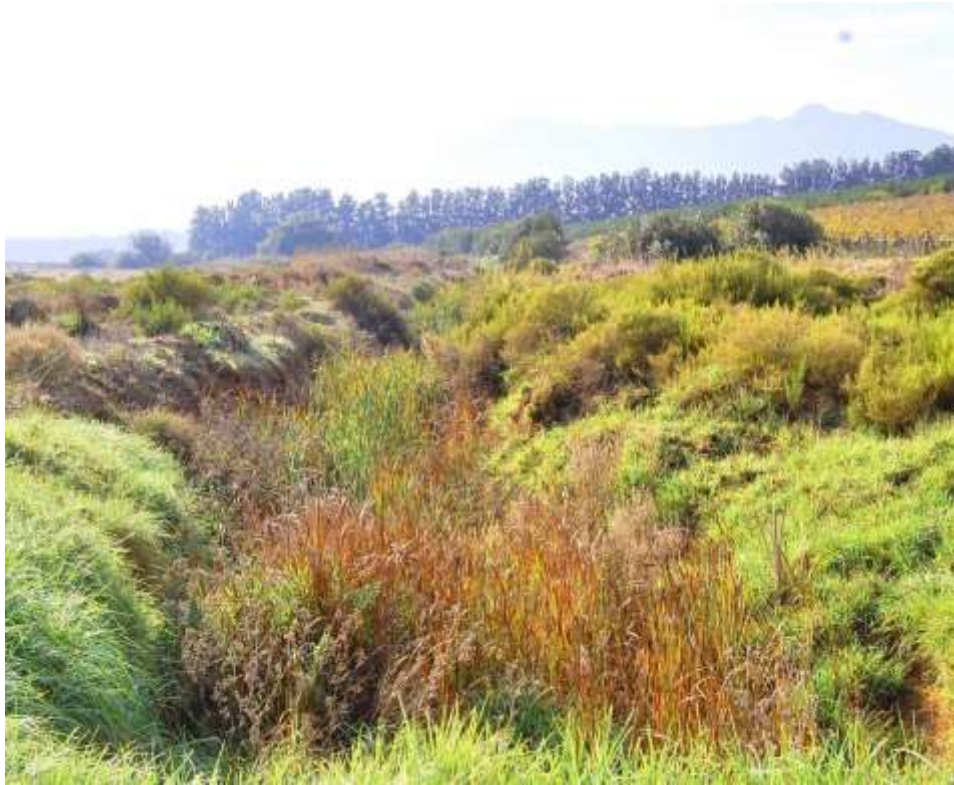
**Figure 10** Irrigation return flow channel

Lower down the slope, in among the orchards and vineyards, the drainage line has been straightened into irrigation return flow channels. The consequent increase in flow rate and erosion, the channels deepened to some 2 to 3 metres. The channels have been overgrown with reeds (Figure 10). To prevent clogging of the channels, they are cleared with an excavator once in three or four years, according to the manager.

The creation and maintenance of these channels will contribute to an increased sedimentation or filling rate of the proposed dam.

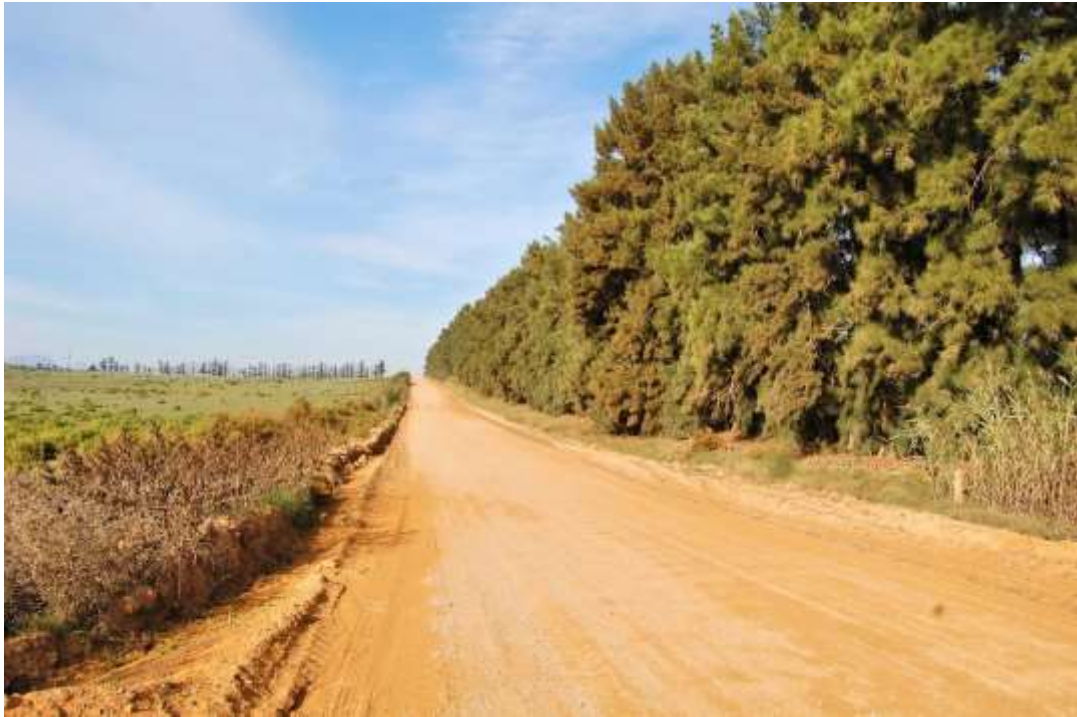
**Figure 11 Road**

The proposed dam wall will be constructed adjacent and just uphill from the road (Figure 11), on the other side of the row of beefwood trees. Here the drainage line passes through a pipe culvert underneath the road.

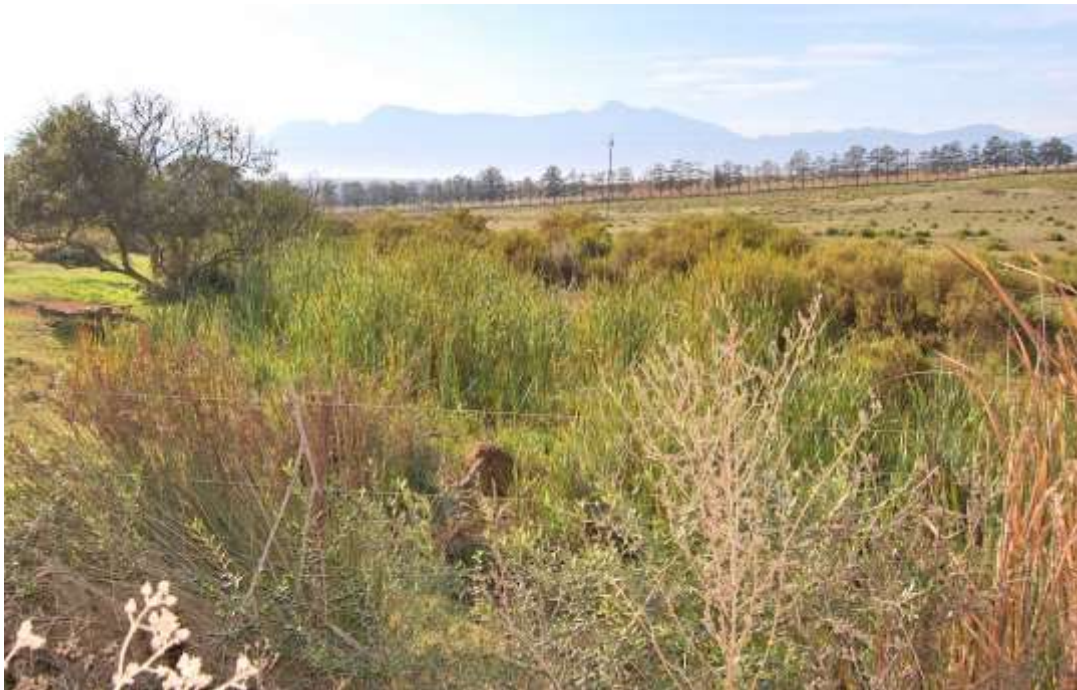
**Figure 12 Reeds**

Downstream from the road, the drainage line is overgrown with *Typha* reeds (Figure 12). The growth of reeds is probably aided by the runoff from the road, apart from the water out of the drainage line. *Phragmites* reeds are growing upstream of the road.

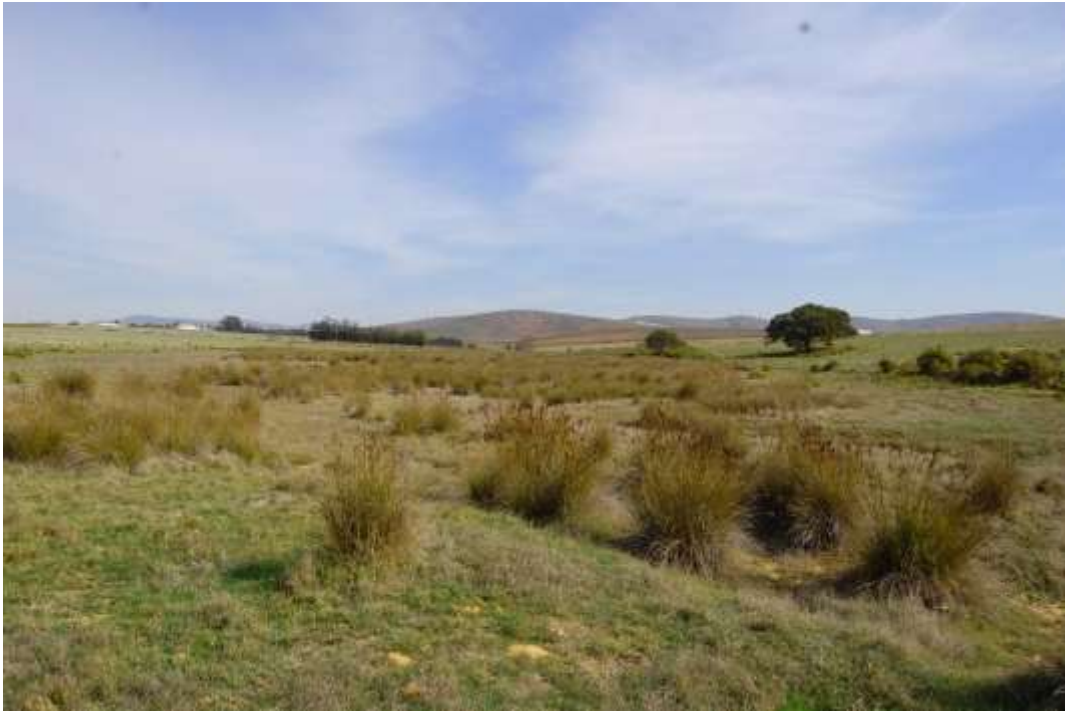
**Figure 13** Lower drainage line flood plain

The confluence of the drainage line with the Berg River is at an elevation of 77masl. This represents a slope of one vertical metre in every 100 horizontal metres. This is a much more even slope, with a slower flow of storm water spreading out over a wide area, which is conducive to deposition of mobilised sediments. Much of the mobilised soils from up the hill was probably deposited in this area (Figure 13).

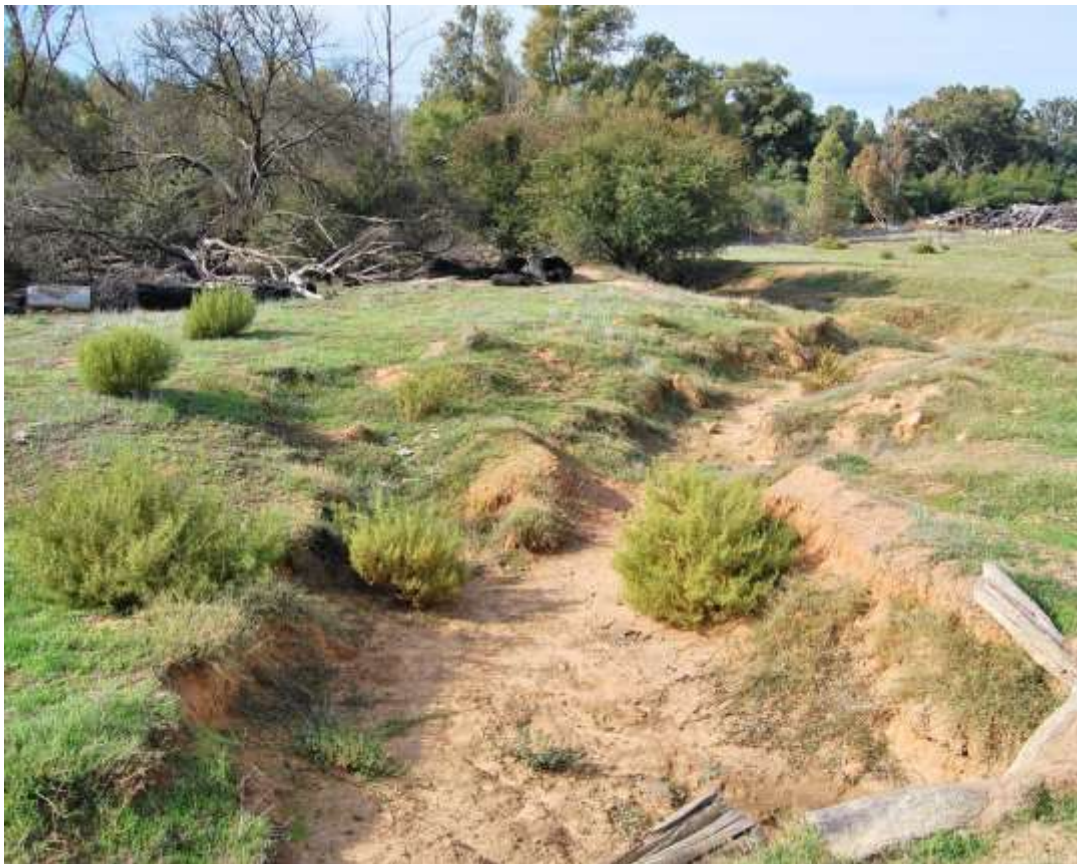
**Figure 14** Shallow channel

Just before the confluence with the Berg River, a shallow channel has been scoured out in the flood plain to give rise to a channelled wetland (Figure 14).

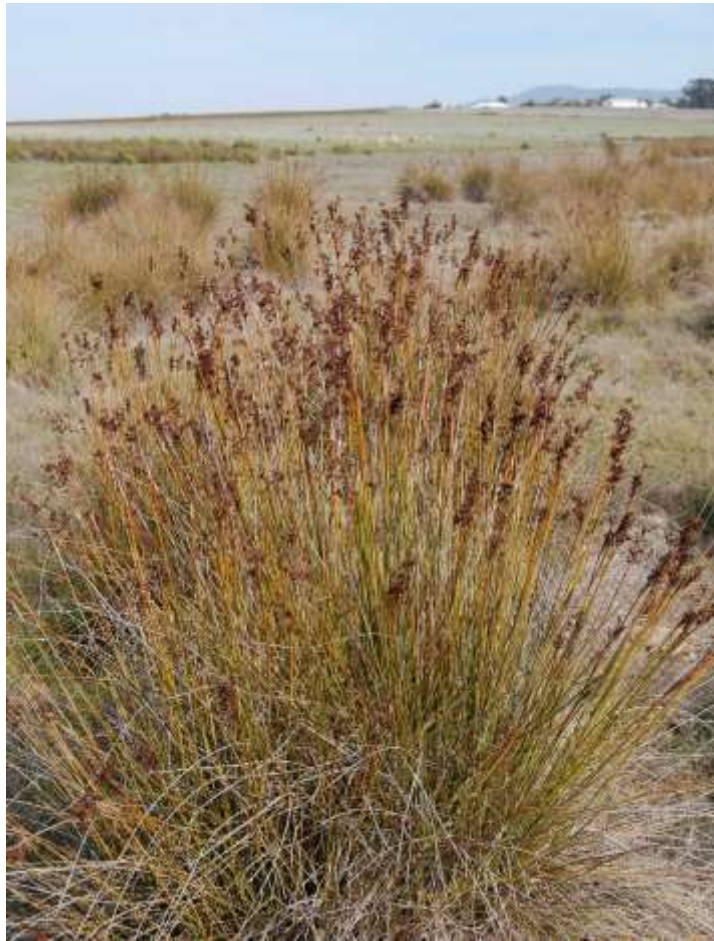
**Figure 15** *Juncus kraussi*

The floodplain is overgrown with the rush *Juncus kraussii* (Figure 15).

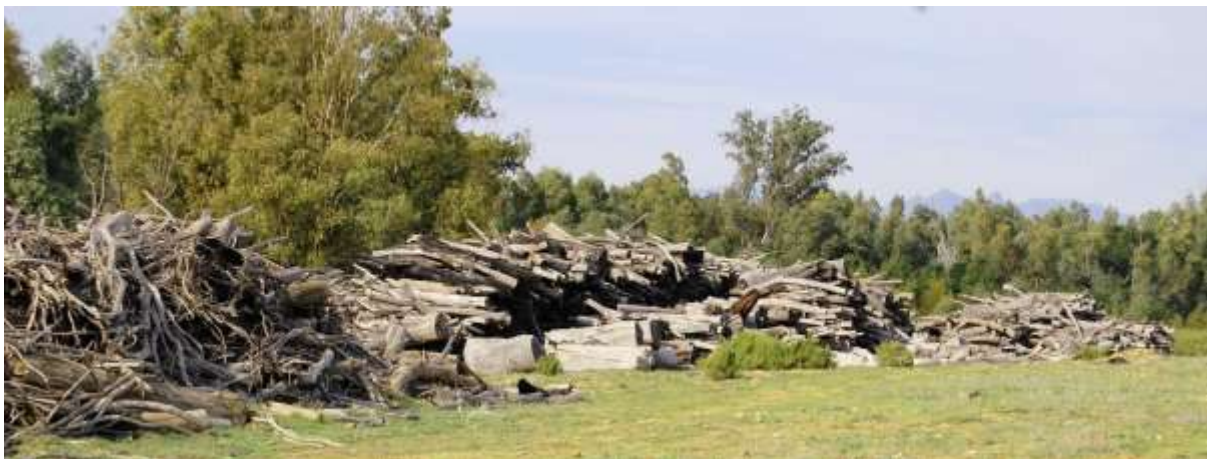
**Figure 16** Wood stacks

The Berg River here is heavily overgrown with blue gum eucalyptus trees. The massive effort to remove these trees, with large piles of felled trees along the river (Figure 16). Obviously, this work is still to be completed. As there are many more of these invasive trees to be cleared out of the river.

The riparian zone previously was overgrown with a stance of mature *Eucalyptus* trees, which were removed. Regrowth is threatening the gains that have been made with the control program and follow-up action is now required. A large portion of these trees remain (Figure 16).

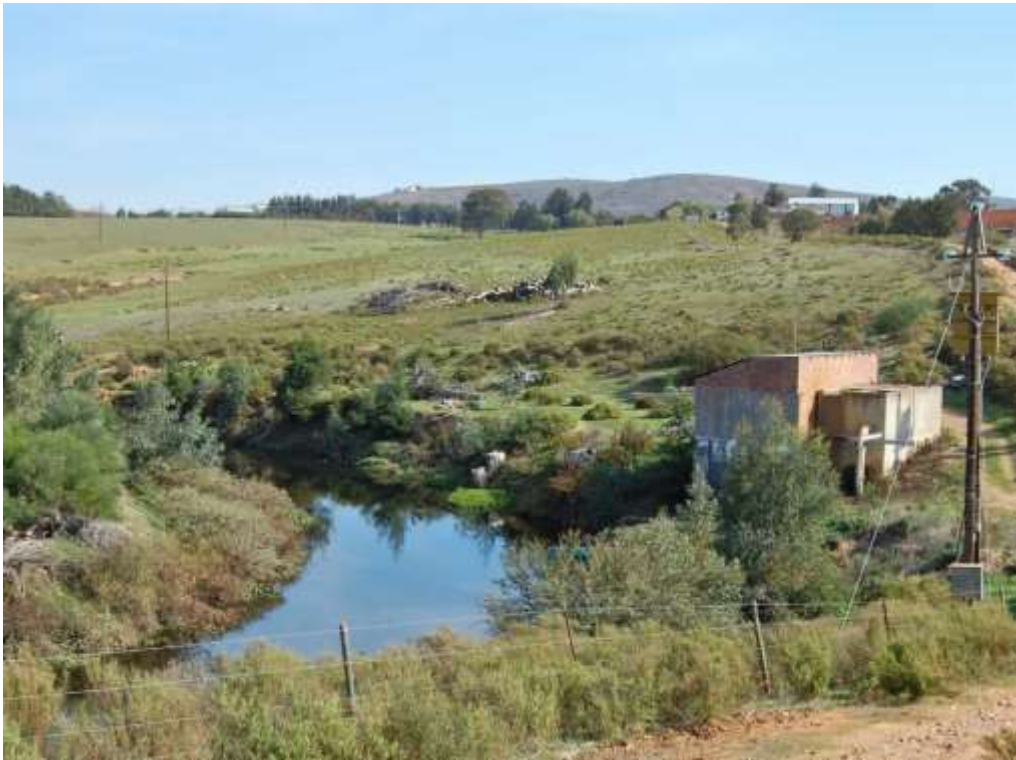
**Figure 17** Pump house

The sampling site was chosen where the pump house (Figure 17) was located in the Berg River to abstract water for the farming operation. It was chosen because the river was accessible, with a patch on the bank not overgrown with dense vegetation (Figure 18).

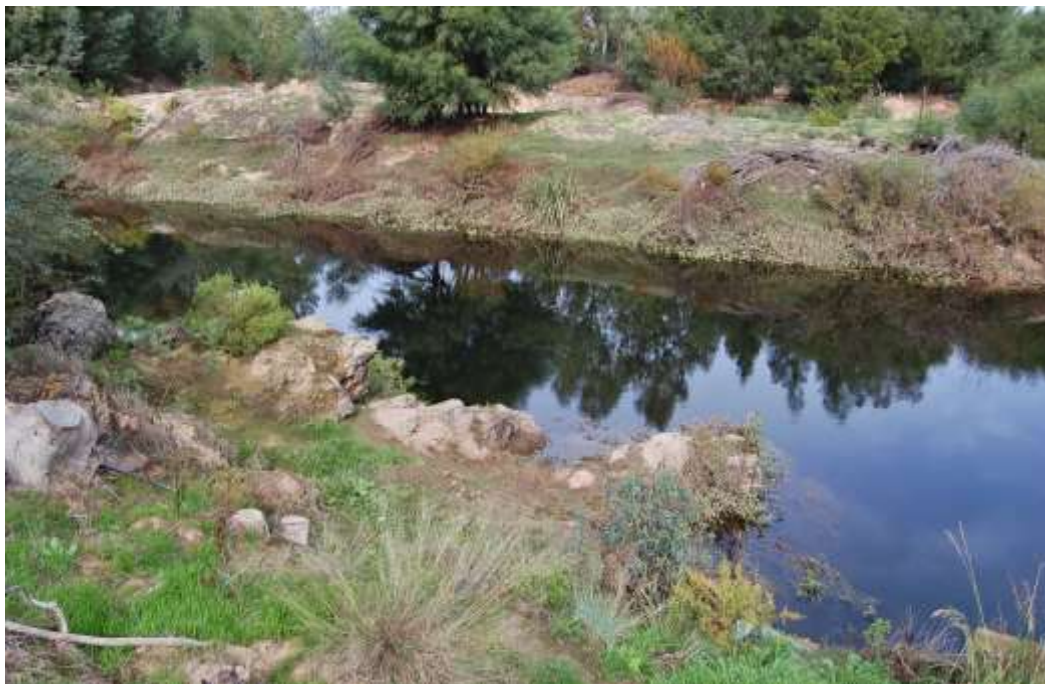
**Figure 18** Sampling point

The banks of the river were very steep, the river deeply incised, which limited accessibility.

The river here was approximately 15m wide. It was flowing slowly, at some  $0.1\text{ms}^{-1}$ , in the middle, with pool-like conditions. There was water cress that made both submerged and emerging vegetation habitat, with a little submerged *Myriophyllum*. There was some shallow water next to the bank, but most of it was deep, along the rocky shore.

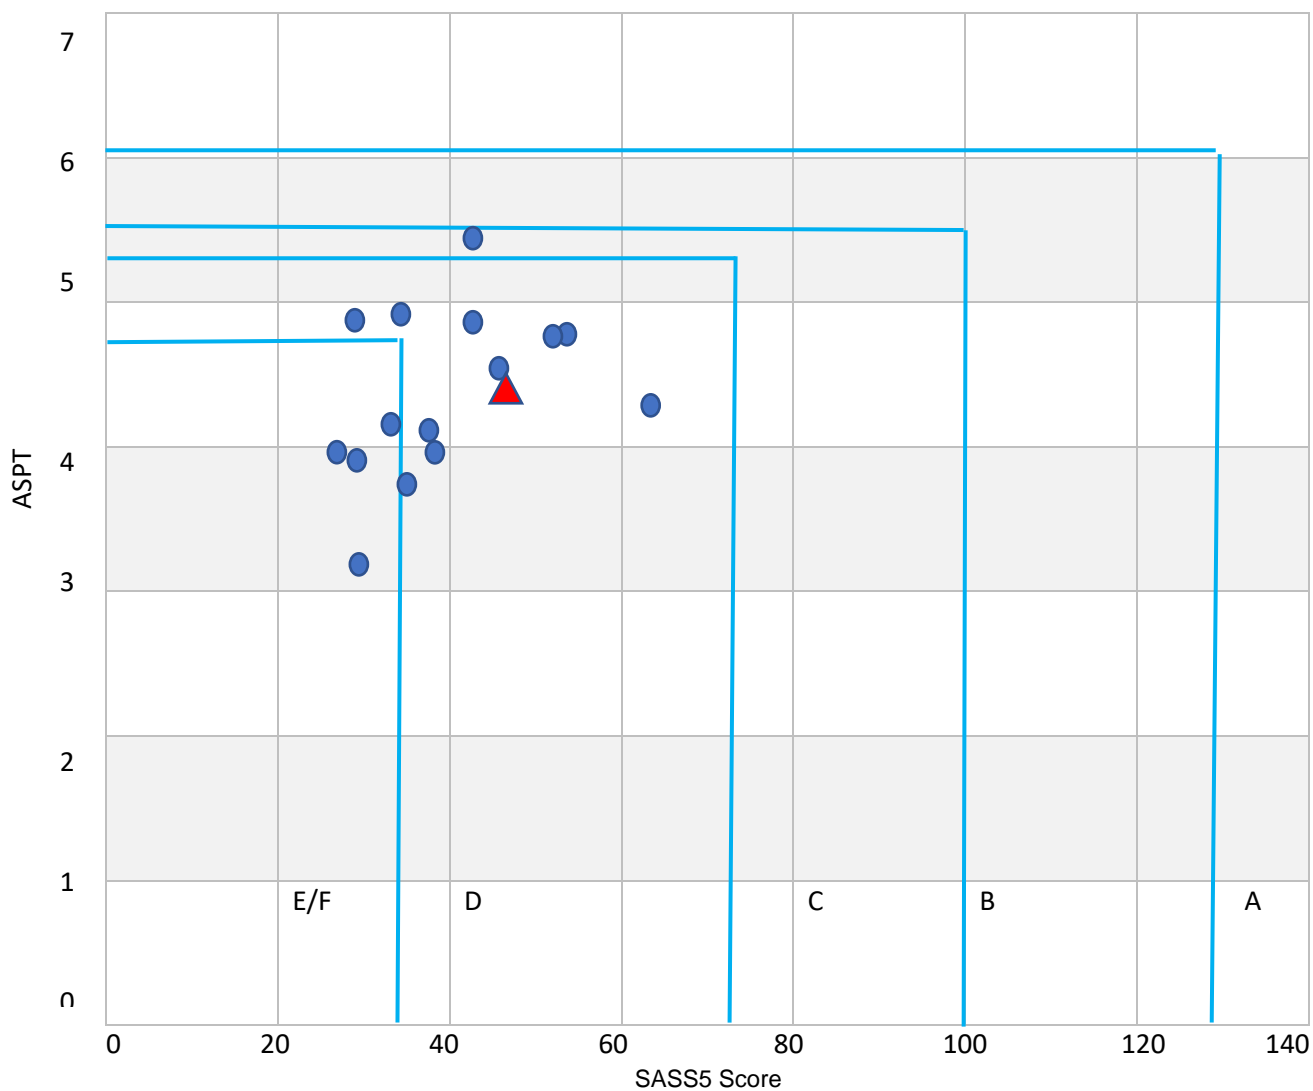
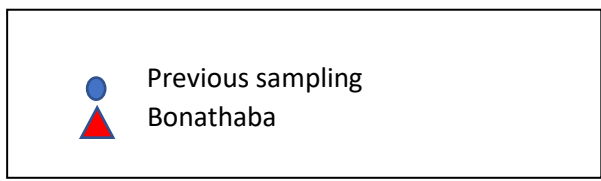
**Figure 19** Biomonitoring

The SASS5 score (see SASS5 score sheet in the Appendix) at 47 was an average score for a mature river on a coastal plain, but with a high number of taxa. However, the aquatic invertebrates were of the low-scoring type, with the result that the ASPT amounted to only 4.3. The score represented a class D (Figure 19), which signifies a "Fair" state-of-the-river.

To put the classification into perspective, from 2015 to 2017 samples were taken for a previous project at the Moredou Poultry Farm near Gouda, some 23km downstream, as the crow flies. Most of these samples resulted in a class D as well (Figure 19). The SASS5 score at Bonathaba was generally higher than those at Moredou, but the ASPT

more or less the same (Figure 1). There are more impacts downstream, such as an abattoir and a dairy farm, which could explain the lower score at Moredou, but then the entire Berg River is impacted. Upstream of Bonathaba are numerous sources of agricultural return flow, wastewater treatment works and urban storm water.
