Freshwater Specialist Report

Fresh Water Report

Proposed Feldspar Mining Operation on

Portion 5 of Farm Rozynenbosch 104 Kenhardt RD

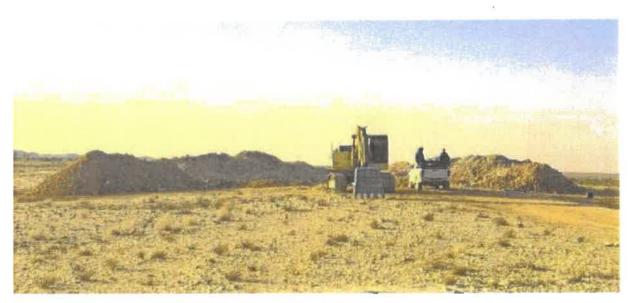
Figure 8 Mining Operation

This is essentially an open cast mine. The overburden is taken off with an excavator (Figure 8) and heaped on one side of the trench (Figure 9). Much of what comes out of the trench are rocks and chunks of mainly quartzite with various forms of mineralization. This waste rock is stored on the other side of the trench. The marketable feldspar is simply loaded onto a waiting truck and transported along the access road to the crusher and sorting plant.

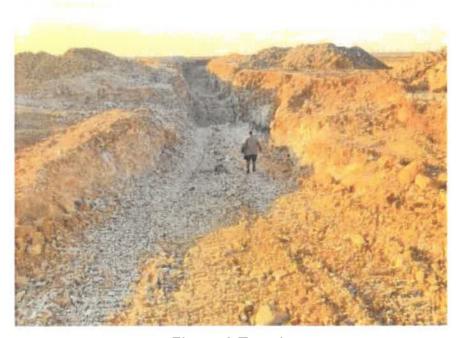
Figure 9 Trench

This is hard work for the excavator, as the substrate is hard and not easily broken up.

The most striking impact is the trench from where the ore is mined, along with the heaps of overburden and waste rock beside it (Figure 9).

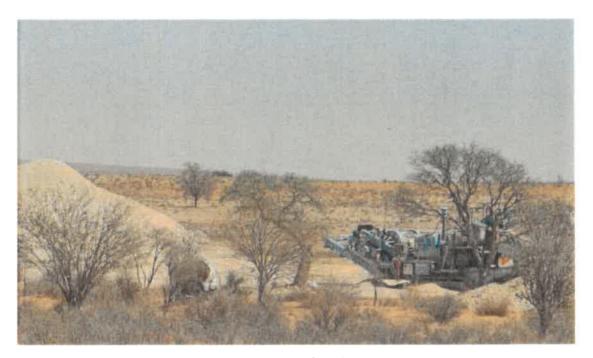
Figure 10 Crusher

At the crusher (Figure 10), the ore gets broken up in various grades, to suit the client's specifications. Again, the final product is loaded onto trucks with a front-end loader. The product is taken off-site to wherever it is required.

The crusher currently is located on another property and will be moved to its designated locality (Figure 10) within the near future.

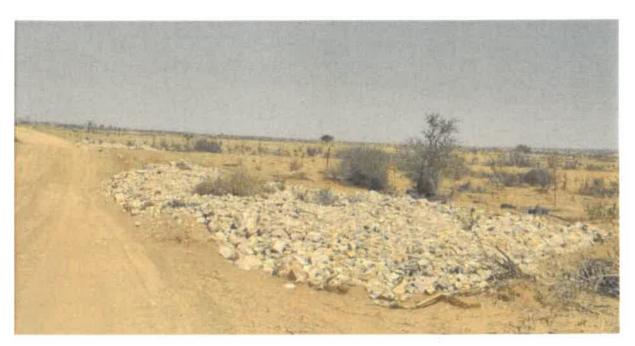
Where the access road passes through the drainage line and its tributaries, erosion is visible adjacent and downstream of the road. The land owner curtailed further erosion by the placement of riprap (rocks) in the eroded areas (Figure 12).

Figure 12 Riprap in eroded areas
