HANTAM MUNICIPALITY
CALVINIA BULK WATER SUPPLY
WATER USE LICENSE APPLICATION
FOR THE CONSTRUCTION OF NEW PIPELINES

FRESH WATER REPORT Version 2.1

A REQUIREMENT IN TERMS OF SECTION 21 OF THE NATIONAL WATER ACT
September 2021

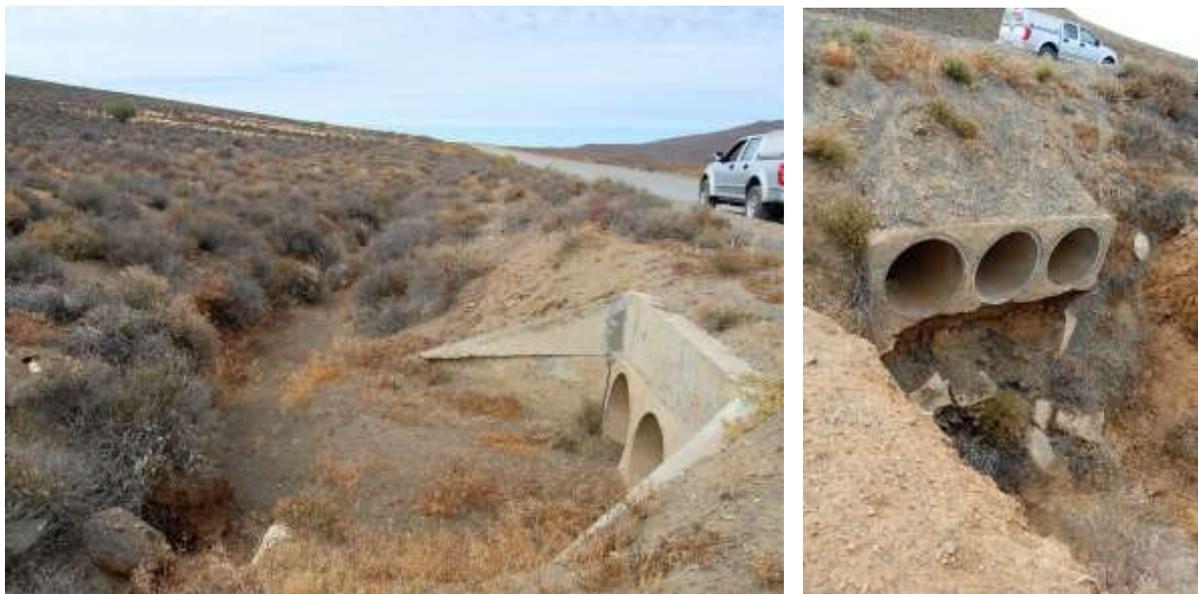
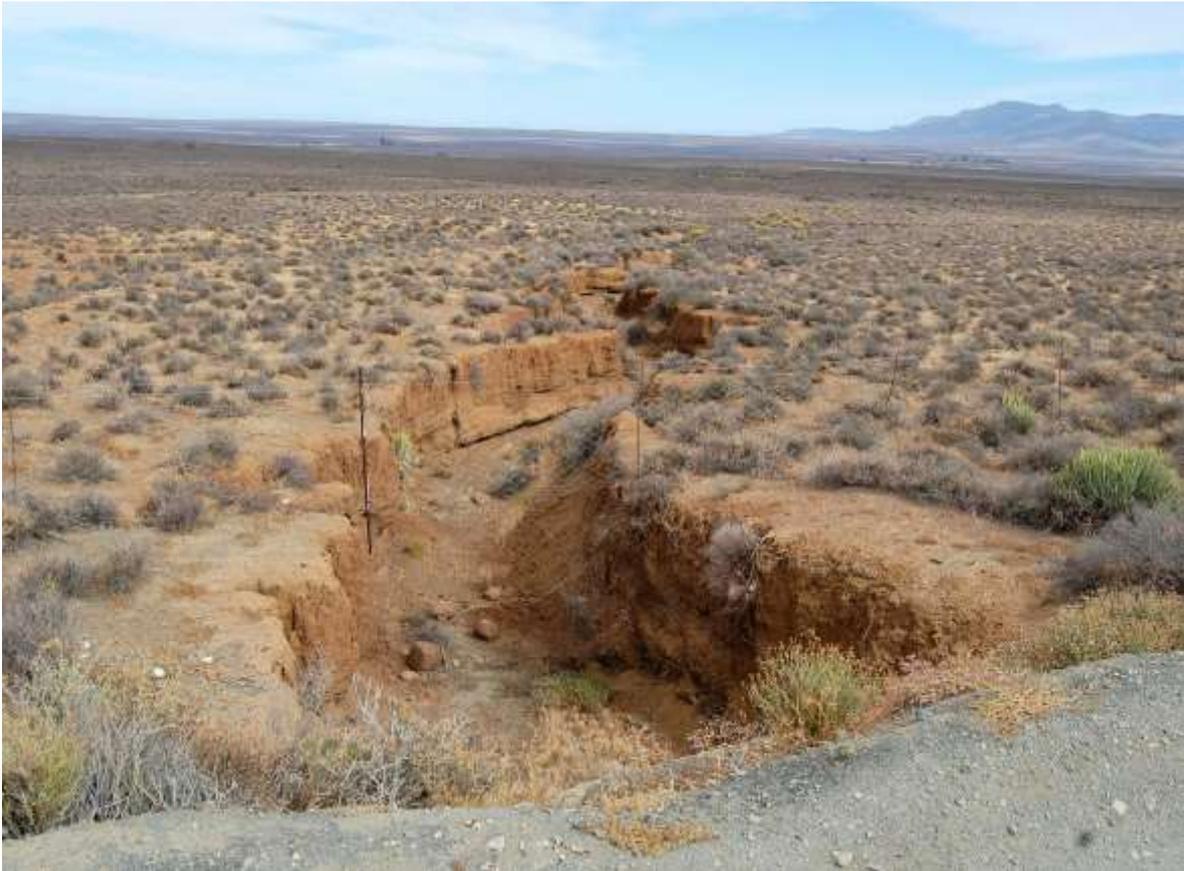
Figure 10 Ceres Road Crossing No. 11

Crossing No 11 (Figure 10) is serves as an example. Upstream, to the east of the road, apart from the storm water trench next to the shoulder of the road, the drainage line is hardly visible. It passes underneath the road with a pipe culvert. These are 3 pipes of 600mm diameter. Downstream of the culvert, the drainage line is deeply scoured out.

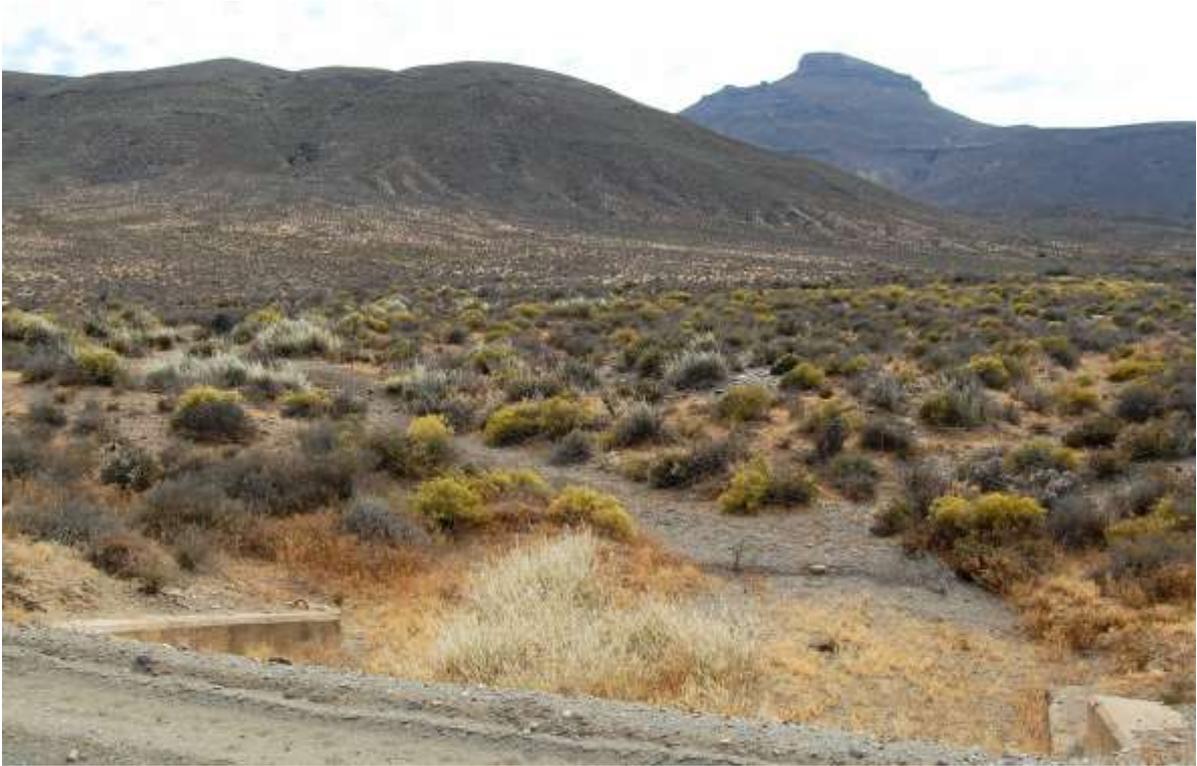
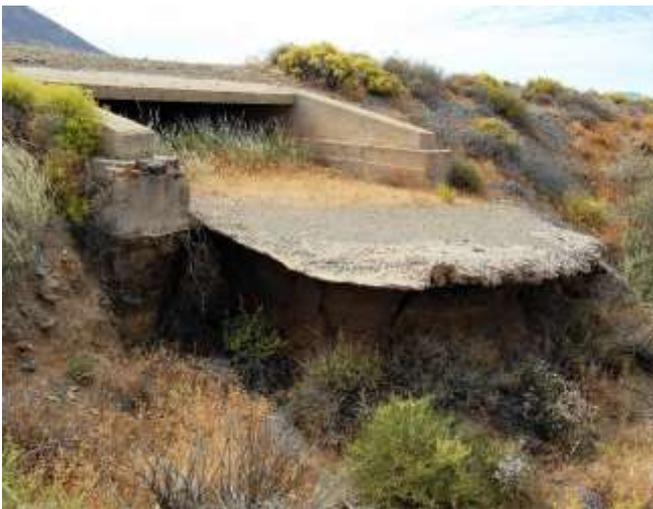
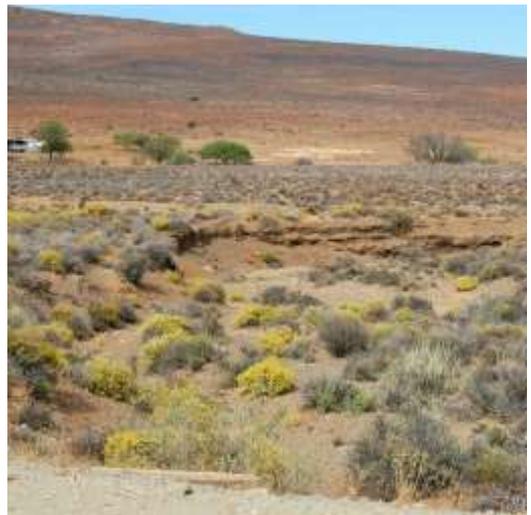
Figure 11 Ceres Road Crossing No. 9

Crossing No. 9 is much larger, with the drainage line stretching to the south around the hill. This drainage line has a much larger catchment area. Upstream of the crossing, the drainage line is well defined, not deeply incised, some 2m wide and looks rather benign (Figure 11). It passes underneath the road through a constructed box culvert. Downstream, the foundation of the culvert is heavily eroded. The drainage line curves to the north, where it is eroded and deeply incised.

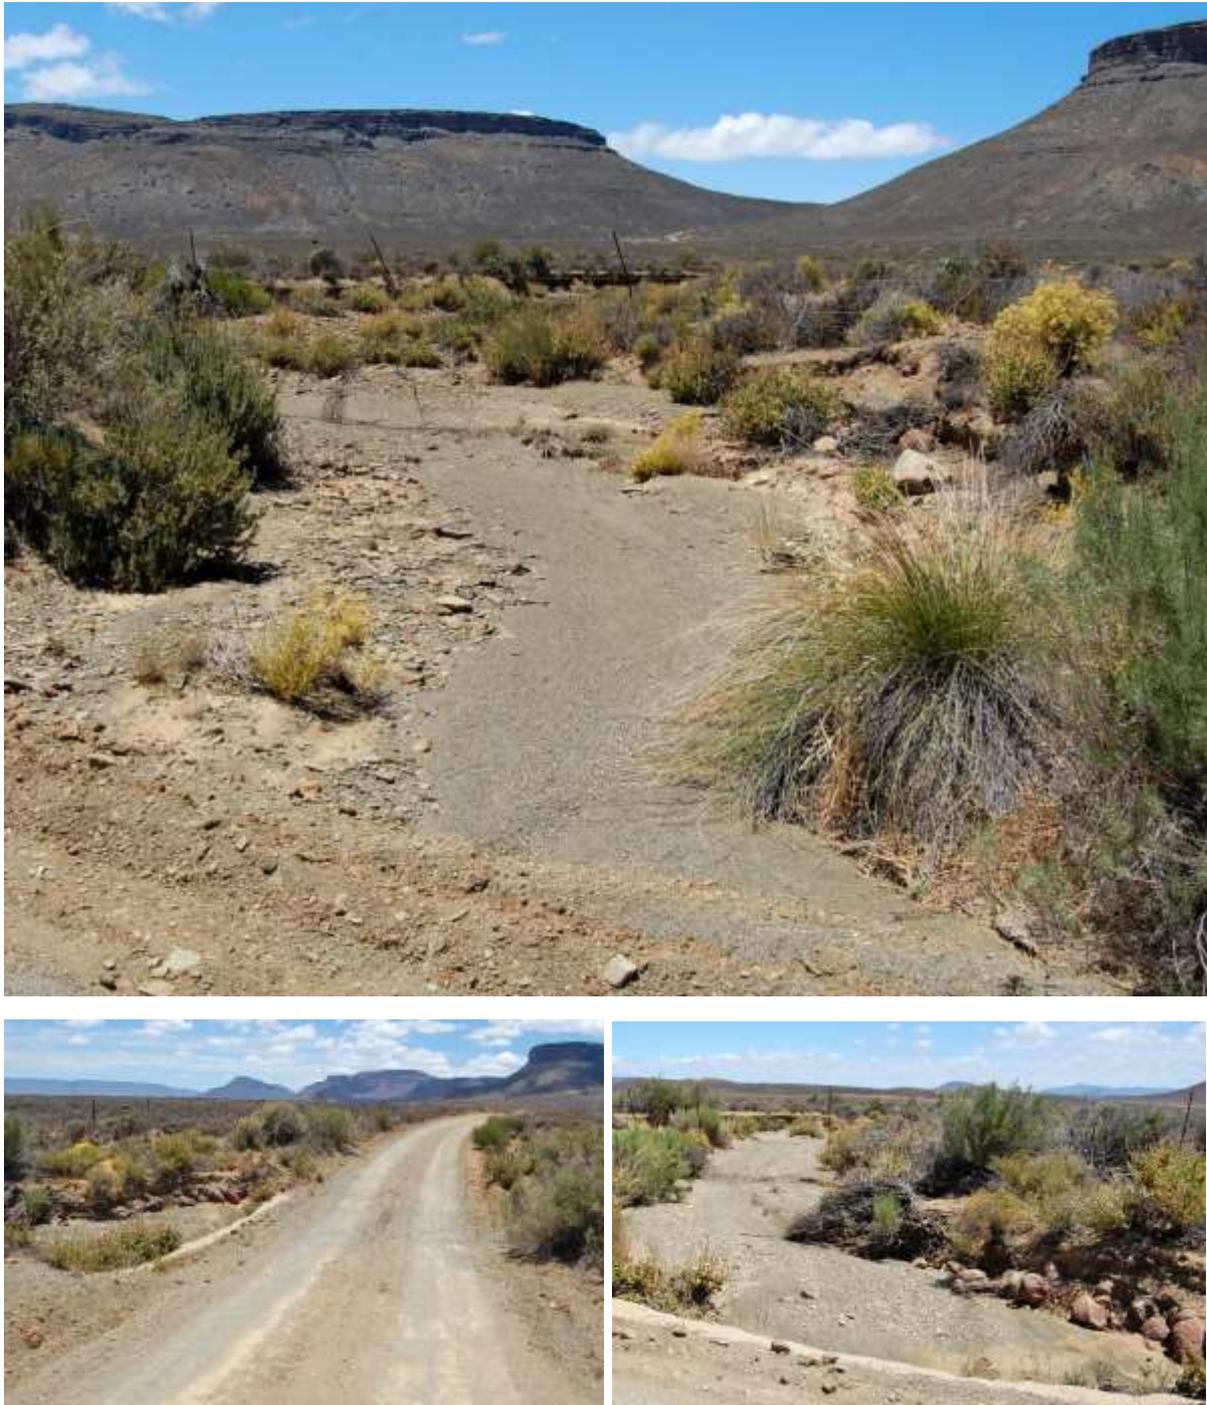
Figure 13 Ceres Road Crossing No. 2

Upstream, Crossing No. 2 is about 3m wide, clearly defined, shallow and with a bed of coarse sand. The banks are lines with broken slate. Some of the bushes next on the banks are somewhat higher than those further away, but there is no clearly defined riparian zone (Figure 13).

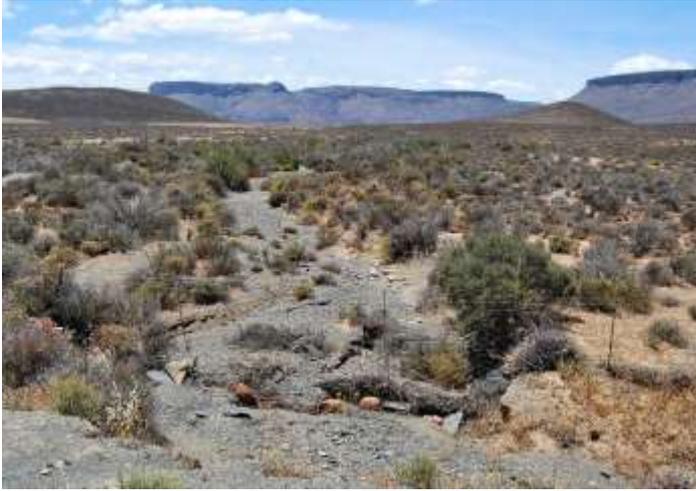
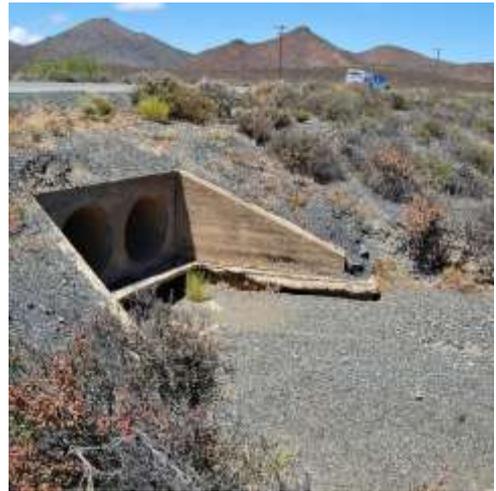
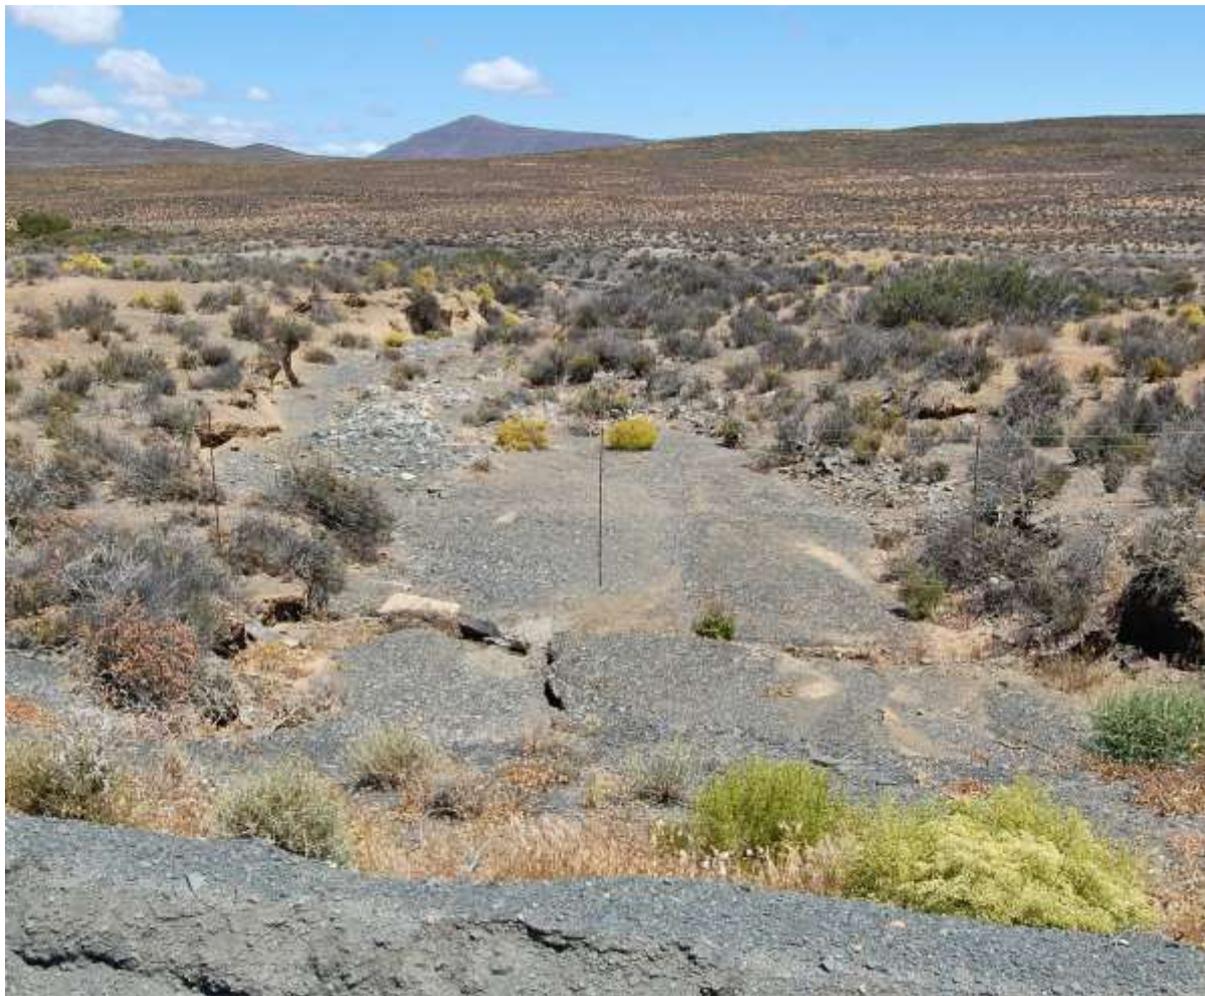
Figure 14 Ceres Road Crossing No. 5

Crossing No.5 (Figure 14) is one of the bigger ones, with a clearly defined drainage line, also shallow, but approximately 5 m wide. Judging from the debris washed up against the fence, the drainage line must, from time to time, burst its banks with

occasional flood water. It crosses the road through 900mm pipes. Downstream, the drainage line becomes more incised, with banks of approximately a meter high.

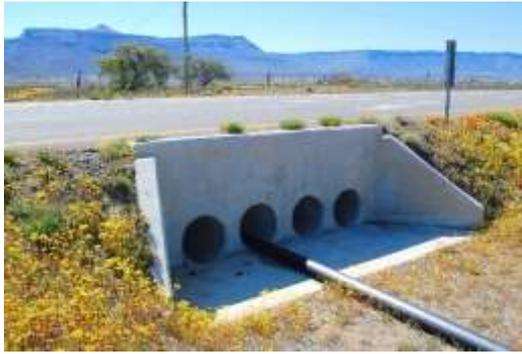
Figure 15 R27 crossing

There is already a HDPE 120mm pipeline on the ground surface that passes underneath the R27 trunk road in a box culvert (Figure 14). Reportedly, this is a temporary pipeline that has been laid with funding from the DWA drought relieve fund from a borehole south of the R27 to the Calvinia water purification works. This is a different project, separate from the current one. However, the new PVC 200mm pipeline will have to follow very much the same route to the connection with the existing pipeline to the west of Calvinia on the R355 (Loeriesfontein Road).

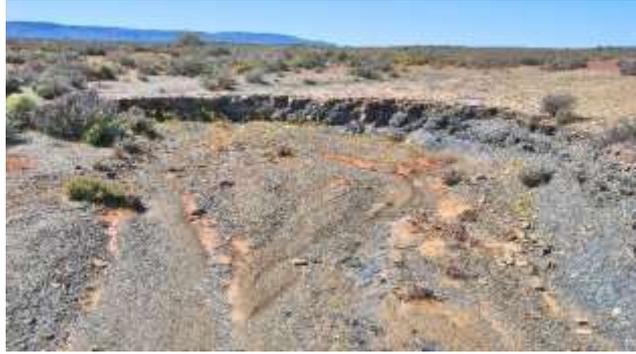
Figure 16 Ceres Road crossing No 12

On the section between the R27 and the Oorlogspoort River is a Class 4 crossing (Crossing No. 12, Figure 15), where the pipe must be dug in deeper.

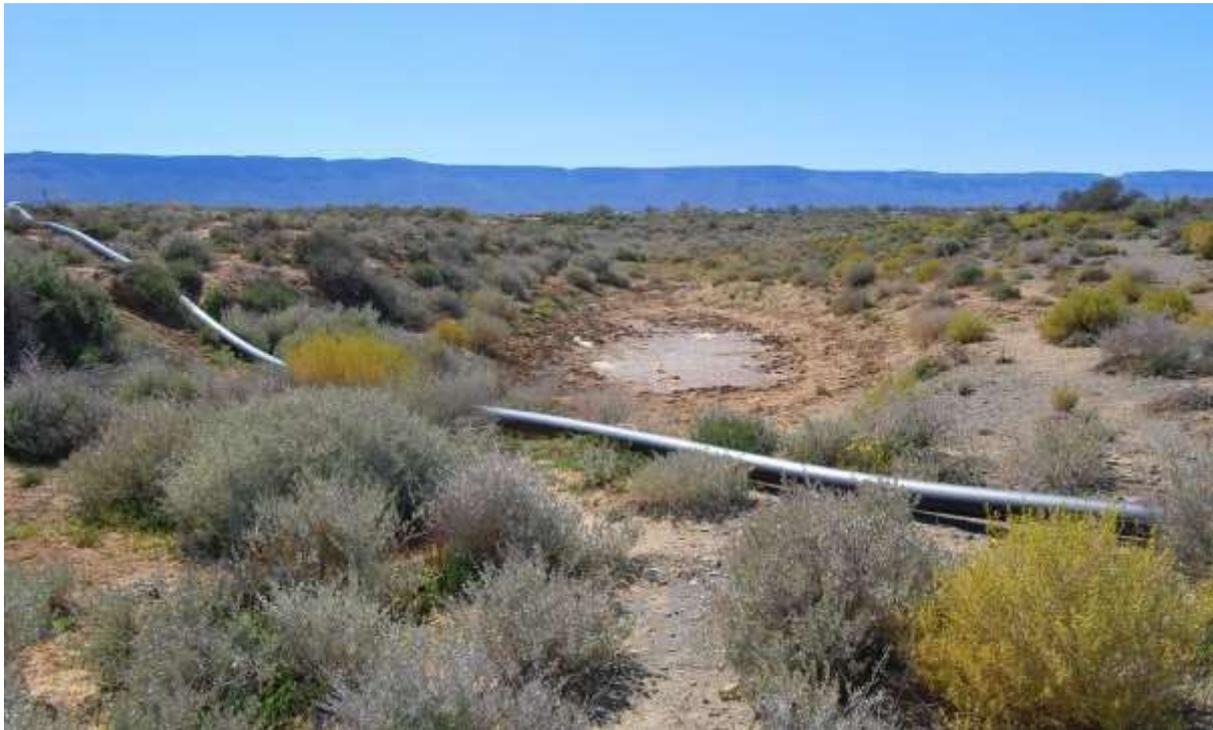
Figure 17 Oorlogskloof River crossing

The Class 5 crossing with the Oorlogskloof River (Crossing No.13, Figure 16) deserves more attention, as the river occasionally come down in flood with such a force that it can threaten the new pipeline. The riverbed downstream from the newly laid HDPE pipeline has been scoured out deeply (Figure 16). The pipeline at this crossing must therefore be protected, dug in deeper, with extra structures such as gabions and a reno mattress.

The flood plain here is wide and barren, with little vegetation and is disturbed because of mostly failed attempts to establish horticulture. The district here clearly is too dry, with rare availability of water in the river. The pipeline can be trenches without any ill effects to the aquatic environment.

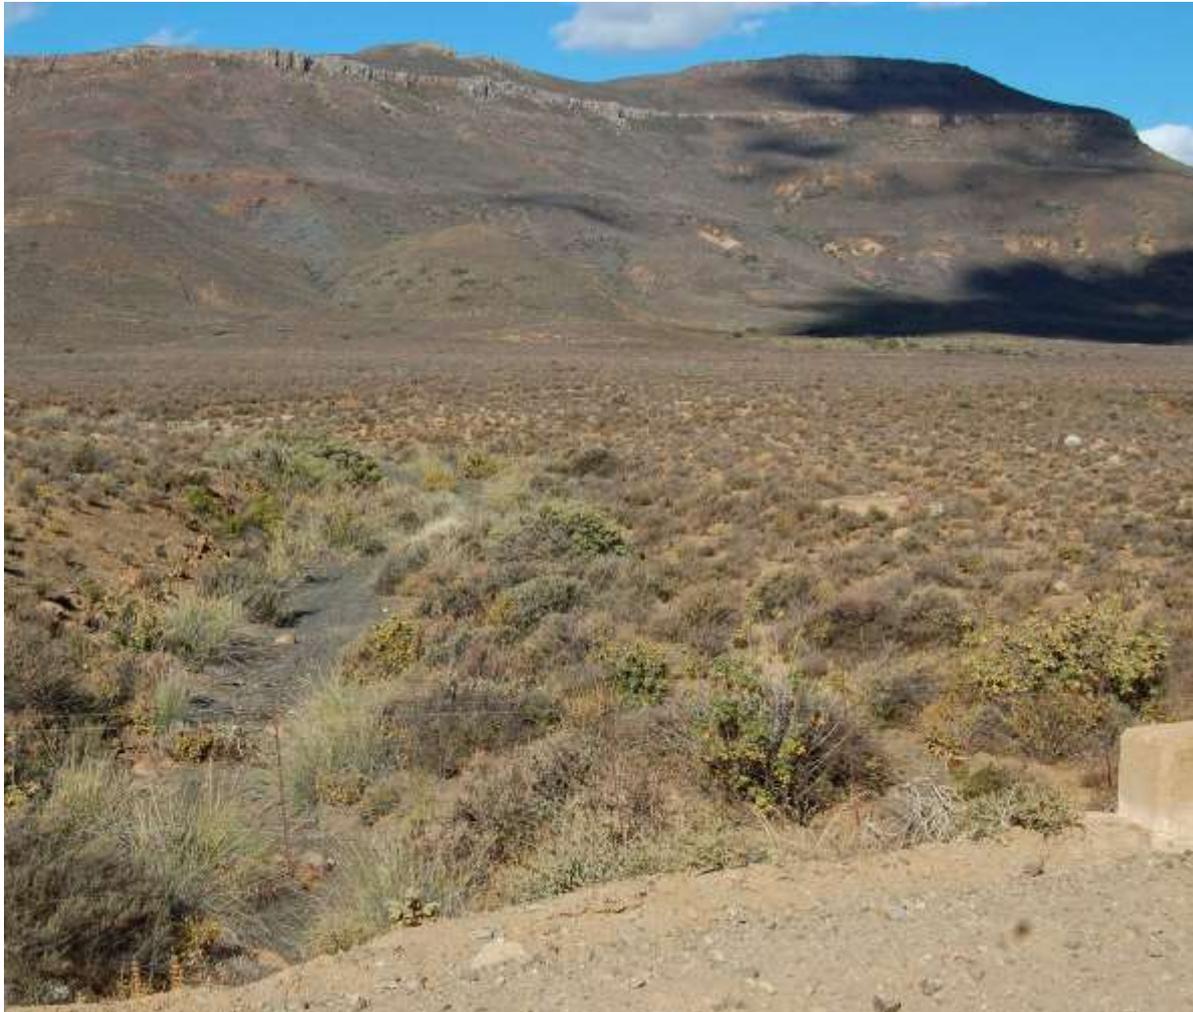
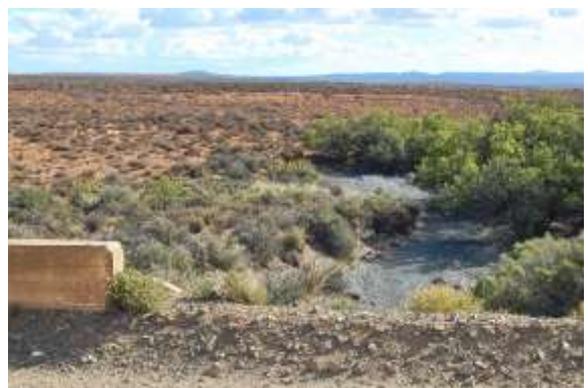
Figure 19 Loeriesfontein Crossing No.2

Upstream of the rather large constructed box culvert of Loeriesfontein Crossing No.2, the drainage line is small, with no more measures required but to dig the envisaged pipeline somewhat deeper in under the ground. Downstream, as is often the case with free-flowing culverts, the drainage line is much bigger, with a broad bed covered with coarse sand. The one bank has trees, that constitutes a scant riparian zone (Figure 19).

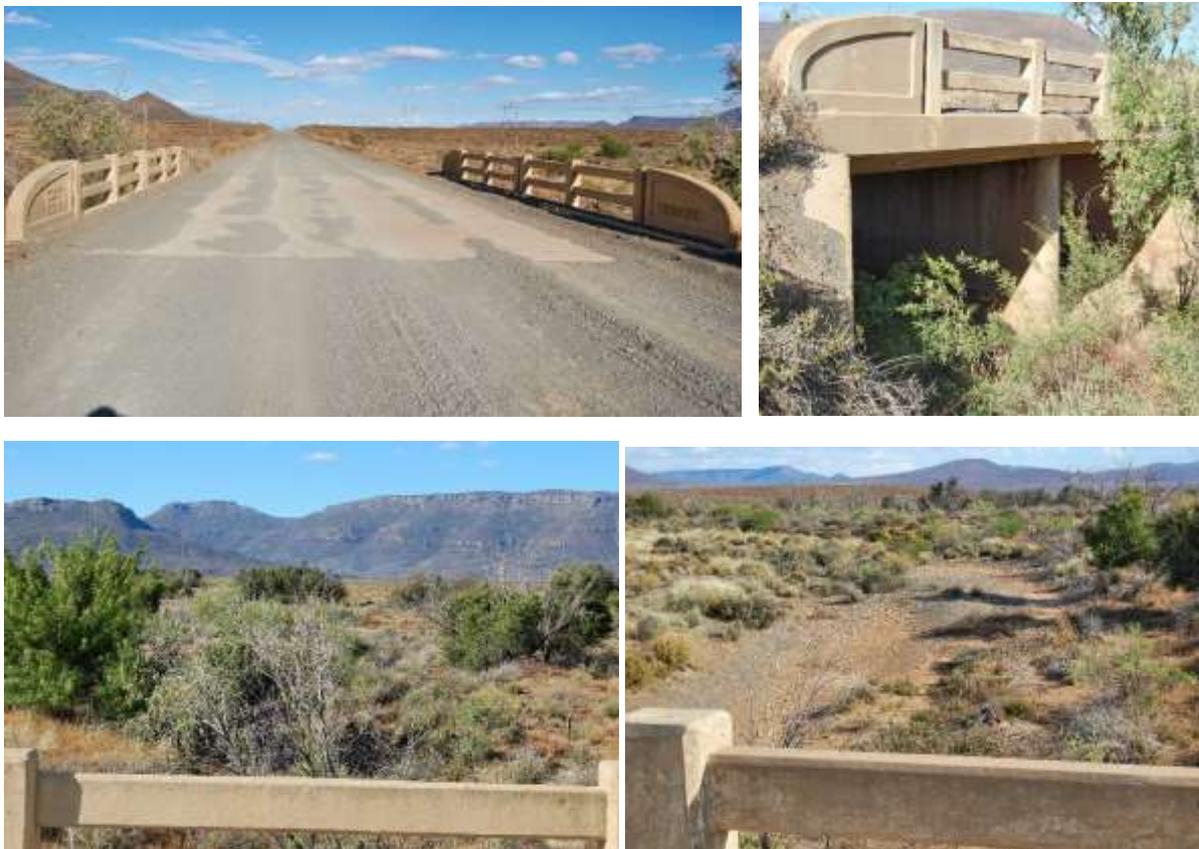
Figure 20 Crossing No. 6 Tierhoek River Bridge

Crossing No. 6 is the Tierhoek River Bridge (Figure 20). Again, the dry river bed upstream of the bridge is rather insignificant. Downstream, it is some 30m wide, with clear evidence of storm water activity. There are mature trees along the river banks, which make up the riparian vegetation.

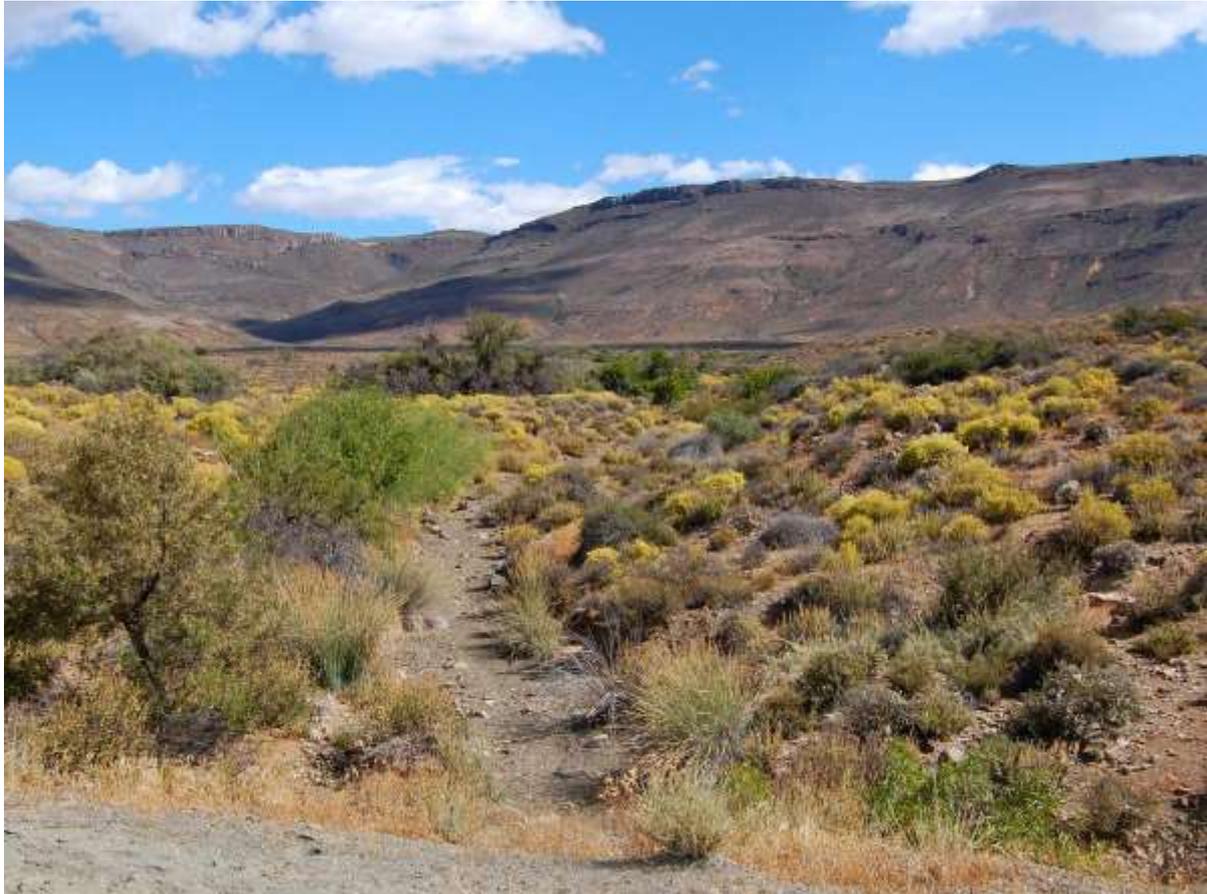
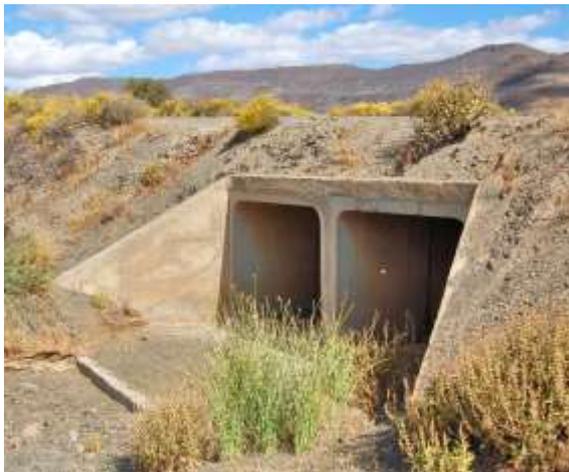
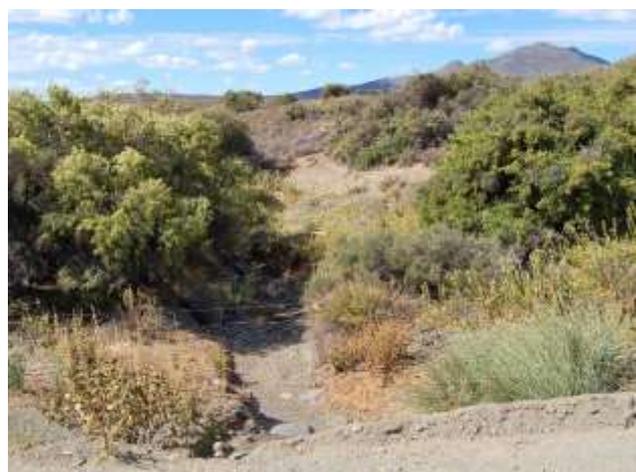
Figure 22 AP2886 Crossing No. 6

The drainage line coming out of the mountain towards Crossing 6 (Figure 22) is well defined and probably will require protection structures such as Reno mattresses and gabions. The drainage line will have to be stabilized with such structures as well. The drainage line passes underneath the road through a double constructed box culvert. Downstream of the culvert, the drainage line is deeply scoured out, down the steep decline, which renders it expensive, with large anchors on the banks of the drainage line, if the proposed pipeline is to be constructed at this location. It would therefore be advisable and financially feasible to construct the pipeline upstream of the road, where the slope and erosion are less. This is applicable to all of the Class 4 and 5 crossings particularly on this section of the proposed pipeline.

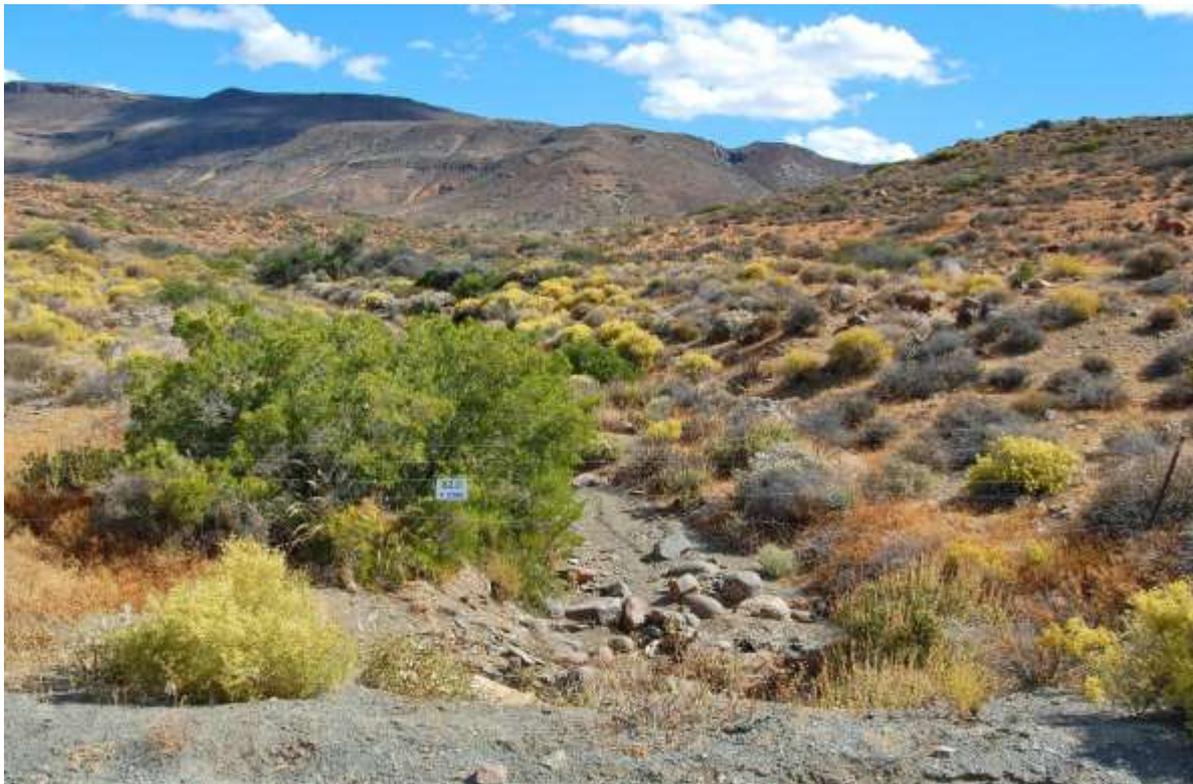
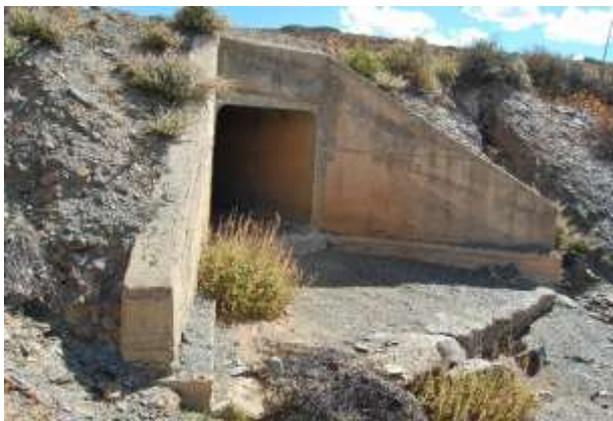
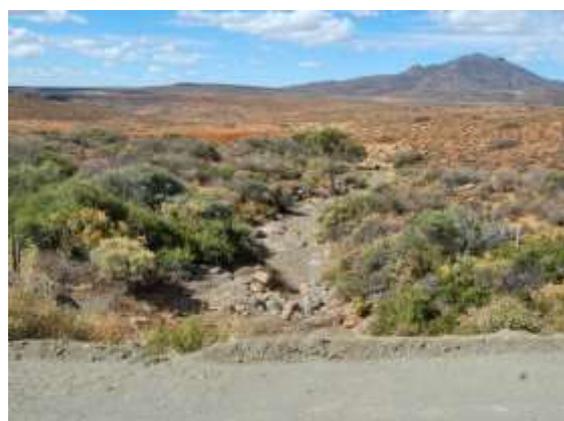
Figure 23 AP2886 Crossing No. 7

This drainage line has a prominent riparian zone around the crossing consisting of an assortment of mature trees.

Crossing No. 7 is similar (Figure 23). The road here is on a high embankment, with a very steep decline on the downstream side. The drainage line passes underneath through a single large box culvert. As with the other crossings along this section of pipeline, it is going to be difficult and expensive to put the pipeline on the much eroded downstream side of the culvert. Even upstream of the culvert, construction is going to be challenging, with a substantial measure of backfill, Reno mattresses and gabions required.

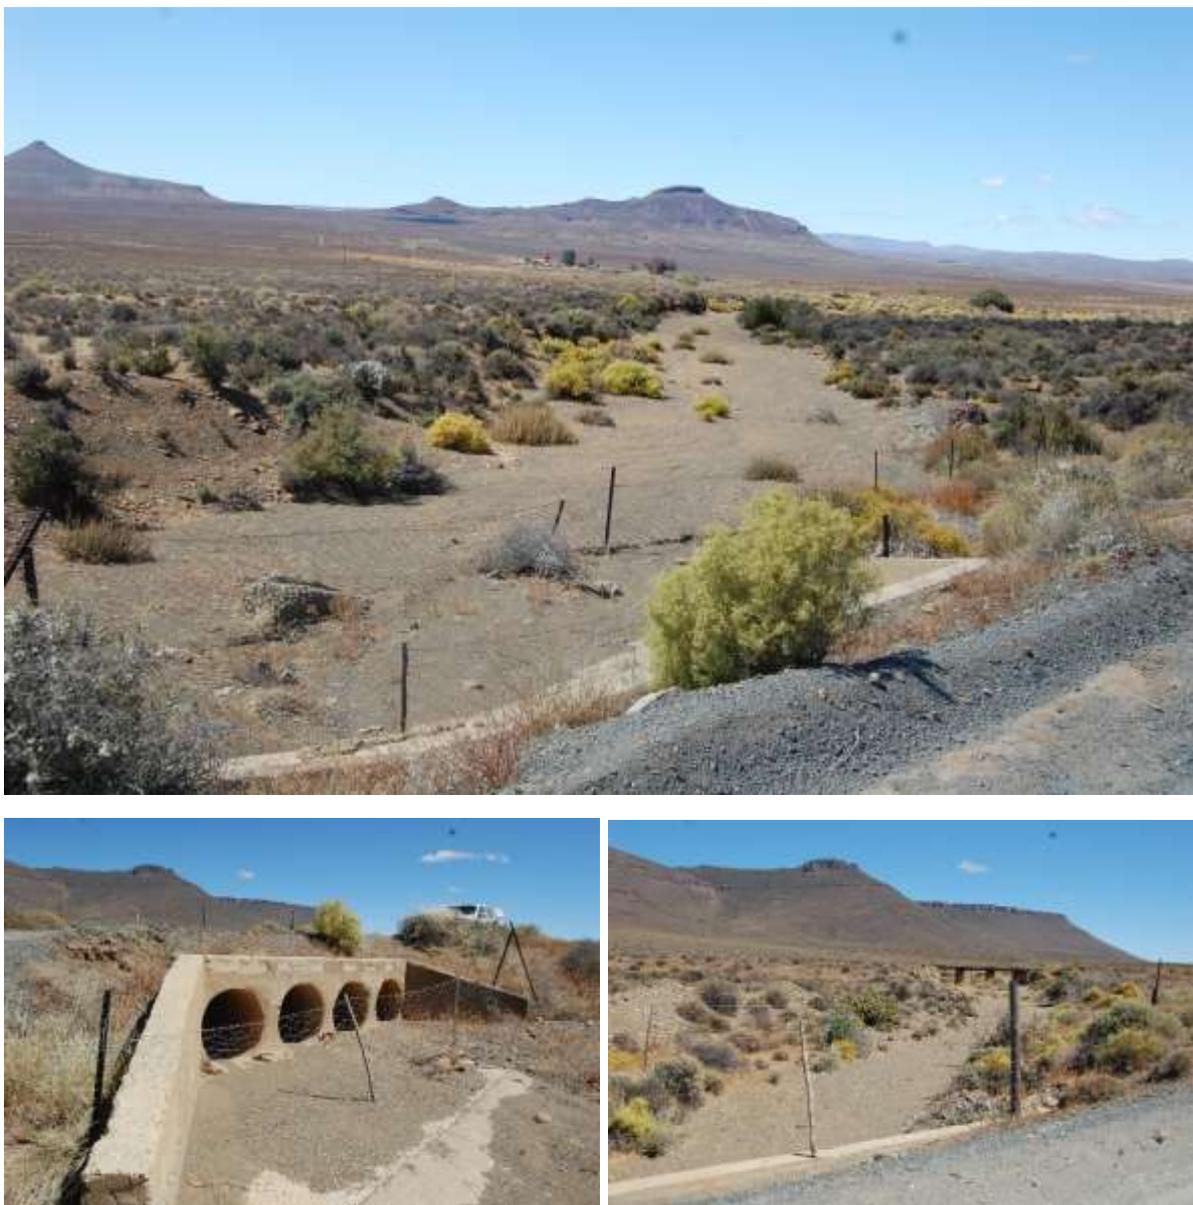
Figure 24 Klipwerf Road Crossing No.4

Crossing No.4 is a box culvert as well. This culvert is seriously eroded and is need of repair. Likewise, there are a number of constructed box culverts that partly that have flood damage.

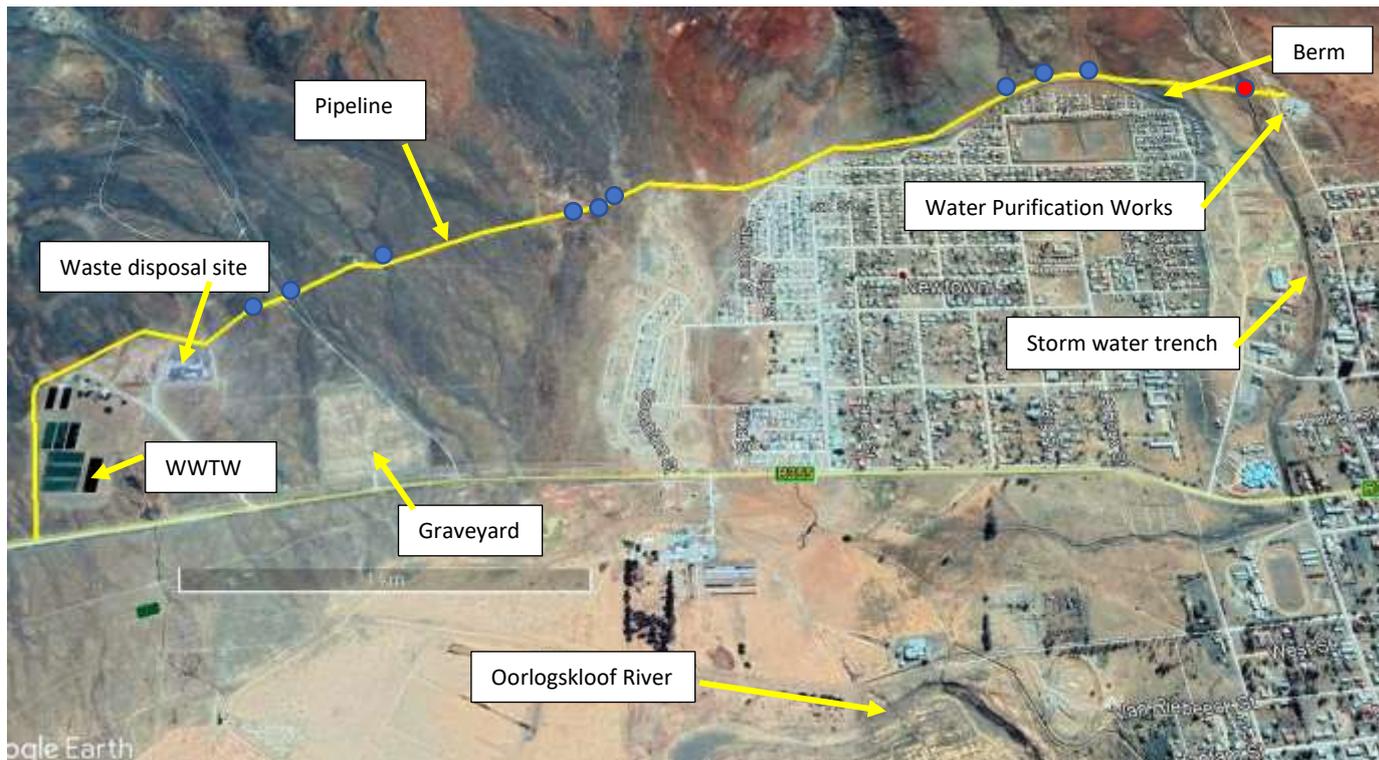
Figure 26 Pipeline in and around Calvinia

There will have to be a connection between the proposed pipeline along the Loeriesfontein Road from the north west of Calvinia and the Calvinia water purification works located at the north east end of town (Figure 30). This pipeline of 4.1km long is to pass north of the WWTW, the municipal waste disposal site and to the north of town (Figure 26). Its position on Figure 26 is only estimated and it is not finally be established by the scheduled time this report was to be submitted. The pipeline is to roughly follow the route of the existing high voltage power line to the north of the town.

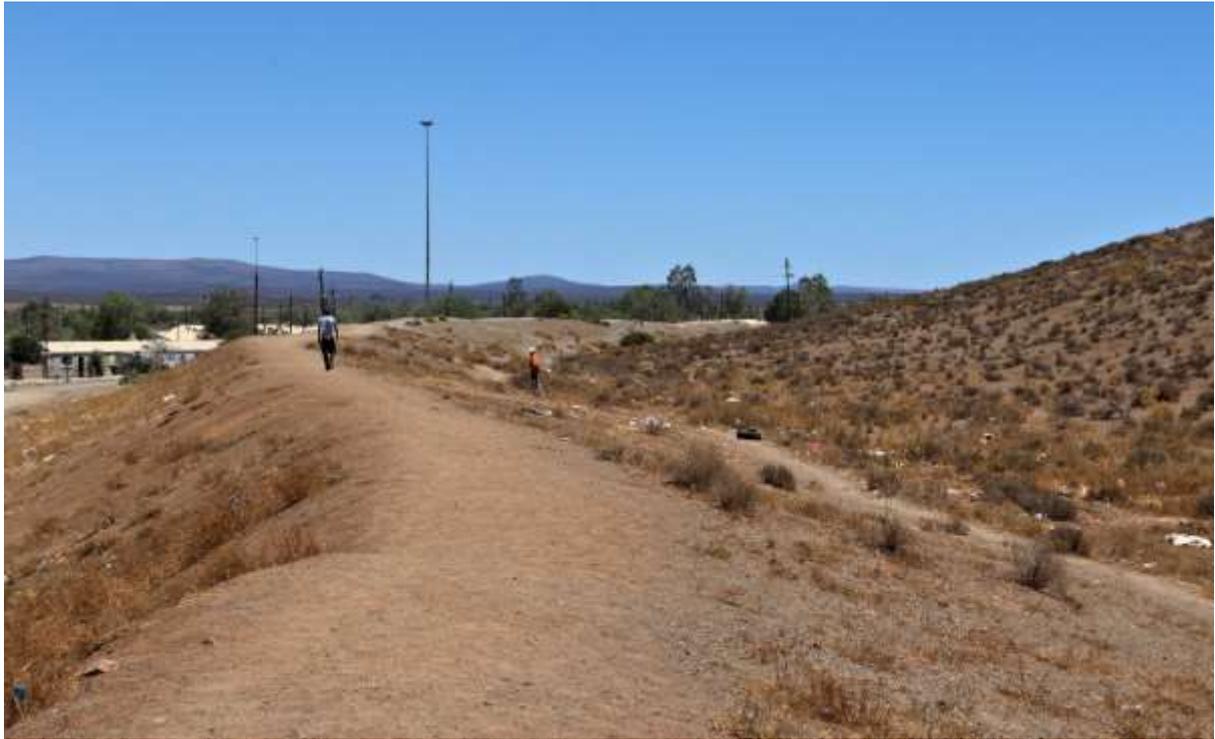
Figure 27 Berm

There are several drainage lines coming out of the Hantam Mountain to the north of town. The flow has been effectively cut off by a berm (Figure 25) that has been constructed along the northern boundary of Calvinia. Storm water is directed around the town to pass the built-up area at the west part of the town.

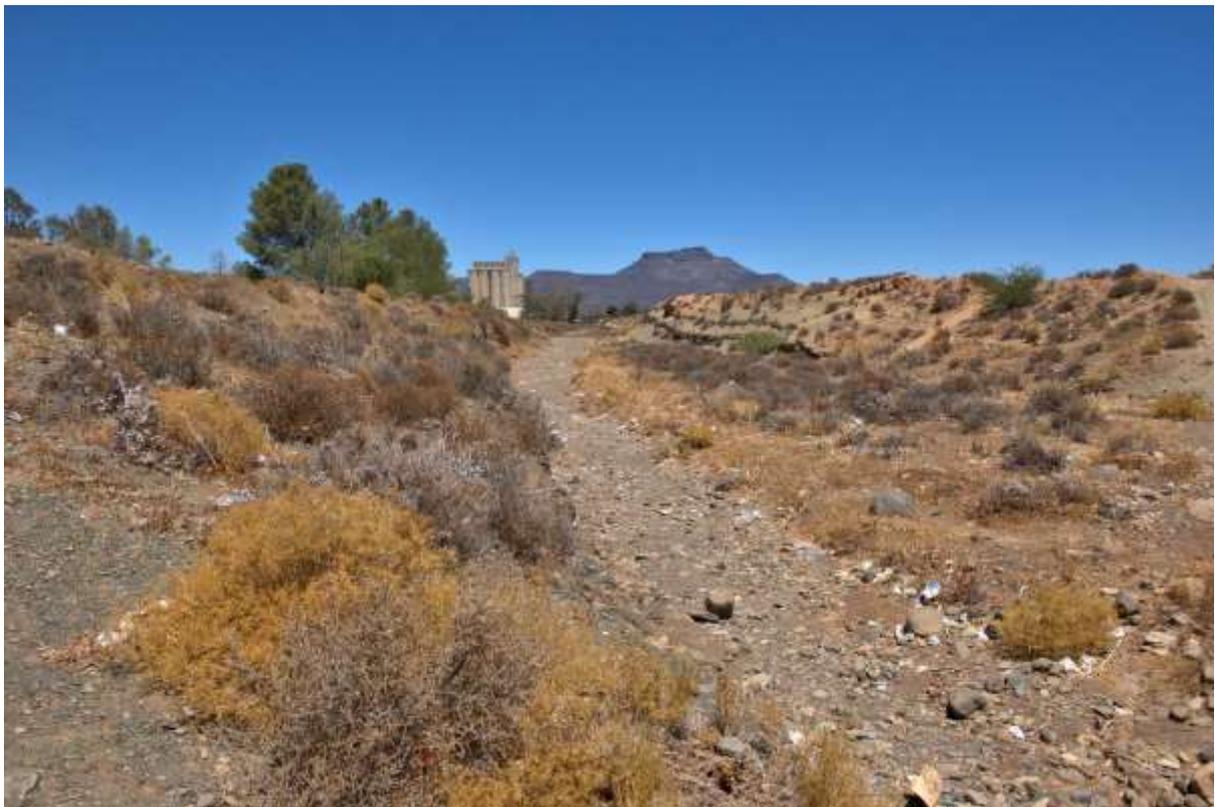
Figure 28 Storm water trench

There are at least 10 Class 1 and 2 crossings in the pathway of the proposed pipeline, which should not pose any challenges apart from extra backfill. The crossing over the storm water trench (Class 5, Figure 28) would require sturdy concrete anchors on the banks, with probably an overhead, exposed pipeline above the high flow water line. But then this is for the engineers to decide how they wish to approach this challenge.

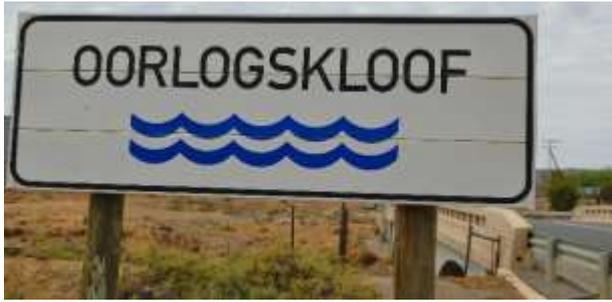
Figure 29 Oorlogskloof River bridge

Initially, the proposed pipeline from the R355 Ceres Road was to angle to the east along the R27 trunk road into town. The pipeline was to cross the Oorlogskloof River adjacent and to the south of town. The pipeline would probably have been attached to the superstructure of the bridge (Figure 29), if SANRAL agreed, in which event no additional mitigation measures or construction is required. From here the proposed pipeline will integrate into the existing water provisioning system, for which no additional civil works are required. However, this option is not considered to be viable any longer. The pipeline will be treched through the Oorlogskloof River to the west of Calvinia.

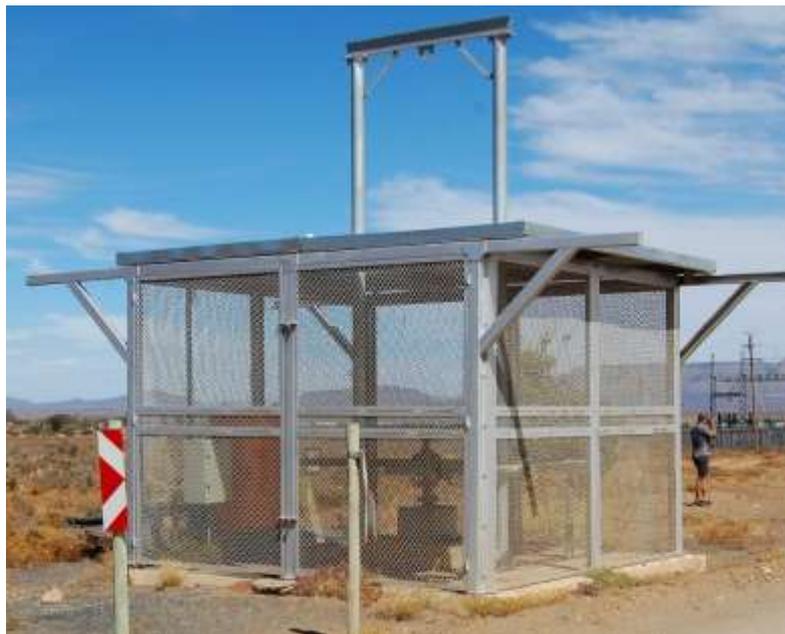
Figure 31 Borehole

The 5 boreholes will be equipped, each with an underground submersible pump, overhead electricity supply and a security structure on a 5m x 5m concrete slab (Figure 31). This is similar to existing borholes that have already been equipped.
