Appendix G3 – Freshwater Impact Assessment

Fresh Water Report

Proposed Viesserspan Solar Plant V2.0

August 2021

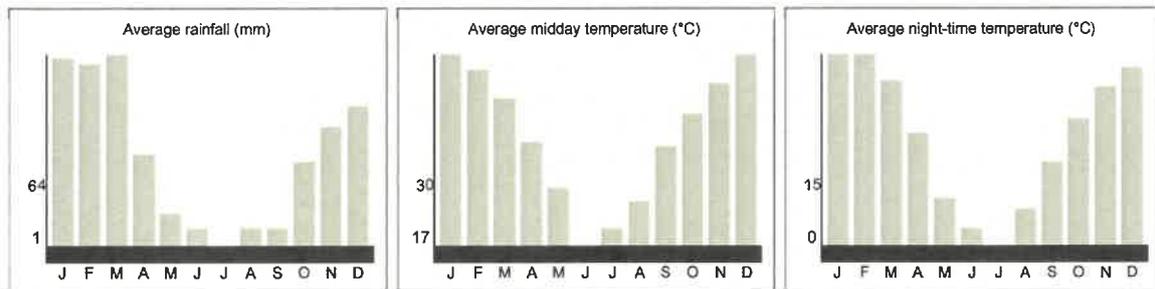
Figure 3 Dealesville Climate

Dealesville normally receives about 357mm of rain per year, with most rainfall occurring mainly during summer (Figure 3). The chart below (lower left) shows the average rainfall values for Dealesville per month. It receives the lowest rainfall (1mm) in July and the highest (64mm) in March. The monthly distribution of average daily maximum temperatures (centre chart below) shows that the average midday temperatures for Dealesville range from 17°C in June to 30°C in January. The region is the coldest during July when the mercury drops to 0.2°C on average during the night.

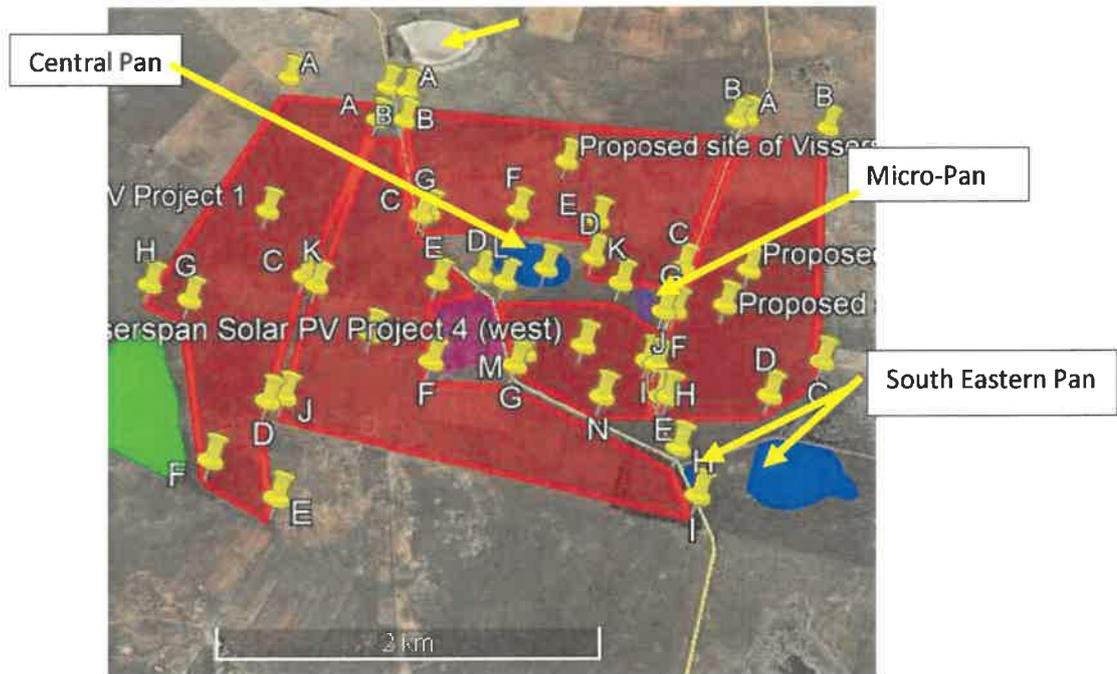
Figure 5 Enlarged Copy

Figure 5 is an enlarged copy to more clearly show the areas that have been placed around the spot that has been marked as a NFEPA on the SANBI BGIS webpage. This marked spot is excluded from the development. This spot will be surrounded by the fields of PV panels.

Note the bare micro-pan to the south-west of the central pan. This micro-pan was not observed during the site visit, as the area was densely overgrown with grasses. The Google Earth image was taken on 5/9/2018. Nevertheless, reportedly the micro-pan was still present and it is included in the NFEPA. It was cut out from the area that is to be developed (Figure 5).

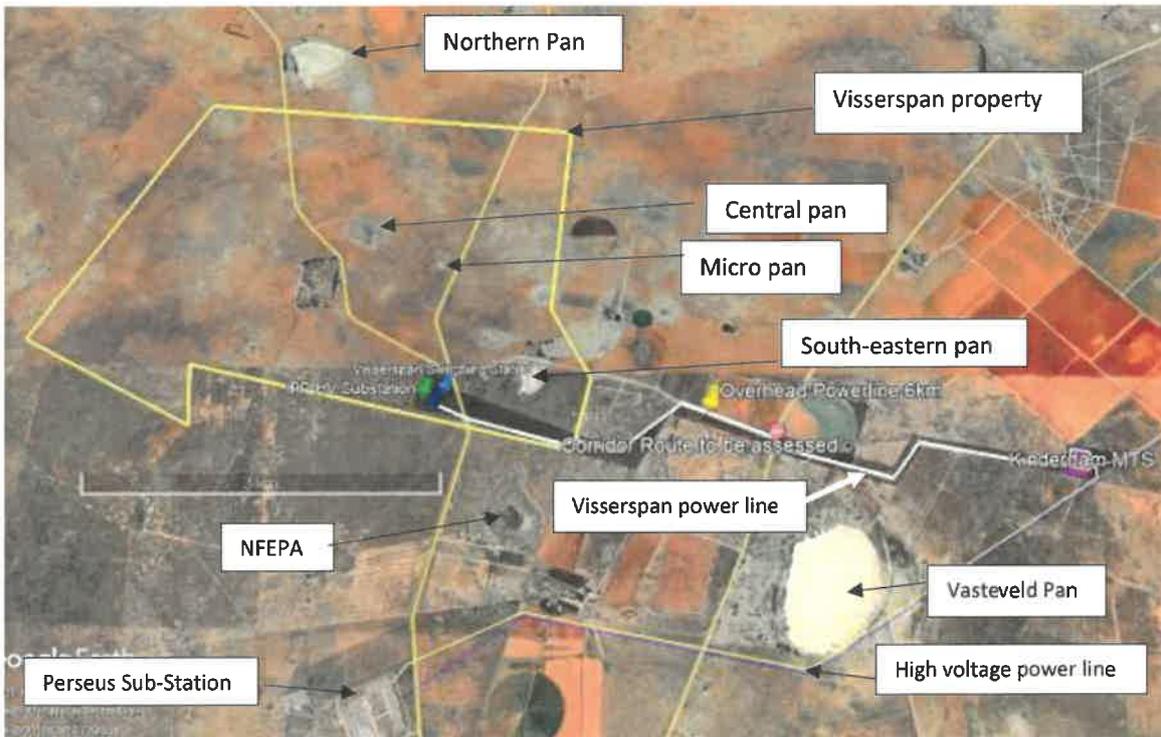
Figure 6 Power Line

The power line connects the PV plant on Visserspan Farm to the national grid. The power line will stretch from the PV plant for 6km to the west over several properties to connect to the high voltage line to the west at Kinderdam Farm (Figure 6). The power line will, as far as possible, follow the boundaries of the farms, rather than crossing farmland (Figure 7).

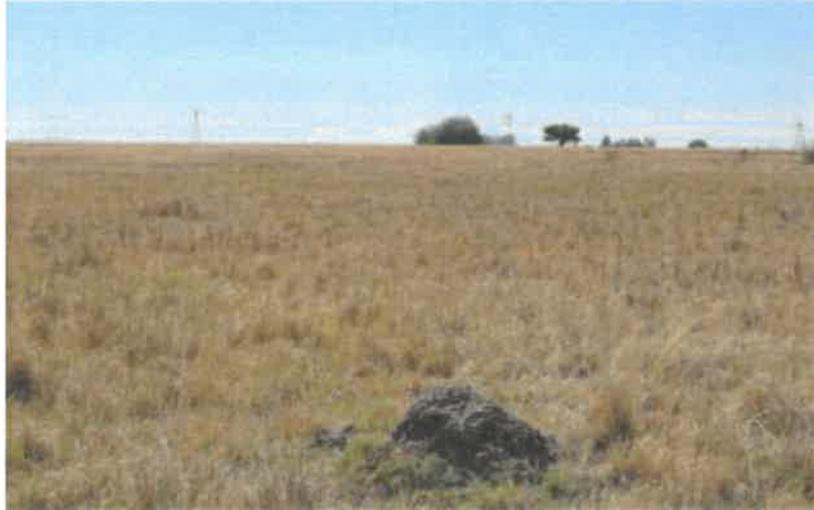
Figure 8 Central pan mixed grass

The presence of this swelling clay is the reason for the existence of a mixed grass pan, without a barren patch, as the clay is too cohesive and heavy to be blown away by the Free State's stormy winds. The central pan developed into a consistent marshy area and not into a bare pan, as is evident in many places all over the western Free State.

The central pan was heavily grazed, with the grasses trimmed of short in most places. There were lots of animal hooves imprints in the clay that has probably been there since the previous rainy season.

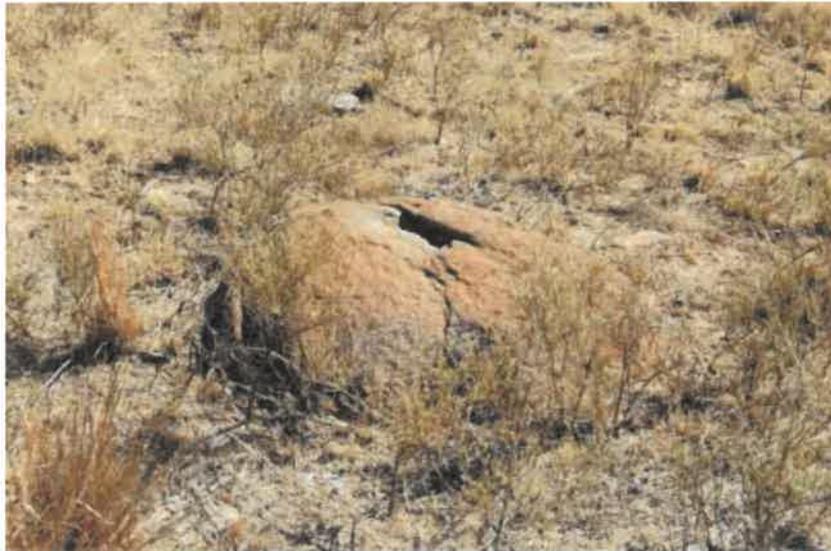
Figure 9 Dolerite

A dolerite intrusion intersects the central pan, with only a couple of dolerite boulders and stones (Figure 9) on the ground's surface. Dolerite weathers into several fractions, the one being a Montmorillonite swelling clay. The central pan consists of this swelling clay (Figure 14), with obvious cracks because of the prolonged current drought.

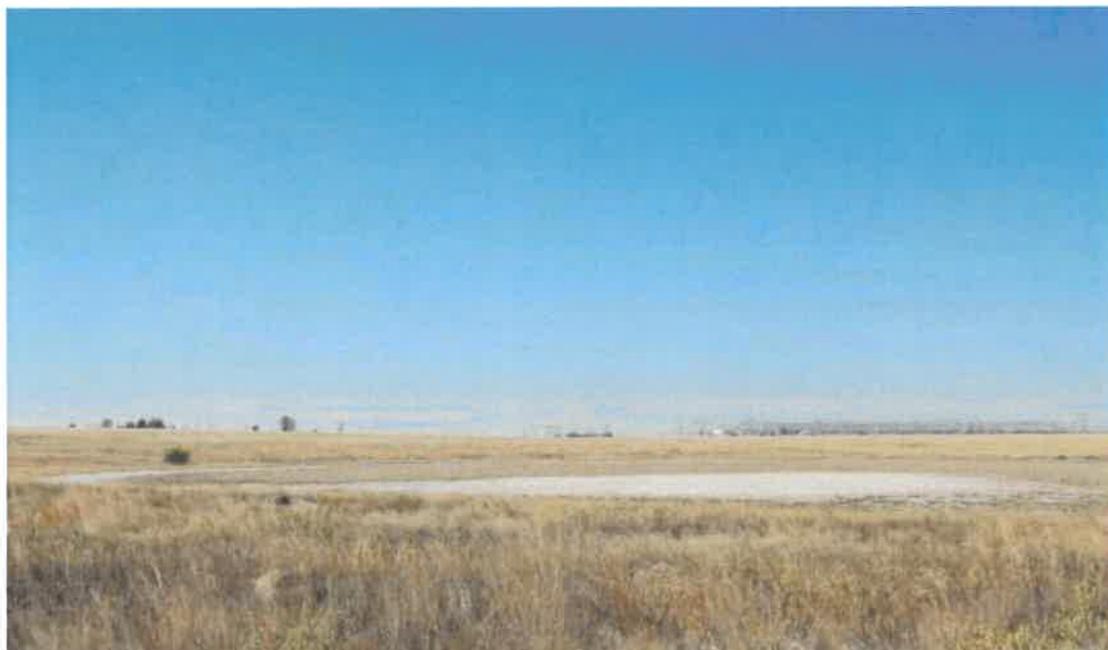
Figure 10 South-eastern bare pan

The southern part is a small bare pan (Figure 10).

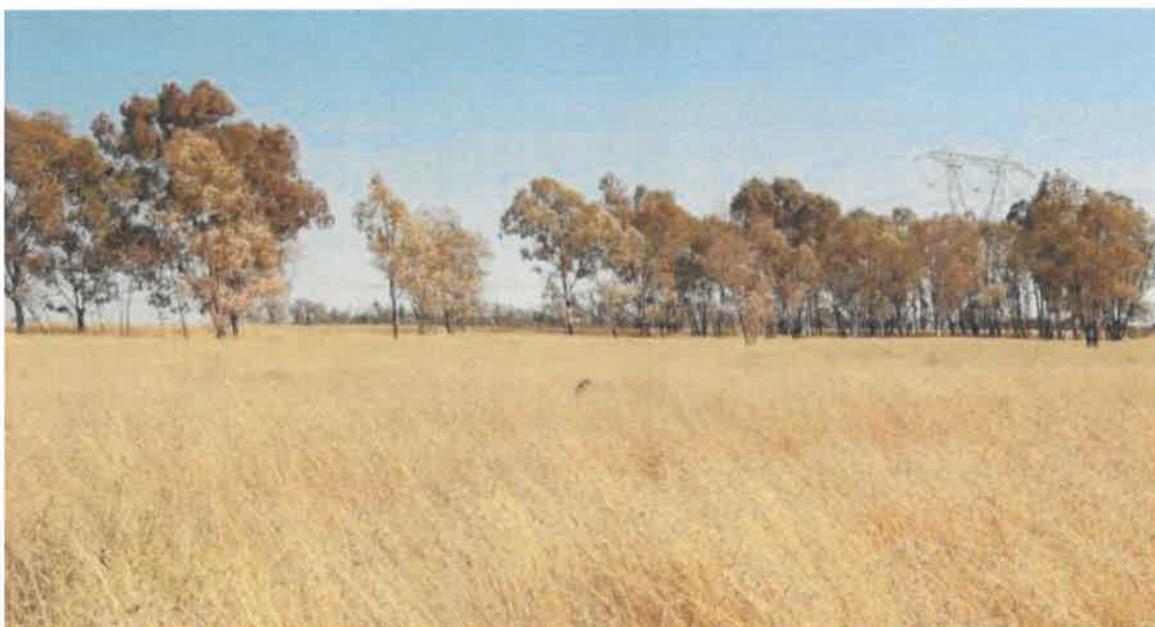
Figure 11 Upper part of the south-eastern pan

The much larger separate northern part is in an advanced state of reverting back to grassland, with a stance of stunted blue gum trees advancing the process. During the August 2021 site visit, it was well overgrown with grass, with little pan signs apart from a topographical depression (Figure 11).

Judging from the termite mounds, the grassland status has been established years ago, if not decades ago.

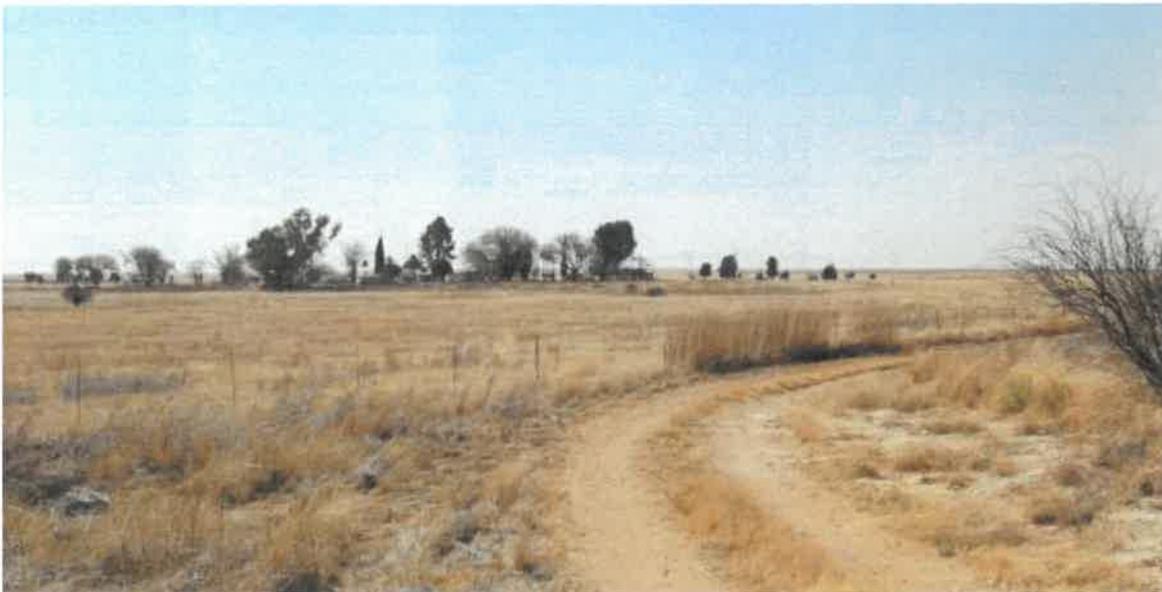
Figure 13 Altered NFEPA

An NFEPA is indicated on the SANBI BGIS webpage approximately 300m south of the proposed power line (Figure 13). This alleged wetland was photographed from many angles during the August 2021 site visit. At this point in time, apart from an indication of Google Earth of a depression, nothing remains. It has been altered into farmland. Hence, it is omitted from any further discussion, as the proposed power line cannot possibly have any further deleterious impact.

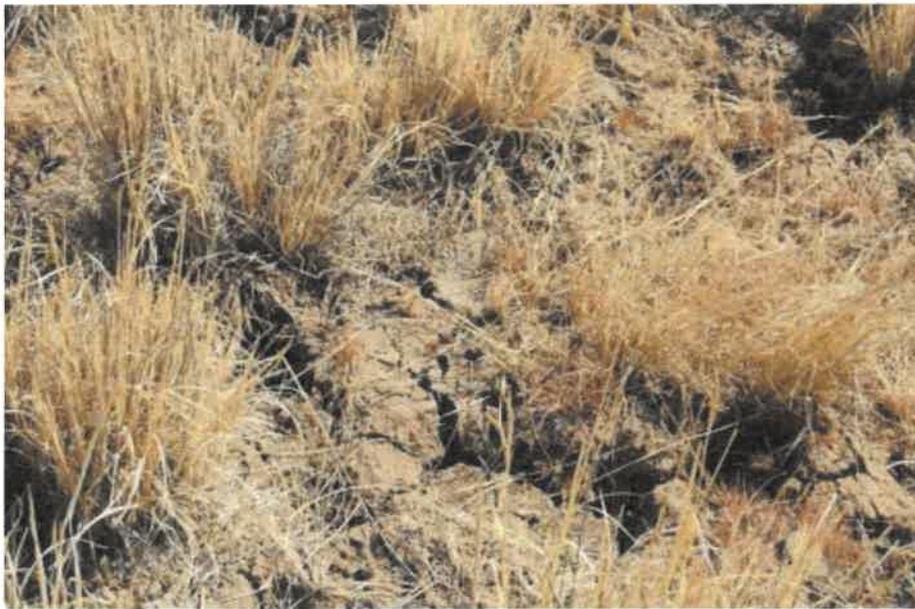
Figure 14 Dry clayey soil with cracks

It was obvious that soils were saturated the previous season, judging from the cracks in the clayey soils (Figure 14). These were obviously hydromorphic soils, verifying its wetland status. This was in contrast with the August 2021 site visit, following good rains, when cracks were less obvious.

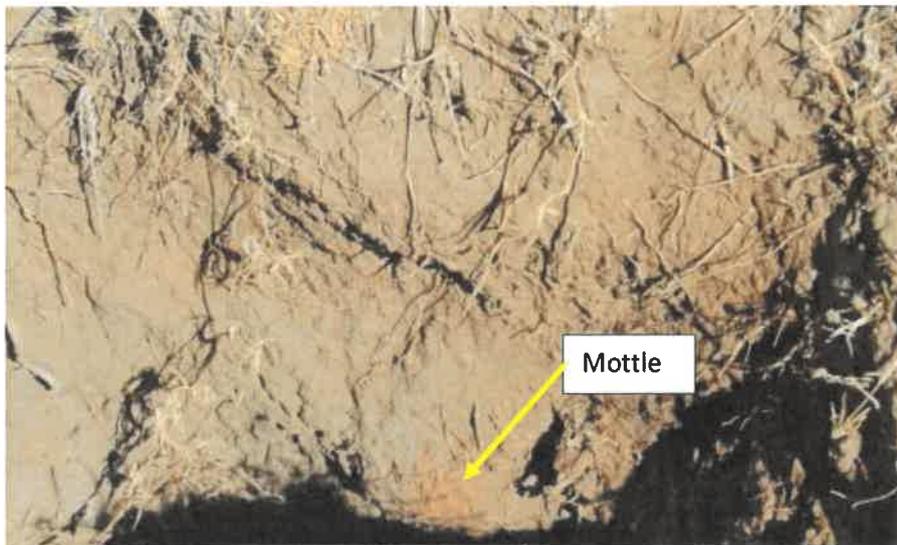
Figure 15 Mottle in hydromorphic soil

No test holes were dug to look for mottles, as are present in hydromorphic soils. Instead, a handy test hole was provided by an aardvark, of which there are plenty in the district. The burrow was approximately 800mm deep, on one side of which was a discernible brown-red mottle (Figure 15), re-affirming the presence of temporary wetland conditions in hydromorphic soils.

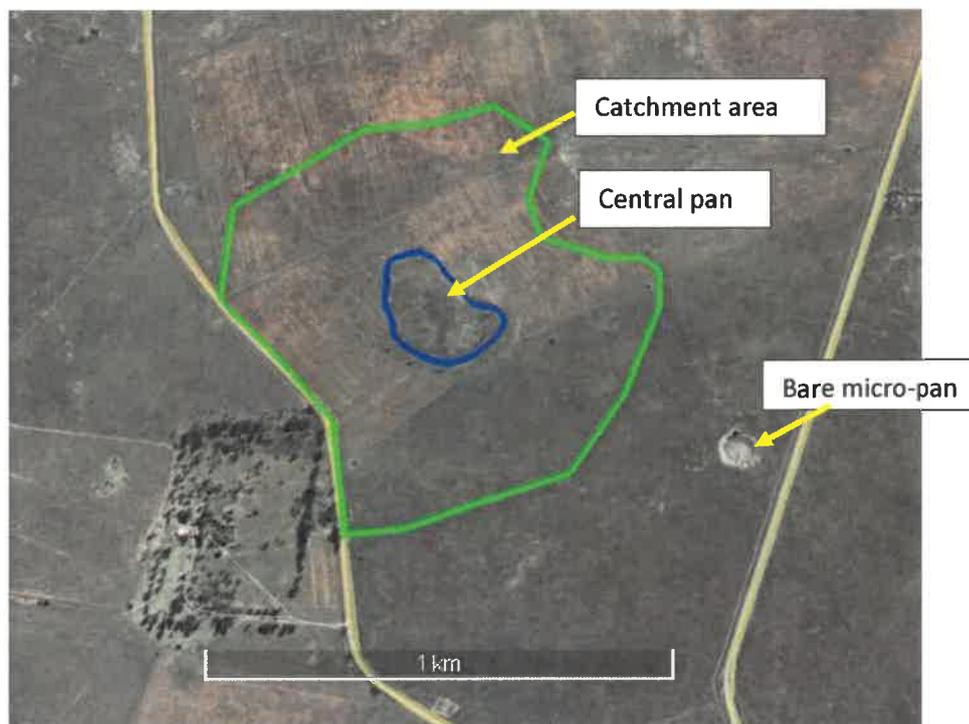
Figure 16 Central pan & catchment

The catchment is 83ha in size, with a circumference of 3.7km.

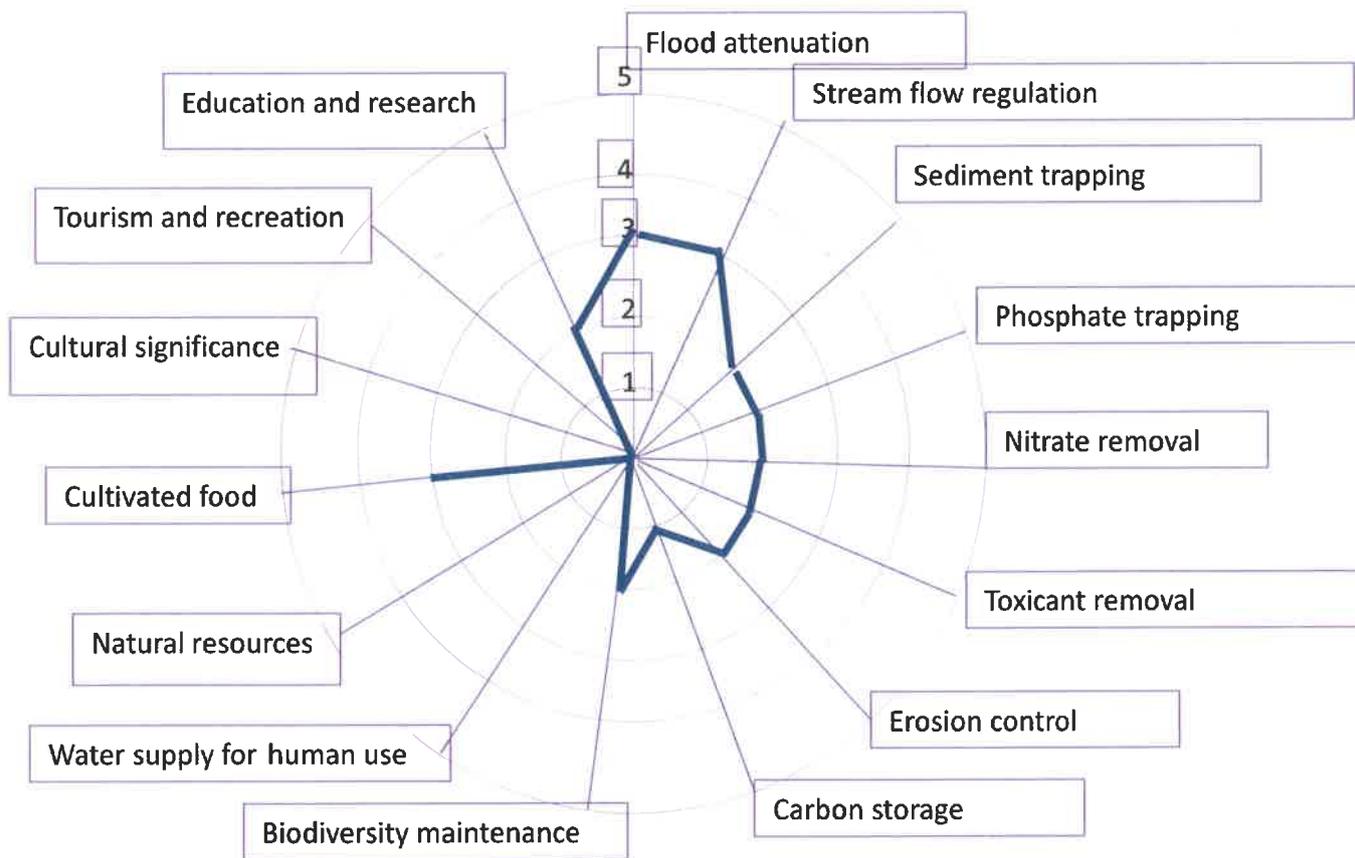
Figure 17. Resource Economics Footprint of the Visserspan central pan

Goods & Services	Central Pan Score	Bare Pans Score
Flood attenuation	3	2
Stream flow regulation	3	2
Sediment trapping	2	0
Phosphate trapping	2	1
Nitrate removal	2	1
Toxicant removal	2	1
Erosion control	2	1
Carbon storage	1	0
Biodiversity maintenance	2	4
Water supply for human use	0	0
Natural resources	0	0
Cultivated food	3	0
Cultural significance	0	0
Tourism and recreation	0	0
Education and research	2	3

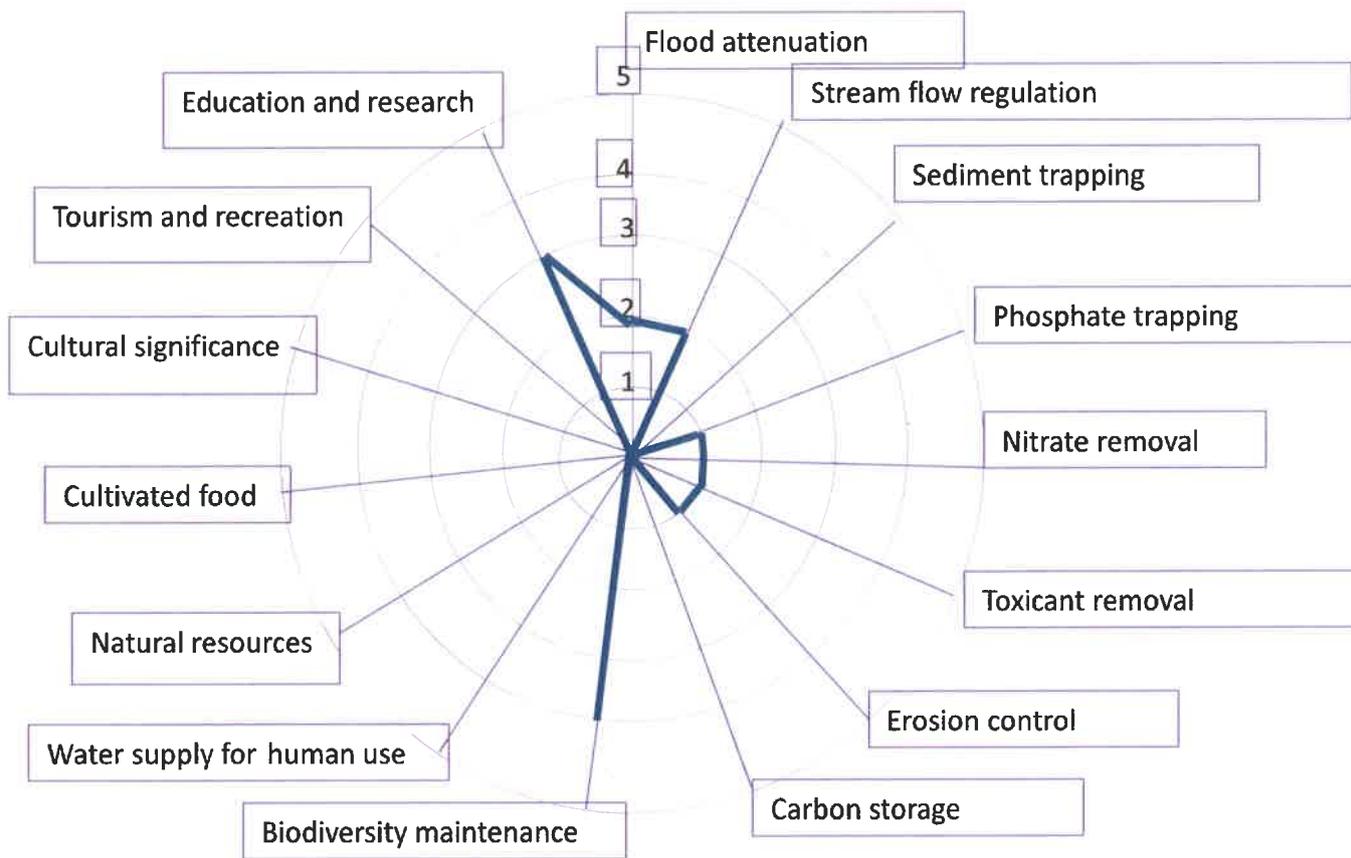
Figure 18. Resource Economics Footprint of the Visserspan and Vasteveld Bare Pans combined

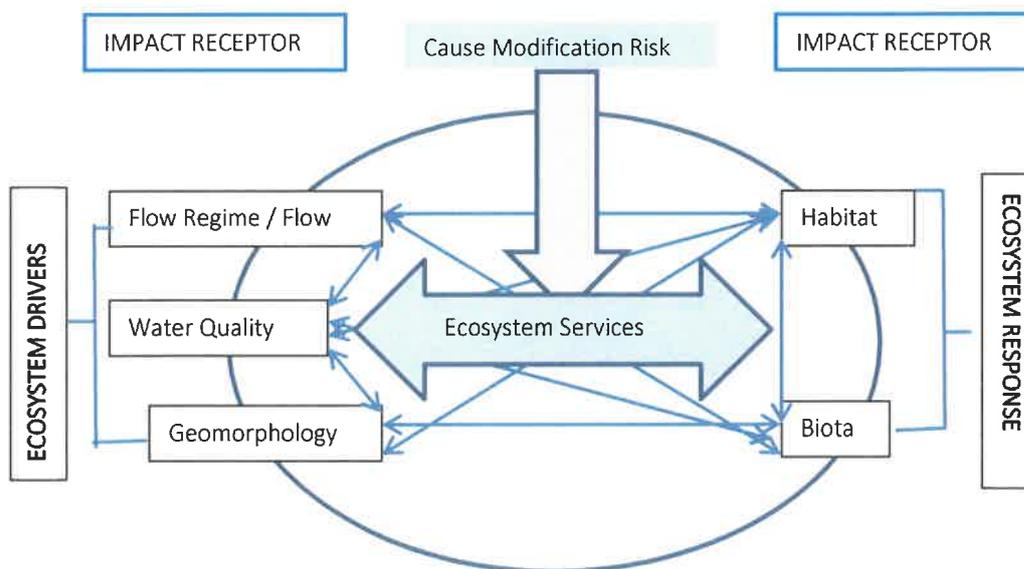
Figure 19 Minimum Requirements for a S21(c) and (i) Application

Figure 19 has been adapted from one of the most recent DWS policy documents.
