TECHNICAL REPORT

Uppington Site 1- Housing Project- Dawid Kruiper Municipality

Preliminary Geotechnical Site Investigation

Project Title	Upington Site 1- Housing Project- Dawid Kruiper Municipality
Client	Dawid Kruiper Municipality
Project Manager	Bernard de Witt- EnviroAfrica
Report Description	Preliminary Geotechnical Site Investigation
Report Number	GC-23-132A
Report Version	Final Report

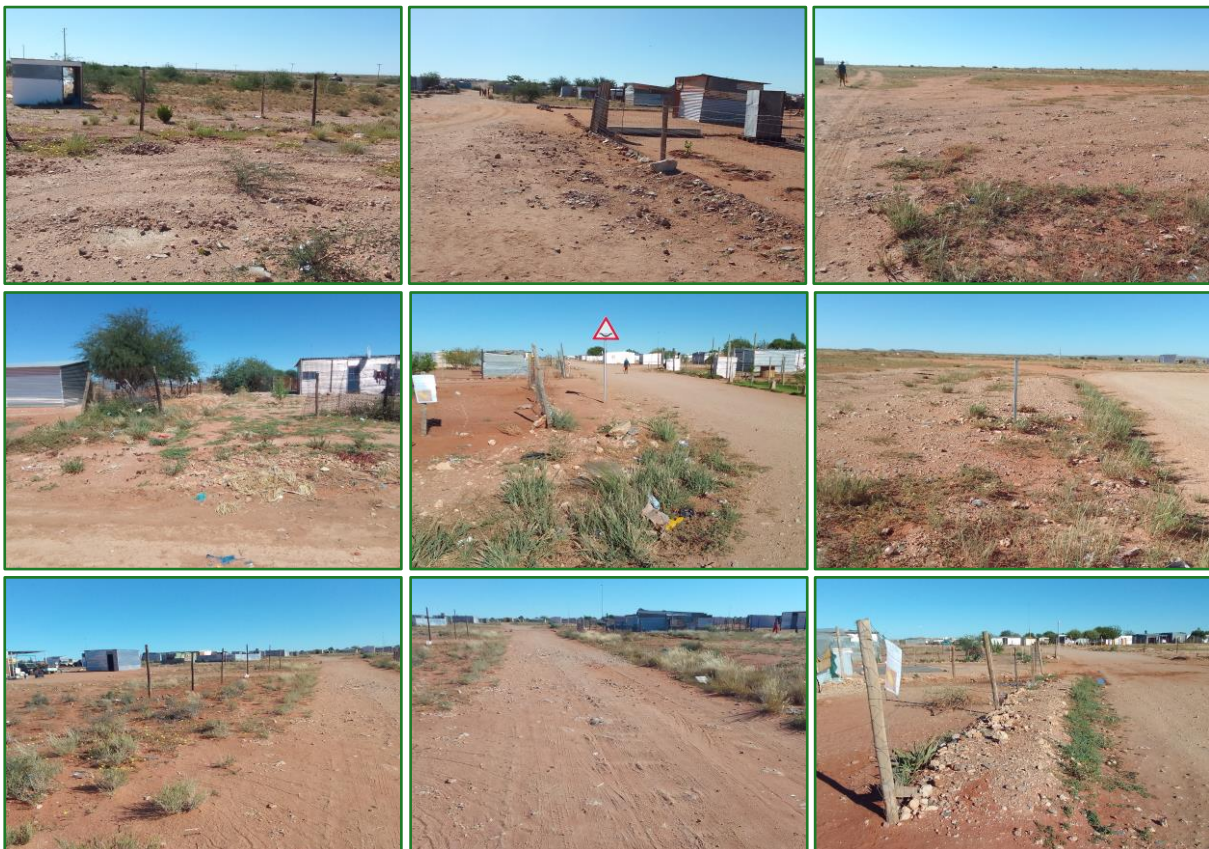
As visually depicted in the photo series below, the surface across the central to south eastern portions of the site has been **remoulded** though past **informal township establishment** practices. The exact extent of the infrastructure in the region is not known (both surface and subsurface). It is envisaged that the informal development across this region will **grow daily**. Furthermore, numerous gravel roads traverse the site, with these roads serving as the primary access points to the various portions. Due to the risk of damages to existing services, the local authorities did not authorise the excavation of tests pits across this area.

Additional to these practices, heaps of **dumped fill** materials were present adjacent to the gravel roads and residential dwellings. The surficial nature of the site was further diversified by its rocky surface. The combination of the items raised above have resulted in the formation of an anthropogenically induced undulating landscape, with the occurrence of localised topographic anomalies.

The photo series below graphically depicts the surficial nature of the site at the time of this study- as presented by *EnviroAfrica*.
