## Upgrading of the Paballelo Jupiter Cemetery

Dawid Kruiper Municipality- ZF Mgcawu District Municipality

Phase 1 Engineering Geological Site Investigation

Project Title	Upgrading of the Paballelo Jupiter Cemetery
Client	Dawid Kruijer Municipality
Project Manager	Bernard de Witt- EnviroAfrica
Report Description	Phase 1 Engineering Geological Site Investigation
Report Number	GC-23-109A
Report Version	Final Report

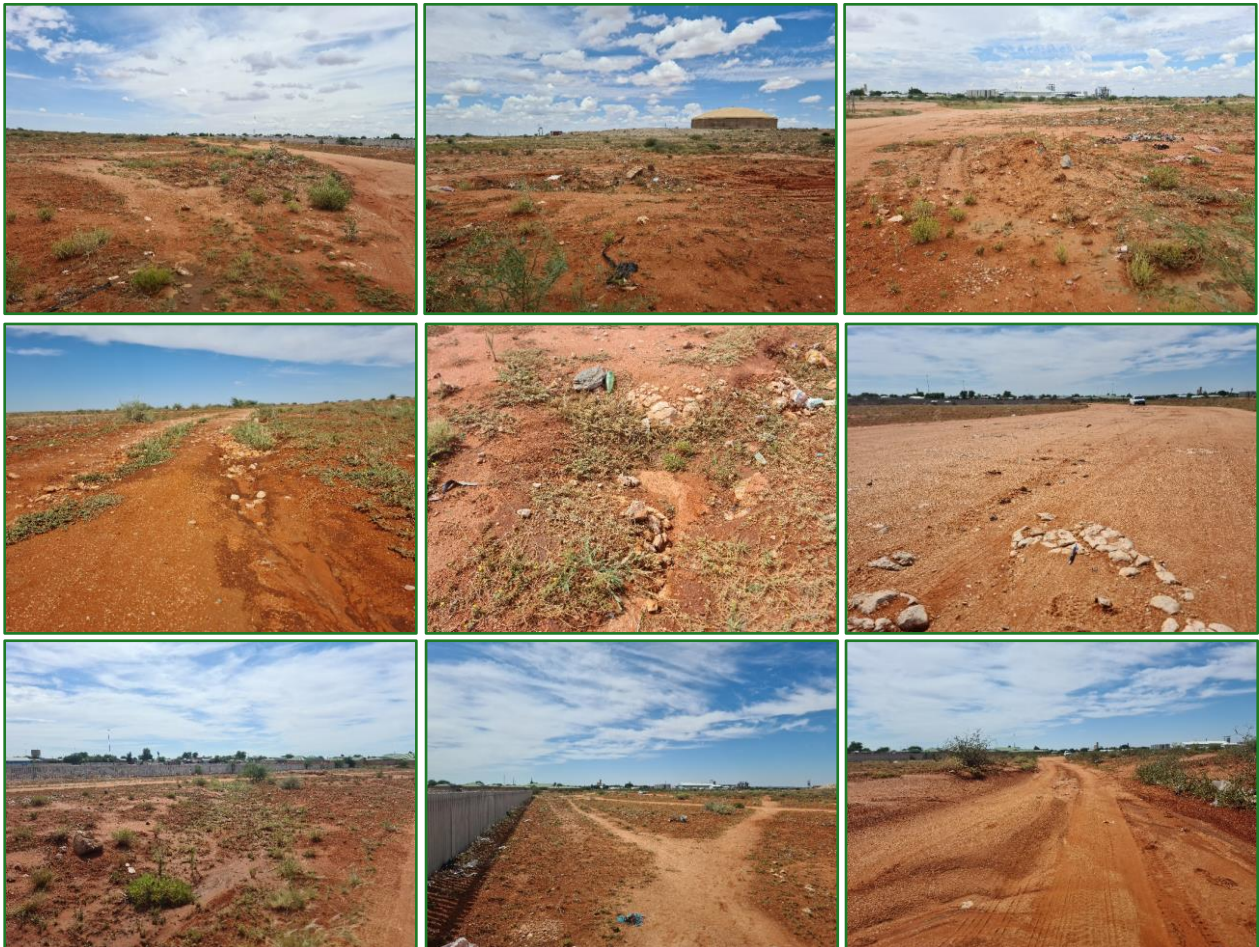
The surface across most of the planned extension/site was seen to display a **reworked nature** attributed to past and ongoing **human activities** in the region. This reworking was predominantly related to the **township establishment** undertaken in the region, including **anthropogenic** features such as services, roadways/pathways, minor sand mines, scattered heaps of dumped fill, basic earthworks and vegetation depletion/degradation. The exact extent of the existing surface and subsurface infrastructure in this region is not known. These combined actions have not only artificially diversified the topographical nature of the investigated area, but also its geotechnical character.

The photo series below graphically depicts the surficial nature of the site at the time of this study.

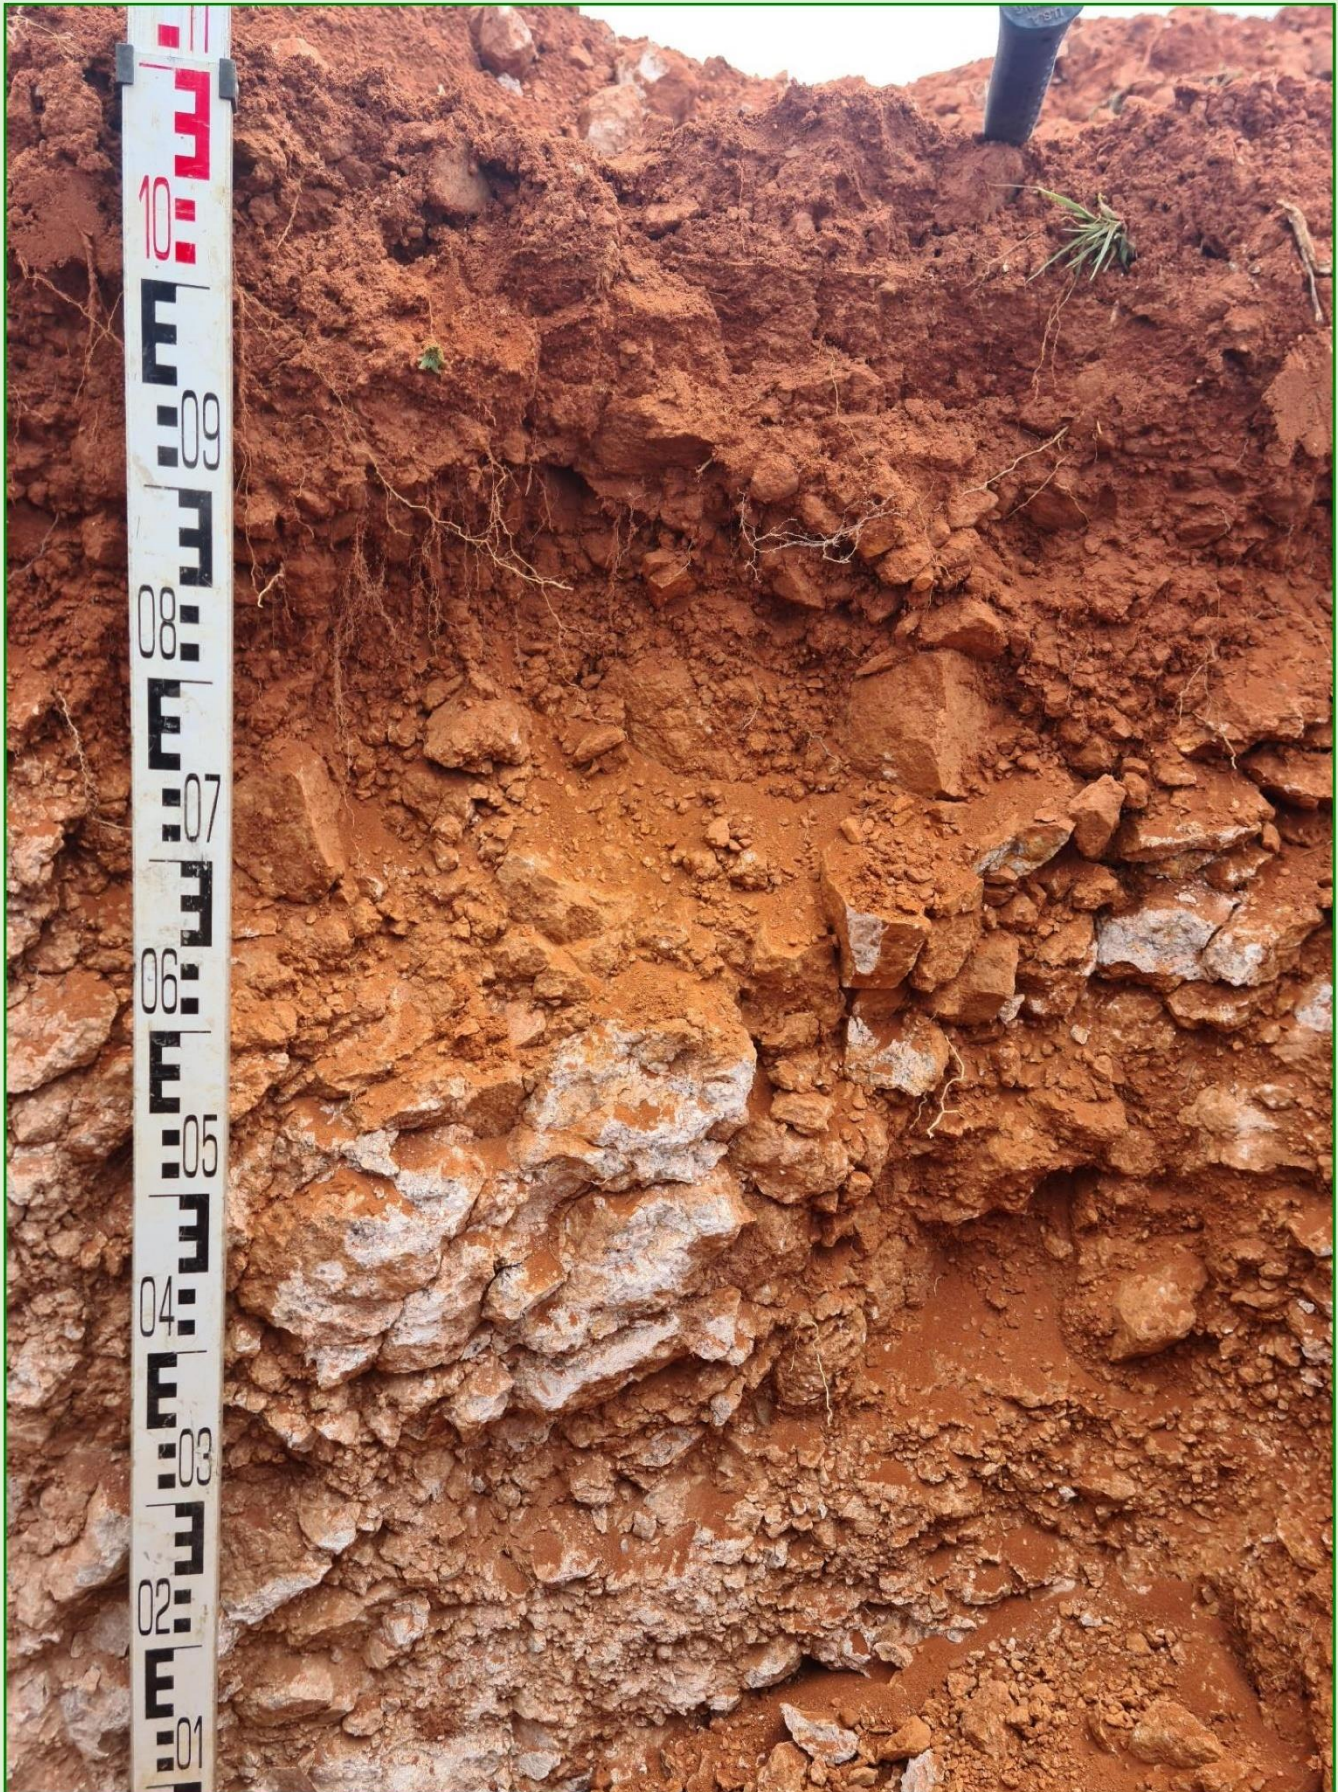
Profile Photo: TP2

slightly MOIST; light orangey BROWN; LOOSE; PINHOLED; silty SAND with traces of gravel; AEOLIAN SAND; abundant fine roots; Not Sampled.

slightly MOIST; light orangey BROWN; LOOSE; MATRIX SUPPORTED; sub-angular gravels and cobbles in a matrix of silty SAND; PEBBLE MARKER; traces of fine roots; heterogeneous composition and poorly sorted nature; Disturbed Sample No. U2.

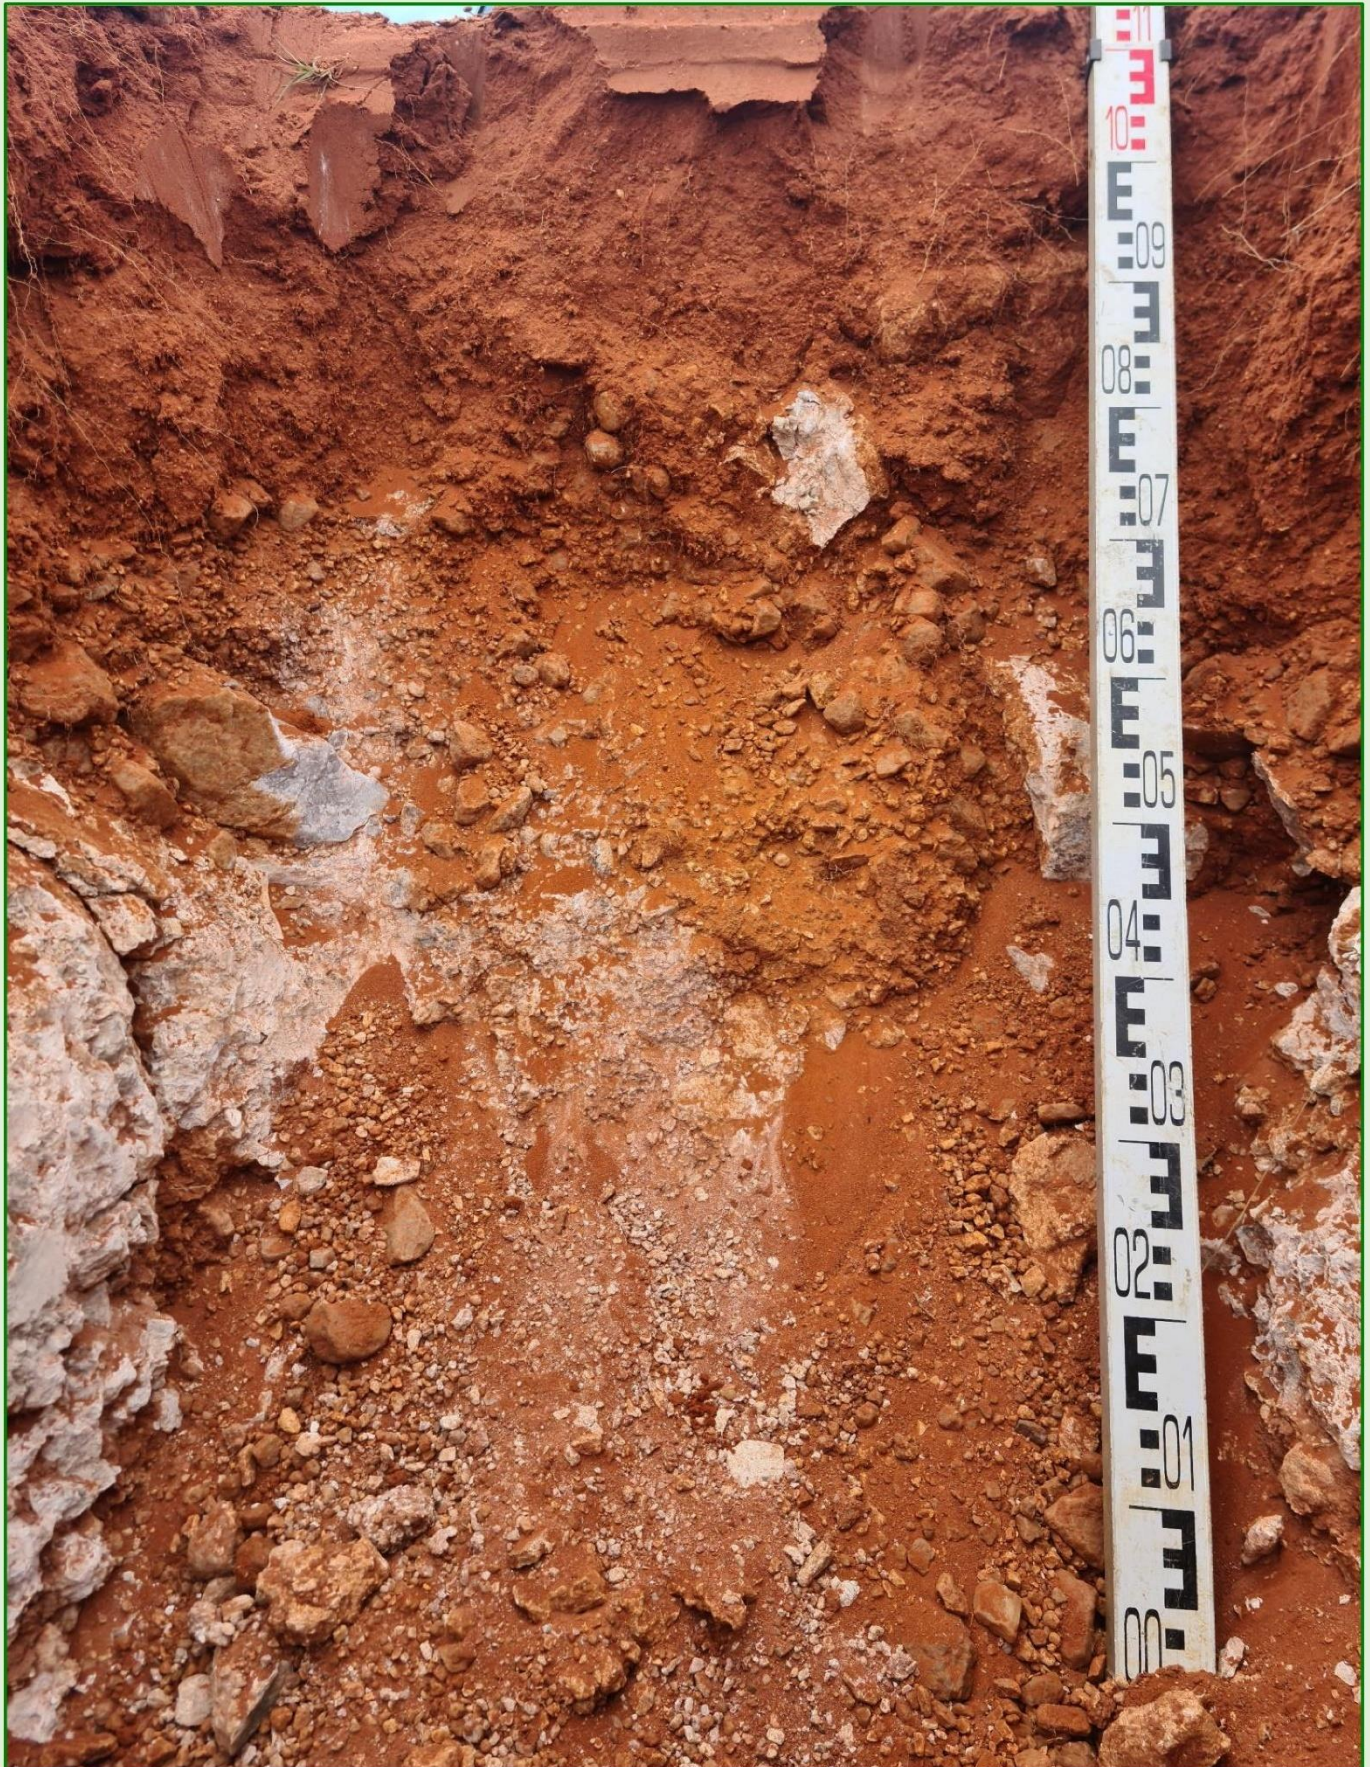
Profile Photo: TP3

Profile Notes		Excavation Description	
<b>Profiled by:</b>	Cole Herbig (Engineering Geologist)	<b>Contractor:</b>	ALS Rentals
<b>Groundwater Seepage:</b>	N/A	<b>Machine:</b>	Bell 315 SK- TLB-type Light Mechanical Excavator
<b>Excavation Stability:</b>	Sidewalls stable	<b>Excavation Character:</b>	Refusal on less weathered calcified gneissic bedrock
<b>Samples Extracted:</b>	1 Disturbed Sample	<b>Date Profiled:</b>	06/02/2023
<b>Elevation (MAMSL):</b>	835	<b>Coordinates:</b>	28.43472°S 21.20105°E

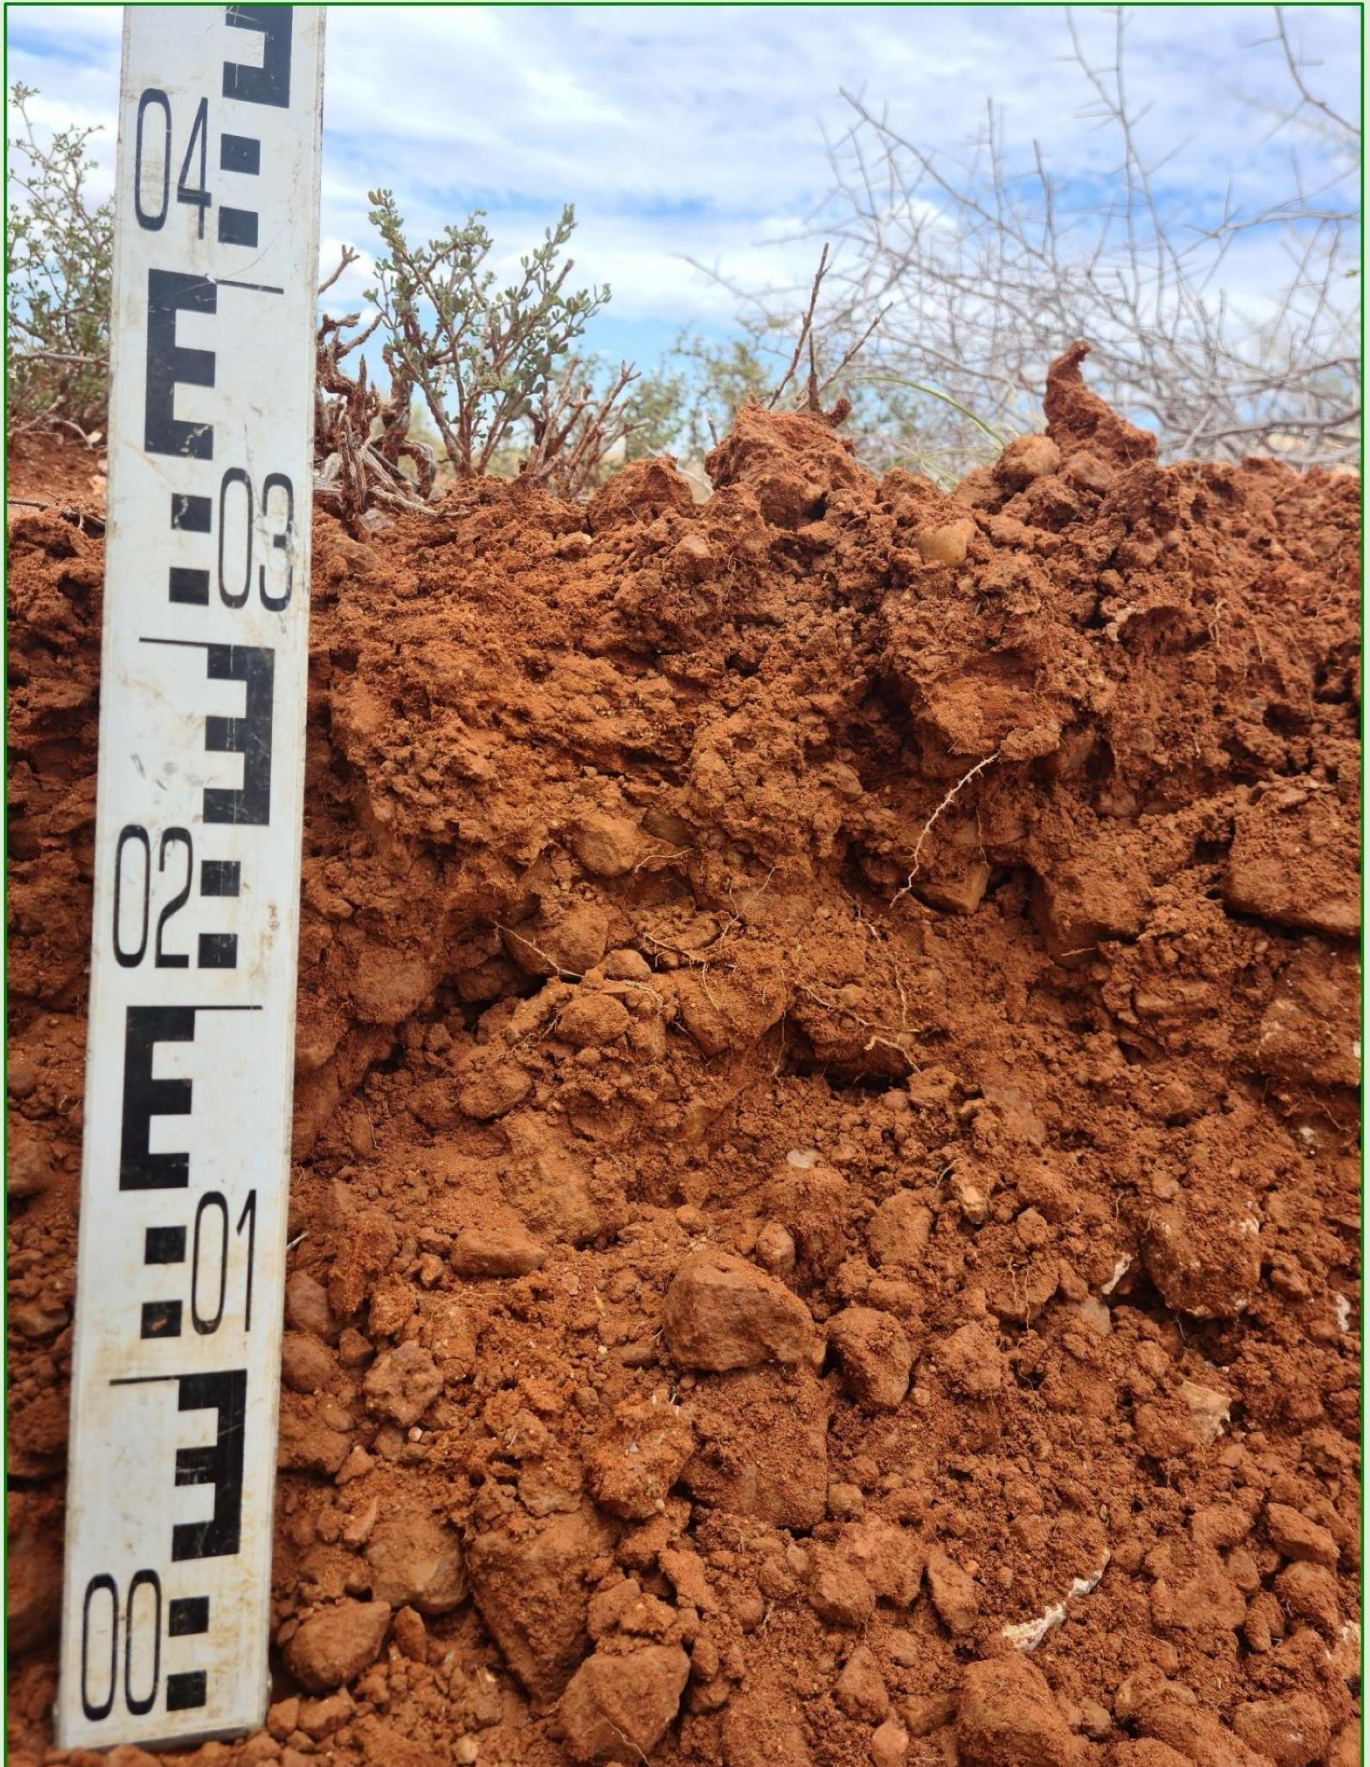
Profile Photo: TP4

Profile Notes		Excavation Description	
<b>Profiled by:</b>	Cole Herbig (Engineering Geologist)	<b>Contractor:</b>	ALS Rentals
<b>Groundwater Seepage:</b>	N/A	<b>Machine:</b>	Bell 315 SK- TLB-type Light Mechanical Excavator
<b>Excavation Stability:</b>	Sidewalls stable	<b>Excavation Character:</b>	Refusal on hardpan calcrete
<b>Samples Extracted:</b>	N/A	<b>Date Profiled:</b>	06/02/2023
<b>Elevation (MAMSL):</b>	834	<b>Coordinates:</b>	28.43542°S 21.20160°E

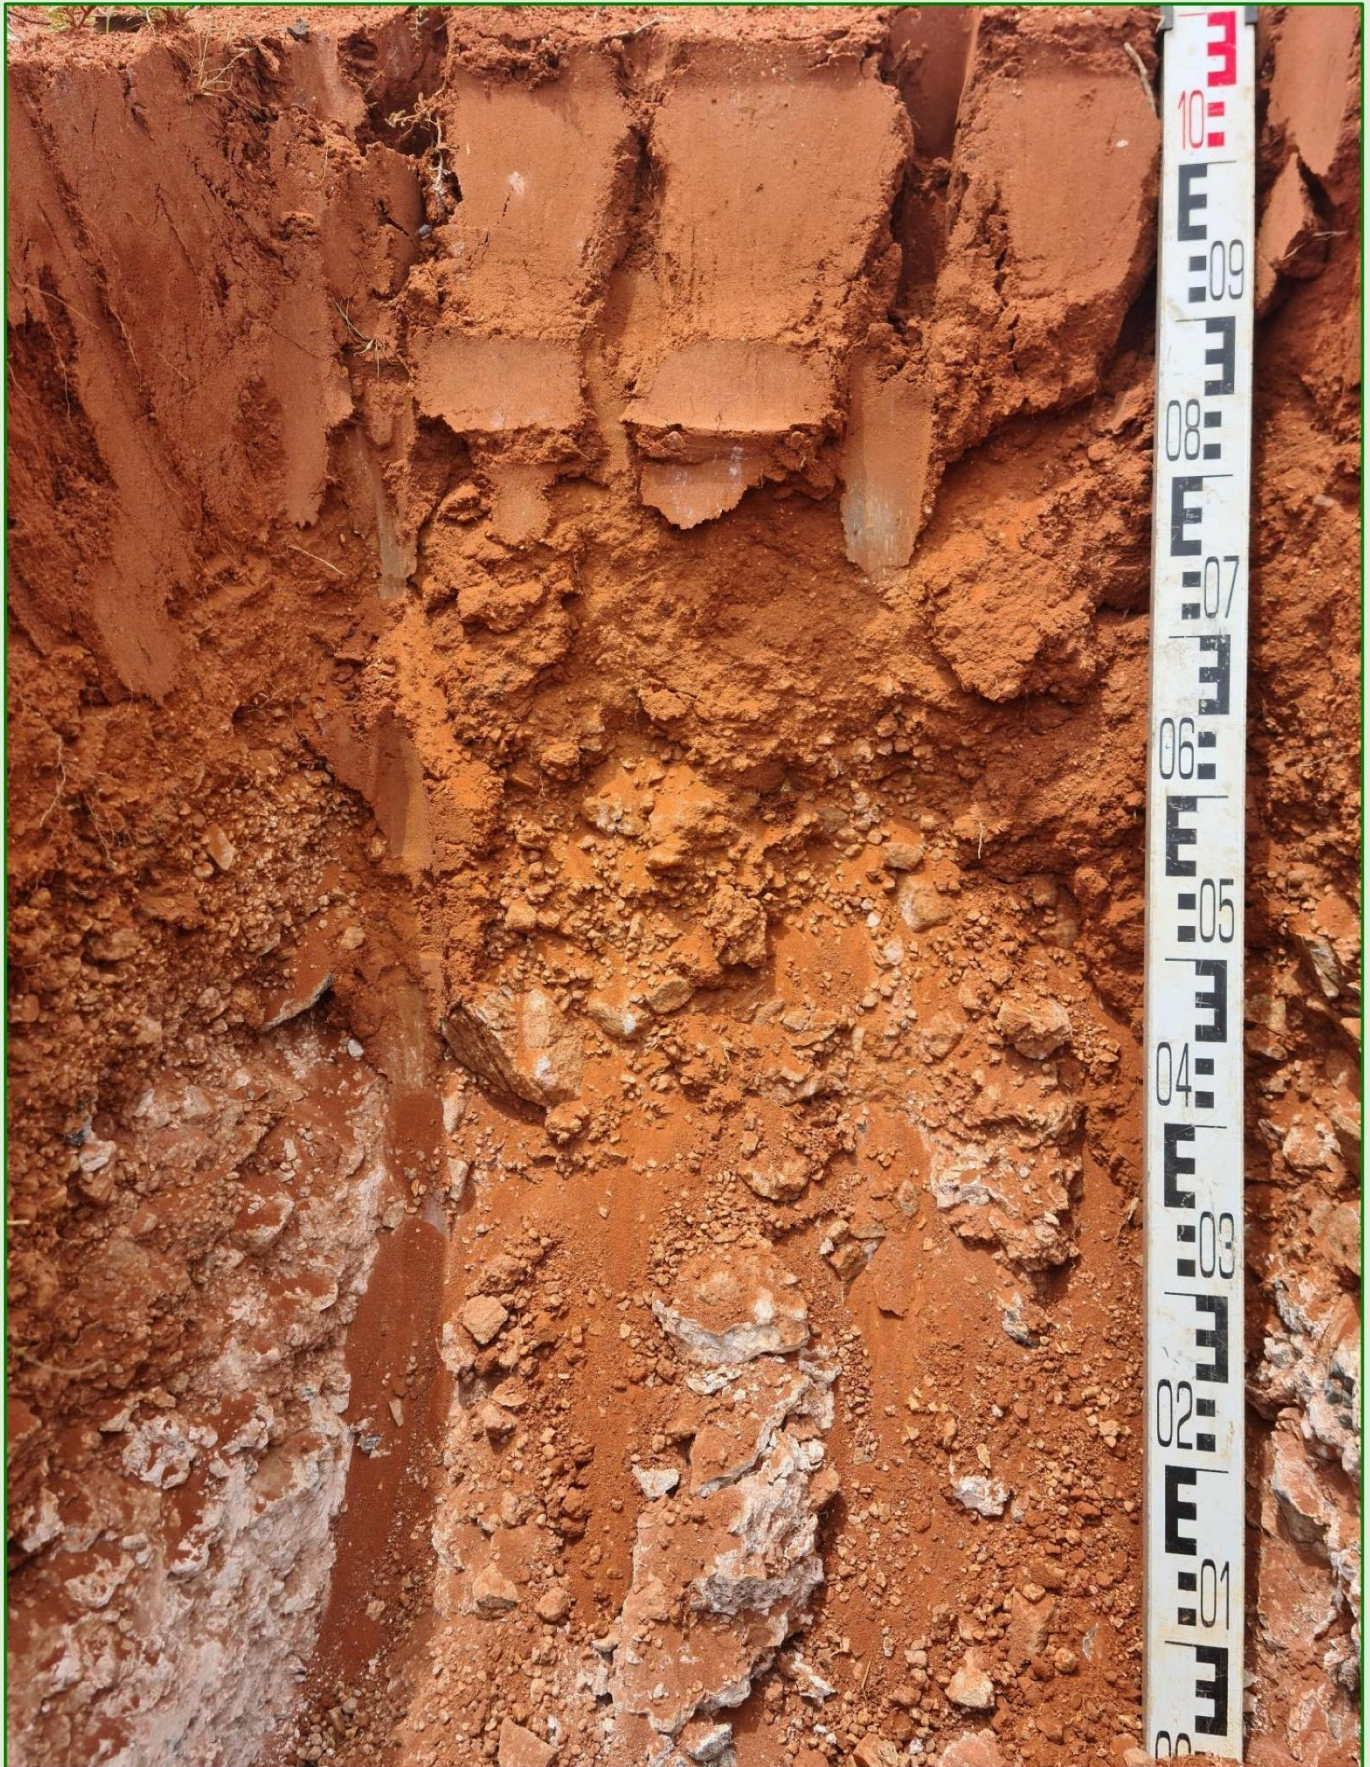
Profile Photo: TP5

Profile Notes		Excavation Description	
<b>Profiled by:</b>	Cole Herbig (Engineering Geologist)	<b>Contractor:</b>	ALS Rentals
<b>Groundwater Seepage:</b>	N/A	<b>Machine:</b>	Bell 315 SK- TLB-type Light Mechanical Excavator
<b>Excavation Stability:</b>	Sidewalls stable	<b>Excavation Character:</b>	Refusal on less weathered gneissic bedrock
<b>Samples Extracted:</b>	1 Bulk Sample	<b>Date Profiled:</b>	06/02/2023
<b>Elevation (MAMSL):</b>	832	<b>Coordinates:</b>	28.43560°S 21.20265°E

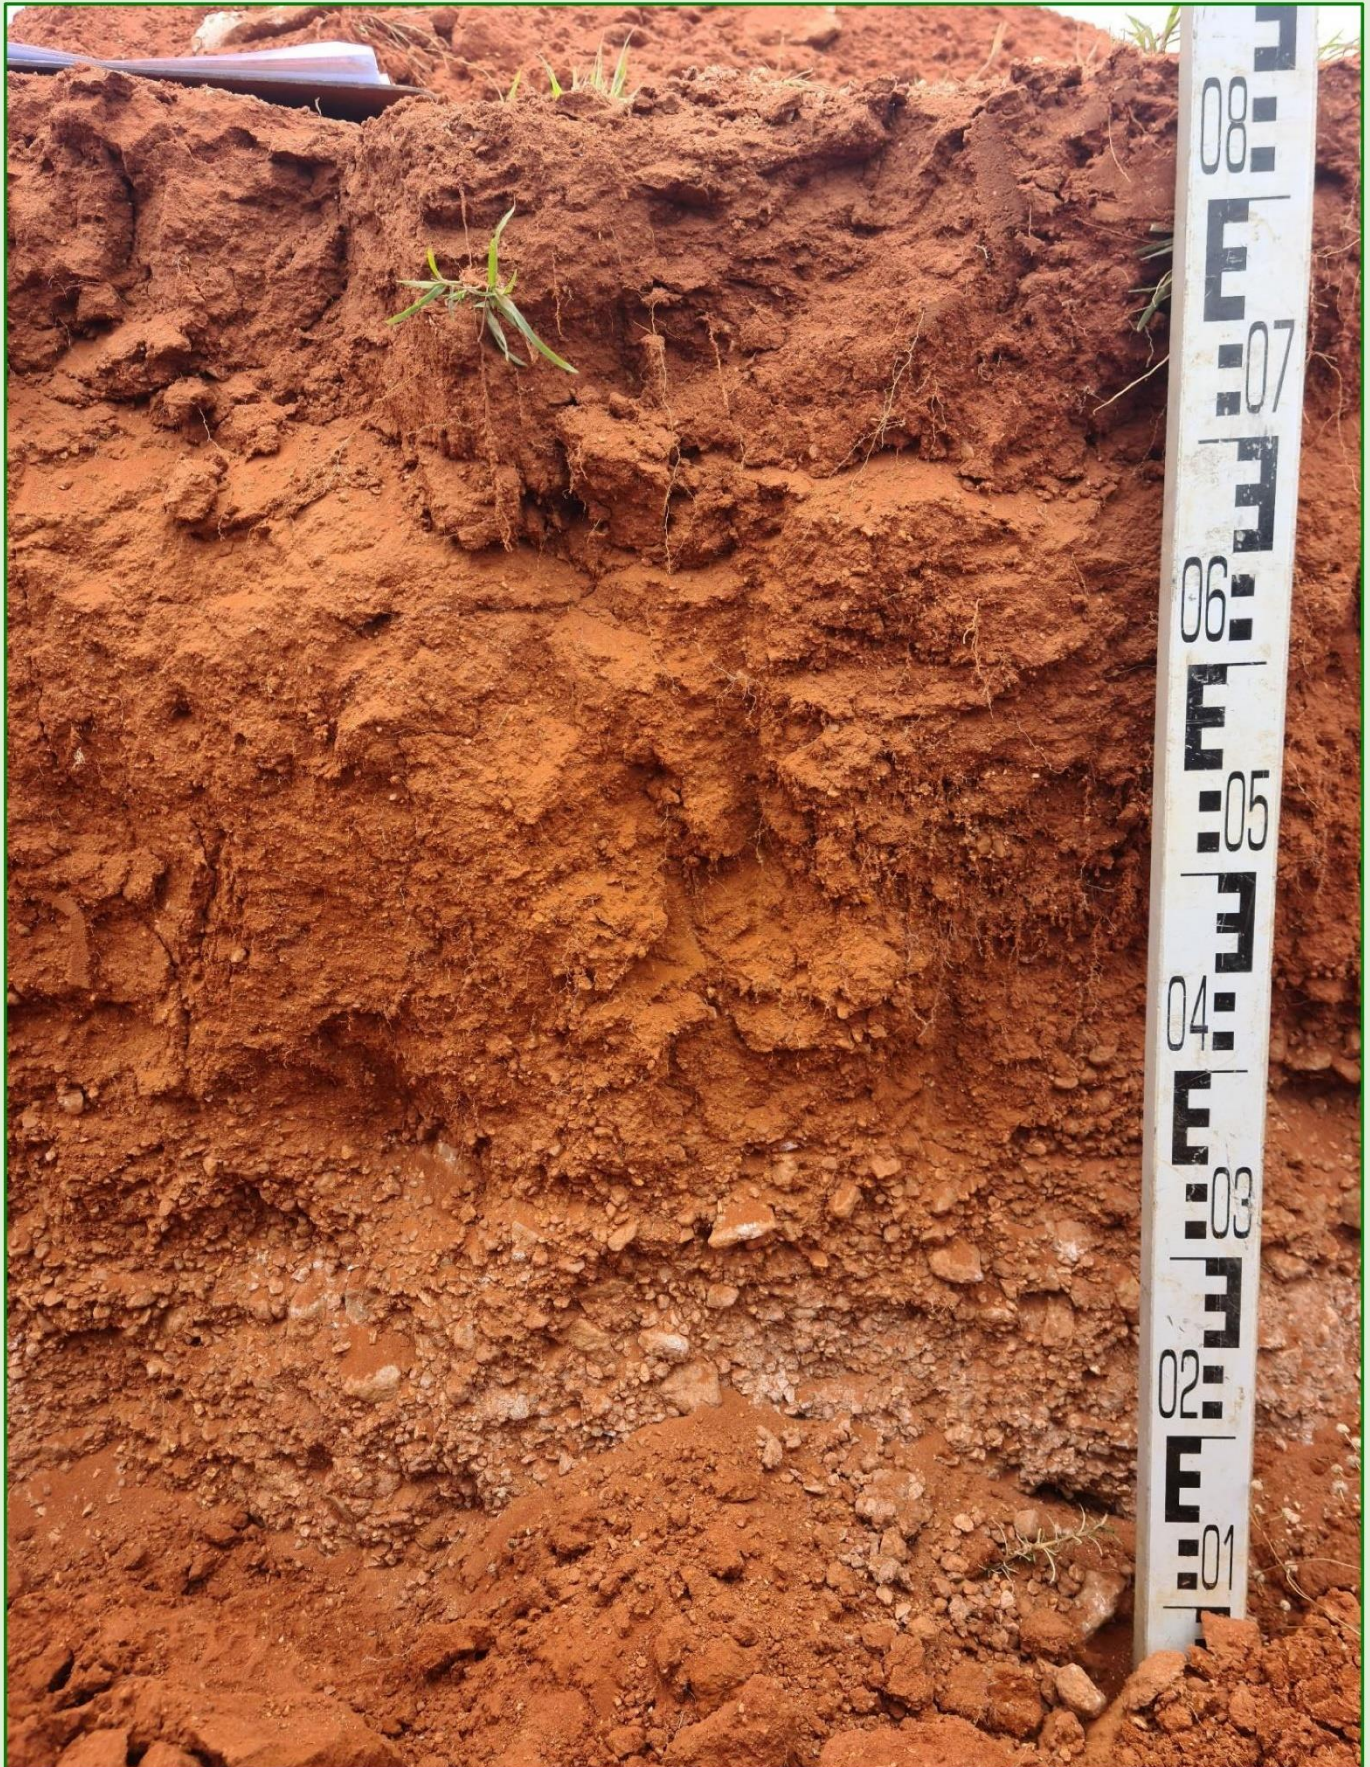
Profile Photo: TP6

slightly MOIST; light orangey BROWN; LOOSE; PINHOLED; silty SAND with traces of fine gravel; AEOLIAN SAND; abundant fine roots; Disturbed Sample No. U5.

slightly MOIST; light orangey BROWN, mottled white; LOOSE; MATRIX SUPPORTED; sub-rounded gravel and cobbles in a silty SAND matrix; PEBBLE MARKER; heterogeneous composition and poorly sorted nature; traces of roots; traces of calcrete boulders; Disturbed Sample No. U6.

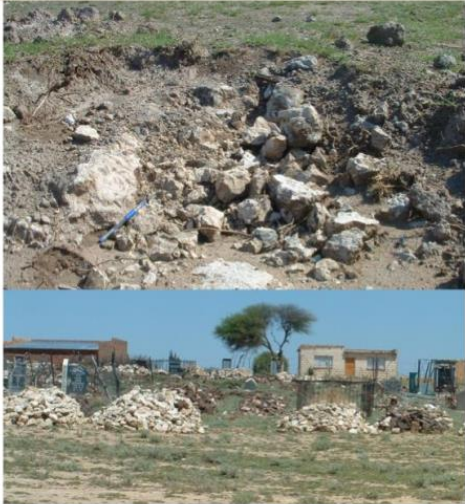
**(c) Excavatability/ Backfill Materials**

(right) Dolomite and calcrete in the vicinity of Taung (2005): difficult excavation in shallow bedrock and hard calcretes result in shallow graves and the need to create rock mounds over coffins.
