# **BOTANICAL SCAN & TERRESTRIAL BIODIVERSITY COMPLIANCE STATEMENT**

## **TIERHOKSKLOOF BULK WATER PIPELINE**

**THE PROPOSED REPLACEMENT/UPGRADE OF THE BULK WATER SUPPLY PIPELINE FOR  
THE TOWN OF WOLSELEY (FARMS 1886 & 1887, CERES),  
WITZENBERG LOCAL MUNICIPALITY, WESTERN CAPE PROVINCE.**

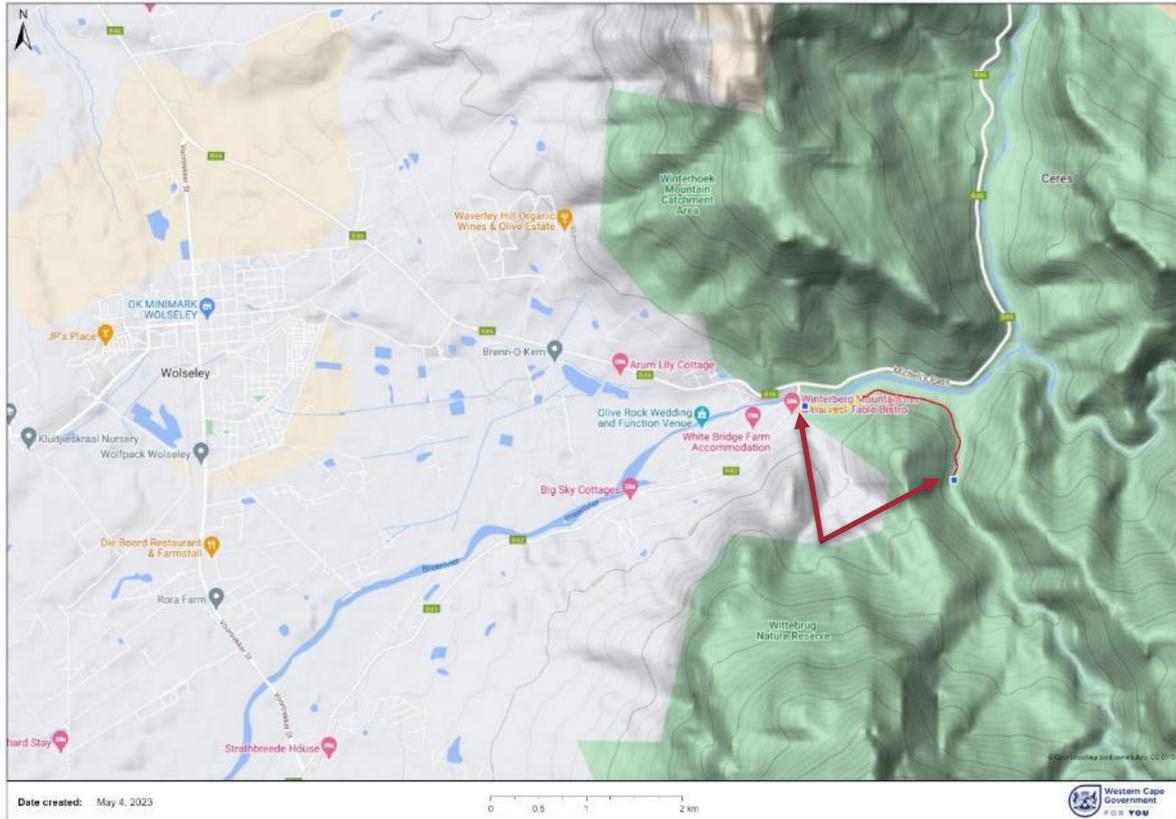
Figure 2: A map showing the location of the pipeline (Red & Yellow) to the east of Wolseley.

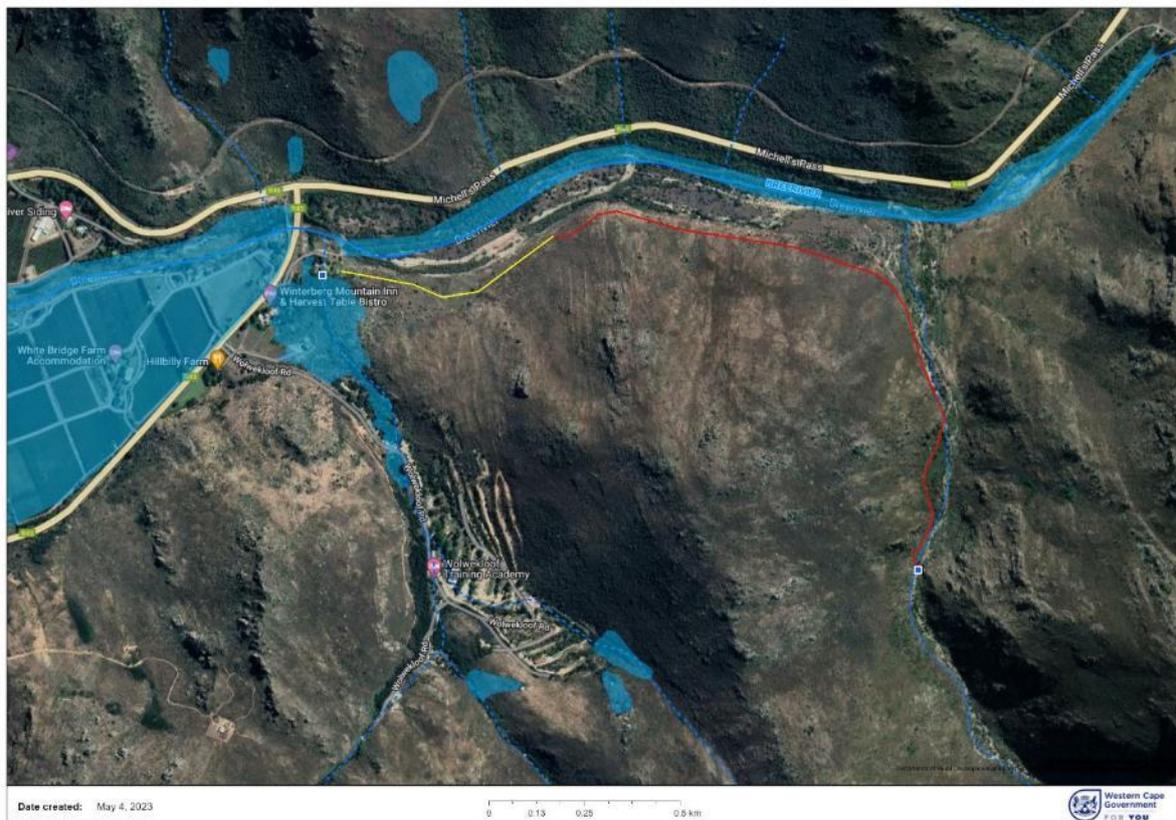
Figure 3: A google image showing the pipeline route: Yellow = underground section; Red = aboveground section.

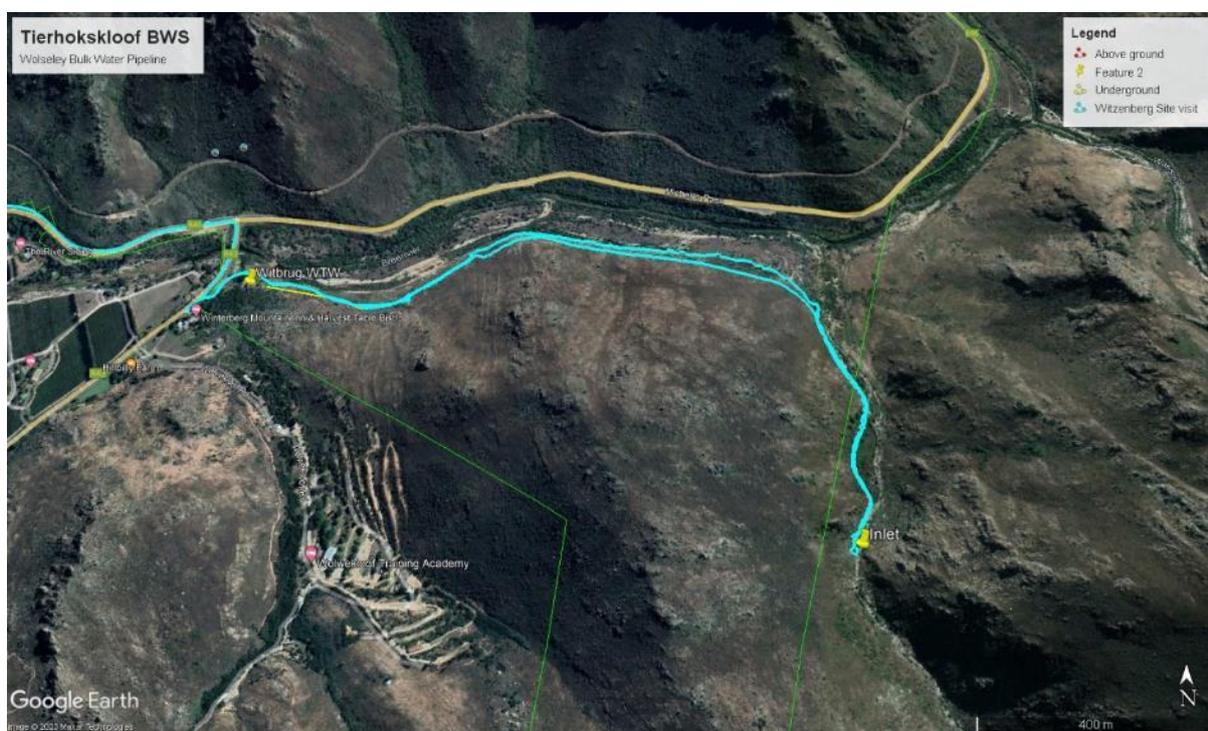
Figure 5: Google overview, showing the study area and the routes walked during the site visit.

A one-day site was performed on the 20<sup>th</sup> of February 2023. The site assessment survey was conducted by driving onto the site and then walking the route while assessing vegetation status. Vegetation sampling was done, by using a modified approach, based on the Braun-Blanquet vegetation survey method (Werger, 1974). During the site visit terrestrial features- and plants of specific significance was, marked, and photographed (Figure 5). A hand-held Garmin GPSMAP 62s was used to track the sampling route and for recording waypoints of locations of specific importance, while taking survey notes, and photographic records. The author endeavoured to identify and locate all significant biodiversity features, including special plant species and or specific soil conditions which might indicate special botanical features (e.g., rocky outcrops or heuweltjies) and watercourses.

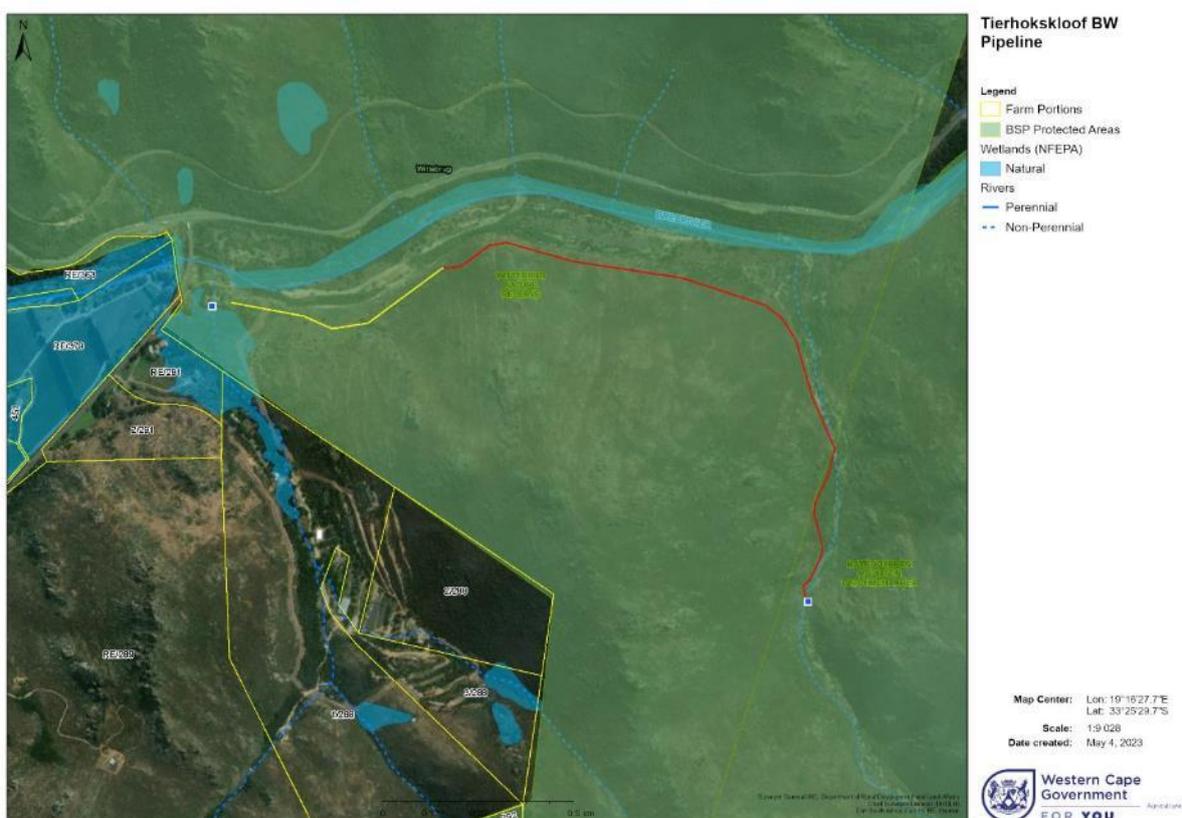
Figure 7: WCBSP CBA map (2017) showing the study area and associated critical biodiversity areas (CapeFarmMapper)

According to the 2017 Western Cape Biodiversity Spatial Plan (WCBSP) (CapeNature, 2017), both properties overlap protected areas (Figure 7). Remainder of Erf 1886 is part of the Wittebrug Nature Reserve (a CapeNature Reserve), while Erf 1887 falls within the Matrosberg Mountain Catchment Protected Area (both statutory protected areas).

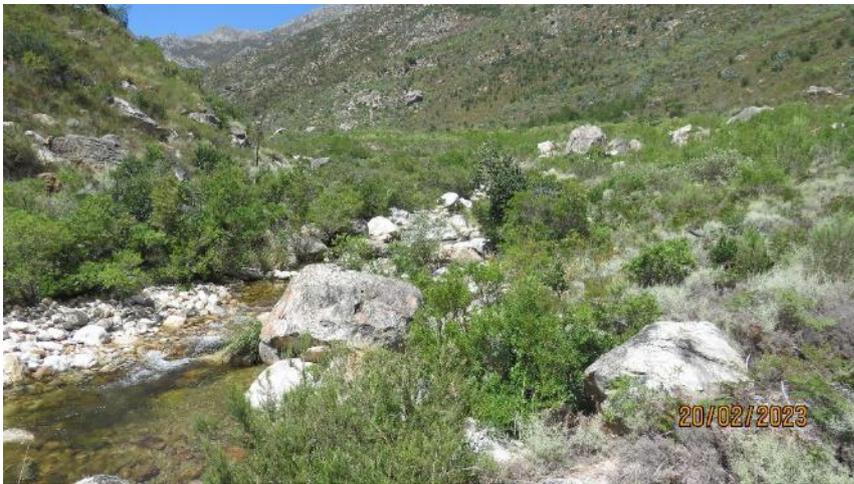
**Photo 1:** The Tierhokskloof River, looking from the inlet weir upstream into the kloof. Note the low riparian vegetation and the rocky bottom.

The inlet structure is relatively small and had been constructed as a weir within the Tierhokskloof River. The natural riparian vegetation in the vicinity of this weir are in pristine riparian condition (as is the case with most of the riparian vegetation in this kloof) (marked in green in Figure 8). The Tierhokskloof River is in a relatively narrow kloof with a very rocky bottom. The riparian vegetation is open to close medium shrubland (not prone to larger trees) (Photo 1 & Photo 2). Near the weir several medium to larger trees were observed, including *Metrosideros angustifolia*, *Searsia angustifolia* (korentebos), *Heeria argentea*, *Dodonaea viscosa*, *Kiggelaria africana* and *Euclea racemosa* as well as grasses such as the riverbed grass, *Pennisetum macrourum*. In drier areas away from the river, bracken fern, *Pteridium aquilinum*, was observed, while large patches of *Stoebe plumosa* (slangbos), dominated open areas in between these shrubs, often alternated by patches of *Searsia angustifolia*.

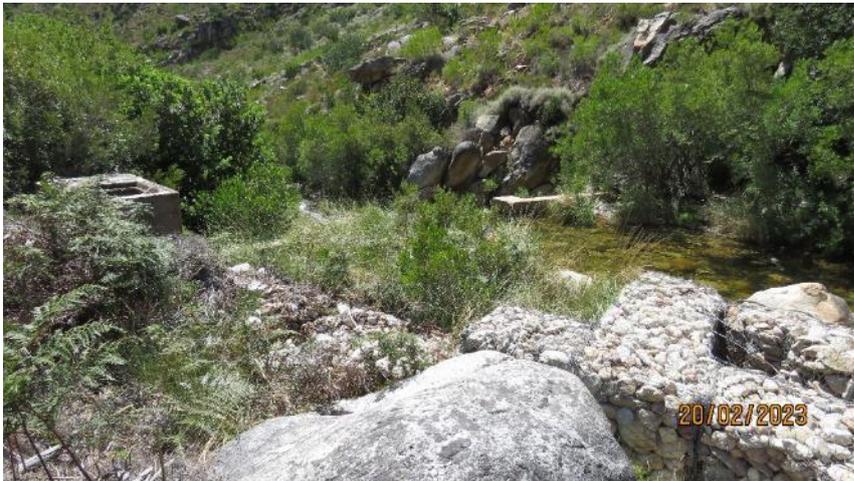
**Photo 2:** Looking downstream onto the inlet weir, which was placed in a narrow spot within the river.

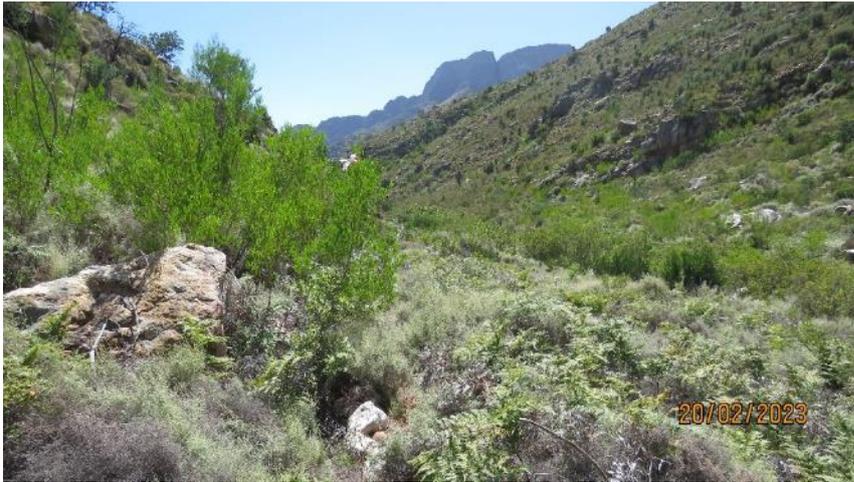
**Photo 3:** Looking down the Tierhokskloof from the weir (which is located to the back and right of picture). Note the dense stands of *Stoebe plumosa*, alternated by *Dodonaea* and bracken fern.

To the west of the weir, going downstream for about 50 – 60 m, a sandy open riverbank was encountered (Photo 3). Here, the vegetation was dominated by dense stands of *Stoebe plumosa* mixed with *Pteridium aquilinum* (bracken fern). *Dodonaea viscosa* fringed along the edges, and several other fynbos species was mixed in between, including *Cliffortia* cf. *strobilifera* (the cone river Cape rose), the straggly herb, *Othonna quinqueidentata*, *Dolichotheix ericoides* and *Metalasia densa*.

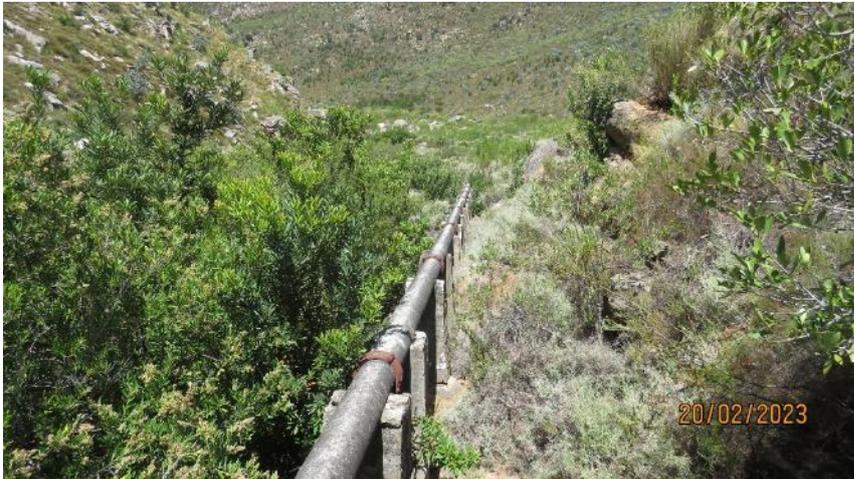
**Photo 4:** One of the narrow rocky areas (looking from the north to south into the Tierhokskloof) in the Tierhokskloof, downstream of the inlet structure. Note the larger trees e.g., *Heeria* and *Brabejum*, towards the river (to the left of picture). Some of these trees might have to be trimmed.

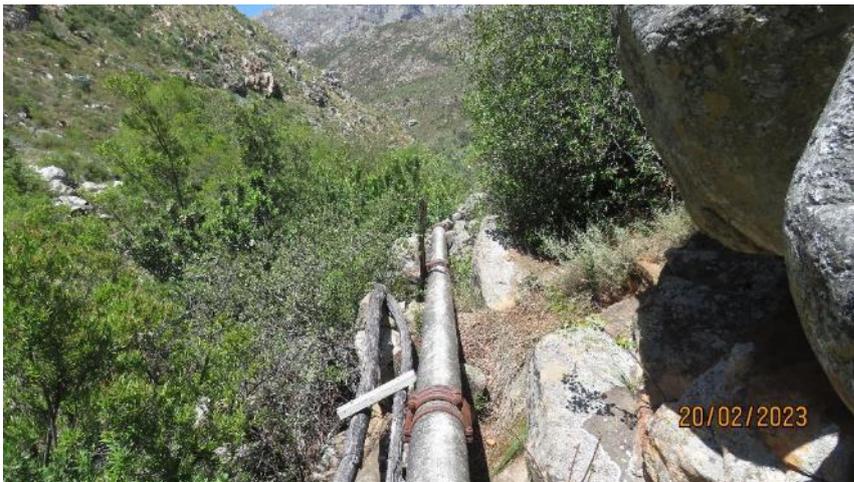
**Photo 5:** Another of the narrow rocky area, slightly further north (downstream from Picture 3) where the pipeline will have to be placed (most likely to the left of the existing pipeline).

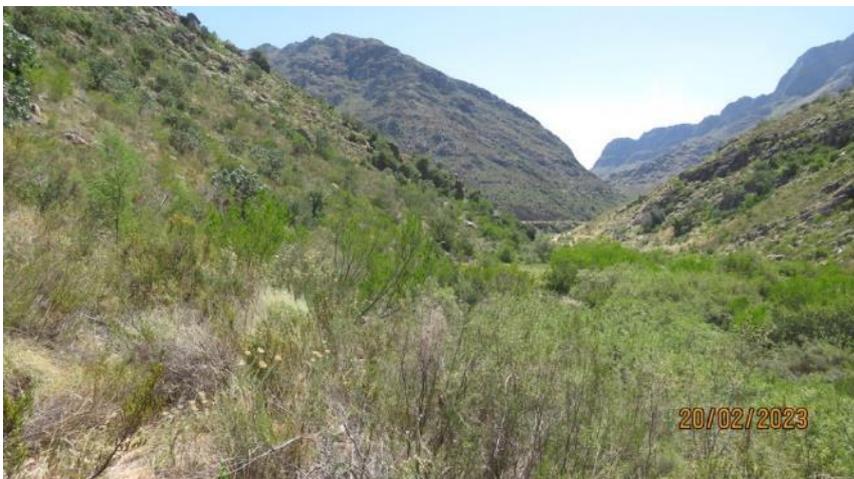
**Photo 6:** Looking downstream (south – north) and the typical vegetation encountered along the pipeline route. *Metalasia* in the foreground mixed with *Dodonaea* and *Cliffortia* towards the middle. In the background *Protea nitida* can be seen along the lower mountain slopes.

For most of this way (apart from near the inlet works – the green area marked in Figure 8) the route is well away from the river systems on the lower slopes of the mountain. The vegetation itself can be described as an open (to closed) graminoid dominated mountain fynbos in pristine condition, varying slightly in age (because of various fire cycles), but being mostly mature veld not yet stagnant. In places the route skirts through the lower distribution of range of *Protea nitida* stands. The veld was normally dominated by dense undergrowth of an array of restioid species mixed with grasses (Photo 6 – 11).

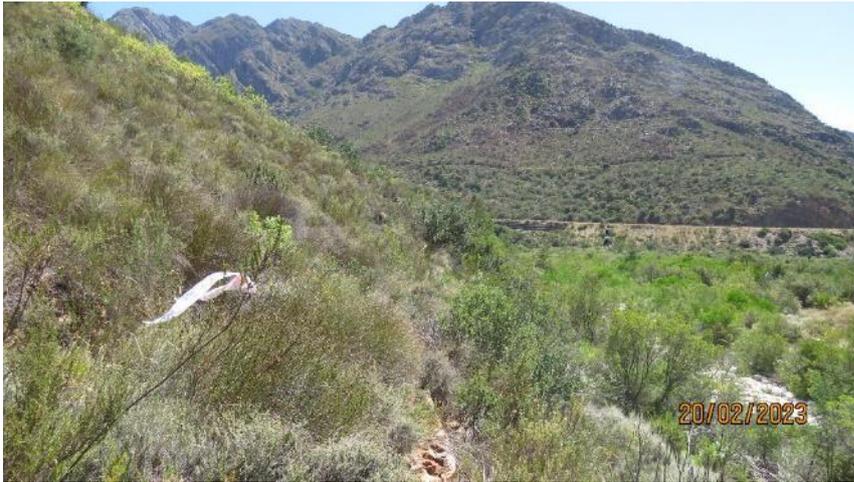
**Photo 7:** The typical vegetation encountered along the pipeline route, almost at the mouth of the Tierhokskloof. *Protea nitida* almost right next to the pipeline route in the background.

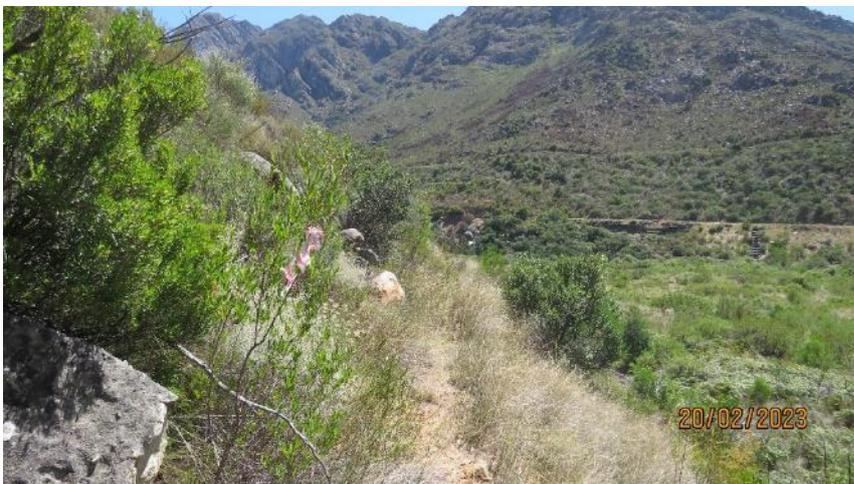
**Photo 8:** Typical vegetation encountered along the pipeline route at the mouth of the Tierhokskloof.

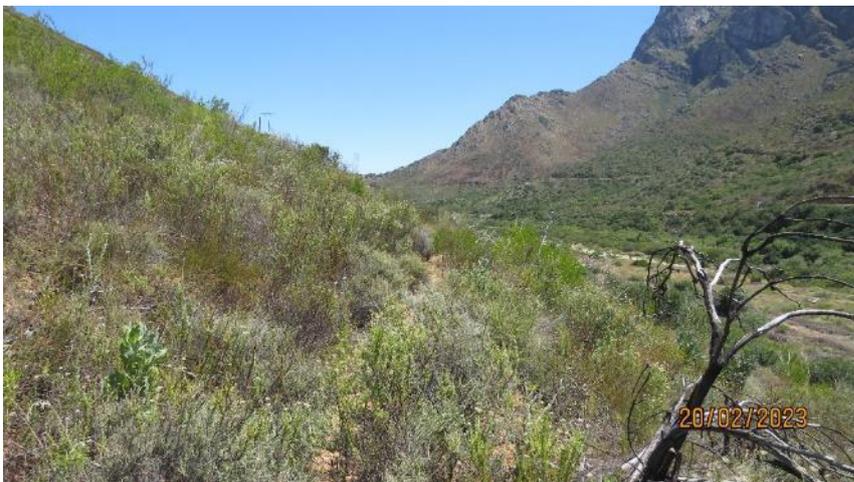
**Photo 9:** Typical vegetation encountered as the route turns west towards the WTW. The Breede River to the left of the photo.

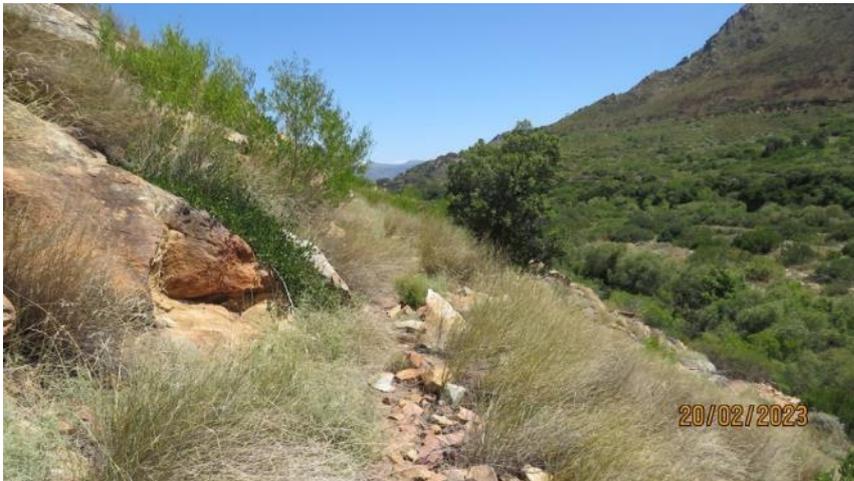
**Photo 10:** Typical vegetation encountered along the mountain slopes towards the WTW, with the Breede River on the right. The tree along the route, most likely *Euclea racemosa* or *Heeria argenticia*.

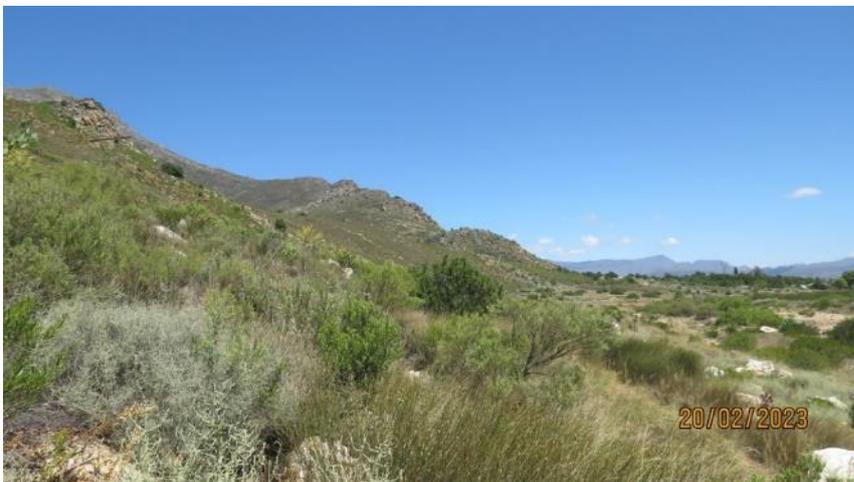
**Photo 11:** Typical vegetation encountered along the last section of the pipeline route along the lower slopes of the mountain, just before it descends to the valley bottom towards the WTW (the Witbrug could be seen in the background).

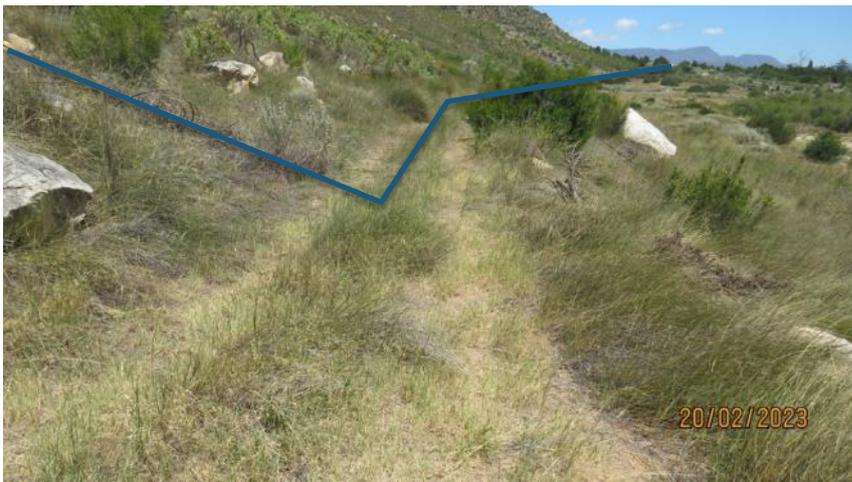
**Photo 12:** The old twee-spoor access road that used to lead almost up to the Tierhokskloof River, (looking from east to west downriver towards the WTW). The blue line indicates the proposed pipeline route.

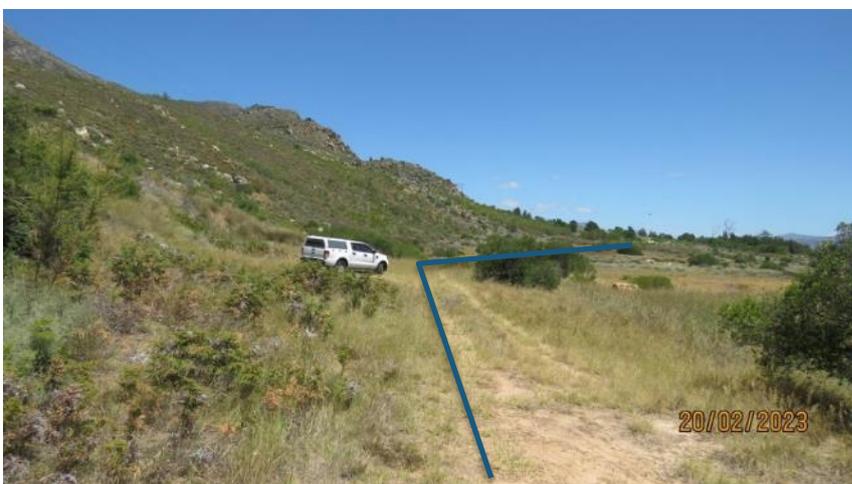
**Photo 13:** Slightly further downstream, showing the proposed location of the underground pipeline. Note the disturbed grassy ground cover.

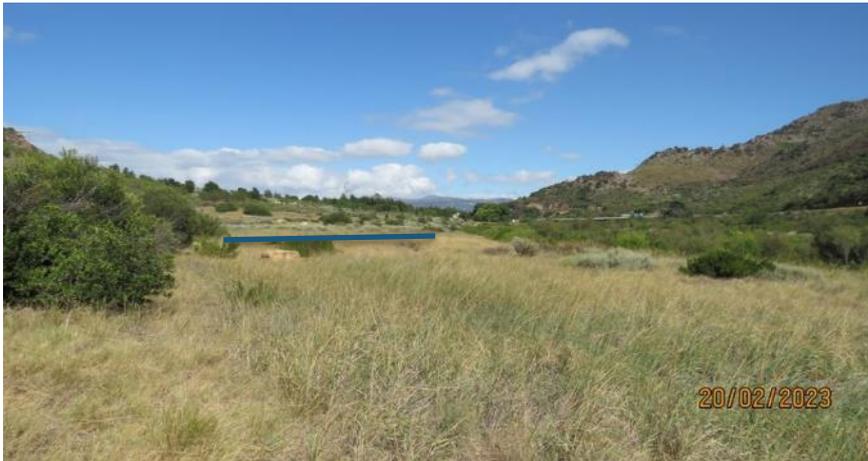
**Photo 14:** Dense stands of *Pennisetum macrourum* encountered in the lower valley towards the Breede River. The pipeline is proposed to run to the left of picture.

**Fynbos.** Whether this is because of past disturbances or because of the dense stands of invasive alien species that used to grow in this area is unsure. During the site visit it was clear that the proteoid, restioid and even fynbos component expected in Breede Alluvium Fynbos had been replaced by a low grass layer, dominated by *Cynodon dactylon* on the slightly higher and drier areas. As one moves closer to the riparian zone *Hyparrhenia hirta* is commonly found within the grassy bottom layer, while *Pennisetum macrourum* (riverbed grass) forms dense patches within the lower wetland areas associated with the Breede River itself and it is more likely to be disturbed version of **Fynbos Riparian Vegetation.**

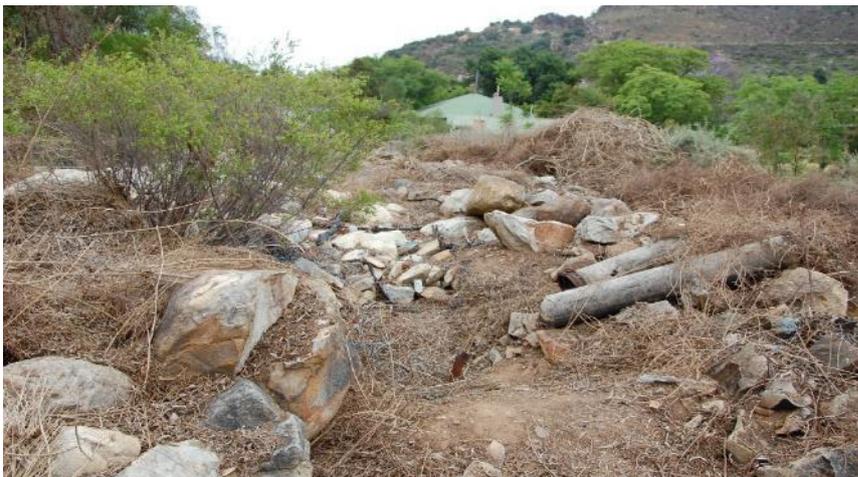
**Photo 15:** The WTW is located on a small rocky outcrop near Witbrug. The photo shows the disturbed footprint area where pipelines had to be replaced (as it goes up this rocky outcrop).

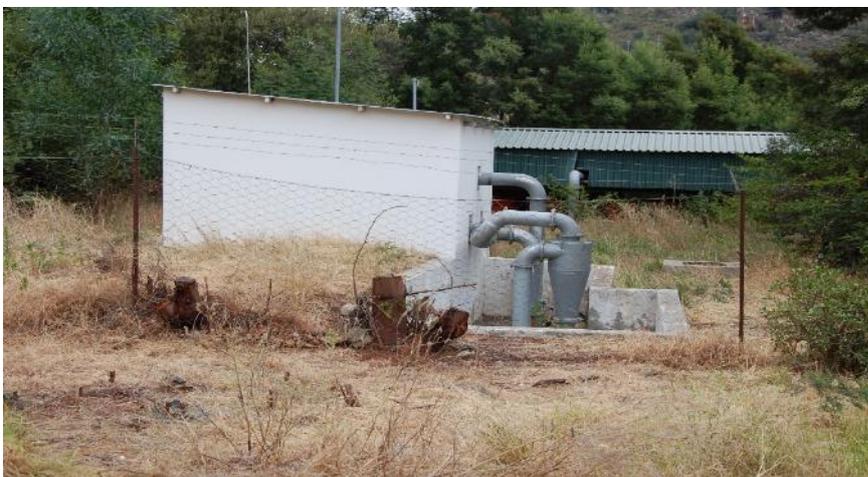
**Photo 16:** A picture of the WTW on top of the rocky outcrop.

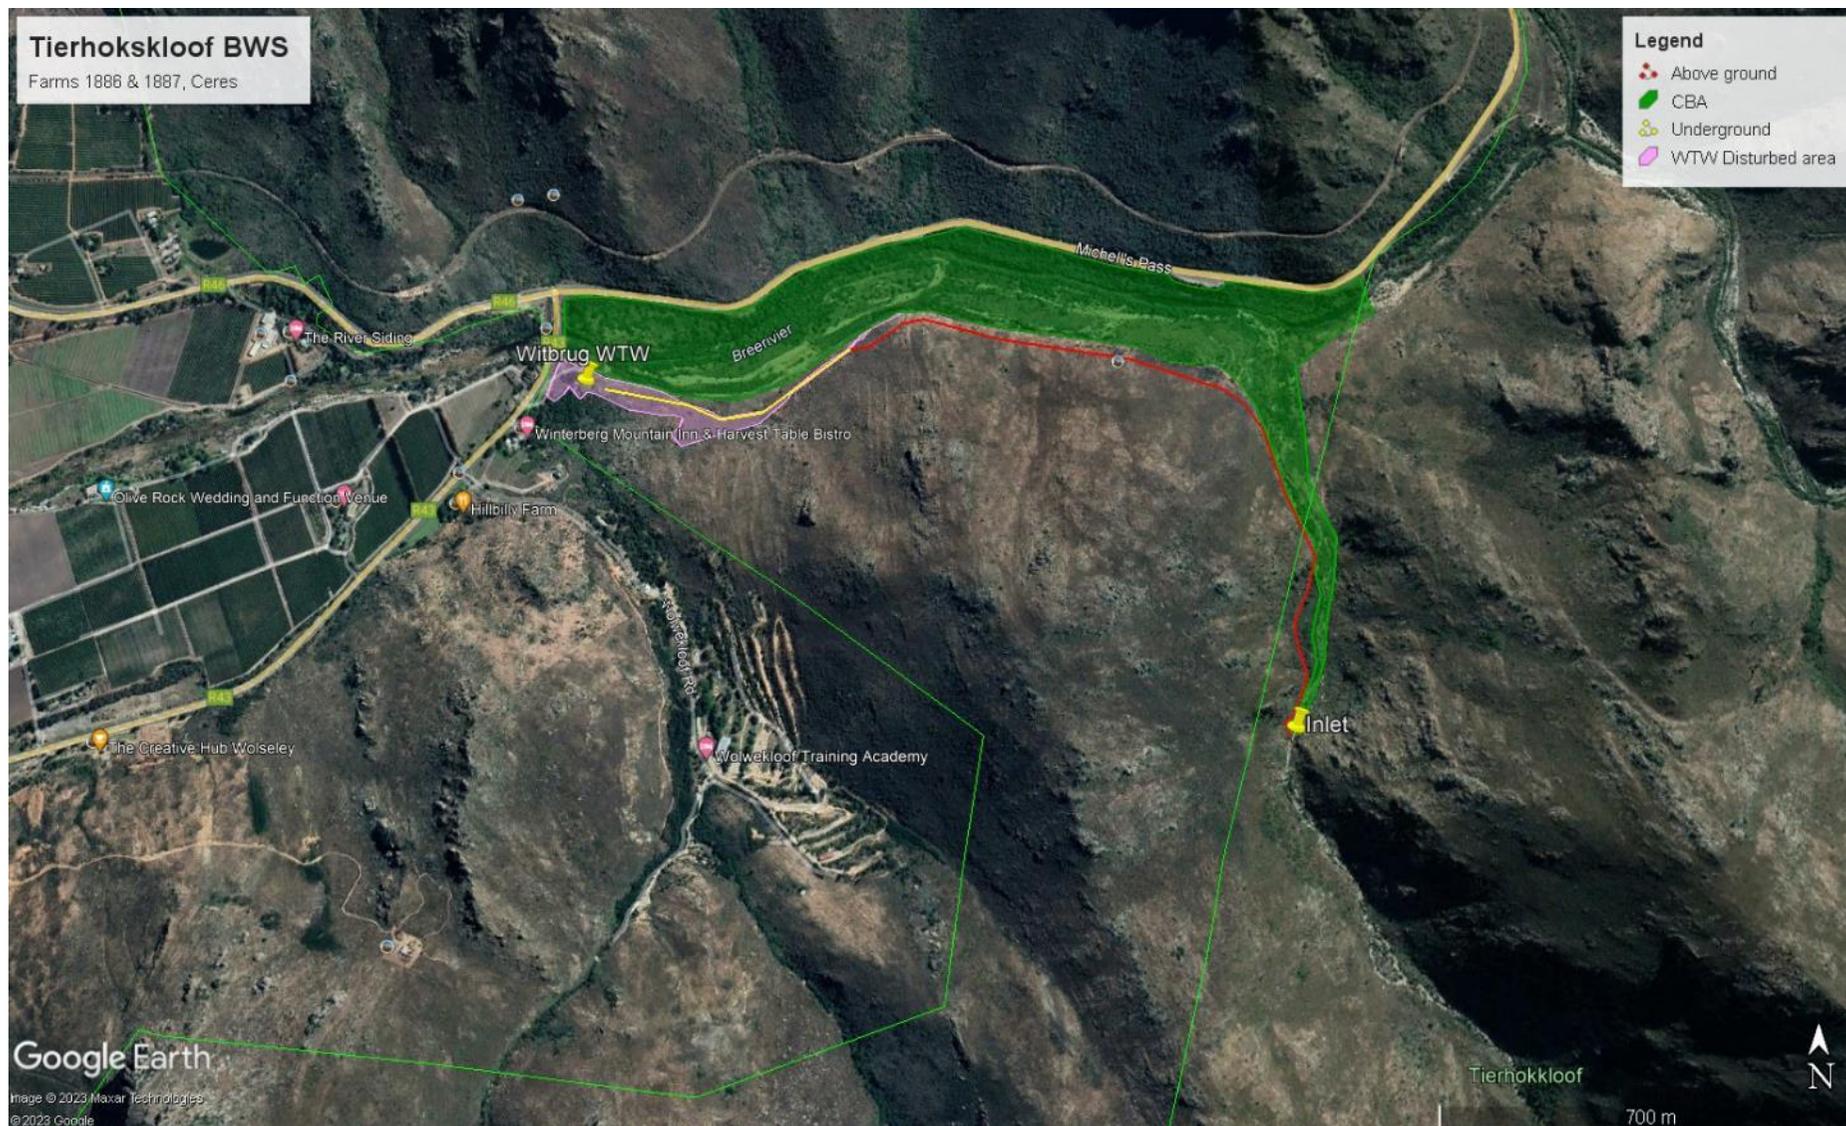
Figure 9: Tierhokskloof Sensitivity map, shows the pipeline route in relation to sensitivity, which aims to protect the river systems and associated riparian vegetation.

The site sensitivity map (Figure 9) describes aims to protect the river systems and associated riparian works, all of which should be considered no-go areas (apart from the works that need to be done at the inlet works within the Tierhokskloof inlet works). The recommendations give further guidelines and details towards the protection of the mountain areas.
