## **Freshwater Report for the replacement of the Tierhokkloof bulk water pipeline**

A requirement in terms of the National Environmental Management Act 107 of 1998  
as well as the  
National Water Act 36 of 1998

May 2023  
Revised July 2023

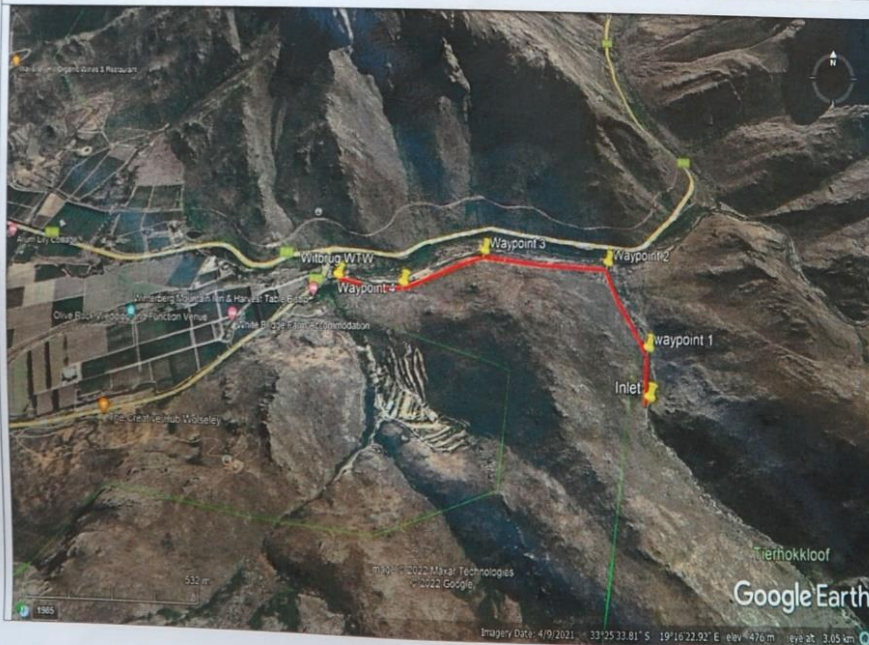
Figure 1 Public Participation

A bulk water supply pipeline of approximately 2.5km in length and 350mm in width is proposed on Erven 1886 and 1887, Ceres to supply water to the town of Wolseley. The proposed above-ground pipeline will be placed on small stilts placed at 4-5m intervals and will extend from an abstraction point in the Tierhokskloof Stream to the Witbrug Water Purification Plant, alongside the old water supply pipeline that was constructed in 1953. The existing pipeline will no longer be used when the proposed pipeline becomes operational.

Start:	33° 25' 44.30"S	19° 17' 01.32"E
Way 1:	33° 25' 33.24"S	19° 17' 04.28"E
Way 2:	33° 25' 15.26S"	19° 16' 59.02E"
Way 3:	33° 25' 11.08S"	19° 16' 32.39E"
Way 4:	33° 25' 19.49S"	19° 16' 13.85E"
End:	33° 25' 18.53S"	19° 16' 00.07E"

— Proposed pipeline route

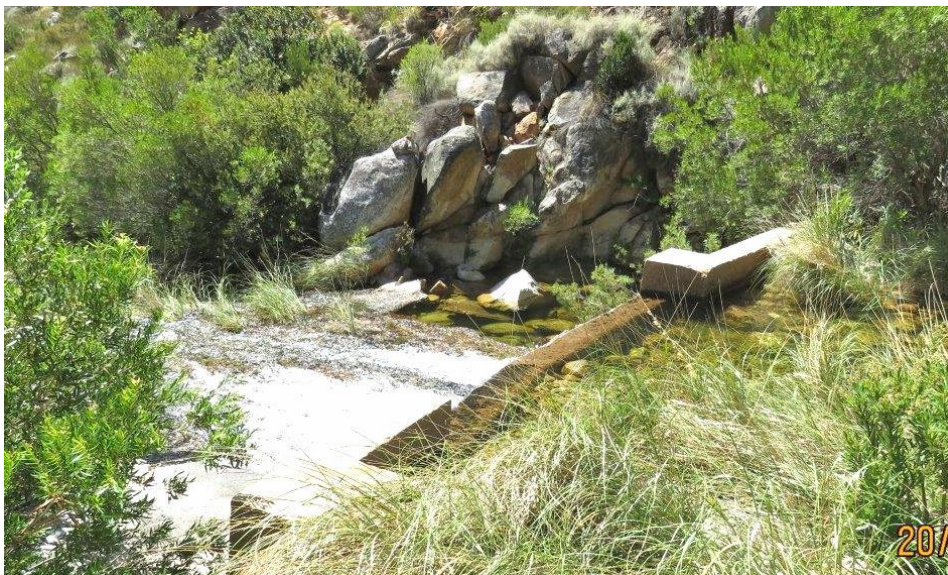
**Figure 7** Tierhokkloof Weir (Photo Peet Botes)

The upper weir in the Tierhokkloof (Figure 7), according to the Preliminary Design Report, will be upgraded. Leaks in the bottom of the weir will be plugged with fast-drying concrete. The existing pebble trap must be upgraded with a proper concrete floor and the existing gabions must be repaired and upgraded.

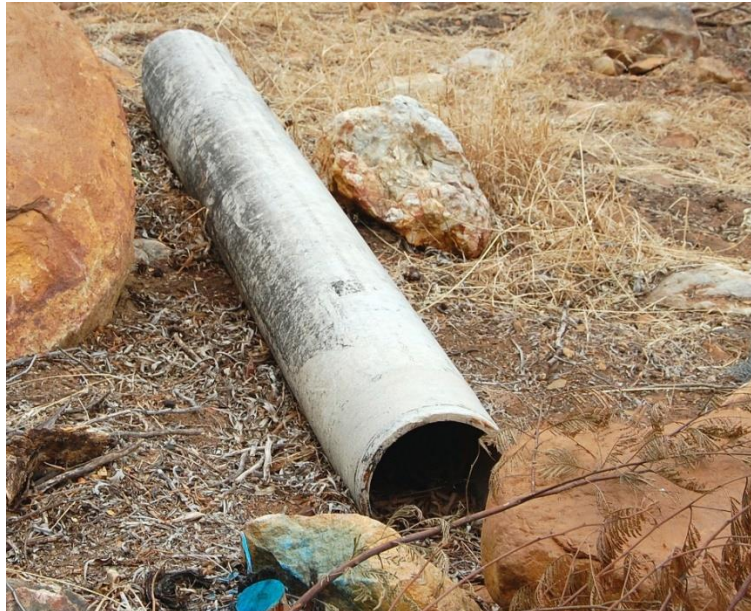
**Figure 9** Broken section of pipe

The existing underground pipeline is no longer serviceable. It has been repaired many times over and by now it cannot be repaired any longer. It is a fibre cement pipe that evidently has collapsed.

It would do more environmental damage to the Tierhokkloof and to the banks of the Breede River to dig the pipe up and to remove it altogether. It would be best to leave it where it is, underground, forever. Along the course of the pipeline, broken sections of pipe (Figure 9) and other debris were left on the ground, leftovers from previous maintenance attempts. These must be removed and disposed of properly, with the disturbed ground levelled and landscaped.

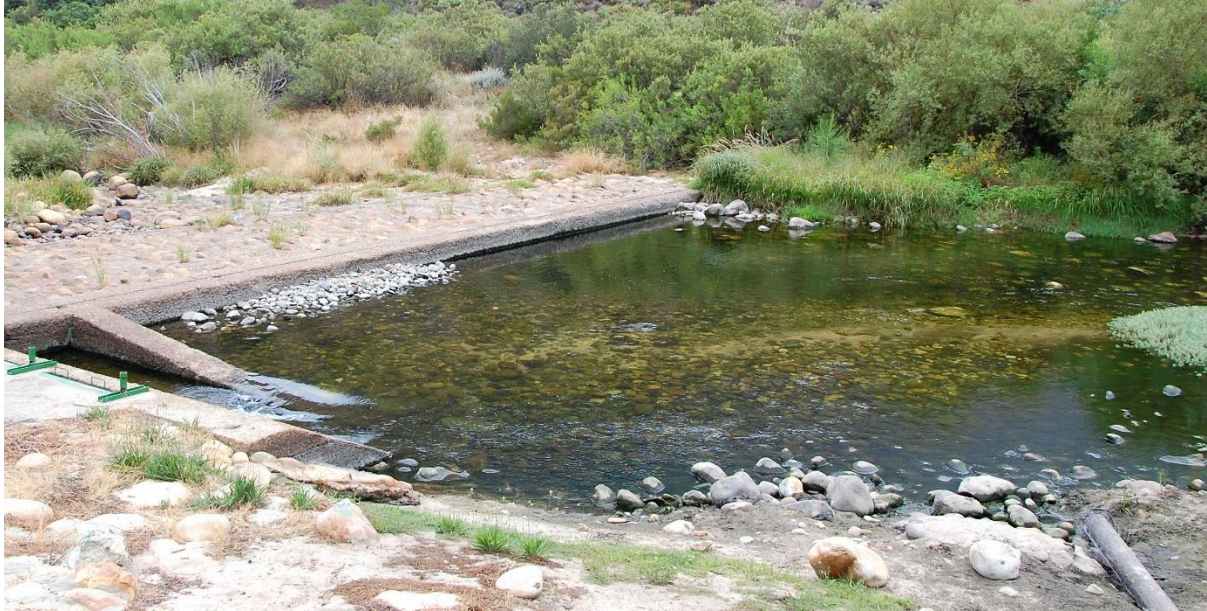
**Figure 10 Weir**

This is an example of all the base flow, the low flow and possibly part of the high flow as well of the Breede River is taken for agriculture and other use and where the only the peak flows overtop the weir and flows down the river to contribute to river health.

This diversion structure was probably constructed long before the promulgation of the NWA in 1998 and before the Ecological Reserve became an integral part of contemporary water management. Today minimum flow requirements for rivers are legally mandatory and the total deviation of a river is no longer permissible.

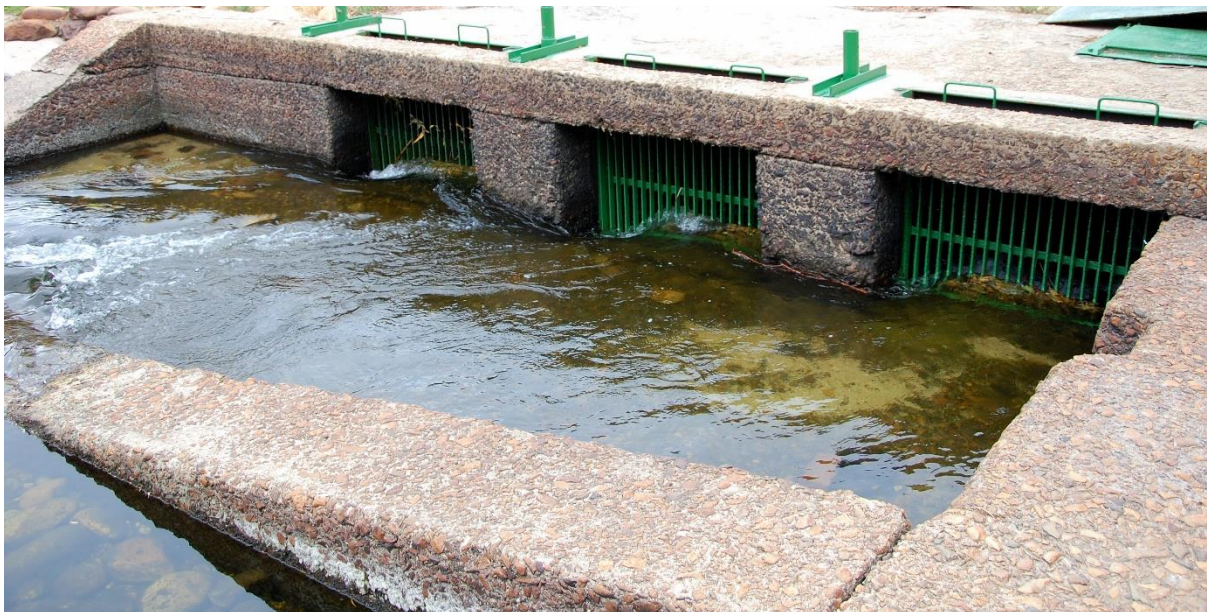
**Figure 11 Culverts**

At the T-junction of the R46 and the R43, adjacent and to the north of the Witbrug water purification plant is a weir across the Breede River (Figure 10). It blocks of the entire river to divert the flow into a set of culverts from where the entire river is relayed underground (Figure 11). No water was flowing over the weir and downstream into the Breede River. Downstream of the weir, the river was dry (Figure 1). This was on 30 November 2022.

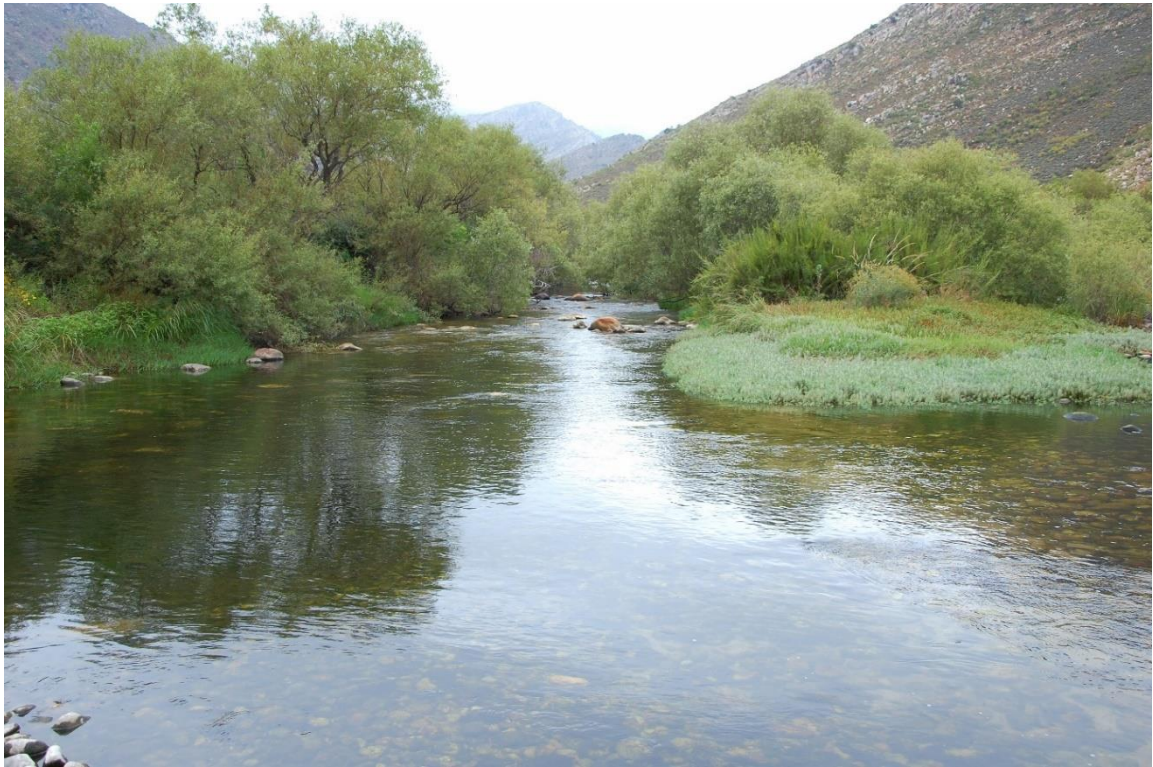
**Figure 13** Pool

Upstream of the weir, a large pool was present (Figure 13). The water was clear and fast flowing, perhaps a meter a second in places.

There was a high stand of riparian vegetation both upstream and downstream of the weir. These were mostly trees. Along the banks were emerging vegetation (Figure 13).

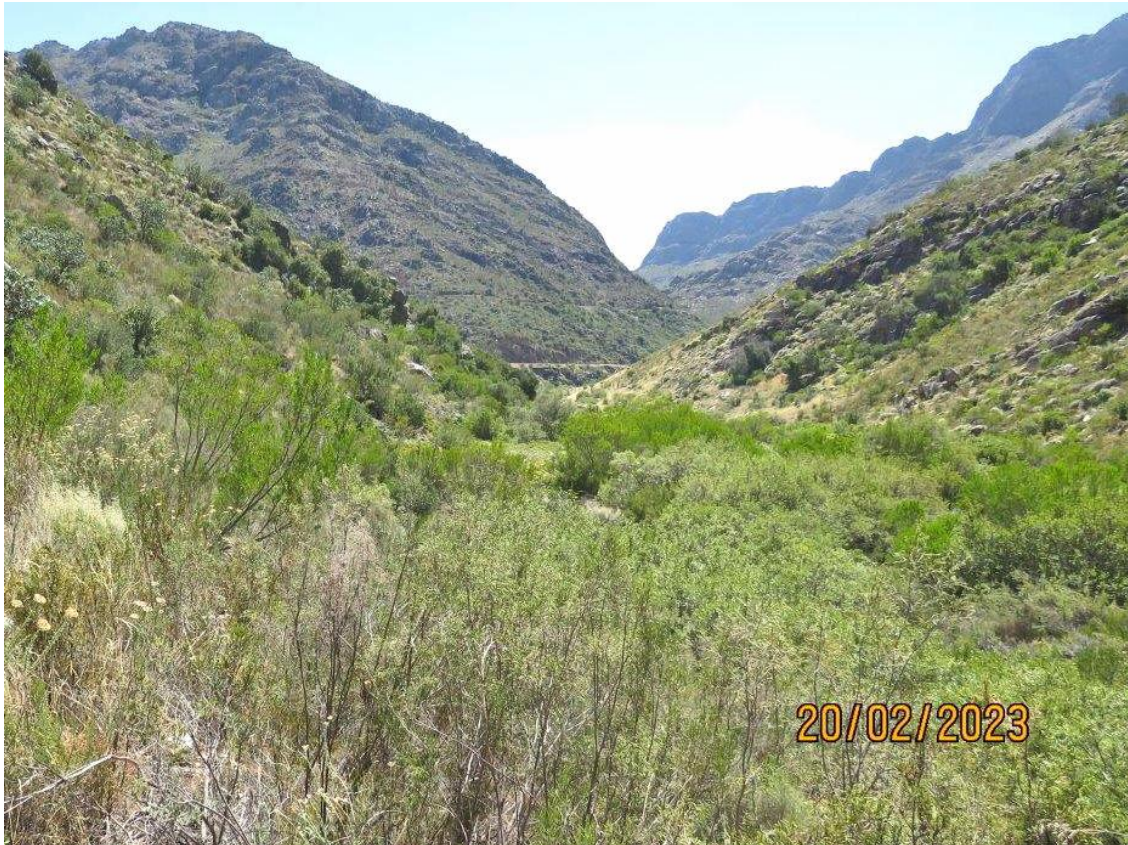
**Figure 14** Riparian vegetation of the Tierhokkloof

Mr Peet Botes of PB Consult in Bredasdorp, the botanist associated with Enviro Africa, visited the site on 20 February 2023, when there was a strong flow of water down the Tierhokkloof. The water was clear and running fast down the mountainside (Figure 14).

The riparian vegetation was markedly higher than that on the surrounding slopes (Figure 14). The vegetation was Fynbos, proteoid.

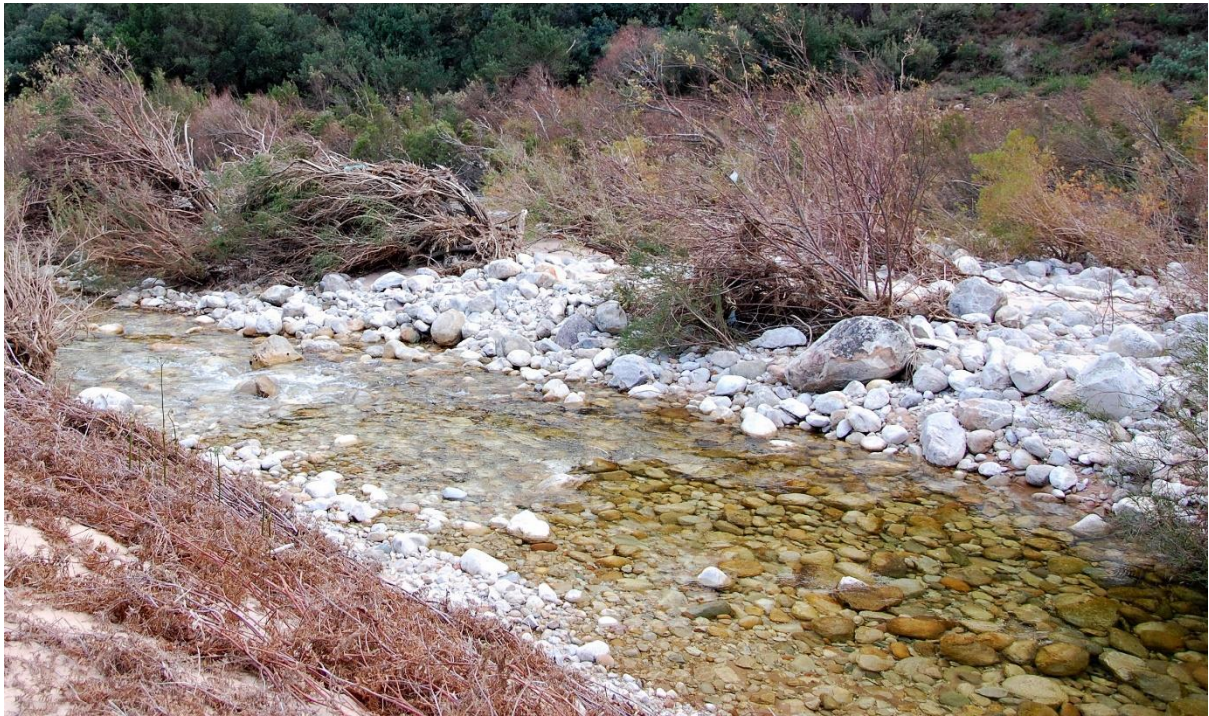
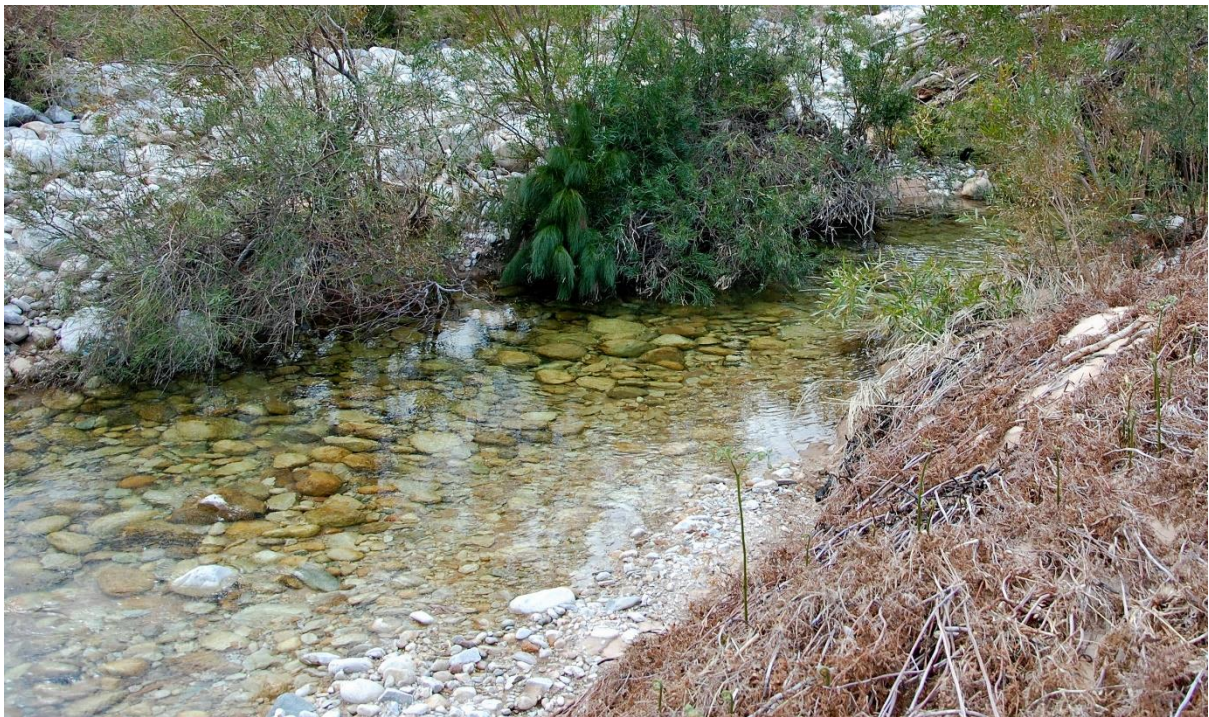
**Figure 16** Tierhokkloof sampling point upstream and downstream

The Tierhokkloof Stream was sampled on 27 July 2023. The stream was running strongly, due to the high rainfall of the current winter rainy season, was approximately 4 m wide at the sampling point, from a few centimetres to 0.5m deep and running at more than a metre per second in the middle of the stream and even faster over the rapids and the runs (Figure 16). The water was clear, with lots of white water in the rapids.

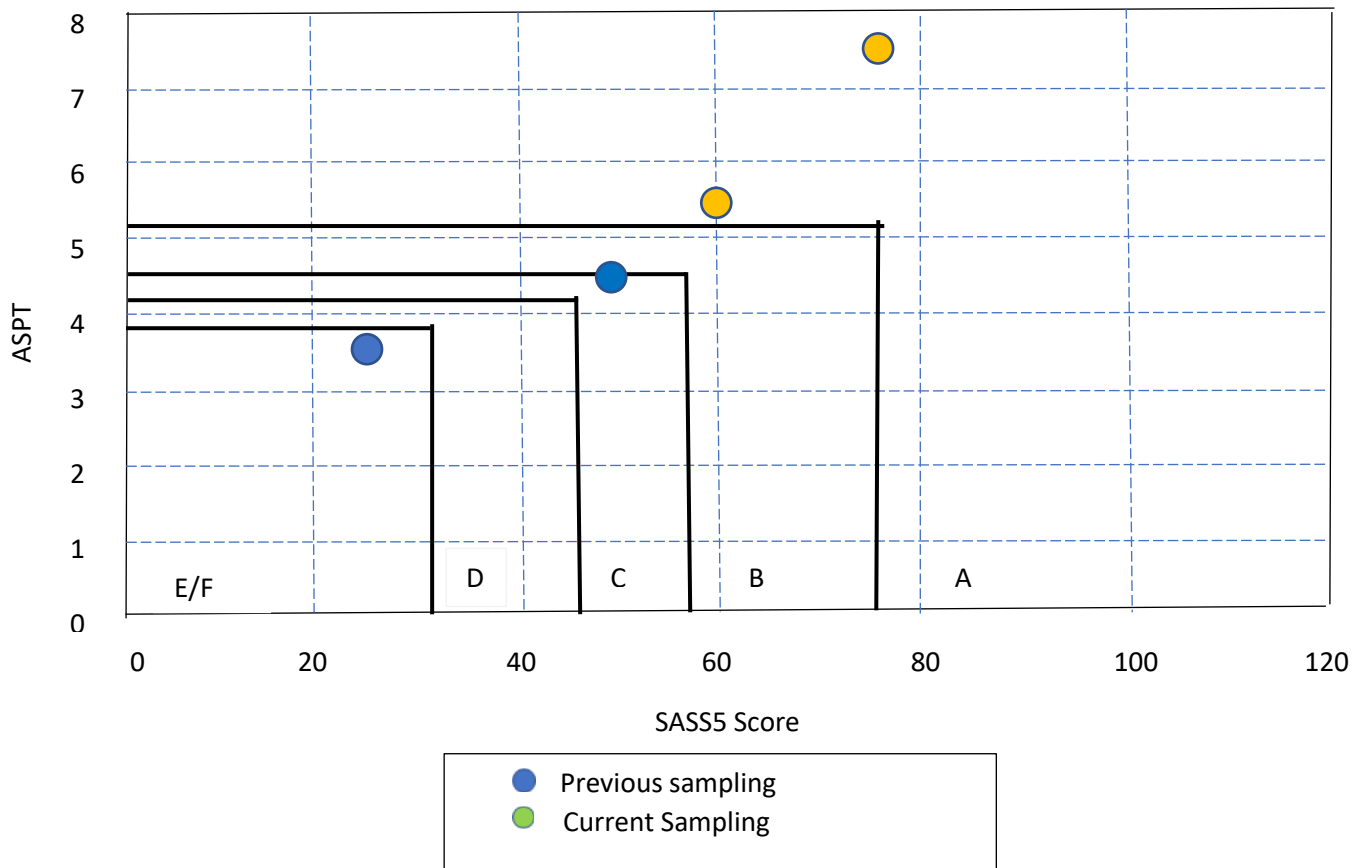
**Figure 17** Biomonitoring Results

The SASS5 score together with the ASPT puts the river at the Witbrug in Class A (Figure 17). This suggest that the river is not impacted and in a pristine state, which is clearly not the case, given the large-scale abstractions and irrigation return flow. This classification was possibly the result of generous rains over the preceding days, as well as less abstraction and less irrigation return flow because of load shedding. Moreover, at such a varied and relatively large habitat availability, the score should be much higher, as can be encountered in the upper near-pristine reaches of bigger rivers.

Integrity Class	Description
A	Pristine; not impacted
B	Very Good; slightly impacted
C	Good; measurably impacted with most ecological functioning intact
D	Fair; impacted with some loss of ecological functioning
E	Poor; loss of most ecological function
F	Very Poor; loss of all ecological function

Parameter	Bredede	Tierhokkloof
SASS5	60	75
Number of Taxa	11	10
ASPT	5.5	7.5
