Thorn and Feather

Portion 9 of Farm 499
Vermaaklikheid

Aquatic Environment Report and water related issues

A requirement in terms of the National Environmental Management Act (107 of 1998)
A report in support of a S24G application

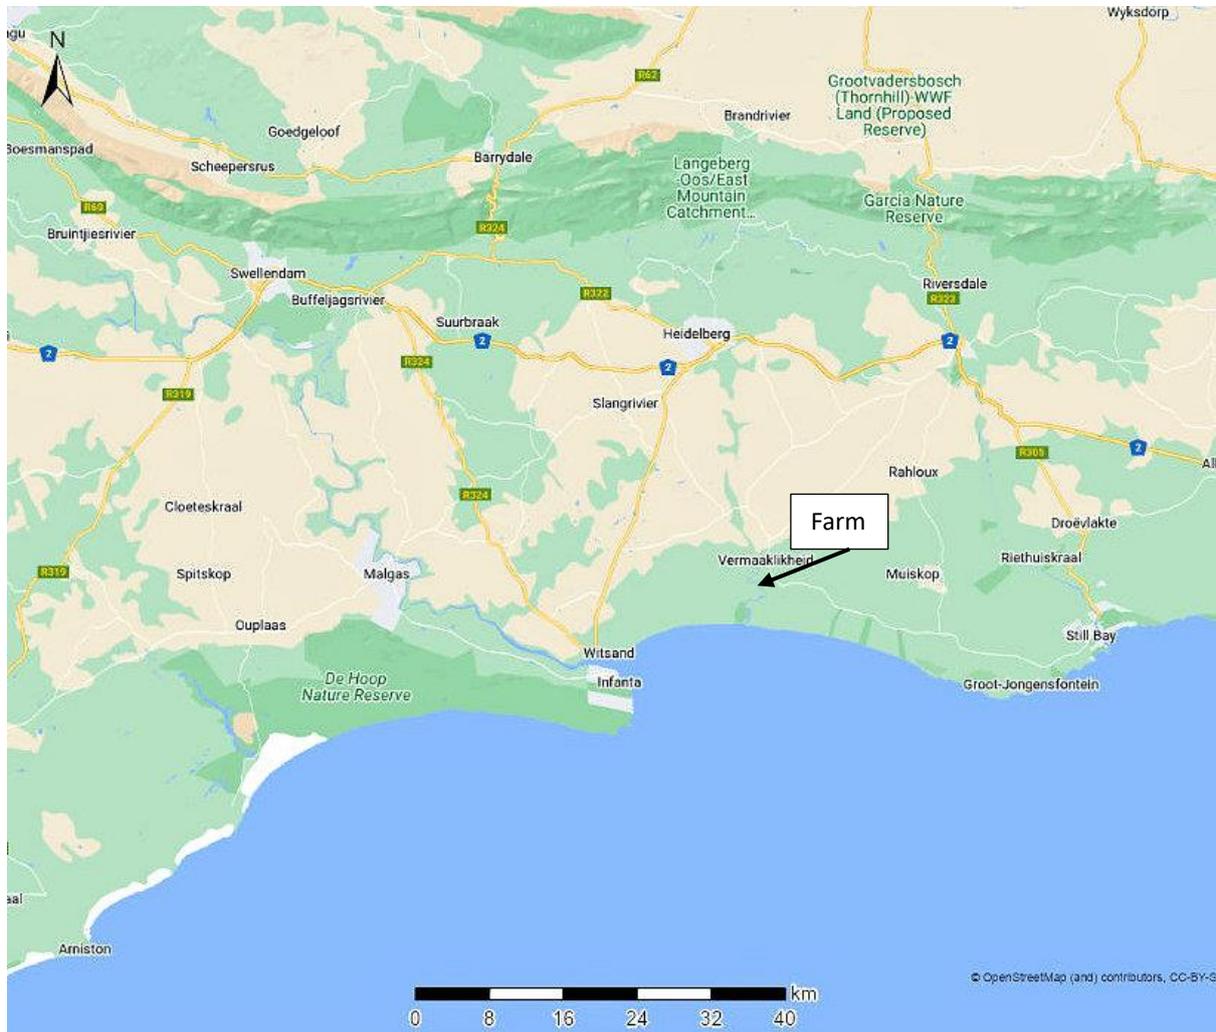
Figure 1 Locality Portion 9 Farm 499

The locality of the Farm is indicated in Figure 1. It is 34km to the southwest of the town of Riversdale measured in a straight line in the Western Cape Province close to the southern seaboard. The farm is on the eastern banks of the Duivenhoks River estuary.

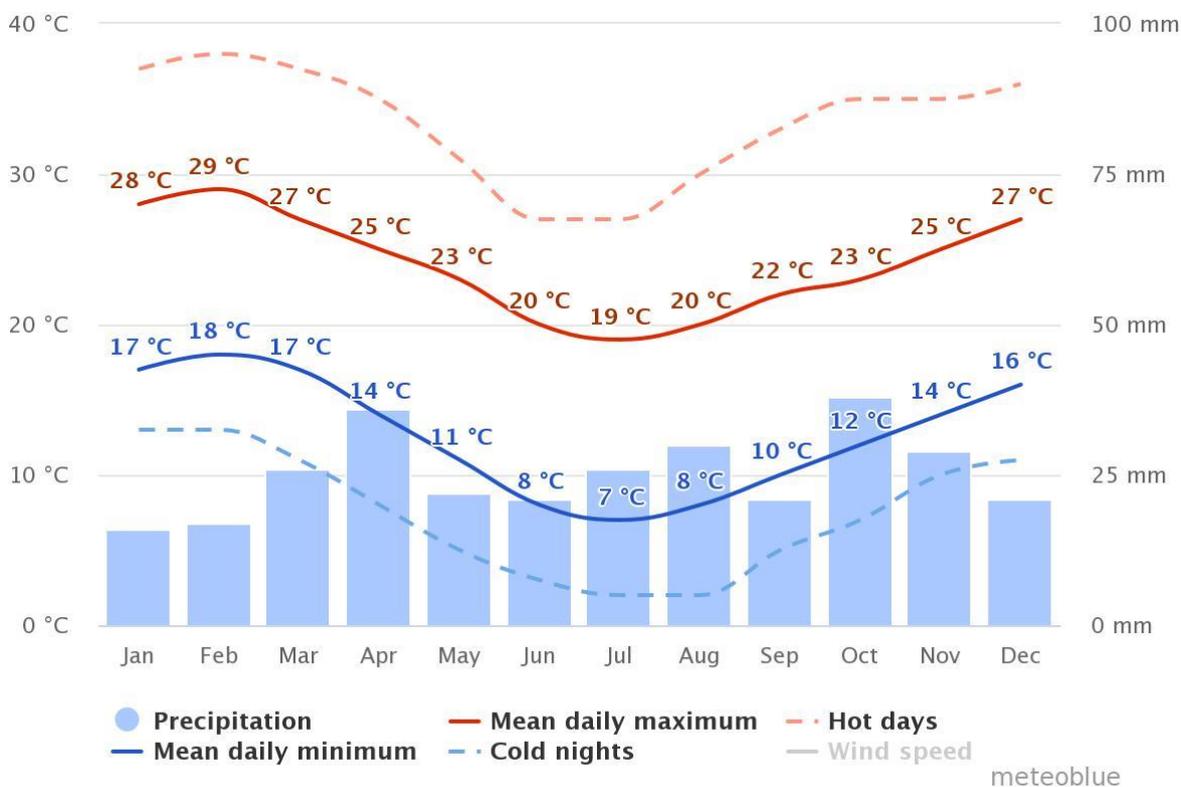
Figure 2 Climate Riversdale

The rain is spread throughout the year, with most in April and October (Figure 2). The annual rainfall is only 407mm.

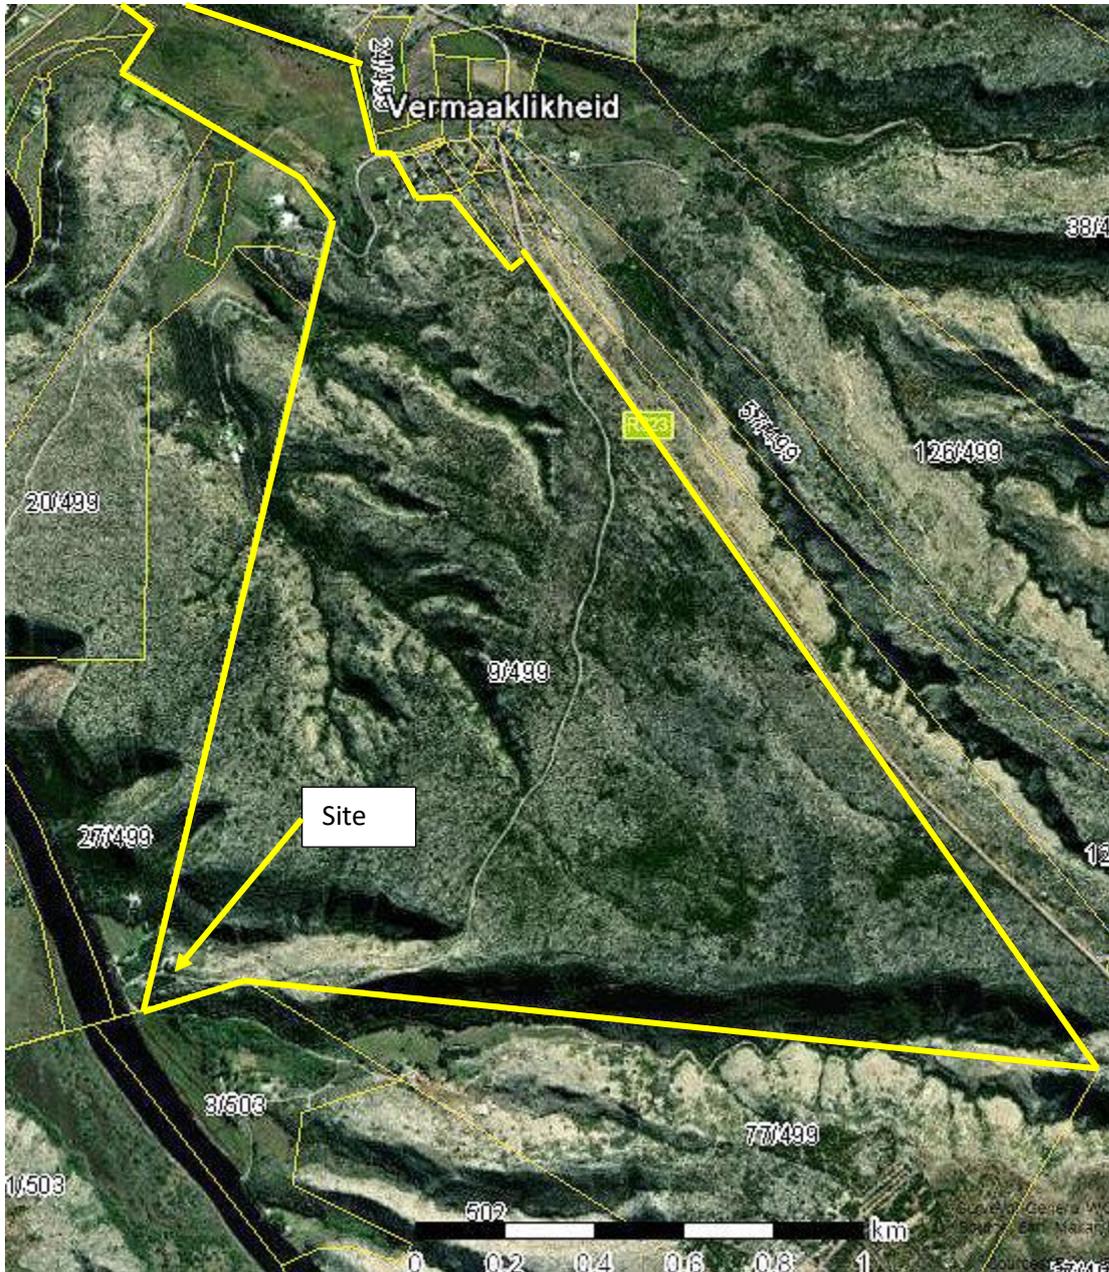
Figure 3 Portion 9 of Farm 499 Vermaaklikheid

The property under discussion is indicated in Figure 3. It is currently under review as some of the land will be sold or exchanged in the foreseeable future. Until that has happened, the application will deal with the land as it is currently registered.

The destination “Thorn and Feather”, as it is named, is in the very far southwestern corner of the property. The development has no access to the estuary other than a path over the next-door property Portion 3 of Farm 503.

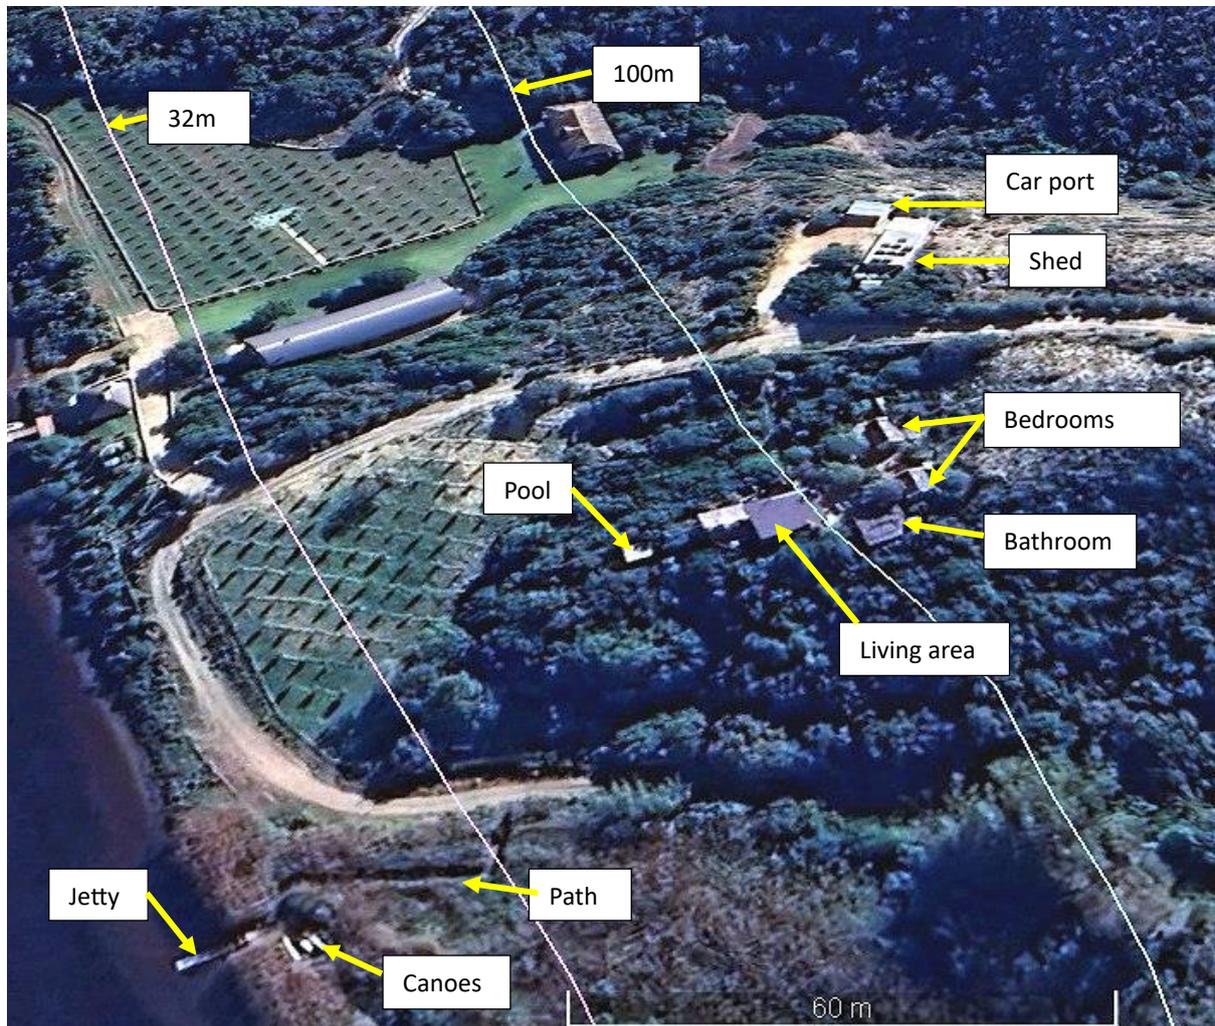
Figure 4 Lay-Out

The development is separated from the estuary by the olive orchard on Portion 27 of Farm 499 in the very south-westerly corner (Figure 4).

The jetty and the foot path through the reeds are within the 32m controlled zone, as specified by the NEMA and its regulation (Figure 4). The main house and the pool are within the 100m buffer zone, as specified by GN509 in terms of the NWA.

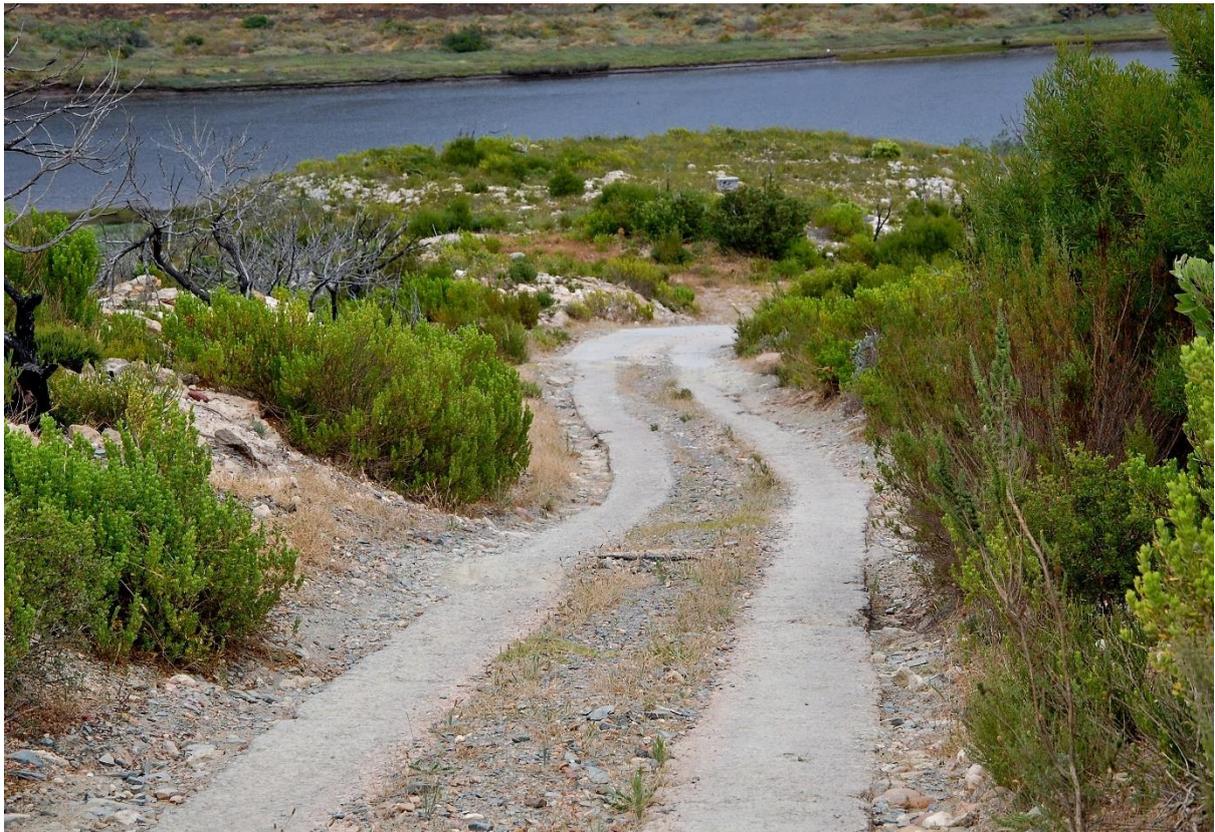
Figure 5 Access Road

When driving down towards the property, the decline is steep, with the access road marked by twin concrete strips (Figure 5). The soils are shallow and underlain by solid calcrete. Erosion along the road is obvious, but only onto the hard and persisting calcrete.

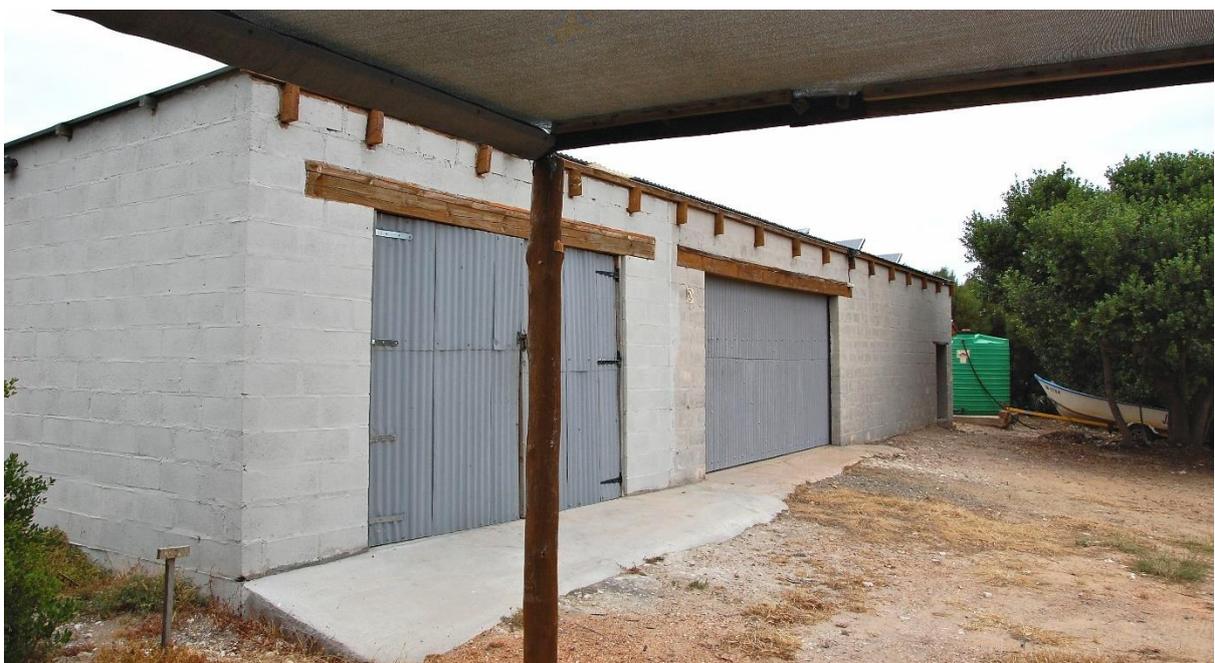
Figure 6 Shed.

Visitor parking space is provided at the shed (Figure 6). There is a car port covered with sun shield mesh. This shed is important for the rainwater harvesting system.

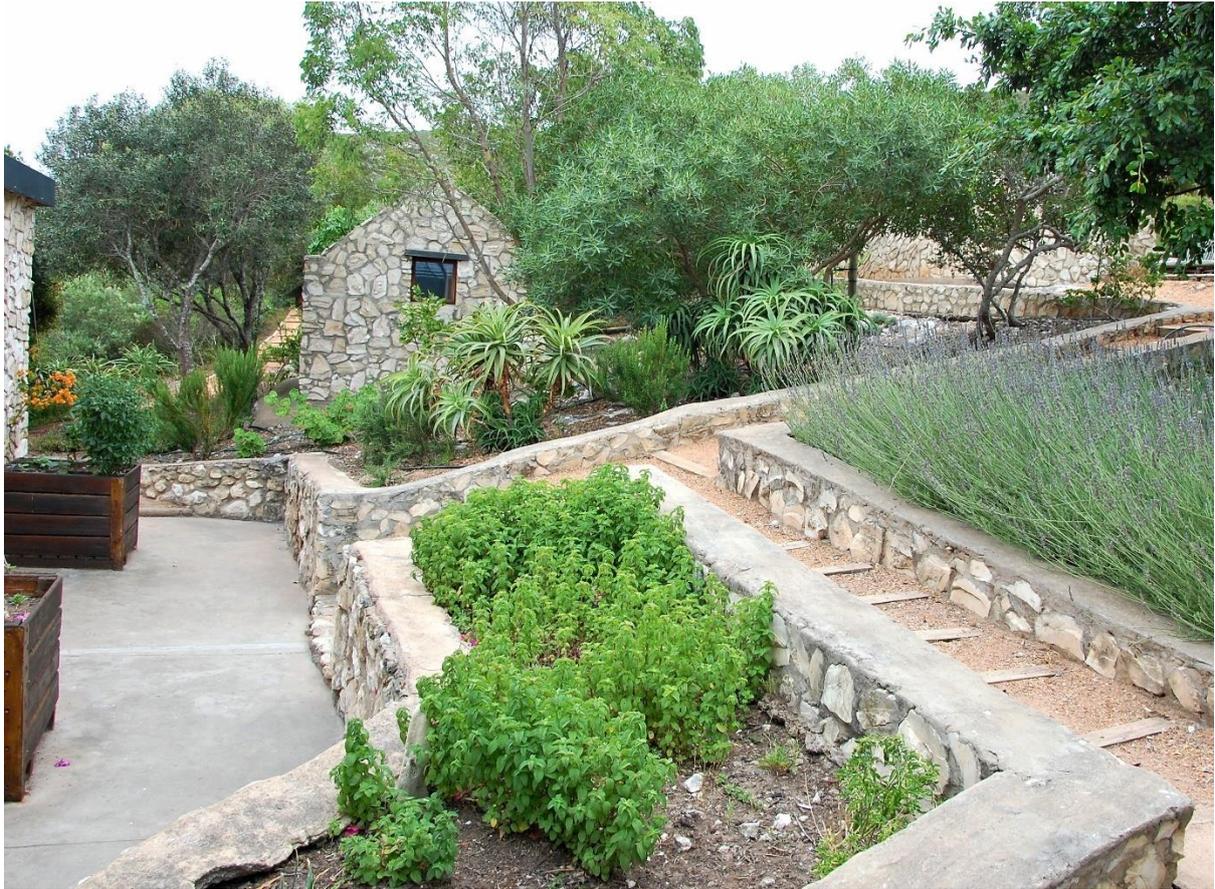
Figure 7 Bedroom and garden

Visitors must cross the access road and pass through a door-size garden gate onto the premises. The path leads to a small garden and the holiday houses (Figure 7). The small size of the garden is important for the water provisioning system.

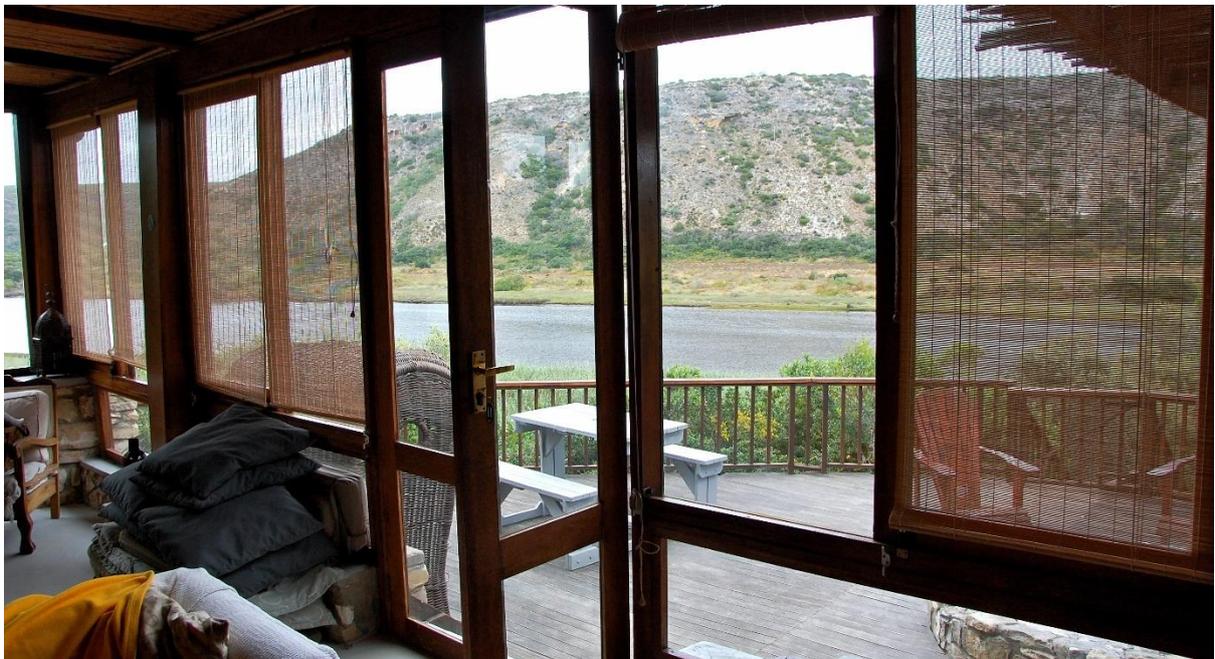
Figure 8 Living Room

The main house overlooks the Duivenhoks River estuary (Figure 8). The deck at the main house leads to a boardwalk onto the pool (Figure 9) downhill.

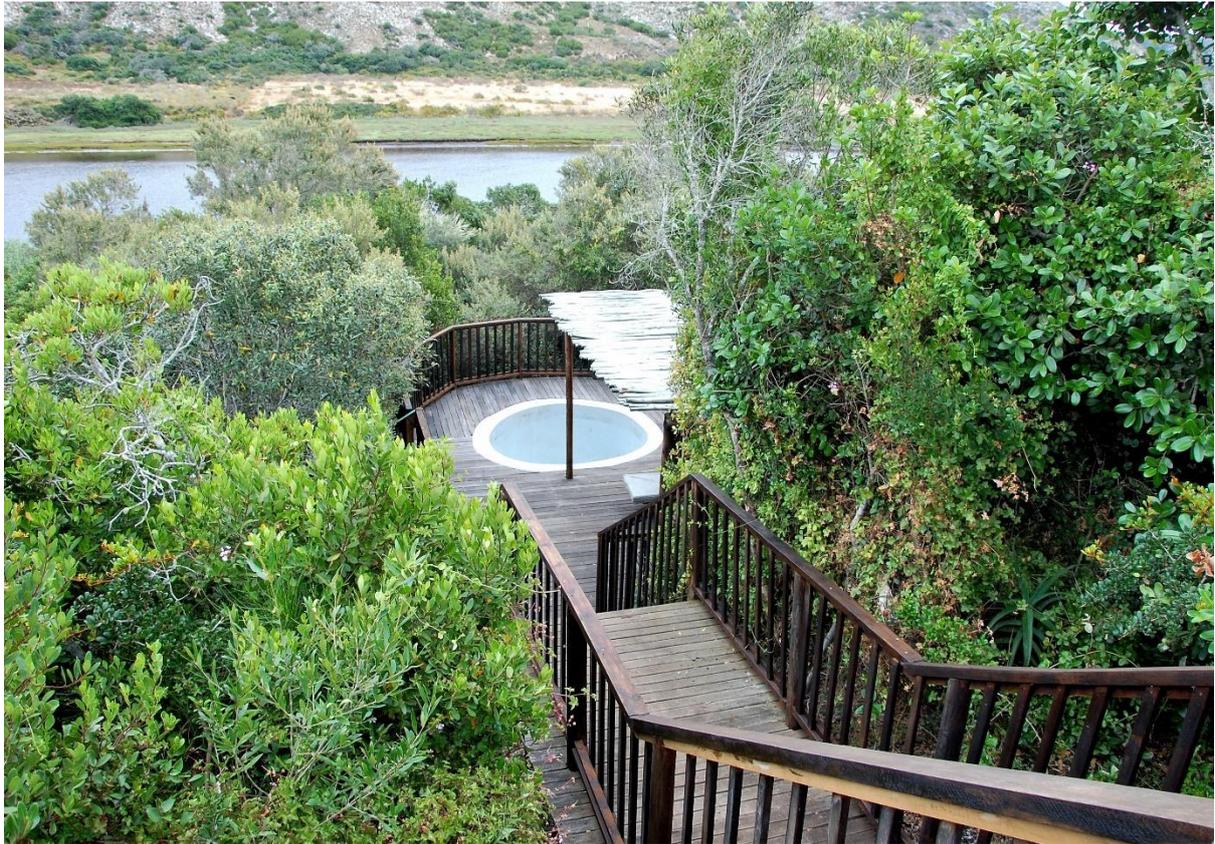
Figure 9 Pool

The lower part of the pool and that of the main bathroom is, according to one of the maps on the Cape Farm Mapper, is within the natural estuarine wetland zone of the Duivenhoks River estuary. Another map, as well as Figure 9, clearly shows that this part of the farm is in the Canca Limestone Fynbos and not in the estuarine zone at all.

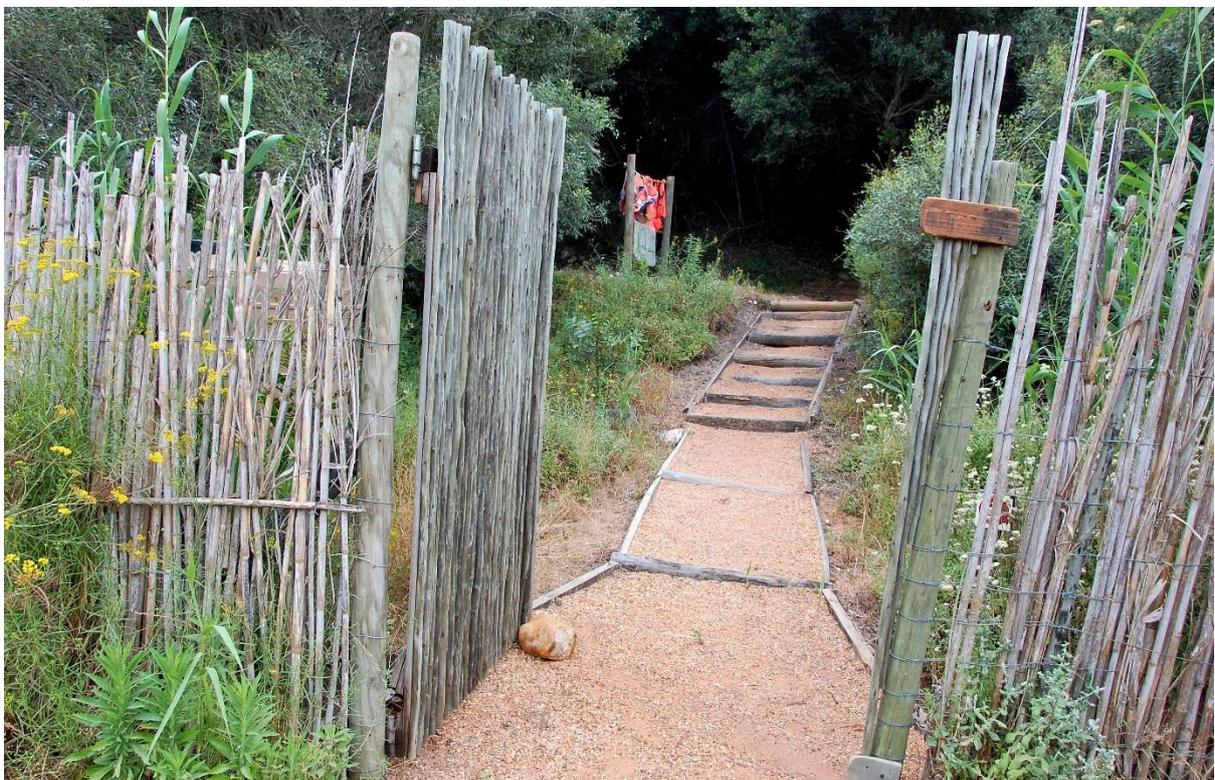
Figure 10 Path

The path past the main house leading to the estuary down the incline is narrow, with room for only one person at a time (Figure 10). Again, the dense vegetation was preserved, with the canopy closed overhead, adding to the sense of place.

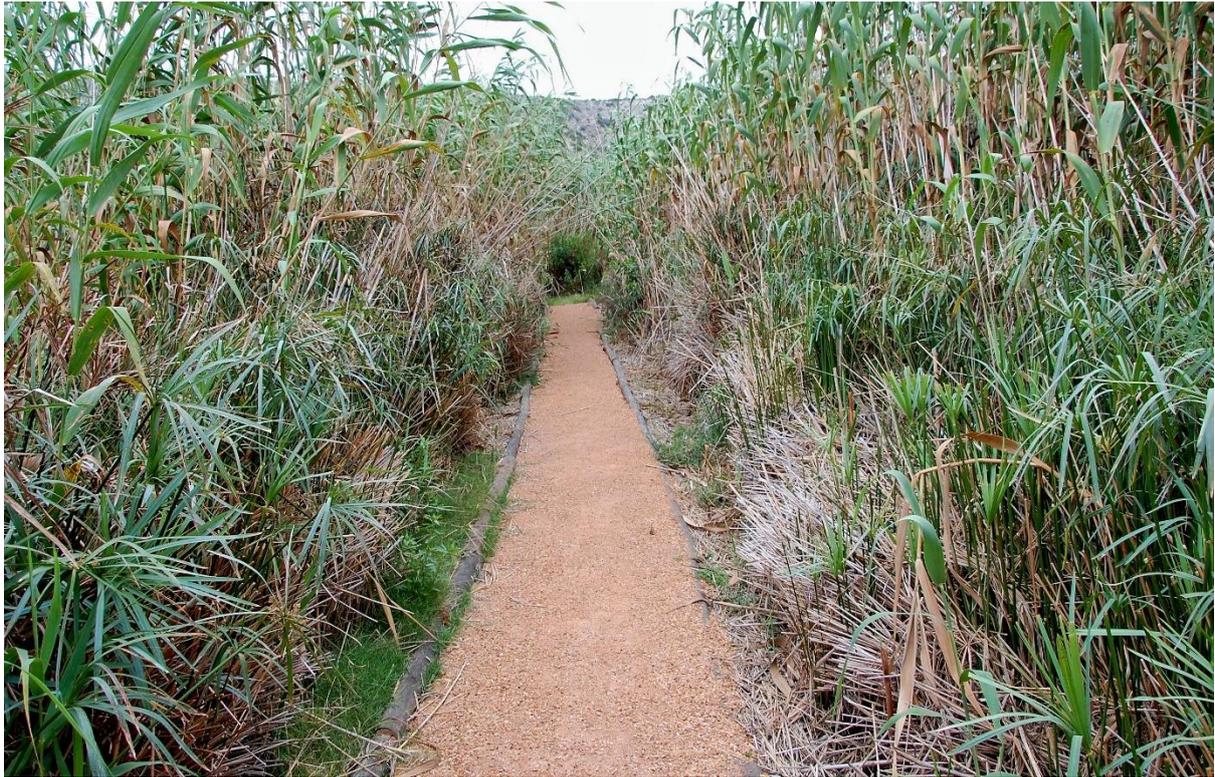
Figure 11 Reeds

Likewise, the path through the reeds on the bank of the estuary was cleared only enough for limited foot traffic (Figure 11). There is a clearing in the reeds to accommodate the canoes (Figure 12).

The path to the jetty through the reeds must not be expanded or enlarged in any way. All care must be taken that the reeds remain in a healthy condition. Likewise, the storage area for the canoes must be kept the way it is now and must not be expanded any further. The path through the trees and thicket from the main house to the reeds must be properly maintained and not expanded. Erosion because of stormwater must be addressed and mud and sand must not be allowed to wash into the estuary.

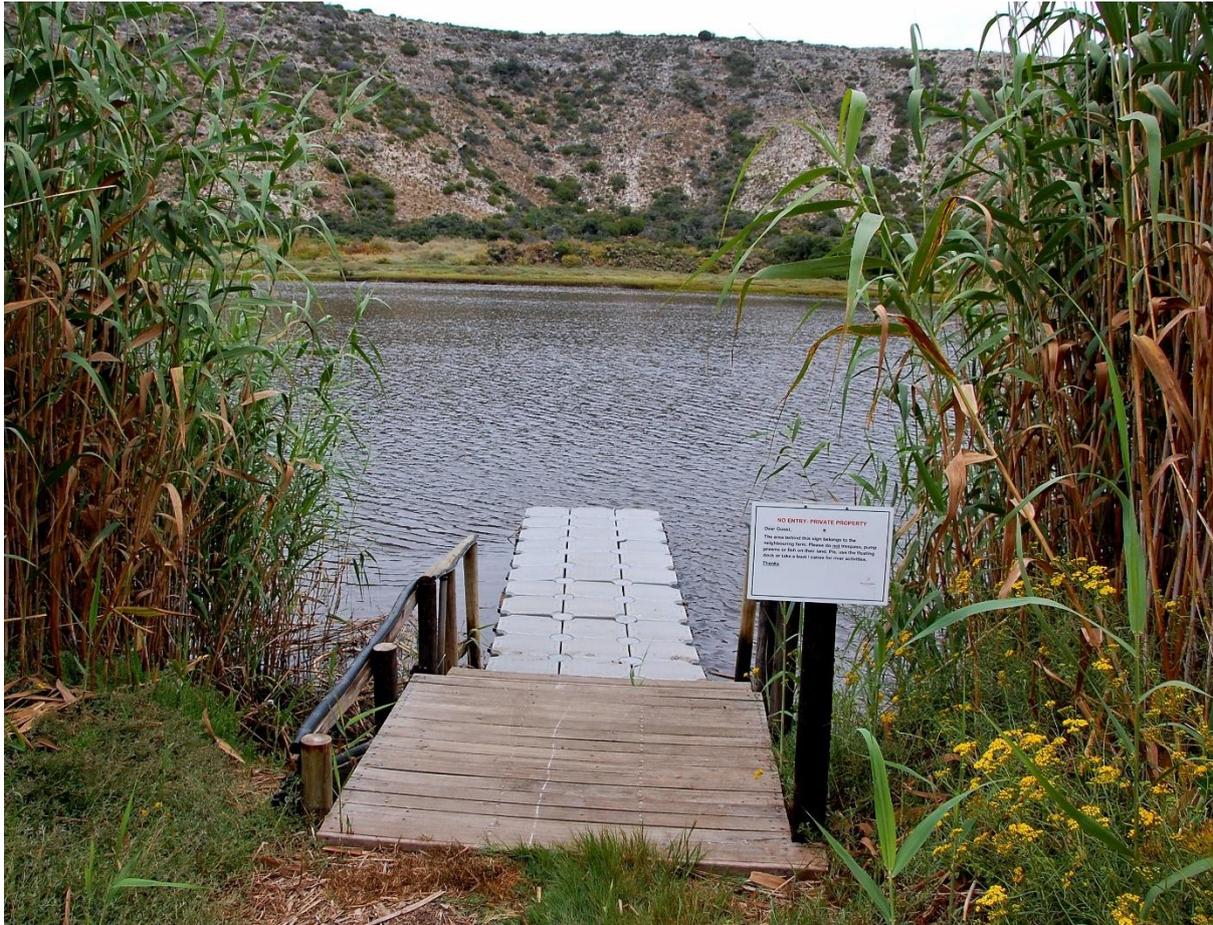
Figure 13 Jetty

A small floating jetty was constructed in the estuary at the end of the path (Figure 13). This is probably the life blood of this holiday destination, as it is the access to the estuary from the property and the main tourist attraction. The poles in the very edge on the bank is the anchorage for the jetty. The free end in the water away from the bank is entirely loose, with no anchoring structures. The floats are interlocking plastic sections. Although moderately unsteady underfoot, the structure is strong to withstand the tidal currents.

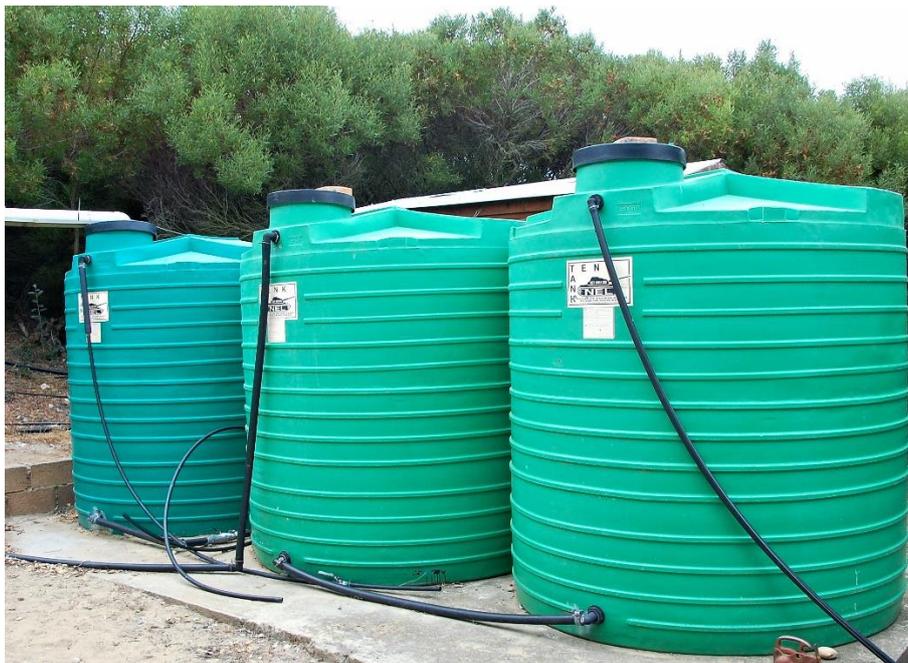
Figure 14 Containers with household water

Water for the kitchen and the bathroom is entirely dependent on rainwater harvesting from the storeroom across the access road. Rainwater from the roof is collected in 3 plastic containers (Figure 14), each with a capacity of 5000 litres. From the tanks it is piped into the house and into the bathrooms.

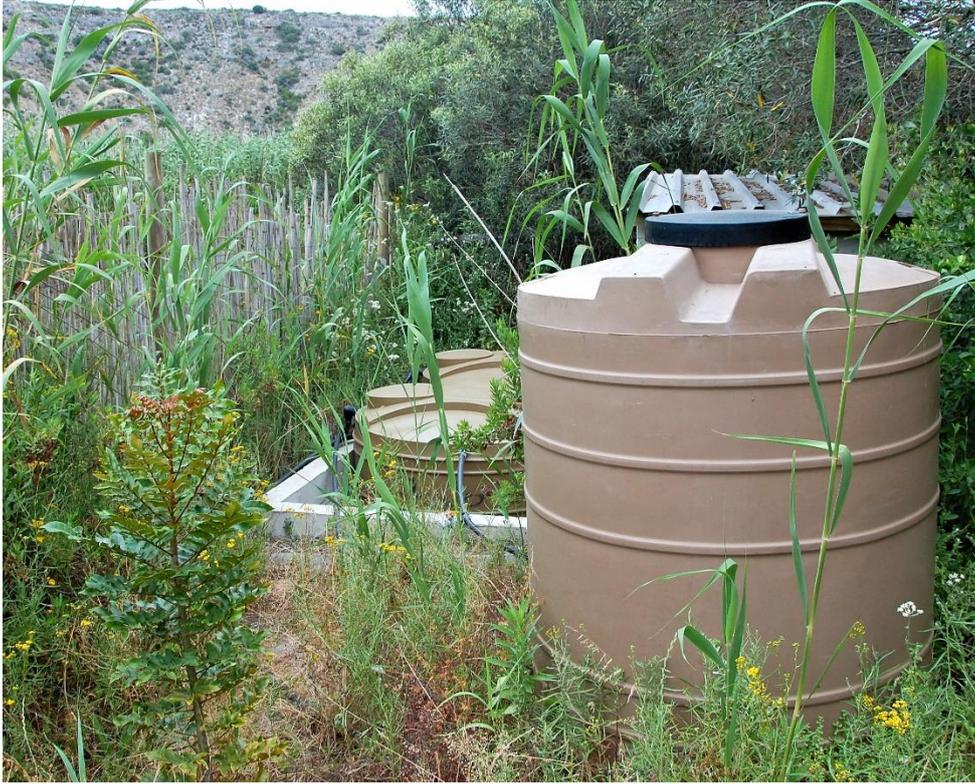
Figure 15 Irrigation system lower water tanks

The next-door farm has a small fountain that has been provided water to at least 5 neighbouring farms since these farms were handed out during South Africa's historic times, generations before any water legislations came to bear. Likewise, water is piped from the "oog" (the eye) to the development on Farm 499. Water is collected in small plastic containers at the lower end of the property closest to the estuary (Figure 15). From here it is pumped up the hill to larger contains placed next to the access road above the development (Figure 16). Eskom electricity is used to drive this pump. From the larger containers, water is piped down the hill to water a small garden and to fill the splash pool.

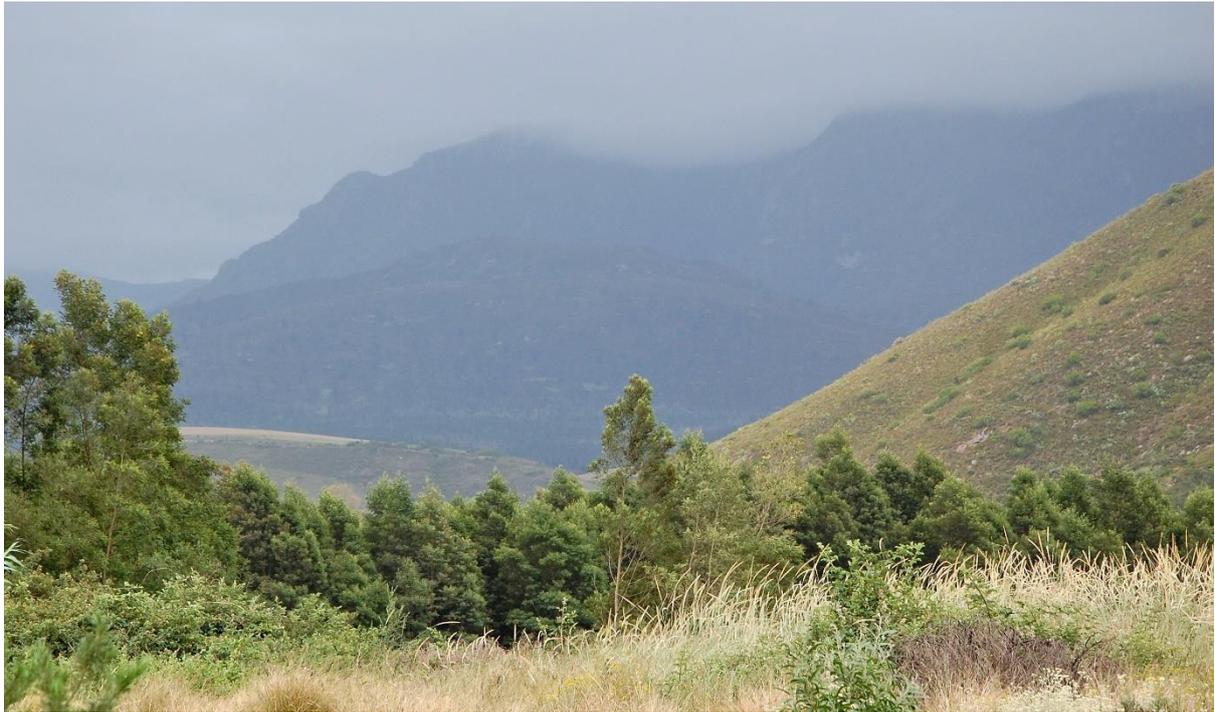
Figure 18 Langeberg Mountains

The Duivenhoks River rises on the high peaks and ridges of the Langeberg Mountains (Figure 18) from where it flows to the south into the Southern Indian Ocean on the southern seaboard of the Western Cape. The catchment area is 53 140km². From the peaks up to 1500masl and the high ridges at 900 to 1100masl to the mouth of the river is approximately 50km.

The catchment is heavily infested in many places with black wattle *Acacia mearnsii* (Figure 18).

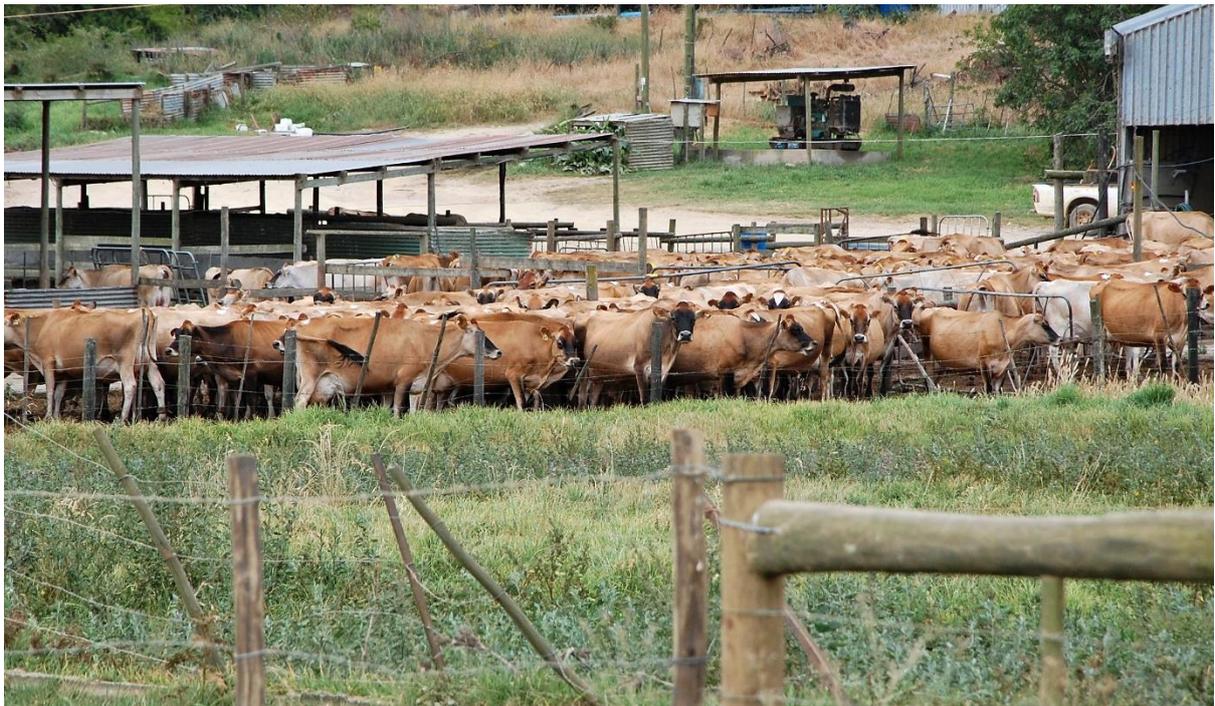
Figure 19 Dairy in the upper catchment

The southern slopes of the mountains are proclaimed nature reserves and mountain catchment areas, with patches of Afromontane forests. The foothills and the upper catchment are heavily farmed with dairy (Figure 19), fruit and cash crops.

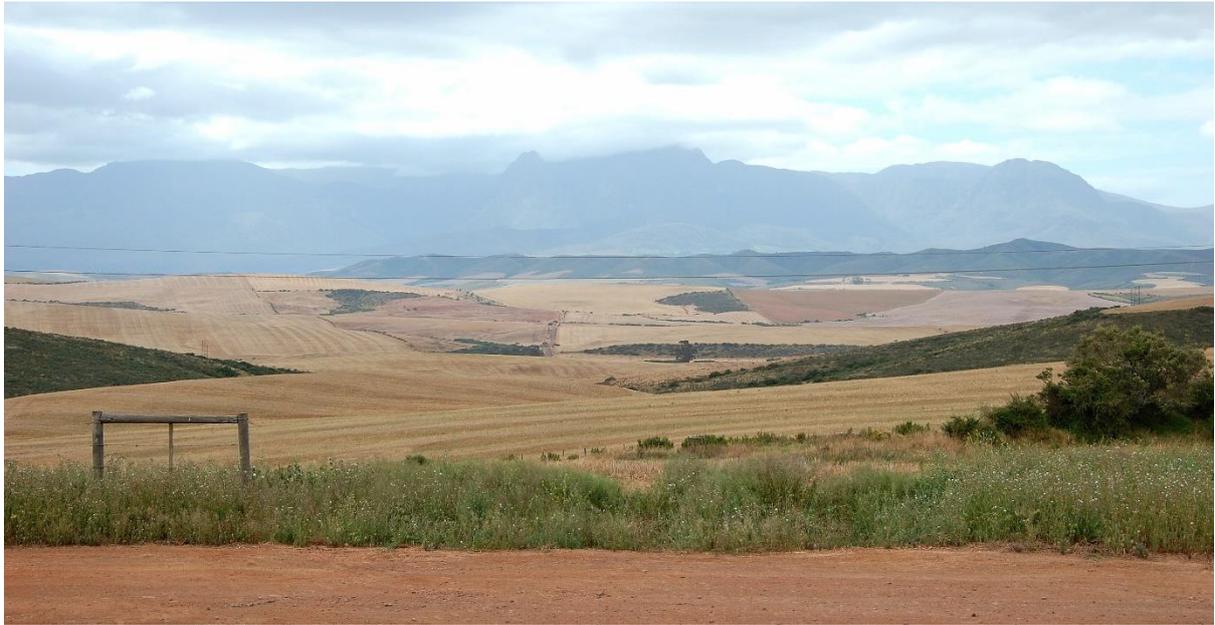
Figure 20 Middle Catchment

Downstream on the coastal flats the undulating landscape (Figure 20) has deeply incised valleys. The area is heavily farmed with wheat and canola. Farm animals such as sheep are prevalent on planted pastures. The valleys with bottom drainage

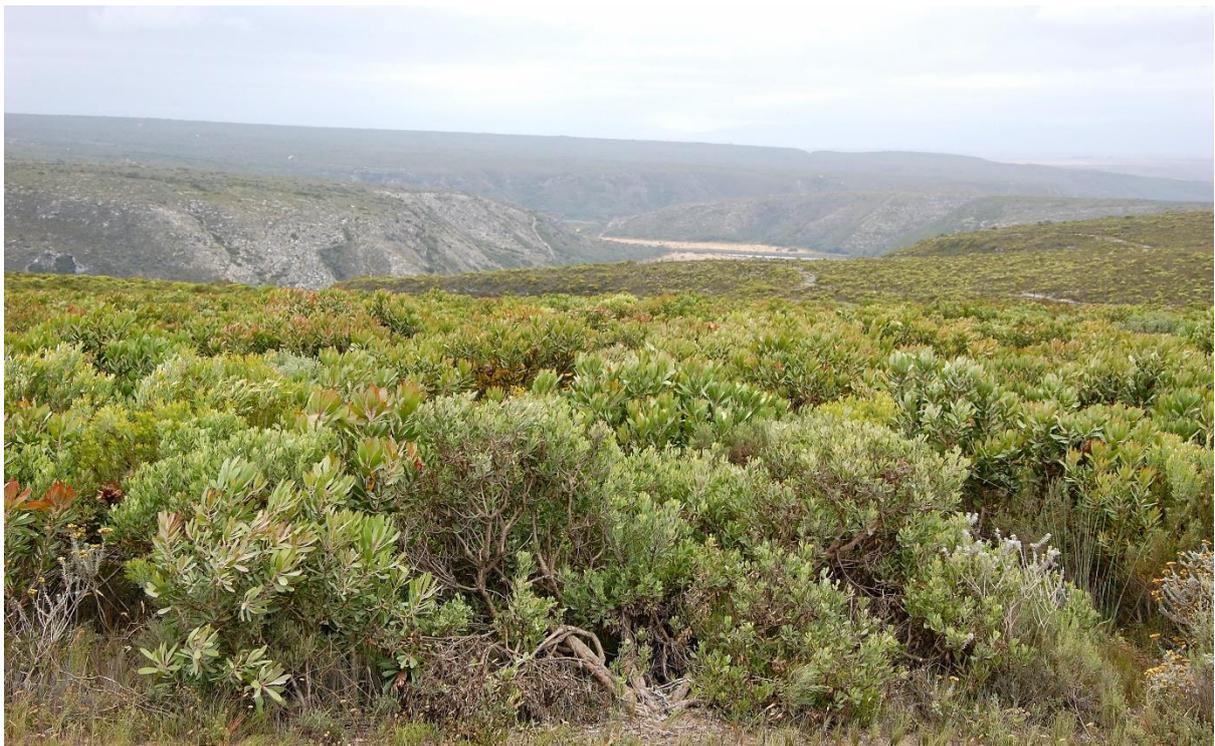
Figure 21 Fynbos

Close to the ocean adjacent to the shore is a narrow strip of natural Fynbos, still well-preserved and mostly unimpacted (Figure 21). This strip is separated from the inland farming activities by land that is heavily infested by rooikrans *Acacia cyclops*.

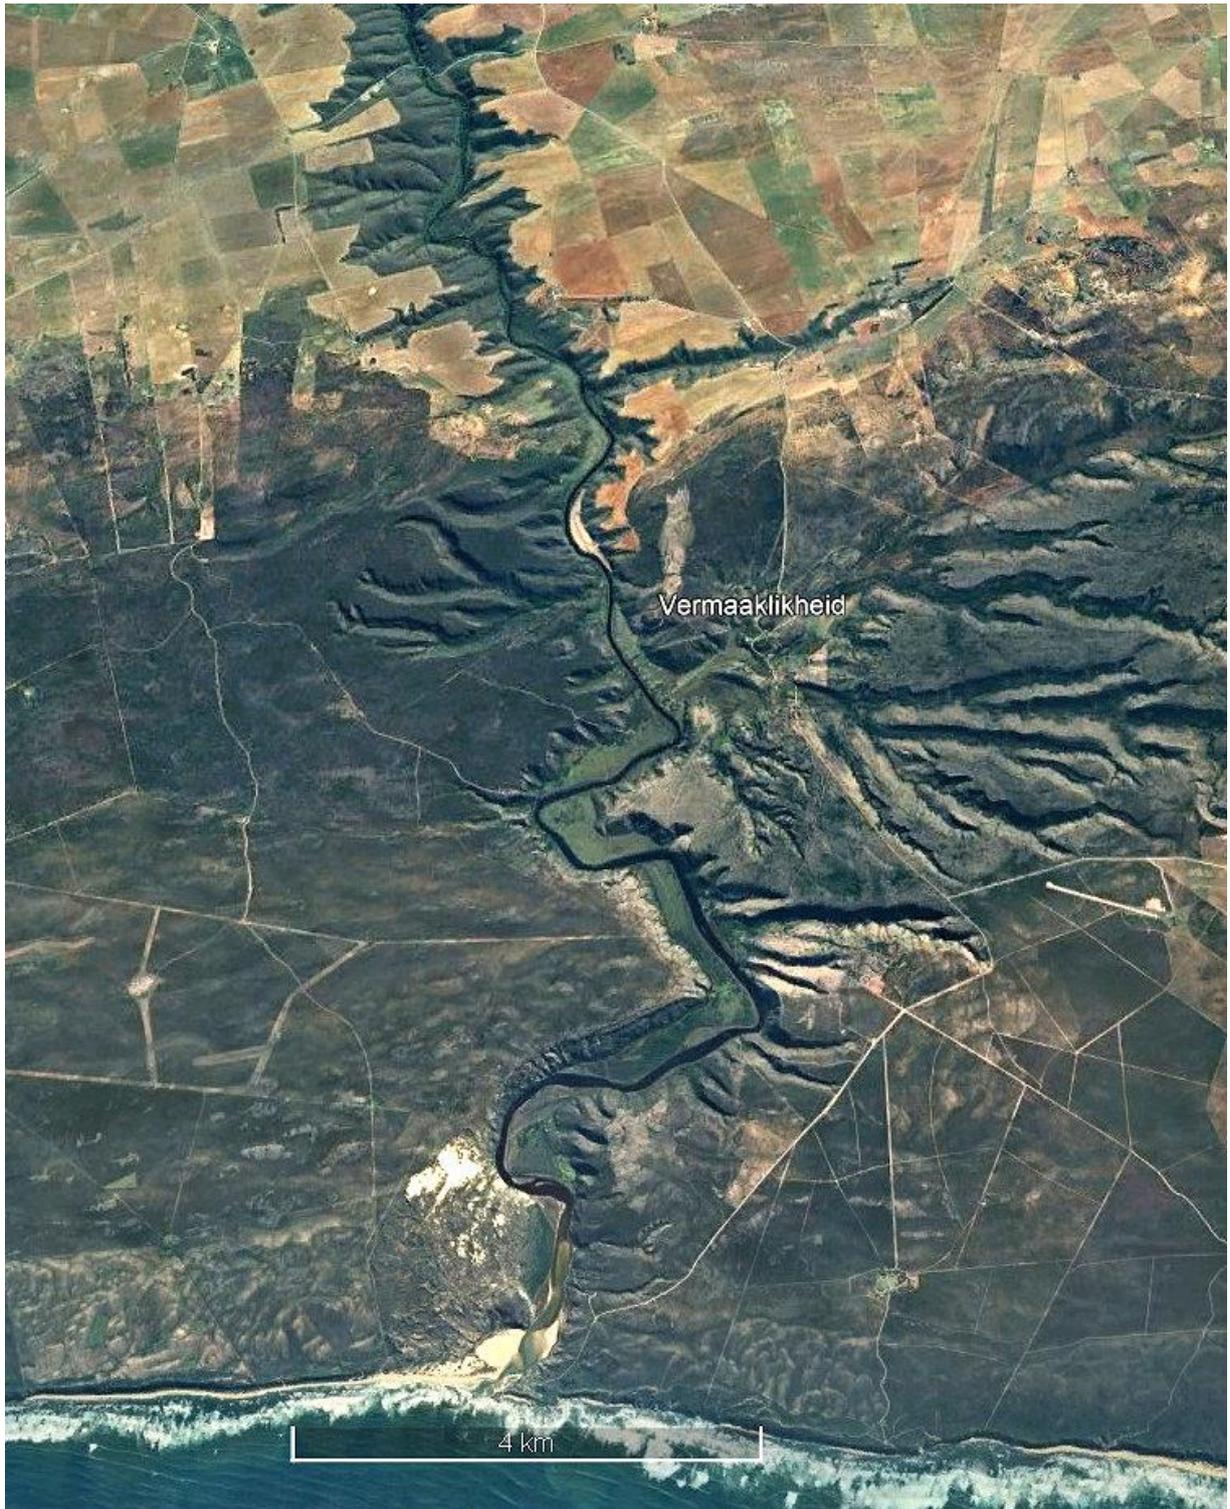
Figure 22 Duivernhoks estuary Google Earth Image

The estuary (Figure 22) is 11km long. It is permanently open to the sea (Figure 23) with a perpetual tidal exchange. The estuary is in a deep valley with steep sides (Figure 24). The bottom of the valley is wide in places, with a band of tidal flats.

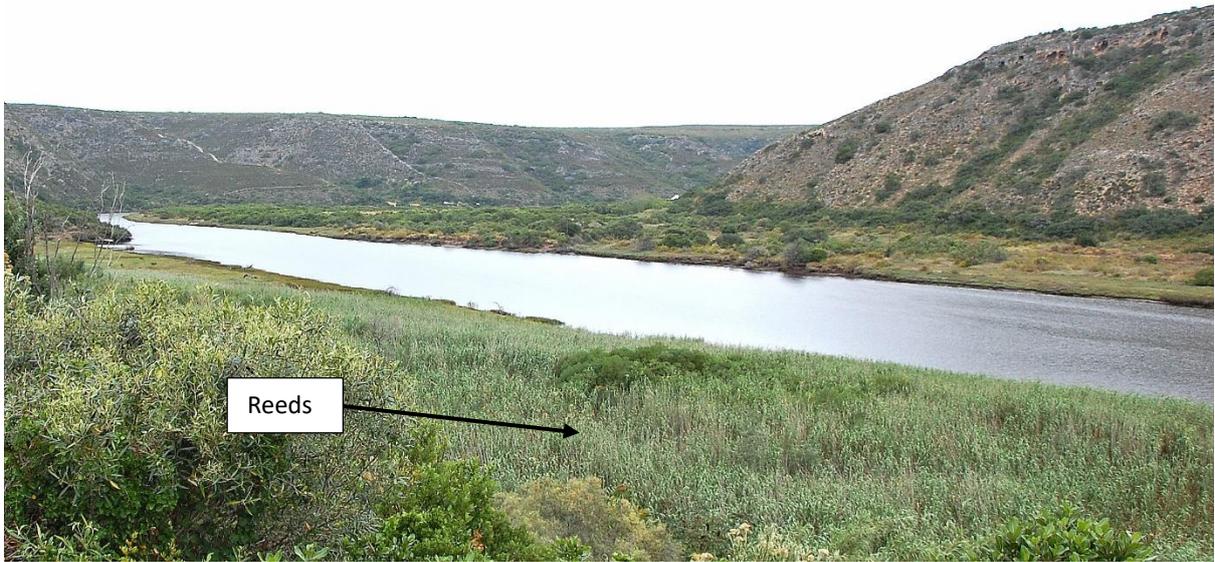
Figure 25 Reeds

There are strips and patches of *Phragmitis* reeds, which are maintained and supported with fresh water, mainly ground water, that flow in from the drainage lines. One such patch of reeds (Figure 25) is in front of Farm 499 and is of importance to this application. This is one of many such stands of reeds along the middle estuary.

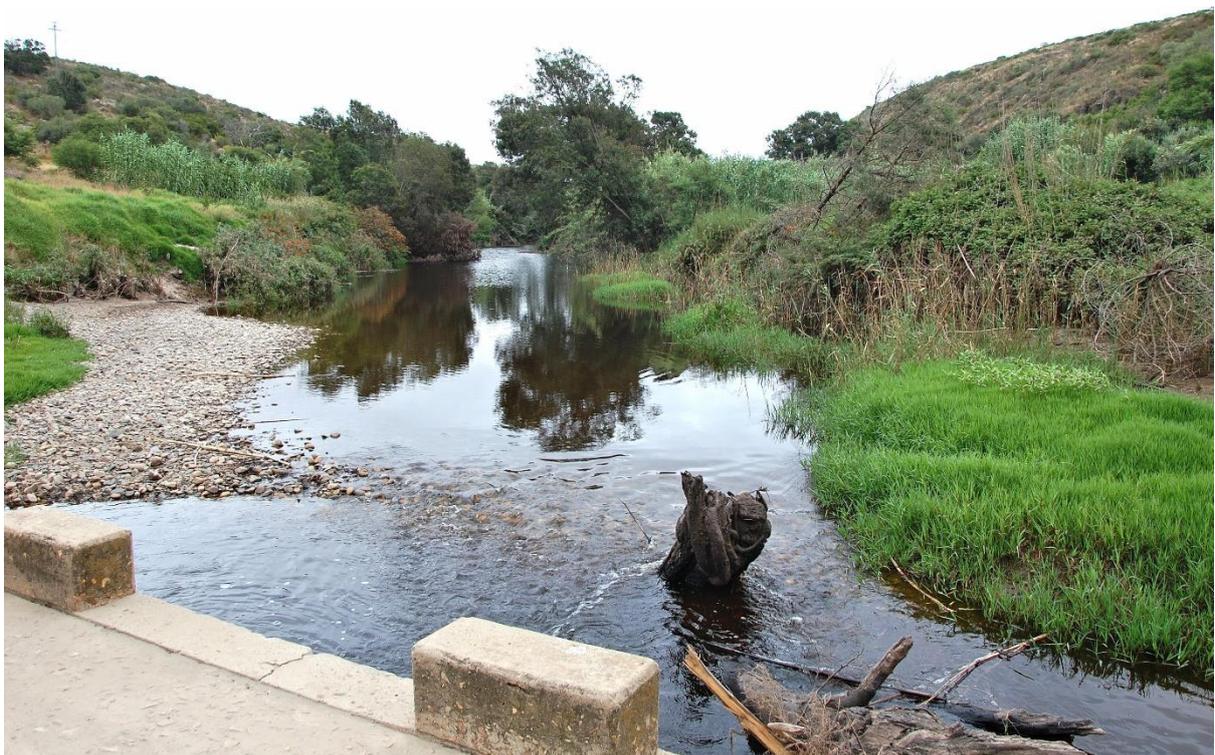
Figure 26 Head of the estuary

The upper end of the estuary (Figure 26) is marked by a low water bridge next to which a DWS water level gauging station is located.
