Thorn and Feather

Portion 9 of Farm 499
Vermaaklikheid

Aquatic Environment Report and water related issues

A requirement in terms of the National Environmental Management Act (107 of 1998)
A report in support of a S24G application

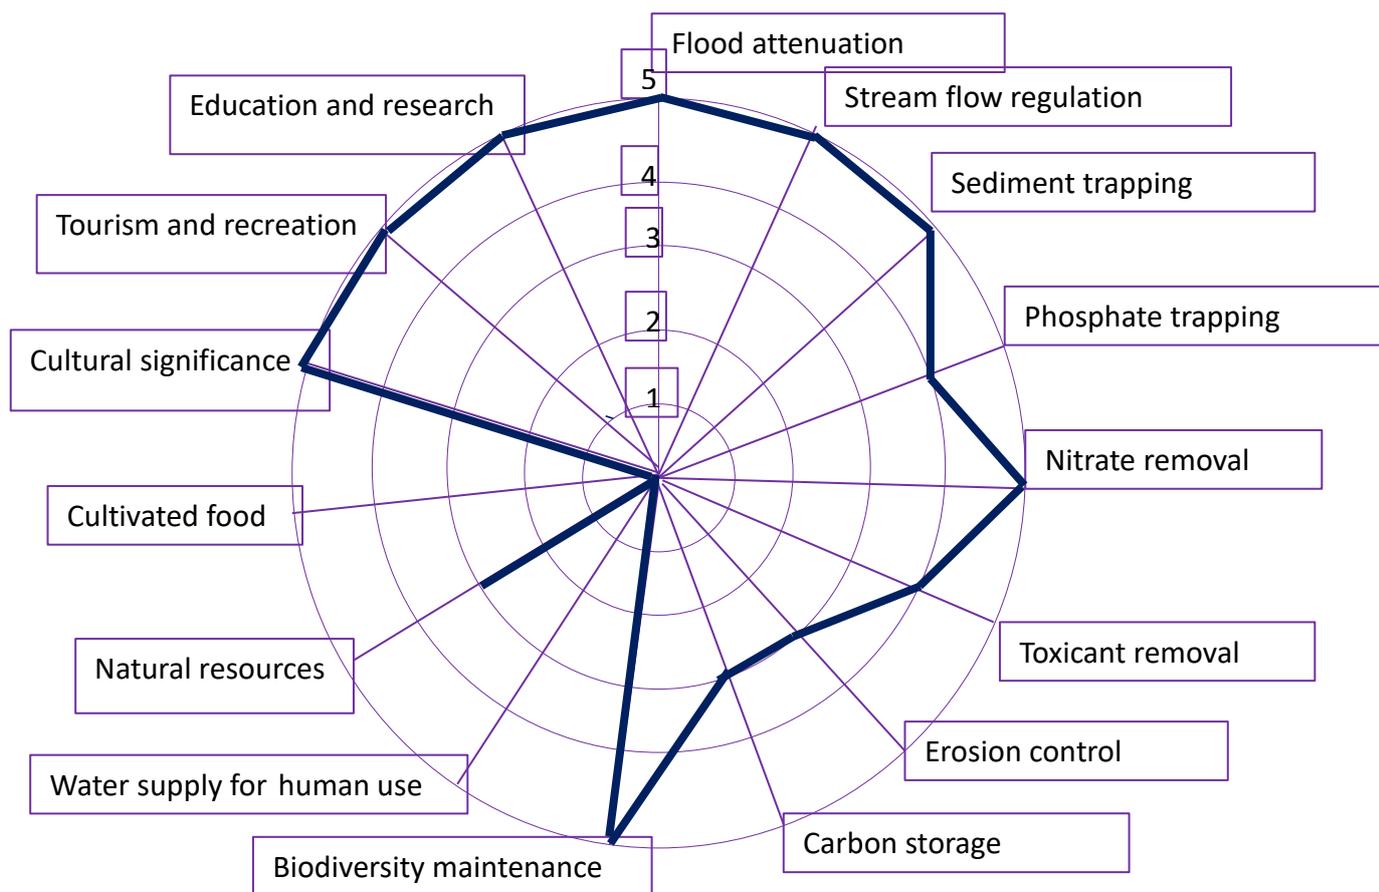
Figure 15. Resource Economics Footprint of the Duivenhoks Estuary

Goods & Services	Score
Flood attenuation	5
Stream flow regulation	5
Sediment trapping	5
Phosphate trapping	4
Nitrate removal	5
Toxicant removal	4
Erosion control	3
Carbon storage	3
Biodiversity maintenance	5
Water supply for human use	0
Natural resources	3
Cultivated food	0
Cultural significance	5
Tourism and recreation	5
Education and research	5

A large resource economics footprint resulting in a large star shape would probably attract the attention of the decision makers. The resource economics footprint of the drainage line indeed is significantly large.
