DE KUILEN RESORT

Freshwater Report for the further development of De Kuilen Resort on Portion 2 of Farm De Kuilen 451 Kamieskroon

July 2023

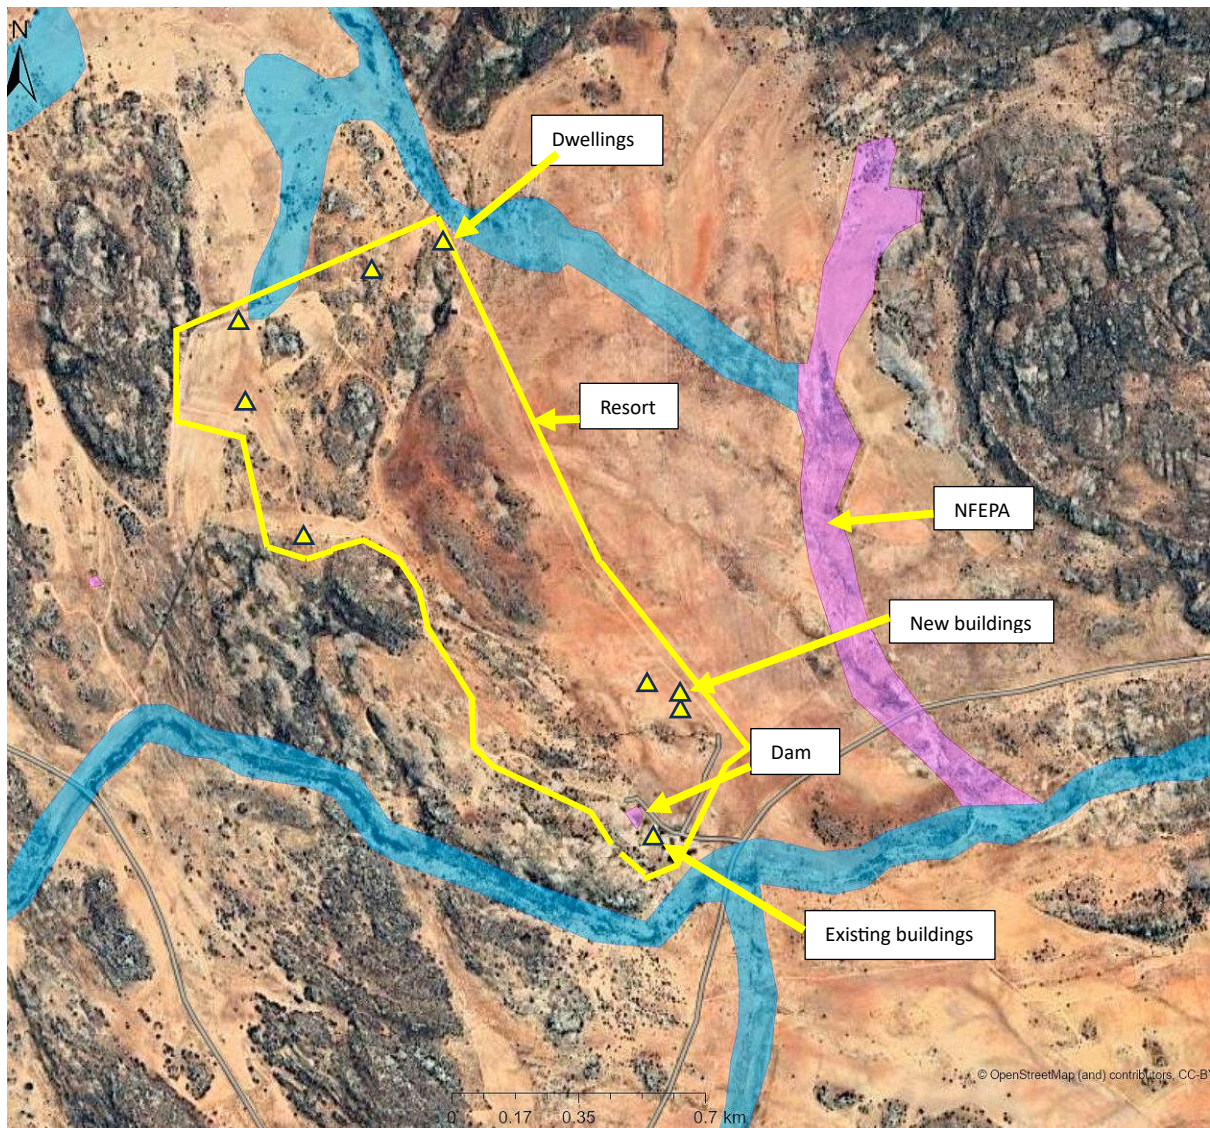
Figure 4 NFEPA Wetland

The Cape Farm Mapper lists the river and the drainage lines as wetland NFEPA's (Figure 4). There is a small farm dam in the southern corner of the property that is listed as well. Some of the existing as well as the planned buildings are within the 500m controlled zone, as stipulated in GN509 in terms of the NWA.

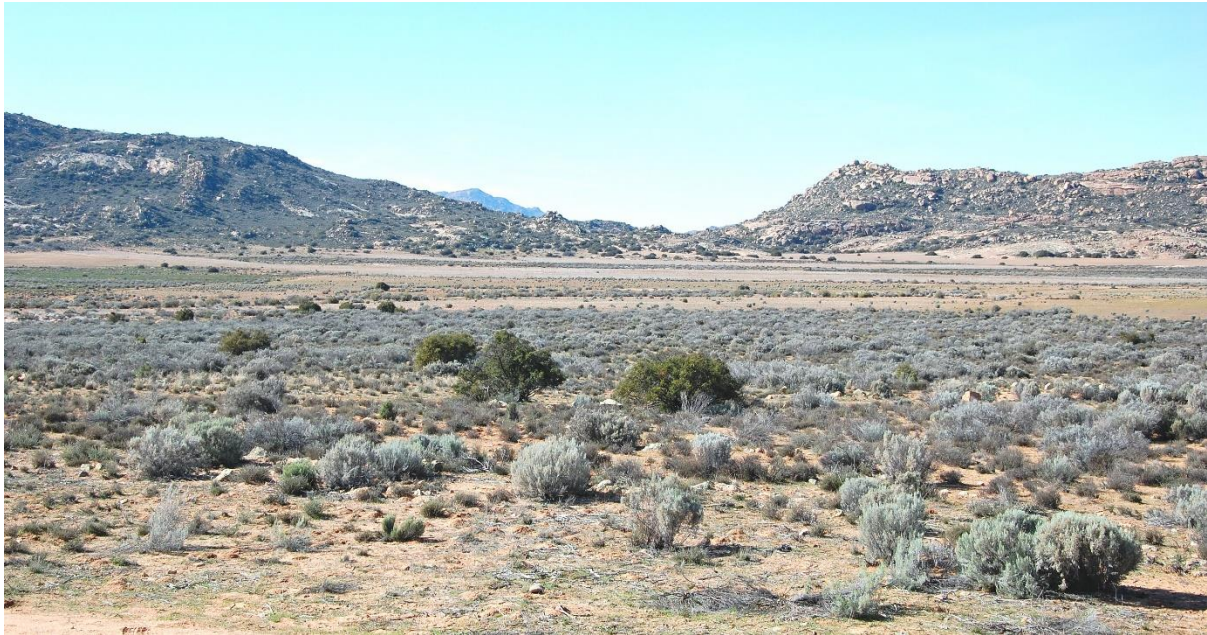
Figure 5 Terrain

The topography (Figure 5) is made up of granite outcrops, the upper ridges of the Kamies Mountains at an elevation of between 1000 and 1300masl. In between these rocks are patches of level ground that have been ploughed over for farming of rooibos tea and wheat. The land was barren during the site visit, with no new crops planted.

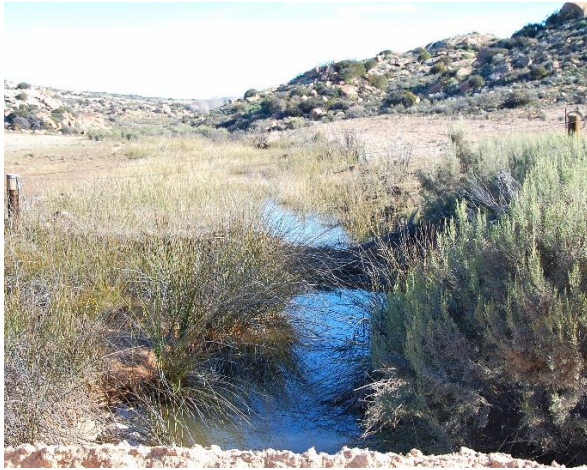
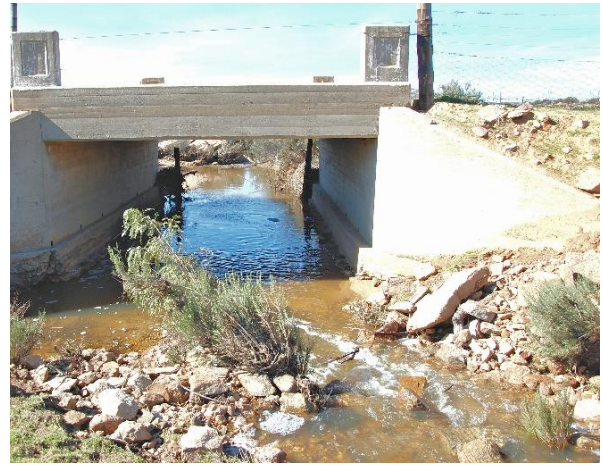
Figure 7 Flow at the upstream bridge and the downstream bridge

During the site visit on 5 July, the river was flowing strongly because of the recent rainfall that resulted in a large flood with a recurrence of perhaps once in 100 years. The flow was observed at the upstream bridge as well as at the downstream bridge (Figure 7).

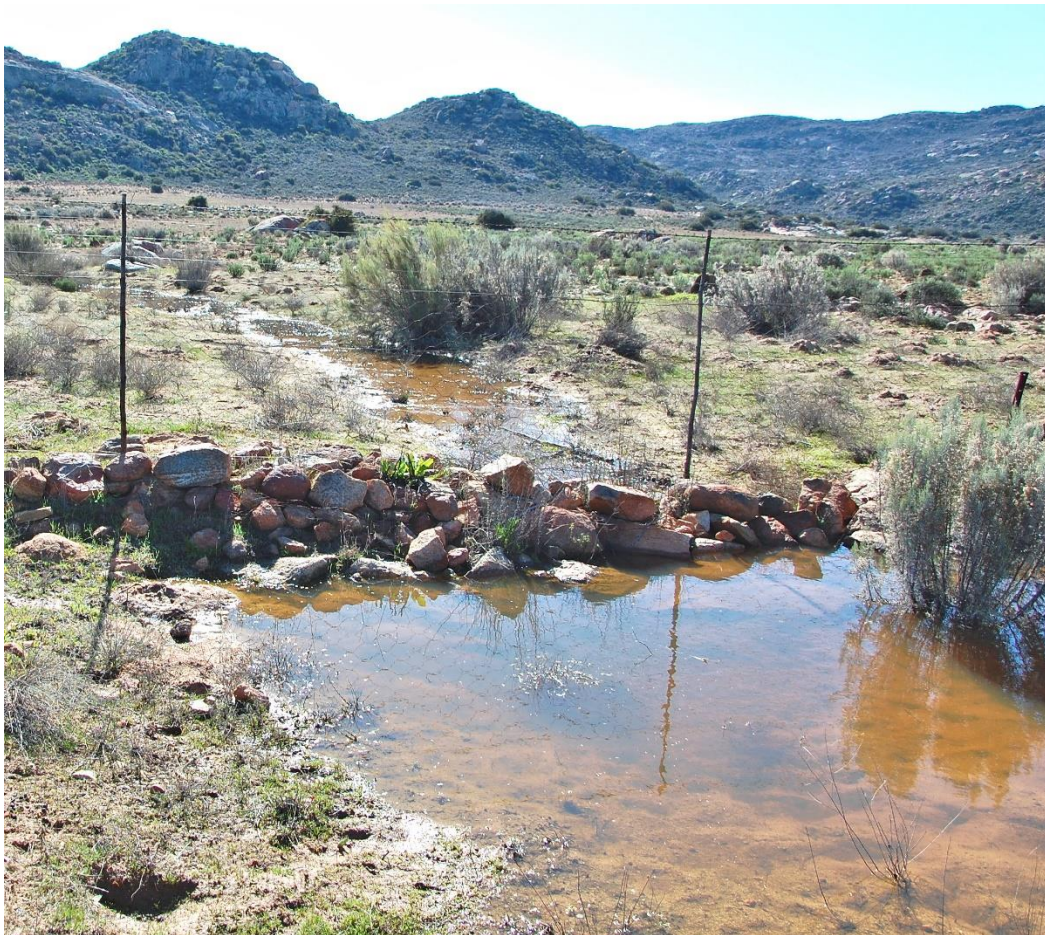
Figure 8 Flow at the fence

Water was running in the otherwise dry drainage line next to the fence (Figure 8) as well. The pool here had many tadpoles.

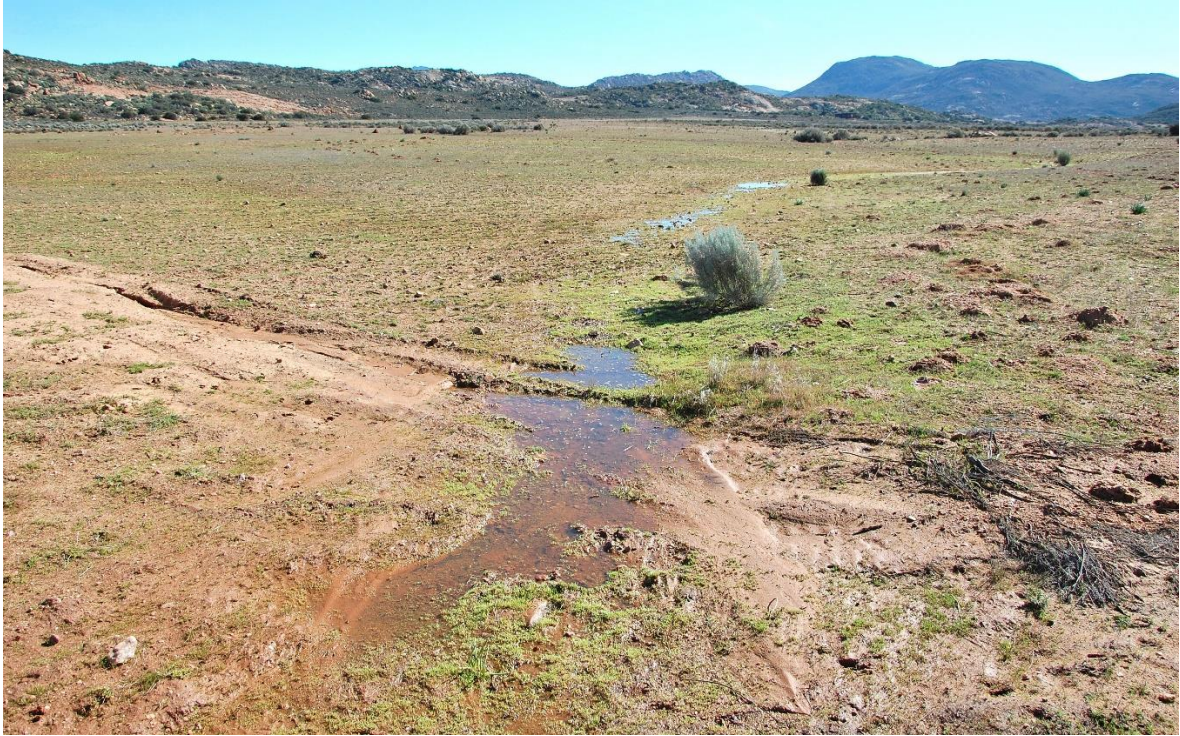
Figure 10 Small drainage line

The level areas between the rocky outcrops have been utilised as rooibos tea fields for many generations of farmers. A faint drainage line is visible of Google Earth right through such a field (Figure 9). During the site visit water was running down this drainage line (Figure 10).

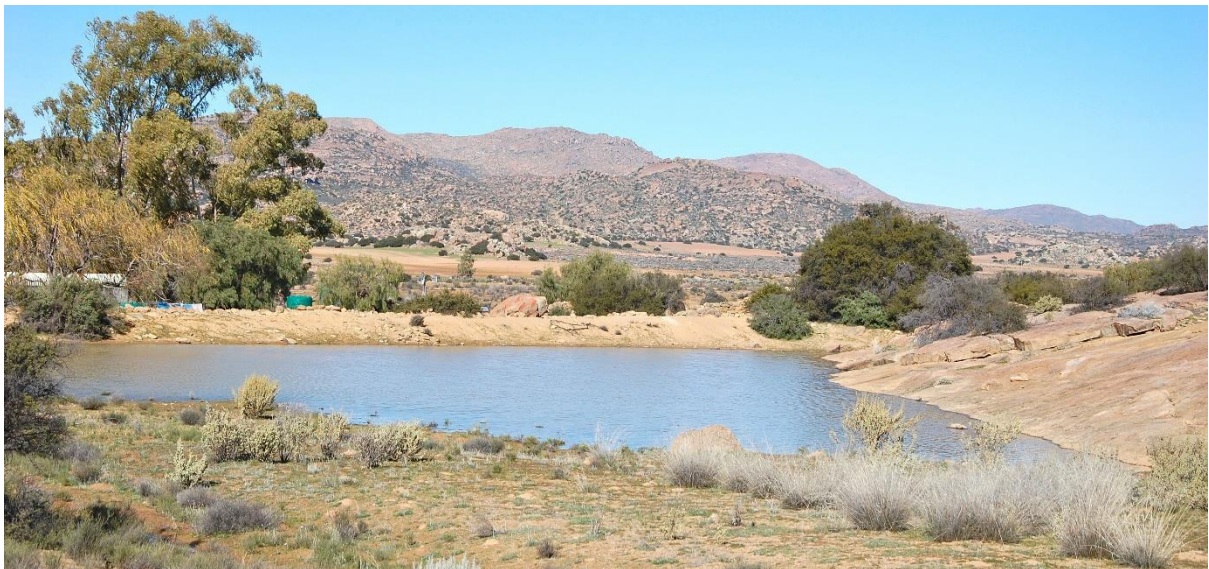
Figure 11 Farm dam

Likewise, there was a small drainage line emanating from the rocks that ended up in a small farm dam (Figure 11). This drainage line carved itself a new flow path down a farm road (Figure 12). The flow was swiftly and manually redirected into the dam (Figure 13) instead of running down the farm road.

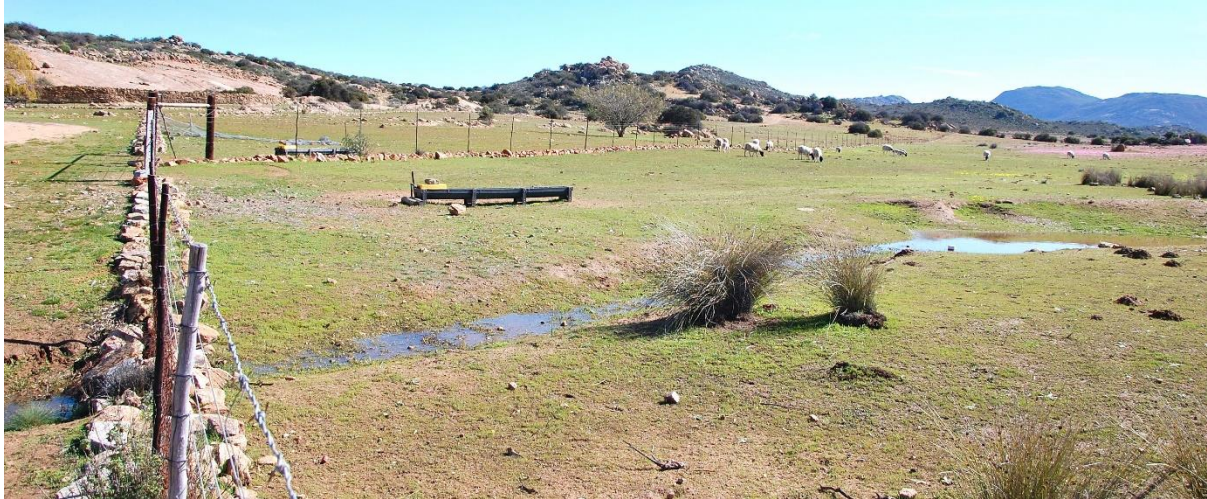
Figure 14 Fountain

The ample rains brought a fountain (Figure 14) back to life, with a trickle of water flowing out of it. Previous farmers of this land dug a pit to get to the to this sparse underground water.

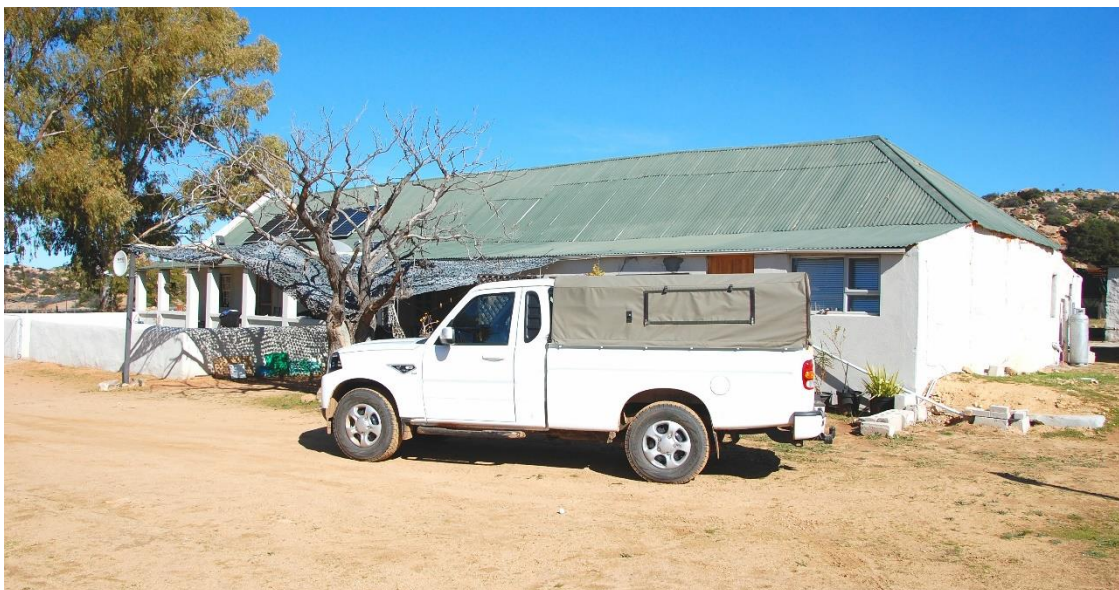
Figure 15 Existing dwelling

Existing infrastructure includes a dwelling at the southern corner of the property (Figure 15 & 16).

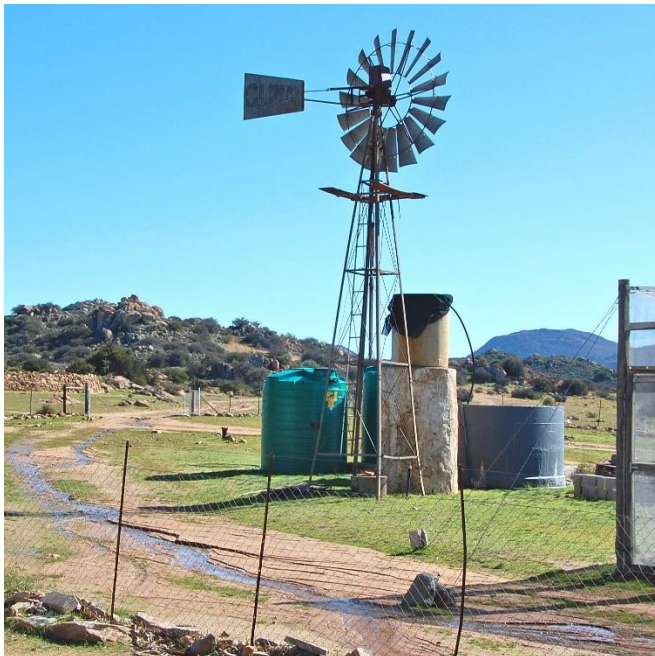
Figure 17 Borehole

Figure 17 depicts the borehole and windmill to the north of the farmhouse.

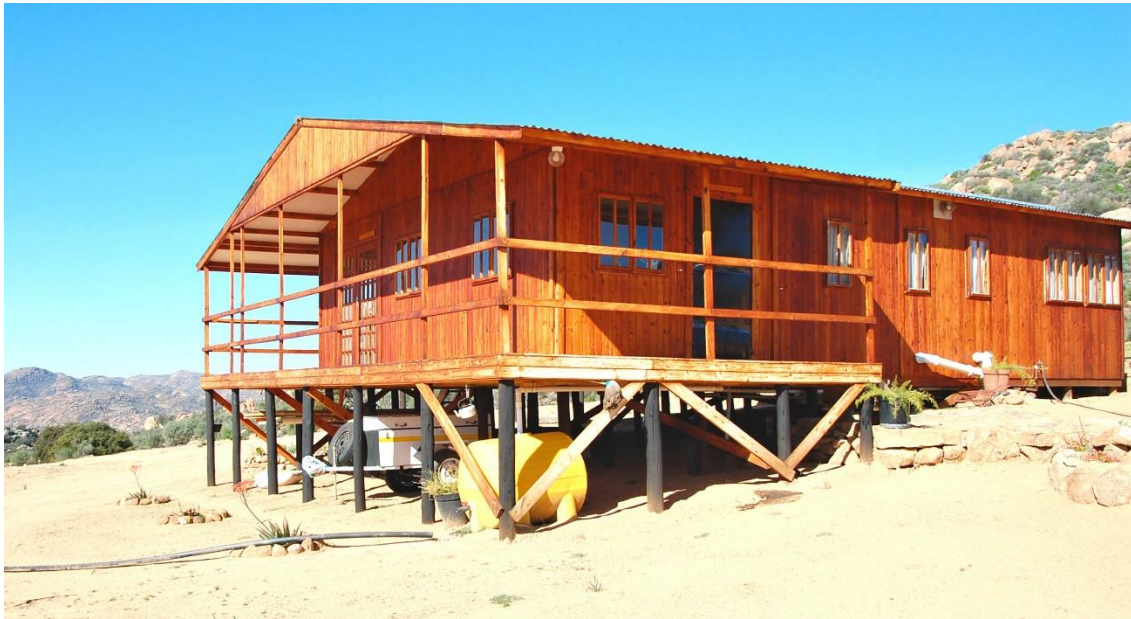
Figure 18 Log Home

There are some log homes as well (Figure 18).

According to plan 7 or 8 of these homes will be added. There will be a wedding and conference facility in the far southern part of the demarcated area. This represents the entire project as no more homes are to be constructed.

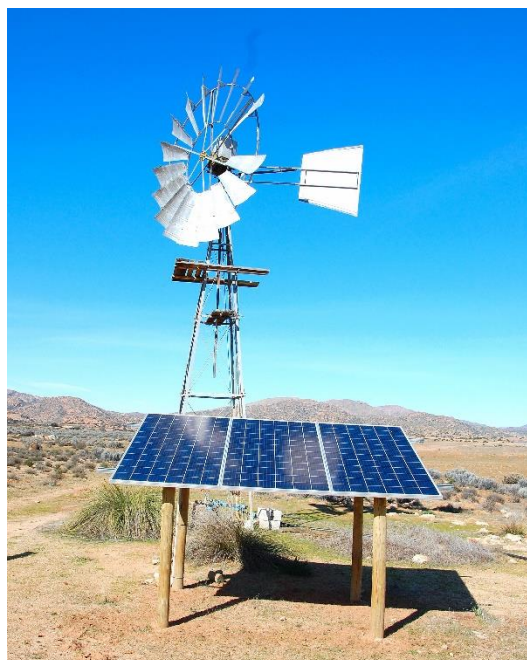
Figure 19 Borehole

The water provisioning consists of 3 boreholes provided with windmills. Two of them are of either side of the existing home and one is next to the eastern boundary (Figure 19).

This borehole is equipped with solar energy and a submersible pump that replaced the windmill. The abstracted water is pumped into storage tanks (Figure 20), from where it is distributed over the property. Houses are provided each with their own storage tank.

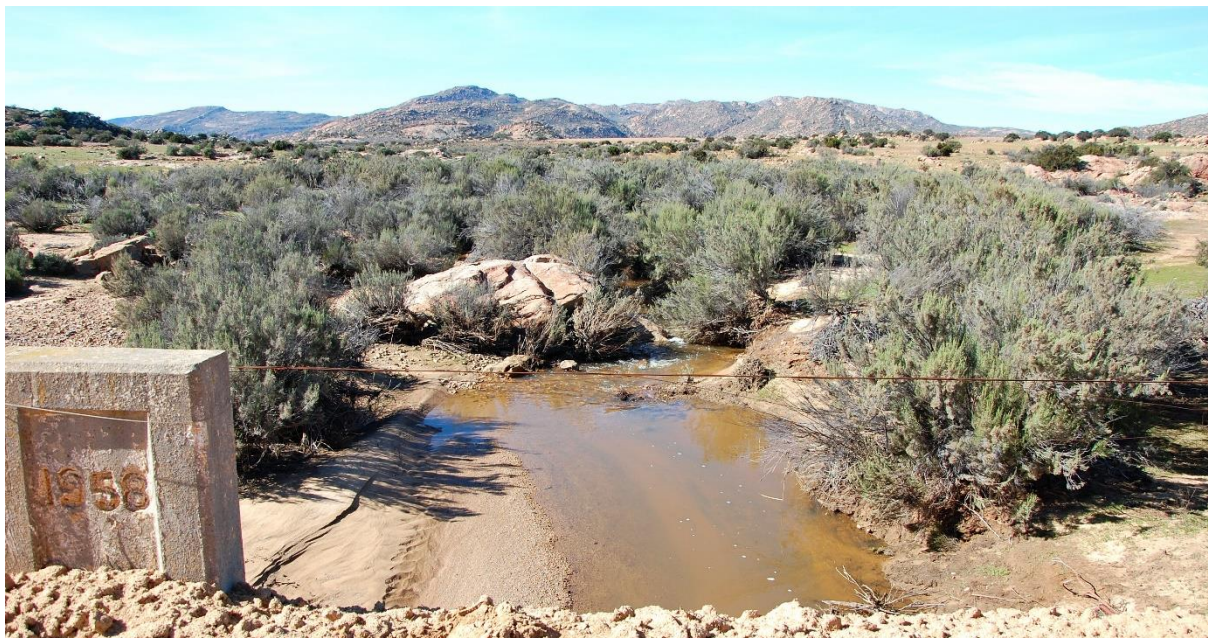
Figure 21 Buffels River at De Kuilen Farm

The Buffels River at De Kuilen was flowing strongly (Figure 21) during the site visit on 5 July 2023, which deviates from the usually dry condition. The riparian vegetation is generally higher than that of the immediate terrestrial surroundings to form an ecological corridor along the river. This vegetation is supported by shallow ground water that seems to persist over the dry period. Higher up the catchment sedges are present as well as a stand of exotic grey poplar trees (*Populus hybrid*).

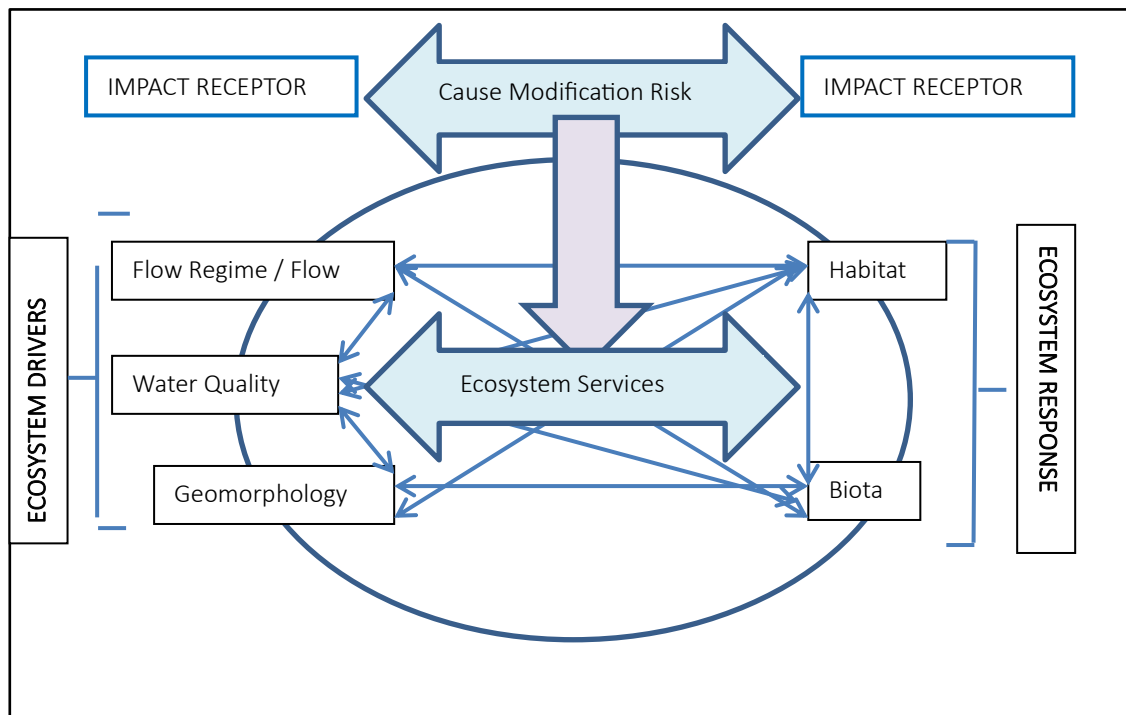
Figure 24 Minimum Requirements for a S21(c) and (i) Application.

Figure 24 has been adapted from one of the DWS policy documents.

“An anthropogenic activity can impact on any of the ecosystem drivers or responses and this can have a knock-on effect on the other drivers and responses. This, in turn, will predictably impact on the ecosystem services. The WULA and the EAI must provide mitigation measured for these impacts.”
