**SHABBY FUFU
LIFESTYLE FARM & RESTOURANT
Garden Route
Plettenberg Bay**

Freshwater Report
for the
Shabby Fufu Farm Stall

A requirement in terms of Section 24G of the National Environmental Management Act
April 2024

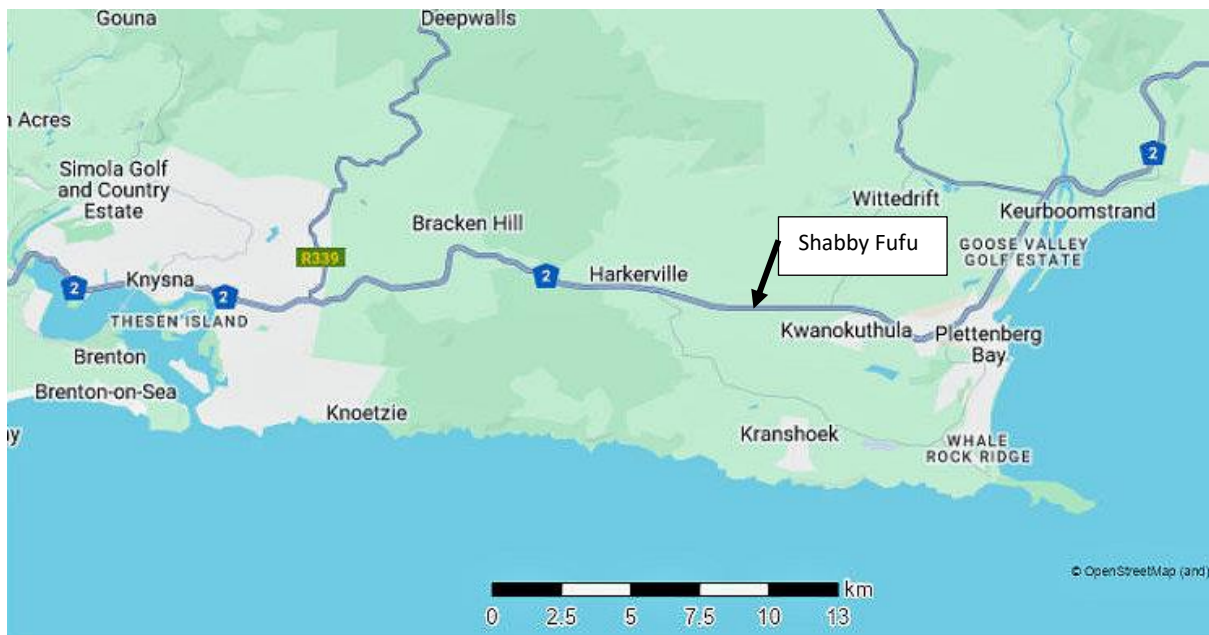
Figure 2 Location

Shabby Fufu is located 9.4km on the N2 trunk road to the west of the Plettenberg Bay seaboard (Figure 2).

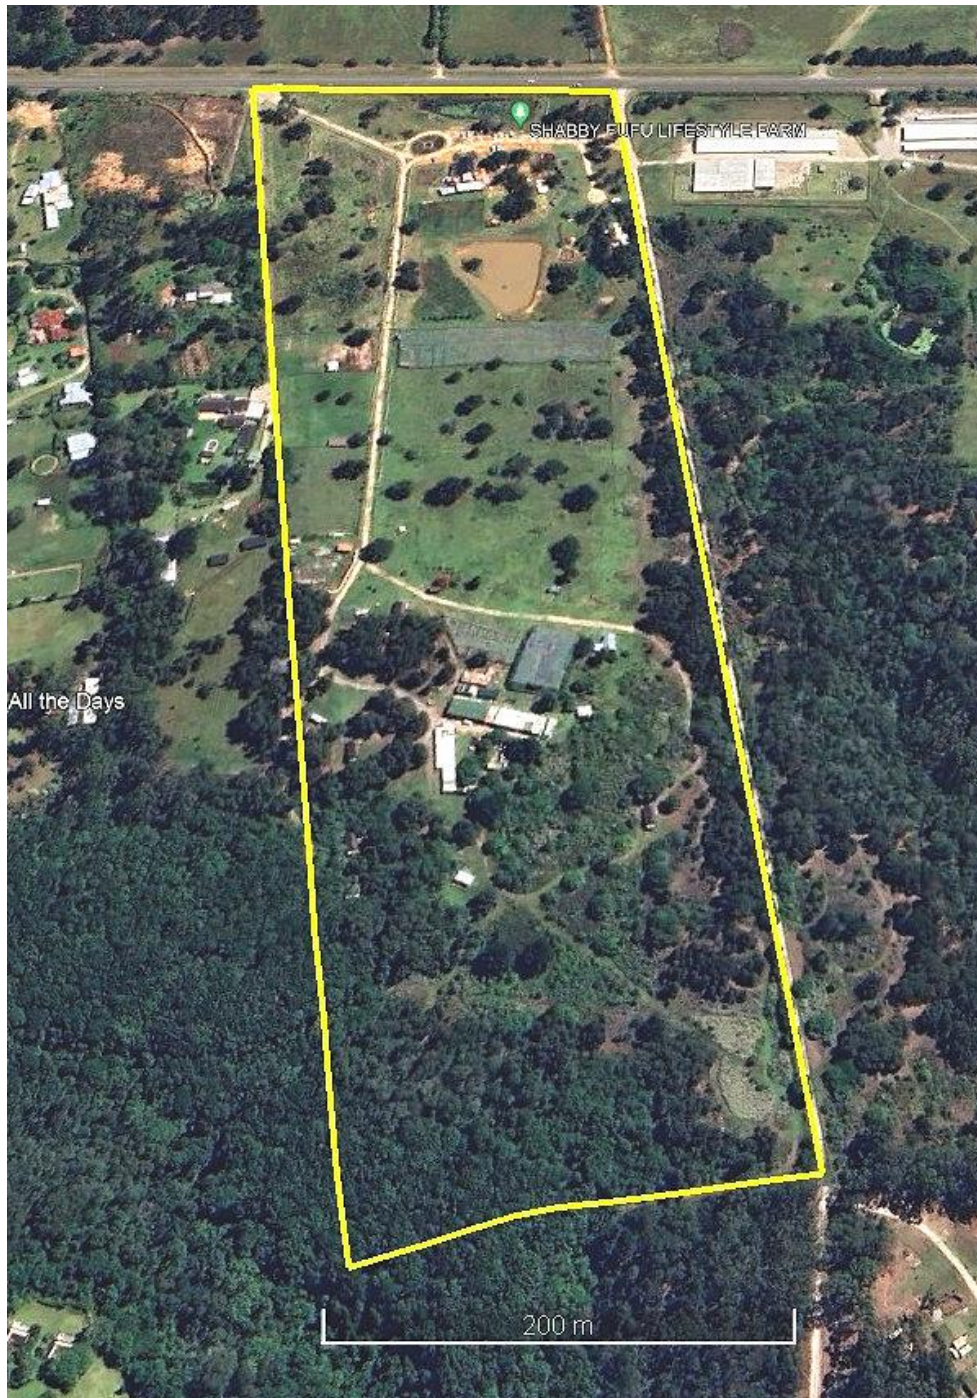
Figure 3 Shabby Fufu site

This site is on the N2 along the Garden Route between Knysna and Plettenberg Bay. It is 16.5ha in size, approximately a rectangle to the south. There is a shopping complex and restaurant focussed on the tourist industry next to the N2 on the premises, as well as a small protea garden.

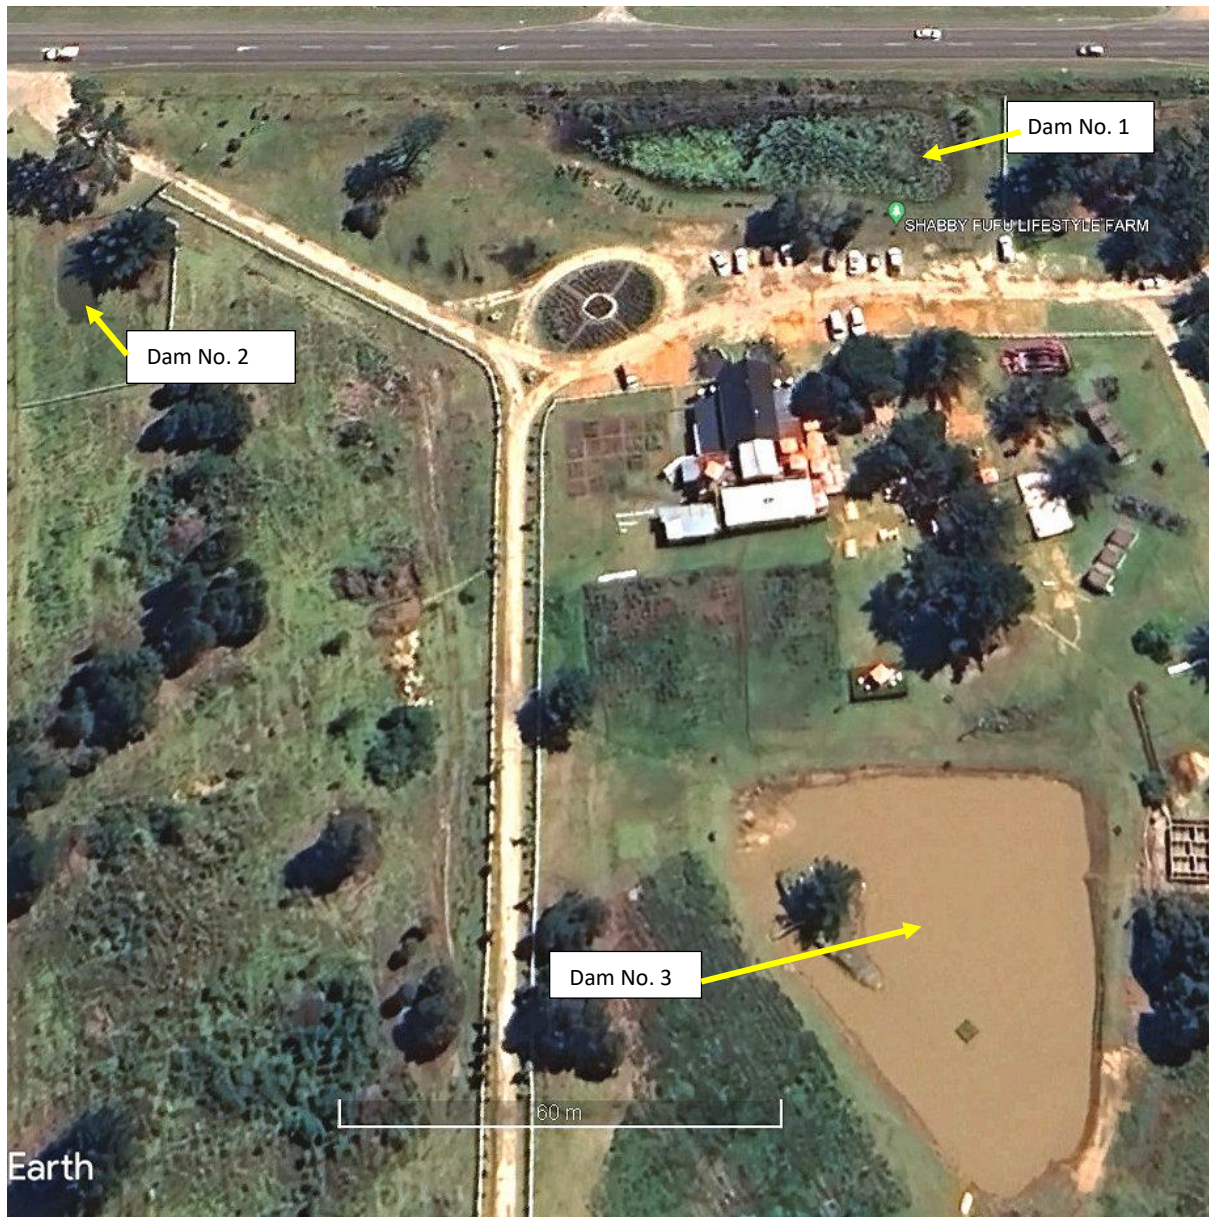
Figure 4 Dams

The dams on the property are shown in Figure 4.

There are three dams on the site. The one closest to the N2 was overgrown with emerging and submerged vegetation, suggesting that this is ideal habitat for the SANBI listed aquatic species. This was during the site visit on 22 May 2023. The dam seemed to be dry on the Google Earth Image dated 28 November 2022. Many aquatic organisms can cope with temporary dry conditions. Dry conditions do not rule out viable aquatic habitat.

There is another small dam next to the N2. During the site visits, a number of geese made this dam their home. This dam does not constitute ideal aquatic habitat for the listed aquatic species.

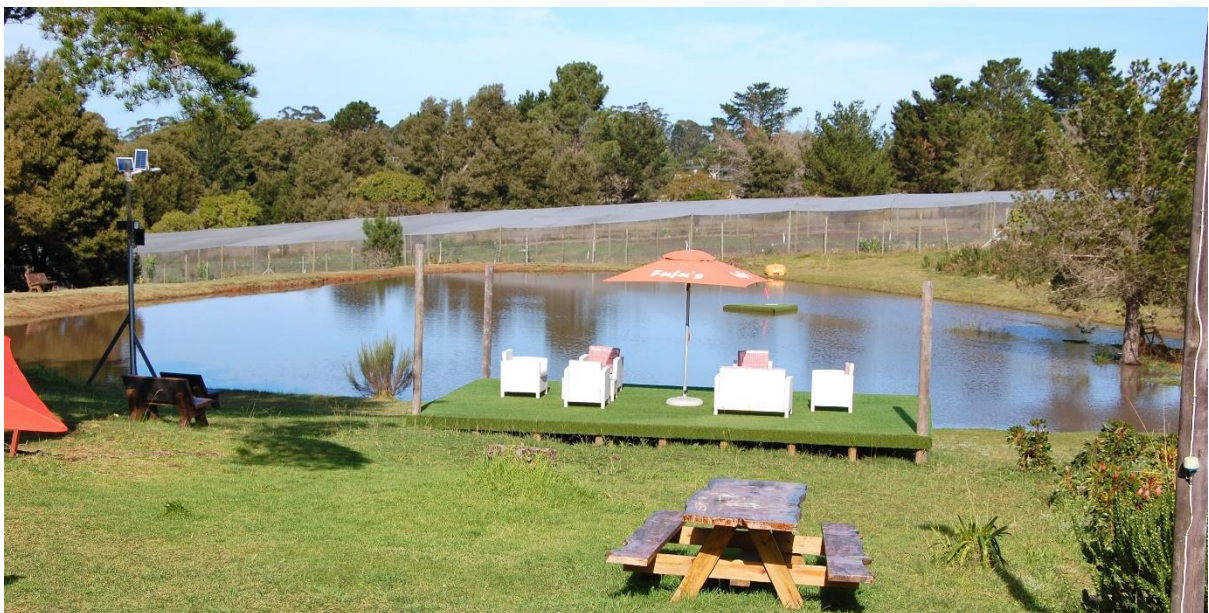
Figure 7 Dam No. 3

Neither does the large dam on the property. This dam is there for the ambiance of the restaurant and surrounds as well as for irrigation. Dam No. 3 (Figure 7) is the largest of the three dams and is the one that triggered the Pre-Compliance Notice. It has a surface area of only 2100m² and a volume of 3150m³. This is an instream dam.

There is no pump on Dam No.3. The water is only there to create a sense of place, for the tourist industry, for recreational purposes. The garden is watered out of a borehole, not out of the dam.

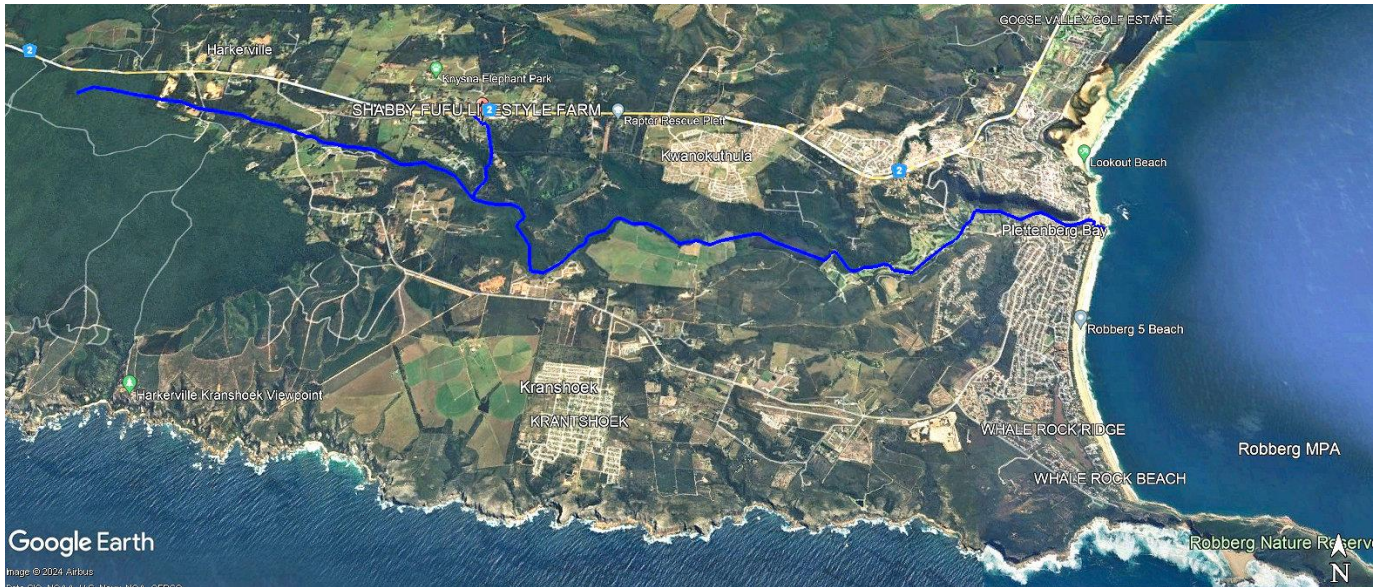
Figure 8 Piesang River

The Piesang River (Figure 8) is a small coastal river that rises in the Tsitsikamma Forest to the south of the N2 highway on an elevation of 268masl. This is one of several small rivers that rise to the south of the Tsitsikamma Mountains that end up in the Indian Ocean. The Piesang River is 19.2km long and enters the ocean through a small, mostly closed estuary at in Plettenberg Bay at the Beacon Isle Hotel, a very well-known landmark. The estuary is a centrepiece for tourism.

The Piesang River runs for most of its length over developed and partly developed land, with patches of the original forest still intact. Farm dams dot the area, with a bigger instream dam just to the west of Plettenberg Bay. The river is heavily impacted by rural development and by agriculture. Apart from the Tsitsikamma Forest on the high ground, the land is much disturbed. The riparian sone is mostly black wattle and other invasive vegetation.

Overflow out of Dam No.3 flows further down the incline, mostly along a farm road, then into a valley and finally into the Piesang River 1.7km downstream.

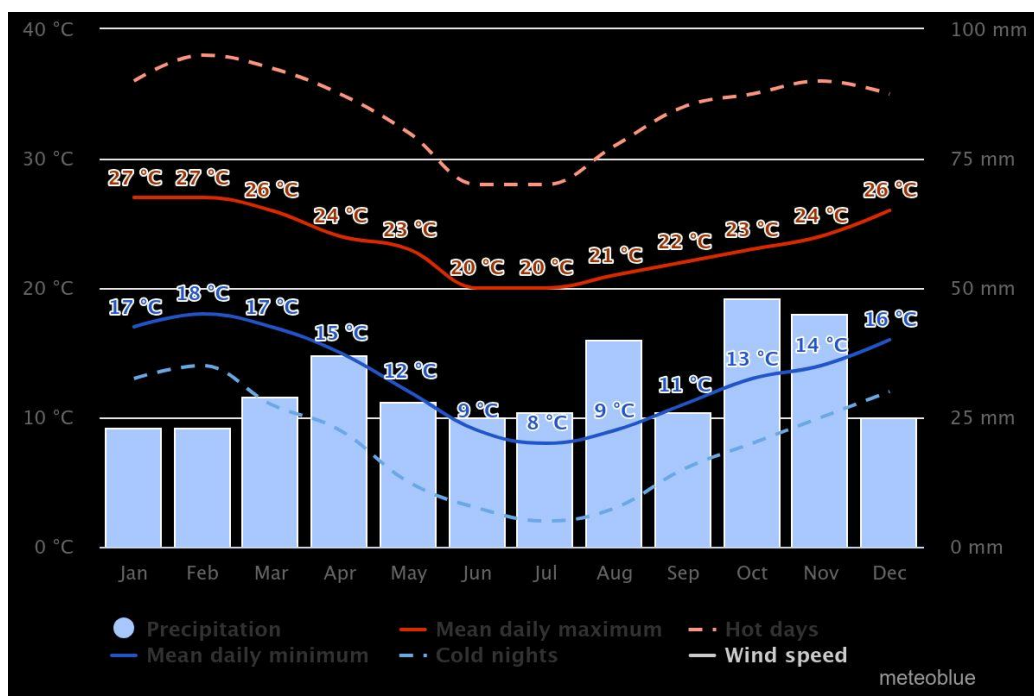
Figure 9 Plettenberg Bay Climate

Plettenberg Bay is the closest location for which online climate data is available. It rains throughout the year, with October and November the wettest months.

The average annual rainfall amounts to 680 mm.

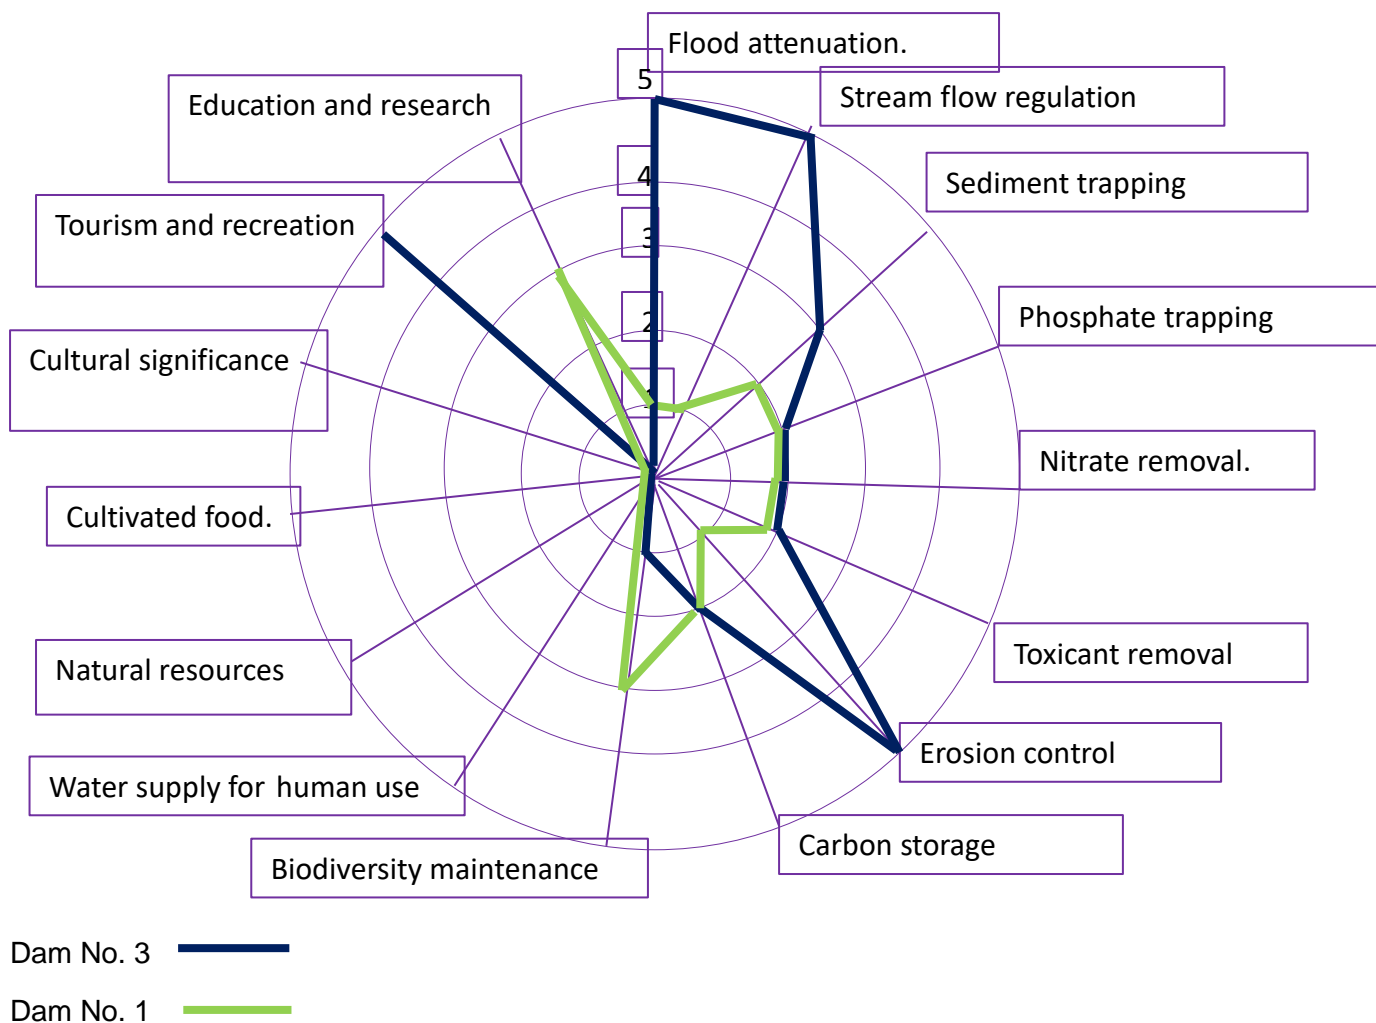
Figure 10. Resource Economics Footprint of Dam No.3

A large resource economics footprint would attract the decision-making authority’s attention.
