Diemersfontein Cell Phone Tower

on Farm 1756 Paarl Road Western Cape

Compliance Statement

DFFE Screening Tool
Aquatic Biodiversity Theme

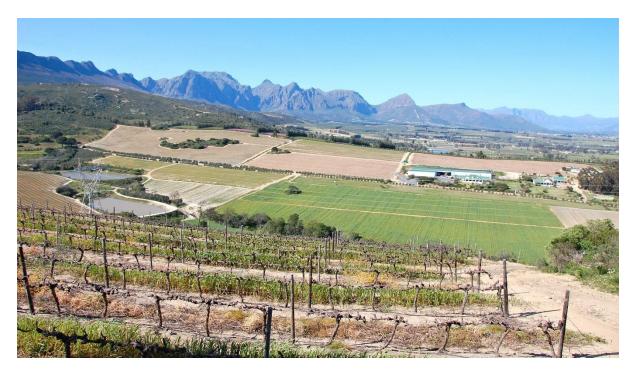
Figure 4 View to the south

The cell phone tower will be erected on a granite elevation, a rocky outcrop, at 252masl overlooking the valley to the south (Figure 4). The outcrop is somewhat higher than the more level land to the north (Figure 5). It is evident from the photographs that this is mountainous country with deep valleys and steep slopes.

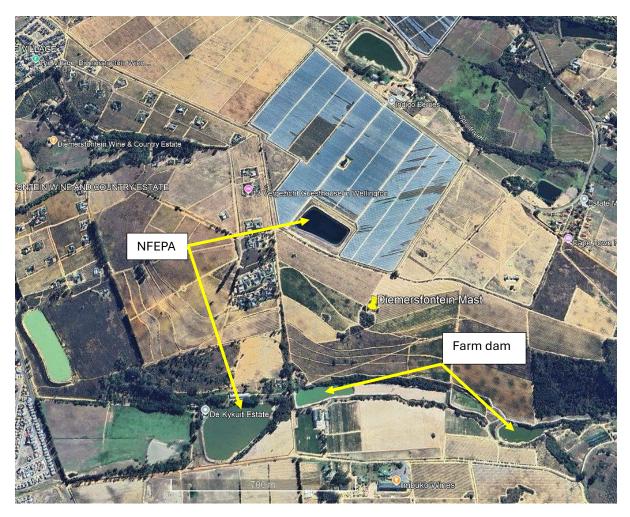
Figure 7 Farm dams

This is a wine-producing area, in the heartland of the Western Cape's winelands, with much of the available agricultural land with vineyards. The landscape is dotted with numerous irrigation dams (Figure 7), with literally all the streams coming out of the mountains heavily altered. Some of the dams are listed as NFEPA's.

The dams are outside of the NEMA-specified 32m controlled zone. Likewise, the stream (Figure 7) that connects the farm dams to the south of the cell phone tower site is further away than 32m.

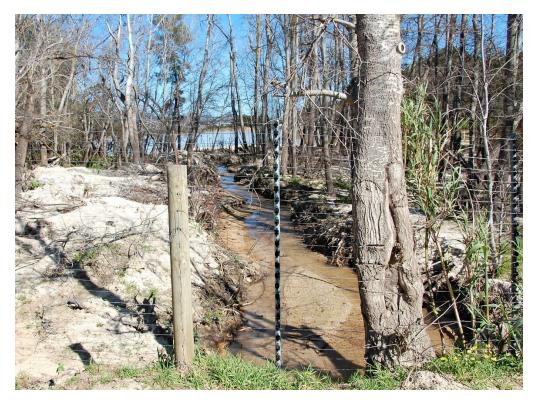
Figure 8 Stream

The stream rises on the high ridges and peaks of the mountains to the east of the site, where the rainfall is high, up to 1500m per year and even higher. The stream is reduced to a trickle in summer, when little if any rainfall occurs. It swells to a torrent during the winter rainfall season and during high rainfall events.

The stream is natural and not impacted high up the slopes of the mountain but is highly modified from the foot of the mountain downhill. The situation on Farm 1756 is not any different (Figure 8). It is engineered into a channel. It is overgrown with alien invasive trees such as black wattle and port Jackson. In places the landowner planted indigenous trees such as olienhout (wild olive, *Oleo europaea* variety *africana*).

As has been indicated before, this stream is more than 32m away from the proposed cell phone tower site.

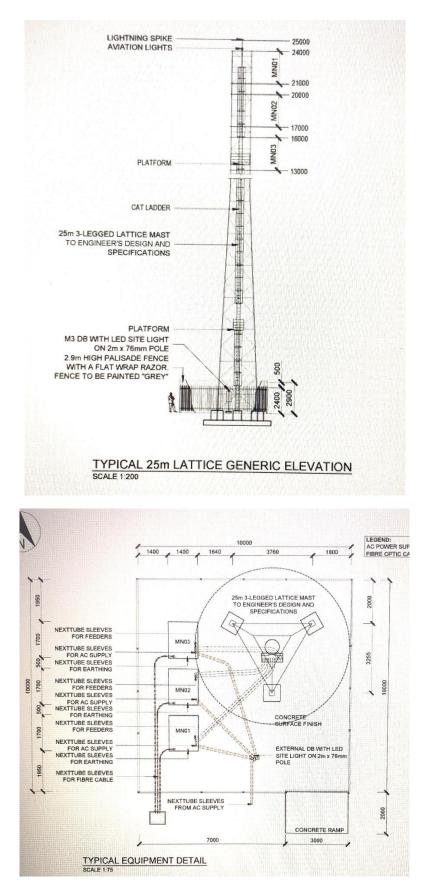
Figure 9 The Mast (Sheobalak Engineering, Umhlanga)

The proposed mast (Figure 9) will be 25m high, a typical steelwork lattice on a concrete foundation. The footprint will be 10m x 10m.
