Raisins

Fresh Water Report for the proposed new vineyard on **Plot 1181, Kakamas**

A requirement in terms of the National Water Act (36 of 1998).
June 2024

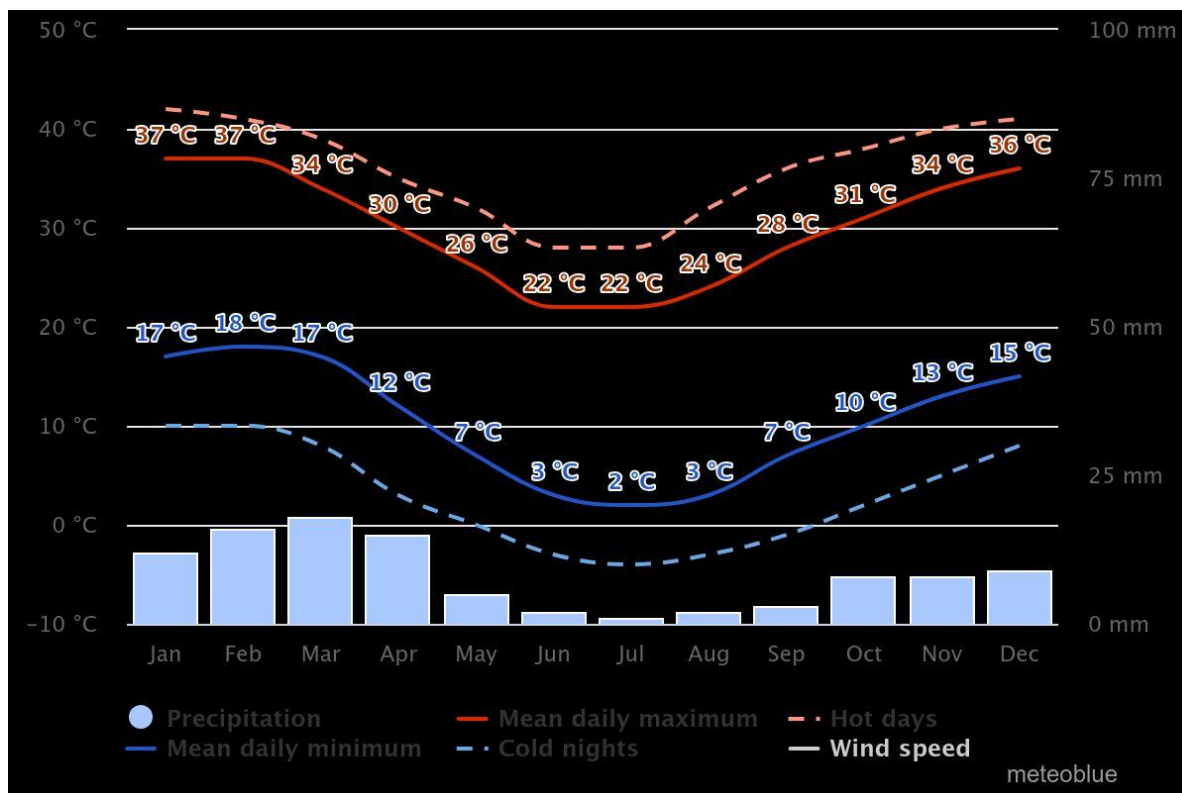
Figure 2 Climate Kakamas

Kakamas normally receives about 62mm of rain per year, with most rainfall occurring mainly during summer (Figure 2). The summers are exceedingly hot, with maximum temperatures well into the 40's. Overnight temperatures in winter can drop below zero. This is a harsh desert-like climate with extreme temperatures and very little rain.

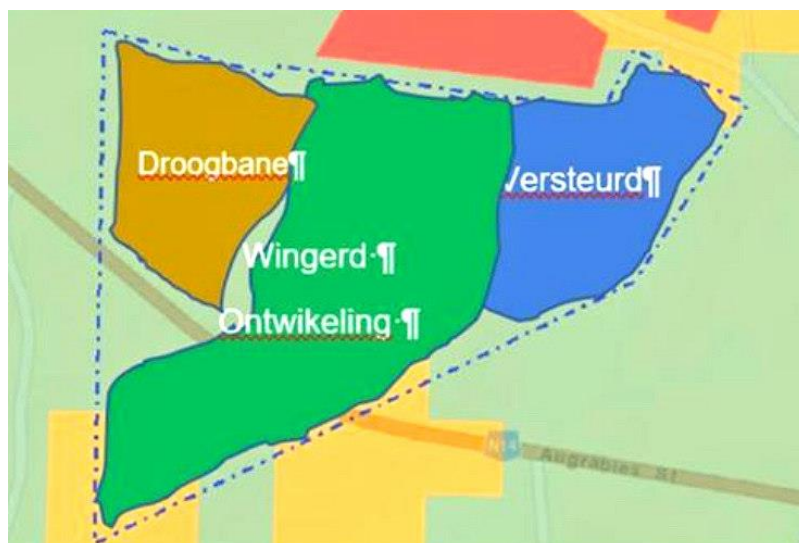
Figure 4 Development

The proponent supplied the above image (Figure 4) to indicate the area that stands to be developed. Only the brown area will be under new vineyard. For the time being, the blue area is not on the cards for development. This is where the drainage line crosses the property. If ever this part is to be developed, a buffer zone of either side of the drainage line must be preserved and not be developed.

The red part will be under a raisin drying facility. This is typically raised drying racks in the blazing sun (Figure 5). Importantly, the permeability of the ground underneath is not affected by these drying racks. The racks are used only following the harvest and once the grapes turned into raisins, the racks lie idle for the rest of the year.

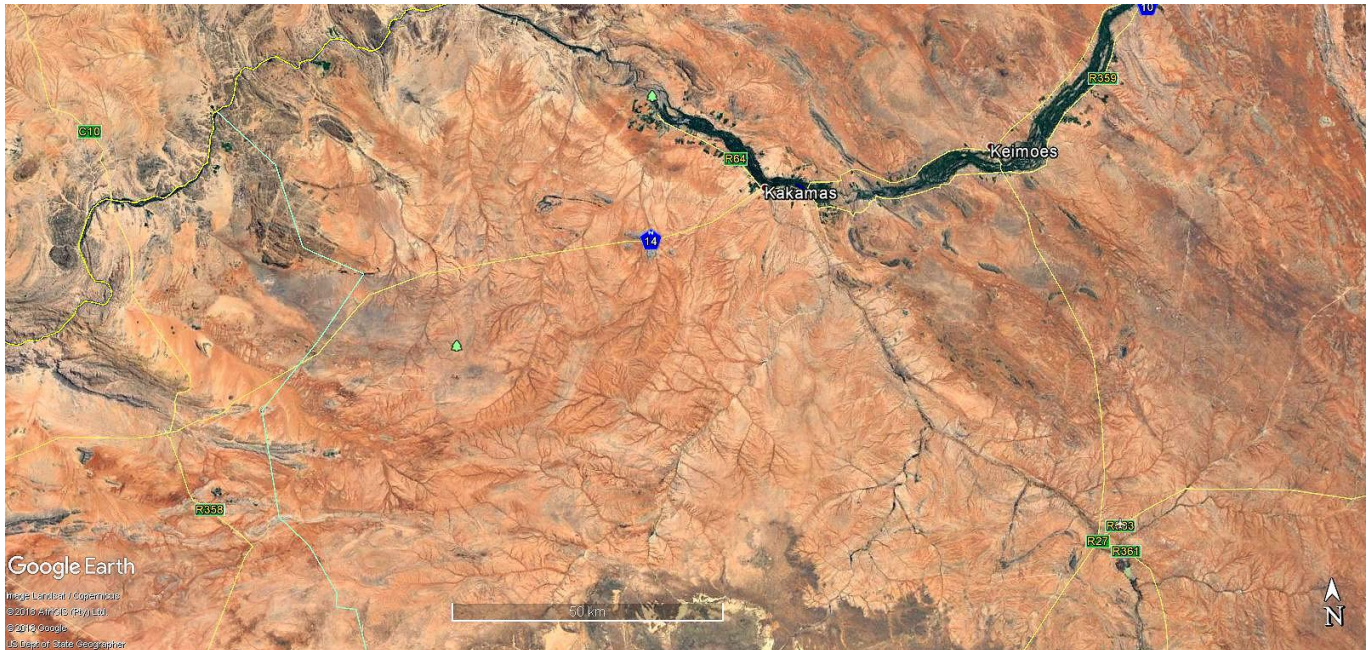
Figure 6 Drainage Lines

The landscape around much of the Lower Orange River and the Sak River is dominated by a dense succession of drainage lines. They spread along the river with many smaller tributaries to cover the entire area. The iron oxides in the sands renders a red hue that is visible from space on the Google Earth images. These reds are concentrated in the drainage lines, making them even more visible (Figure 6).

Smaller drainage lines all over the landscape are marked by lines of driedoring (*Rhigozum trichotomum*) rather than red iron oxide depositions. These woody and thorny bushes find more soil moisture along the drainage lines than elsewhere, hence the denser stand. These small lines are visible on Google Earth images. This landform can be described as drainage line wash fields.

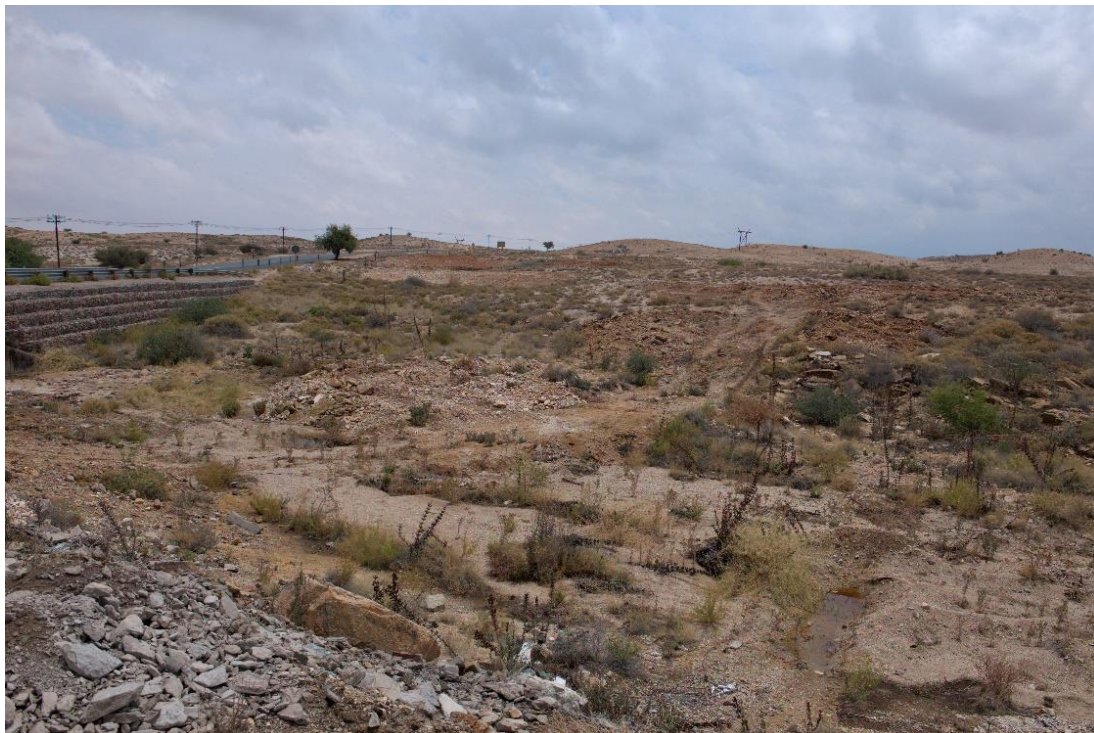
Figure 8 Path through drainage line

Upstream from the vineyards along the Orange River, next to the N14, there is a path through the drainage line (Figure 14). In this area the drainage line is degraded by litter and building rubble. At this locality the large embankment and N14 culvert can be observed (Figure 8).

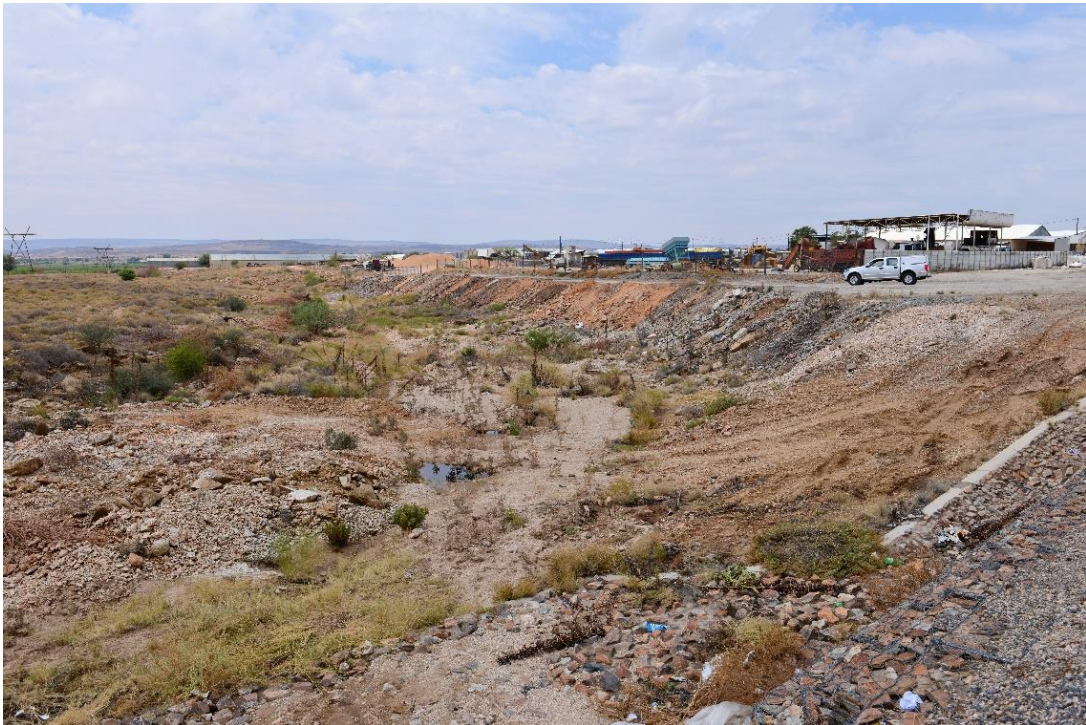
Figure 10 Infilling of bank

Looking downstream the left bank along the Kakamas industrial district has been heavily impacted by infilling (Figure 10). The opposite bank is still more or less intact.

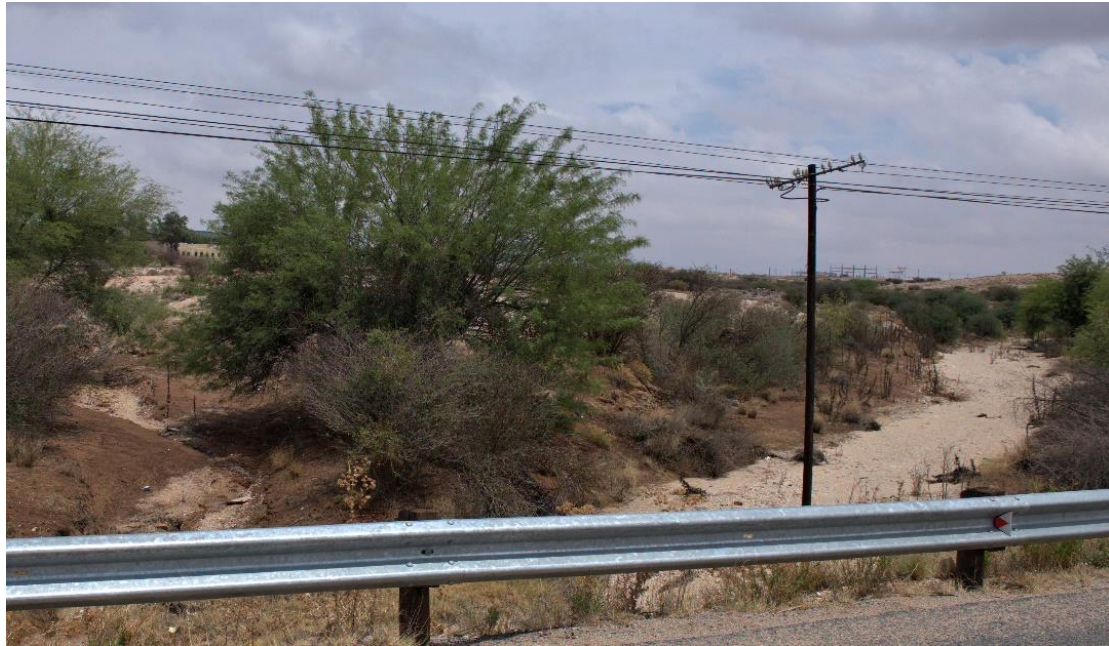
Figure 11 Drainage line upstream of N14 culvert

Two tributaries of the drainage line converge just upstream from the N14 culvert. The bed of the drainage line here is sandy (Figure 11), it is incised and the banks show signs of erosion (Figure 12), right down to bedrock level, despite the low rainfall, even slope and small catchment area.

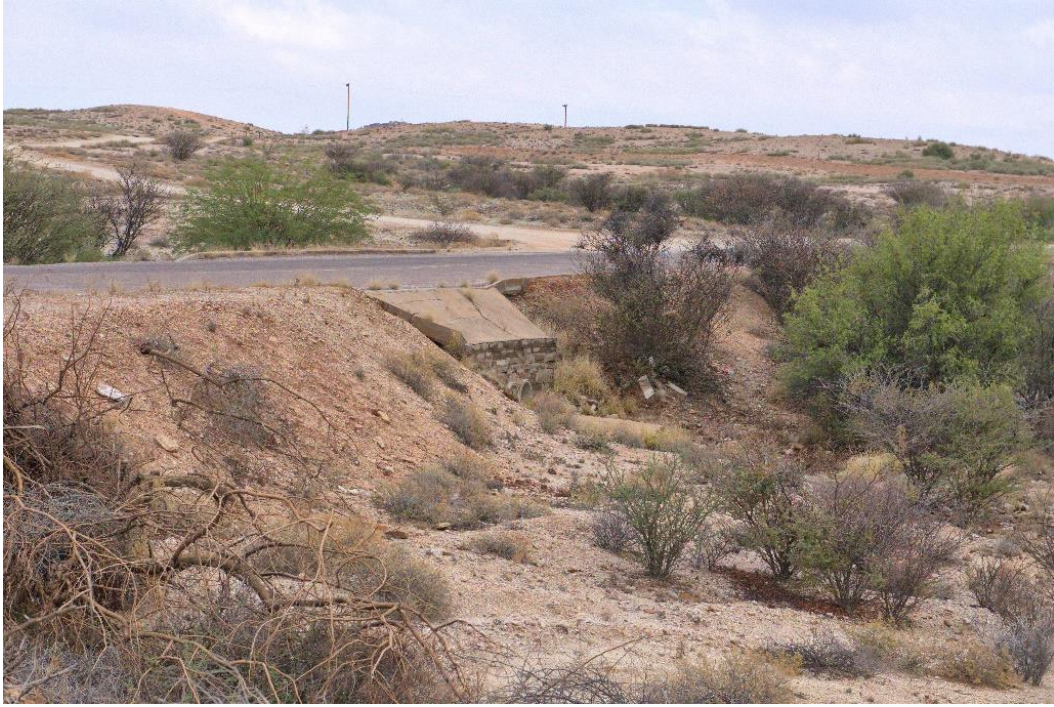
Figure 13 Storm water pipes

There is yet another road crossing the drainage line further up the catchment, that allows for flow only with a set of pipes (Figure 13). Still further up the drainage line is crossed by a number of paths and tracks (Figure 14).

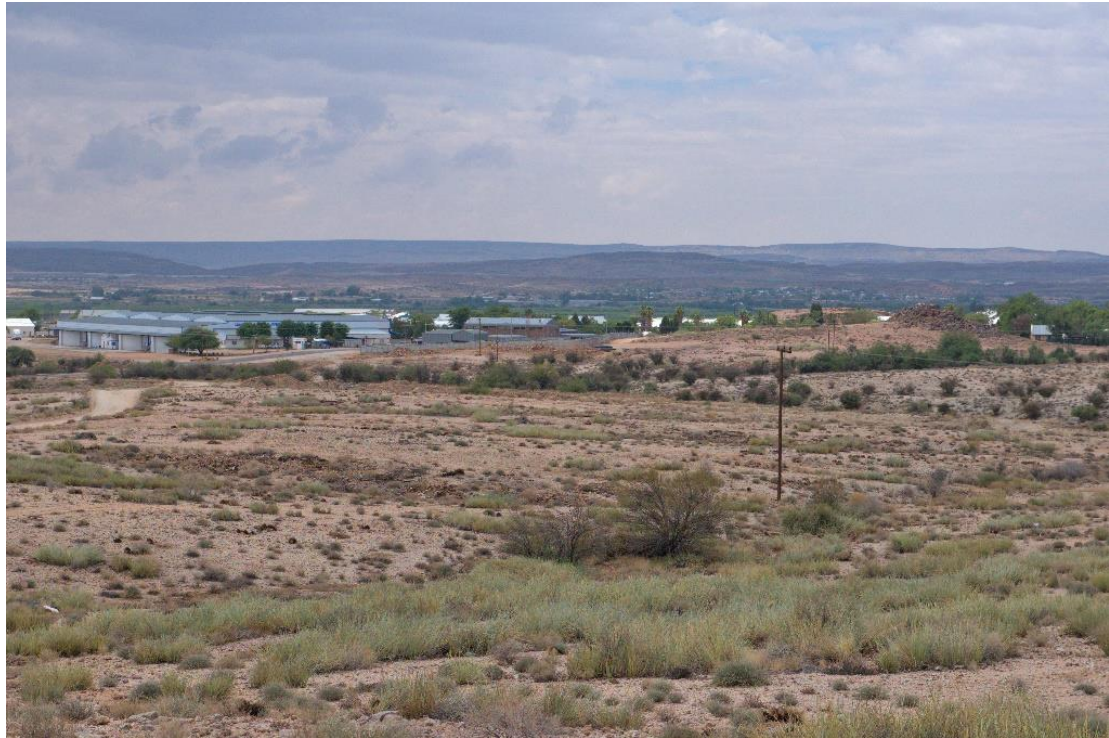
Figure 15 Upper Sub-Catchment 2

The upper reaches of the sub-catchment are less disturbed (Figure 15), with higher vegetation such as swarthaak (*Senegalia millefera*) in the riparian zones.

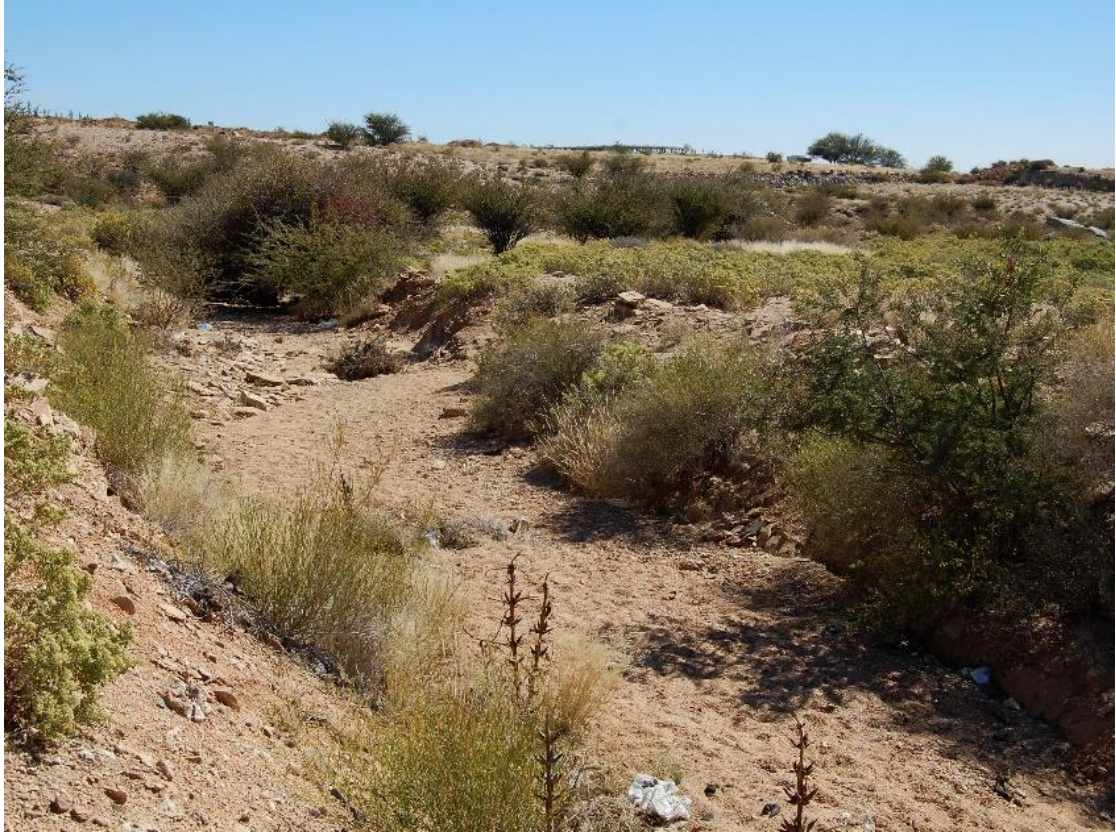
Figure 16 Drainage line downstream of the N14 road

The drainage line directly downstream of the road culvert is shown in Figure 16.

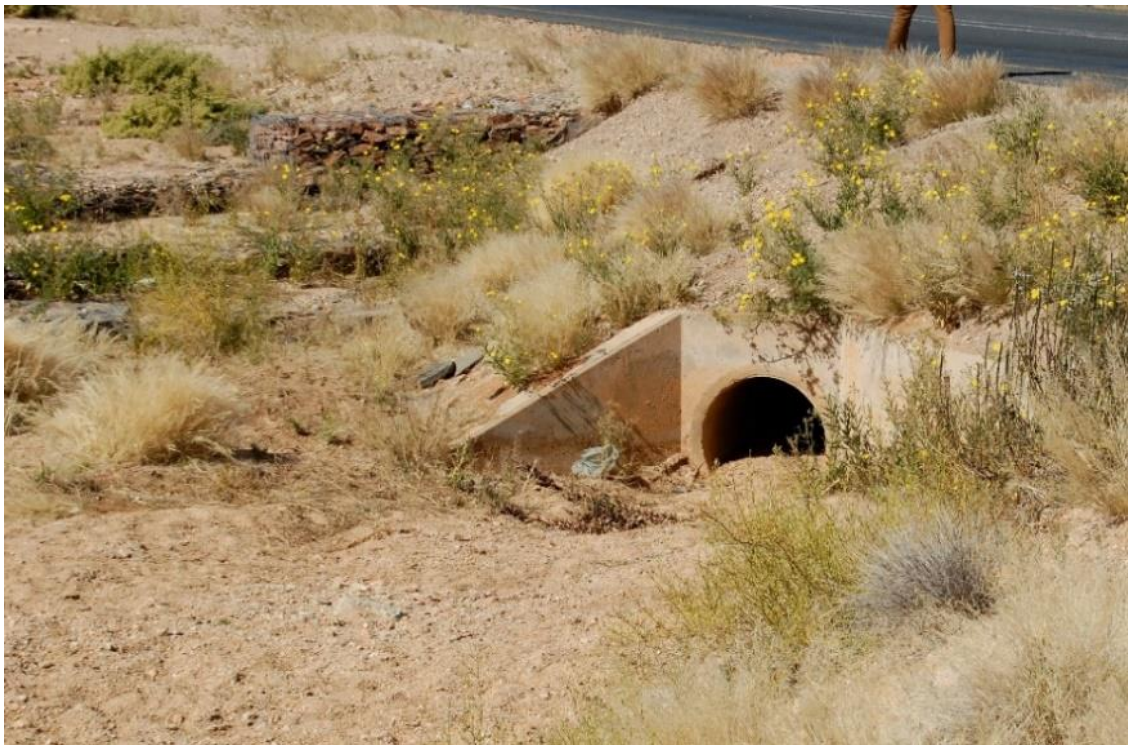
Figure 17 Culvert

The drainage line passes under the N14 trunk road with a culvert (Figure 17).

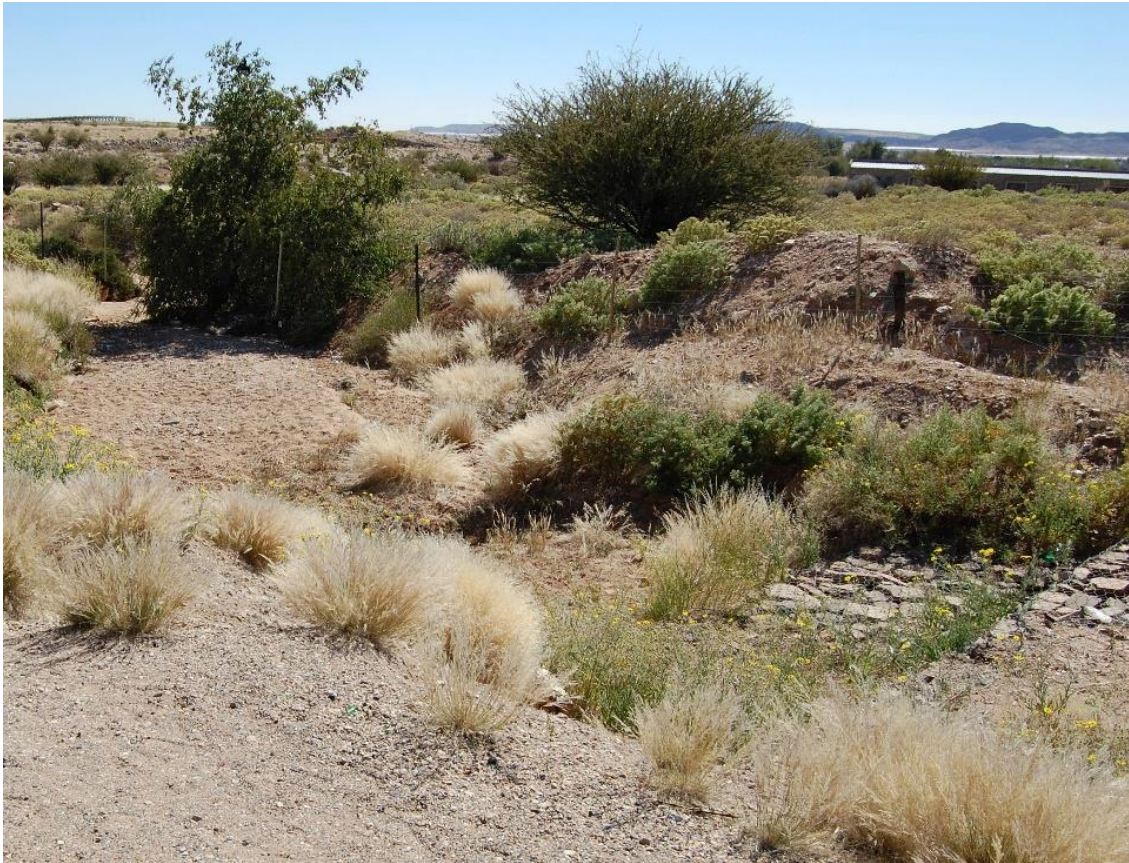
Figure 18 Gabions

The northern shoulder of the road, uphill from the culvert, has been deeply incised by running storm water. There was an attempt to stabilise the trench with gabions, but the storm water found its way around this constructed obstacle (Figure 18).

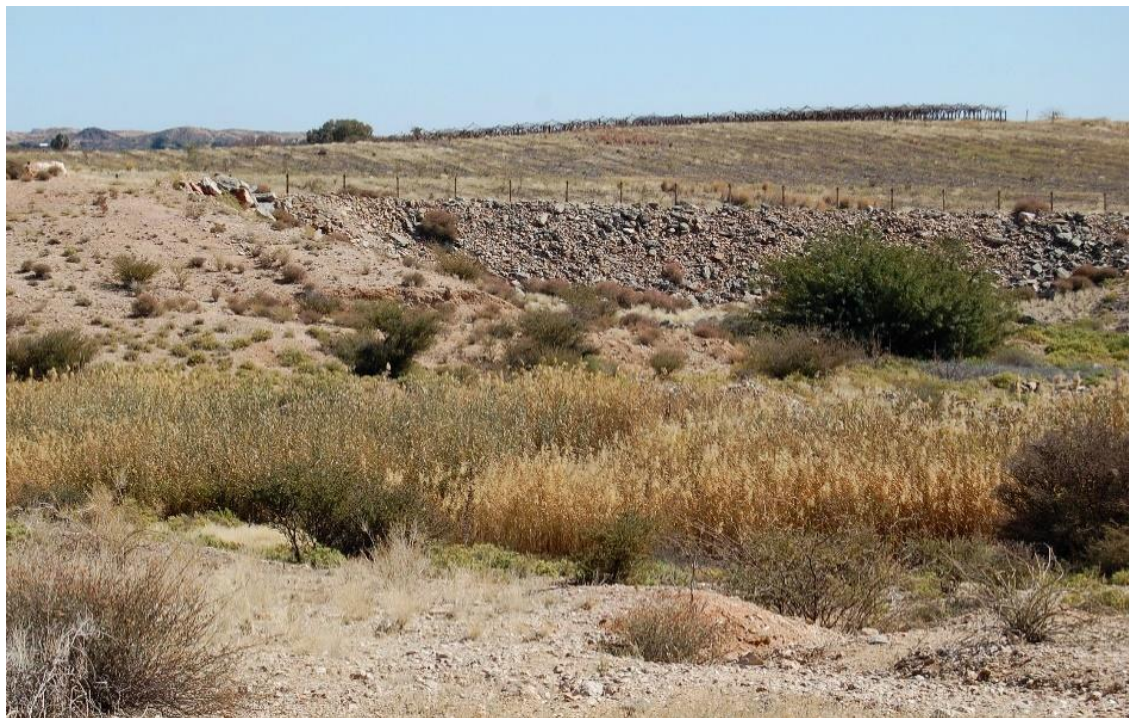
Figure 19 Reeds

A short distance further downstream the drainage line is overgrown with *Phragmites* reeds (Figure 19). These reeds have taken root here probably because of the runoff from the road, combined with some agricultural return flow. Natural, unimpacted drainage lines in the area are devoid of any reeds.

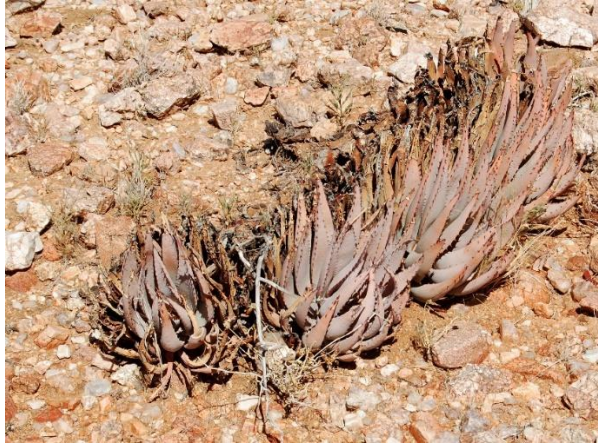
Figure 21 *Aloe claviflora*

Prior to planting, a search-and-rescue operation is to be undertaken to remove any valuable plants. These plants should then be re-planted on a suitable site to insure their survival. The only plant of such description were two small stands of aloes, *Aloe claviflora* (Figure 21). This aloe is plentiful in the region and is not endangered in any way.

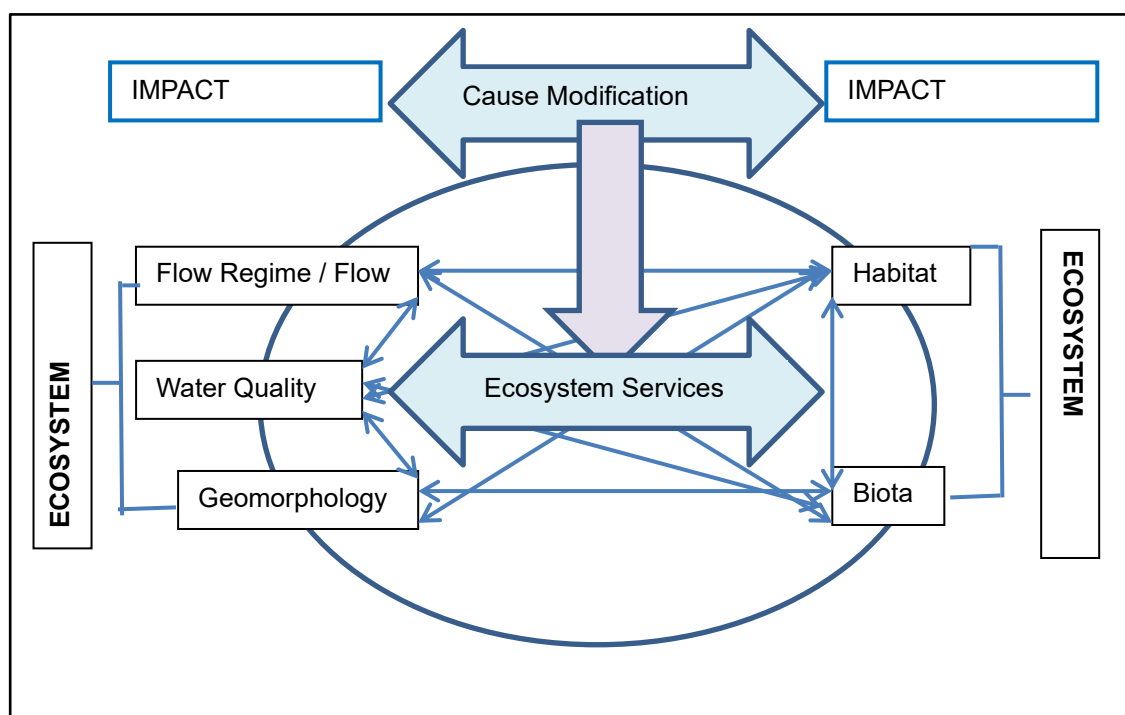
Figure23 Minimum Requirements for a S21(c) and (i) Application

Figure 23 has been adapted from DWS policy documents.
