KOTULO TSATSI ENERGY (PTY) LTD

FRESHWATER REPORT

For the construction of a water provision pipeline from the Orange River at Keimoes to the Uitkyk Farm near Kenhardt, Northern Cape

November 2022
Version 3.0 March 2024

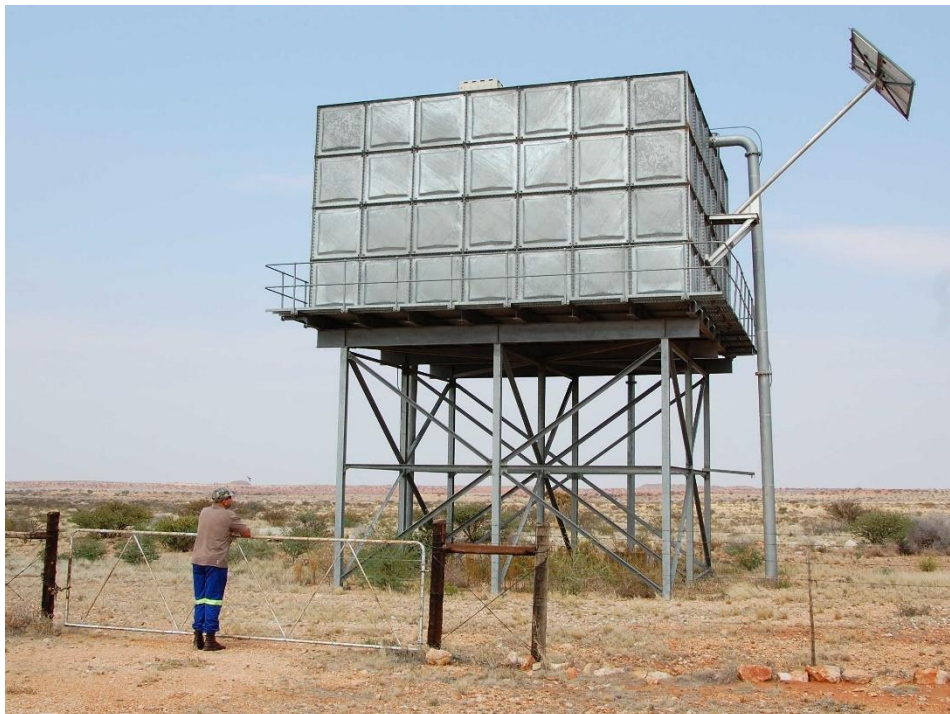
Figure 5 Piet Rooi Reservoir

An existing reservoir at Piet se Berg (Figure 5) will be upgraded with more capacity and will not be discussed any further as it is away from any drainage lines.

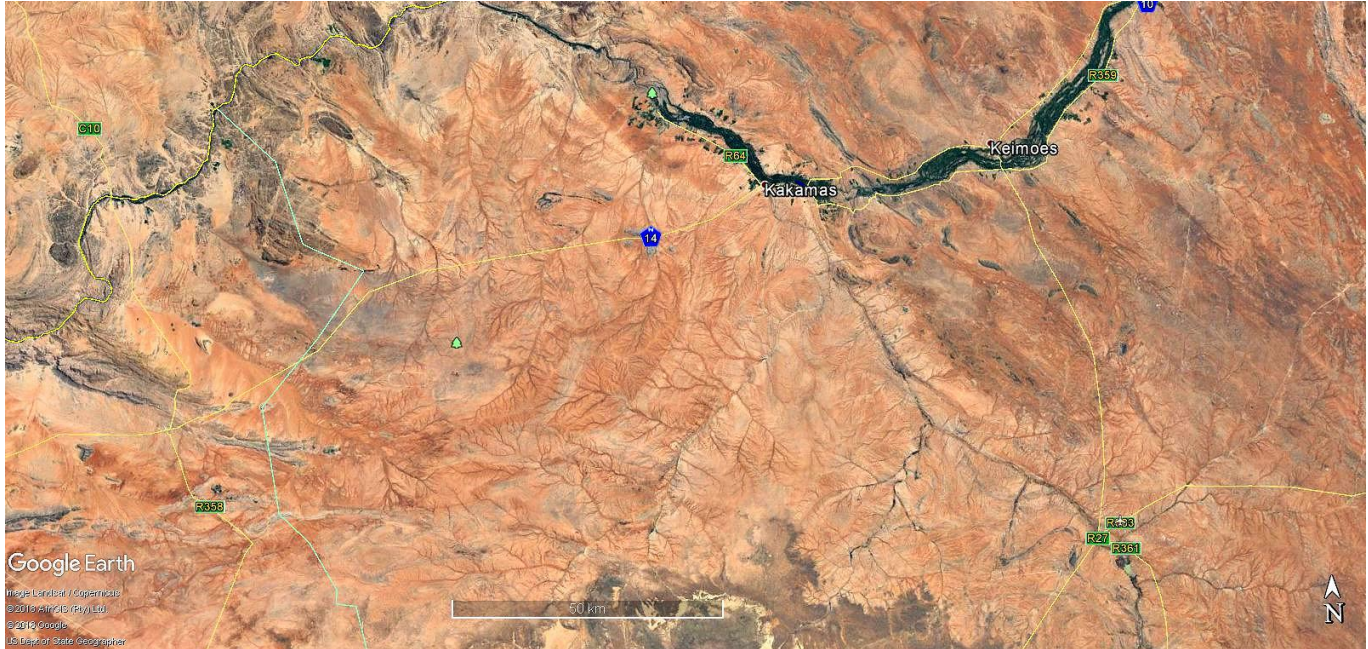
Figure 7 Drainage Lines

The landscape around much of the Lower Orange River and the Sak River is dominated by a dense succession of drainage lines. They spread along the river with many smaller tributaries to cover the entire area. The iron oxides in the sands renders a red hue that is visible from space on the Google Earth images. These reds are concentrated in the drainage lines, making them even more visible (Figure 7).

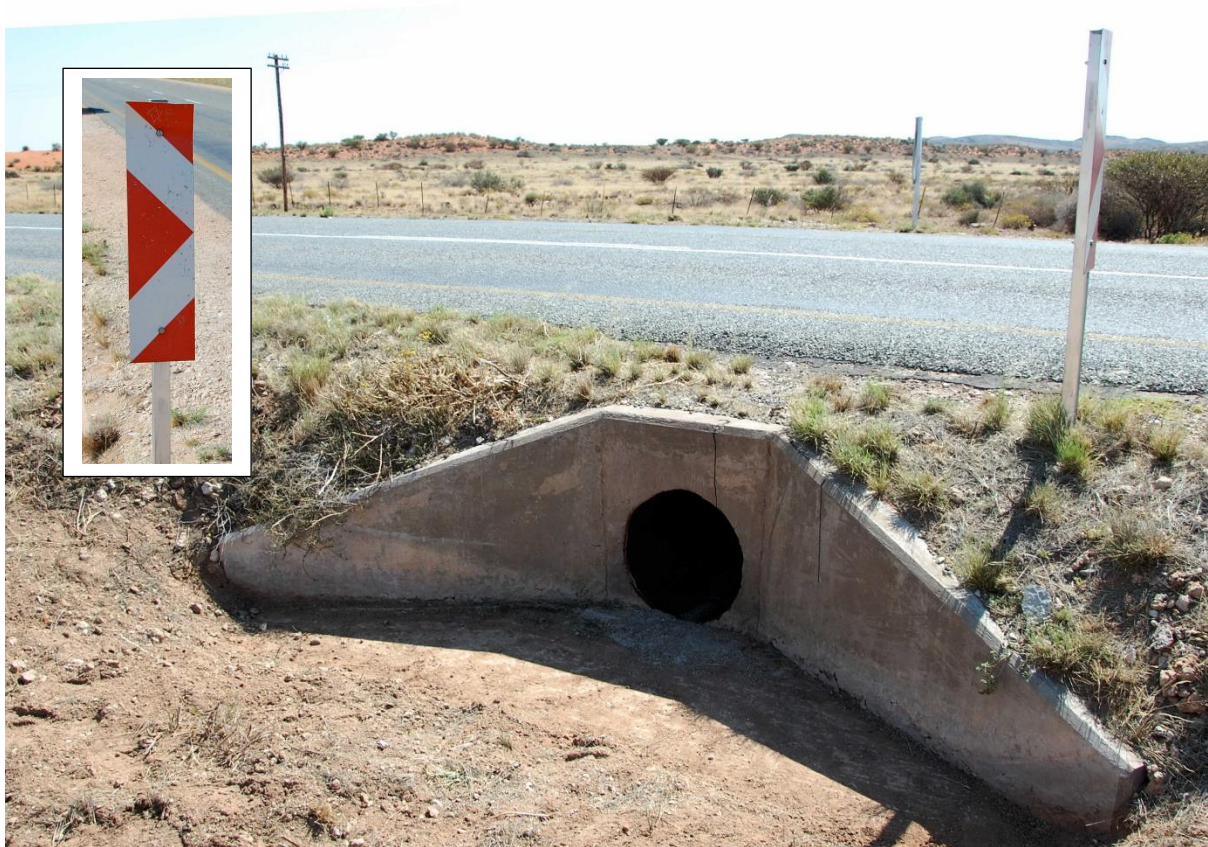
Figure 9 Class 1 drainage line with pipe culvert.

During the site visit in October 2022, maintenance was going on, with teams of workers manually shoveling sediments, debris and weeds out of the entrance to the culverts. As a result, the entrances were clearly visible from a passing vehicle.

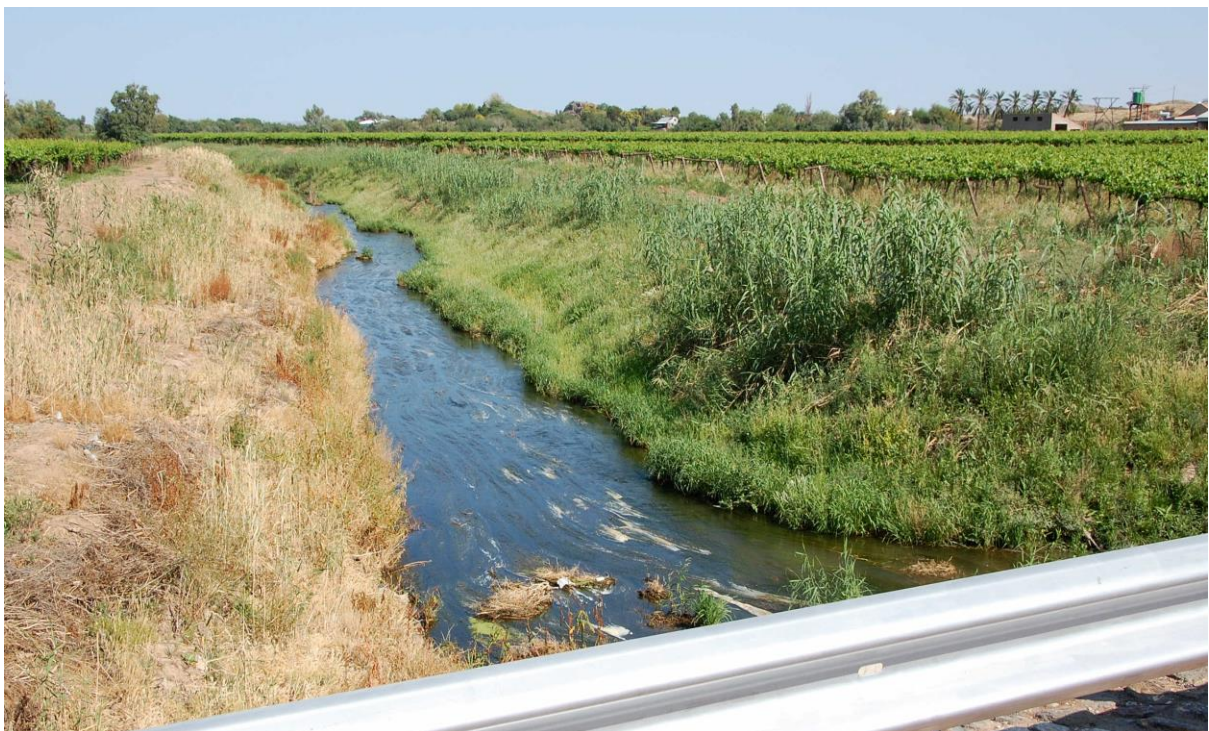
Figure 12 Sout River

From here the pipeline is directed towards the south along the R27 and through the vineyards where it will cross the Sout River (Figure 12). This branch of the braided Orange River now is merely a deep trench that acts as a conduit for irrigation return flow. The pipeline will be constructed over the Sout River, on pedestals on the banks and will have no mentionable impact, as long as building rubble and loose dirt is kept out of the river during the construction phase.

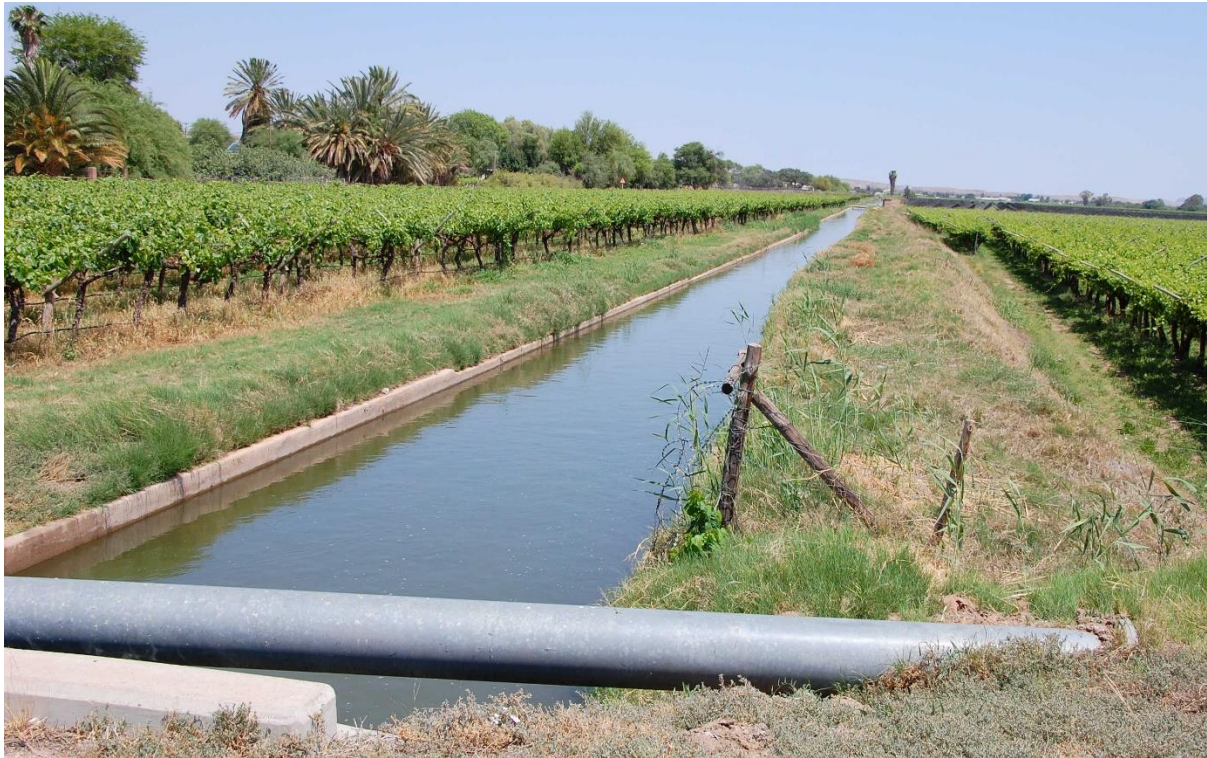
Figure 13 Irrigation canal

The pipeline stretches further south through the vineyards and then over an irrigation canal (Figure 13).

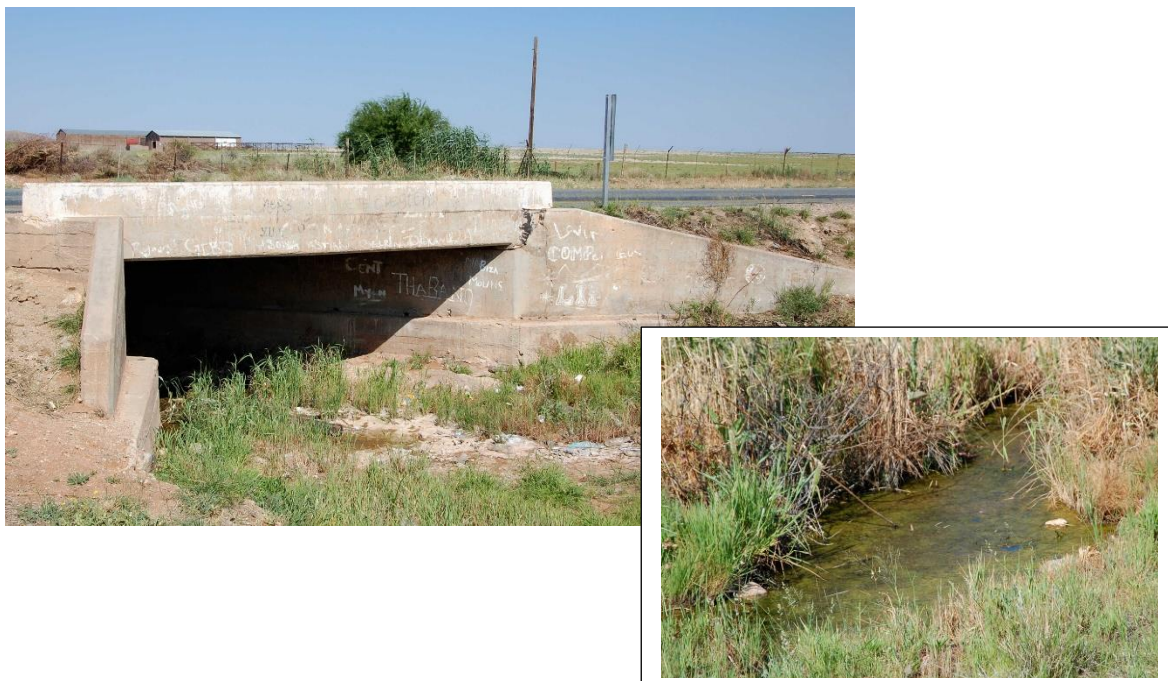
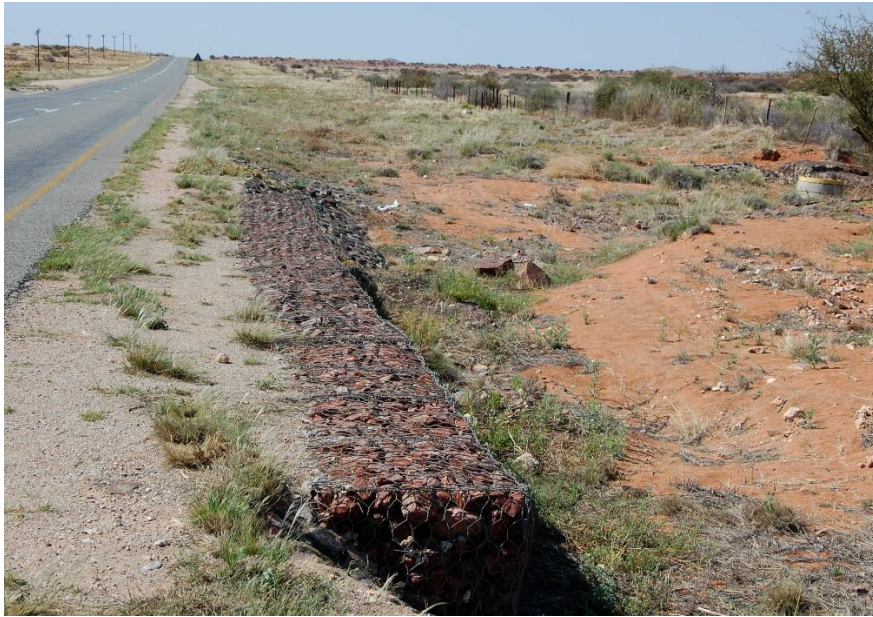
Figure 15 Crossing at Point No.2 at municipal water works.

The first Class 4 drainage line has a box culvert close to the municipal water works along the R27 Point No. 2 in Figure 15 and in Table 1. The drainage line at the crossing is shallow and sandy. The side of the road is enforced with a gabion. A precast concrete turret rises out of the existing underground pipeline and it was leaking water at the time of the site visit that collected in a puddle at the side of the road (Figure 15).

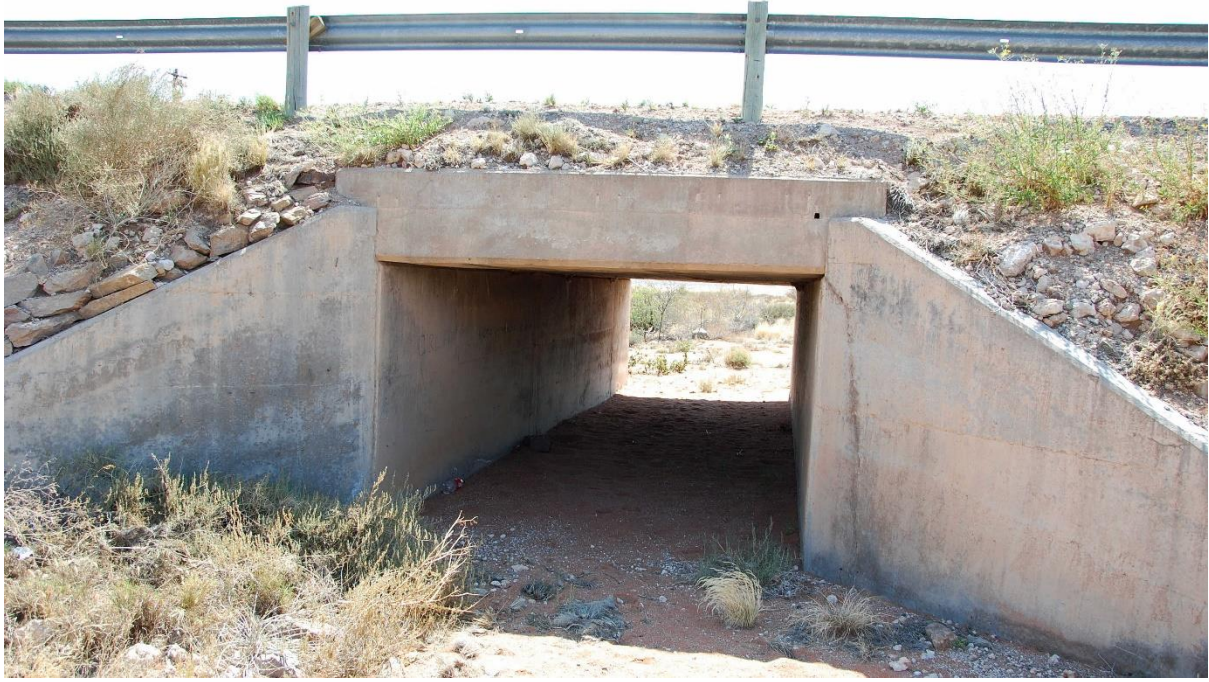
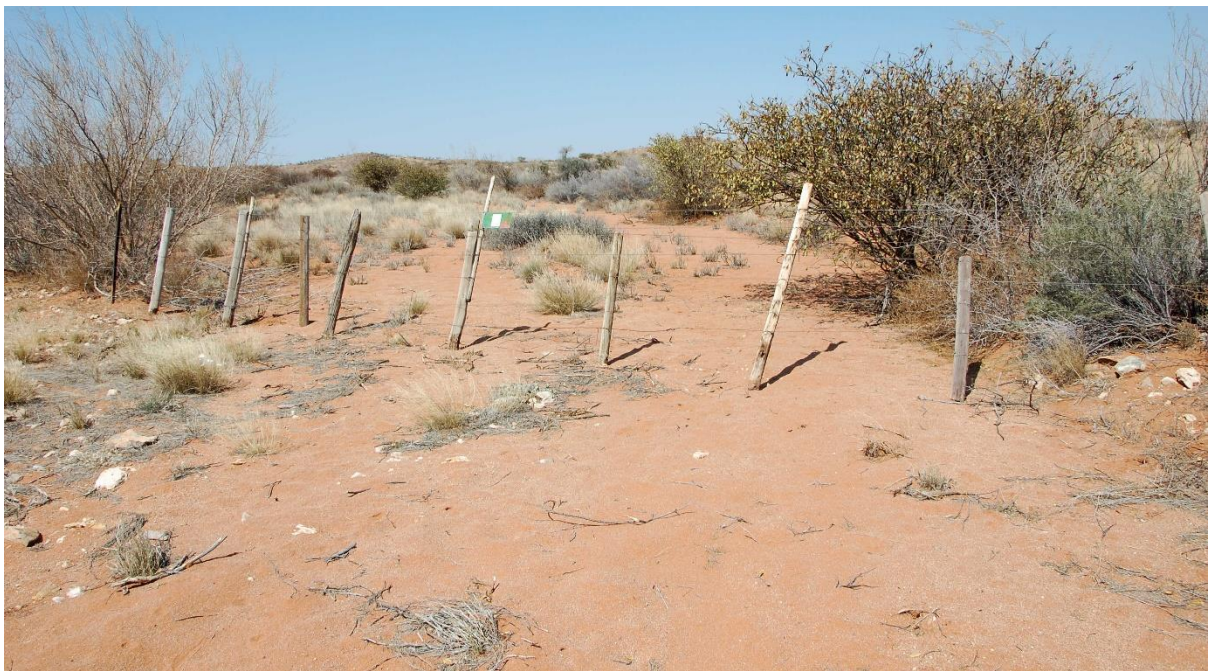
Figure 16 Crossing at Point No.3

Crossing at Point No.3 is just 500m further along the R27 towards the south and is similar, except that the drainage line is more emphasised, wide and sandy (Figure 16).

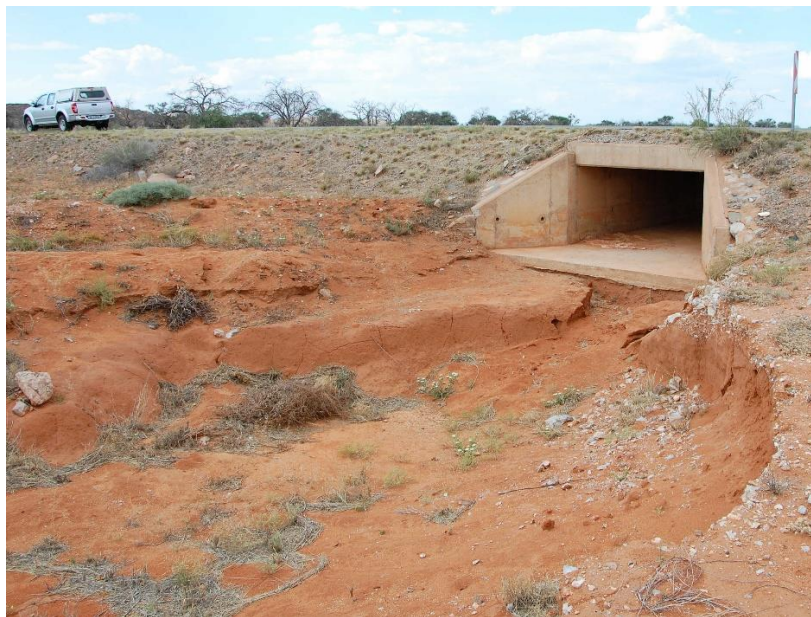
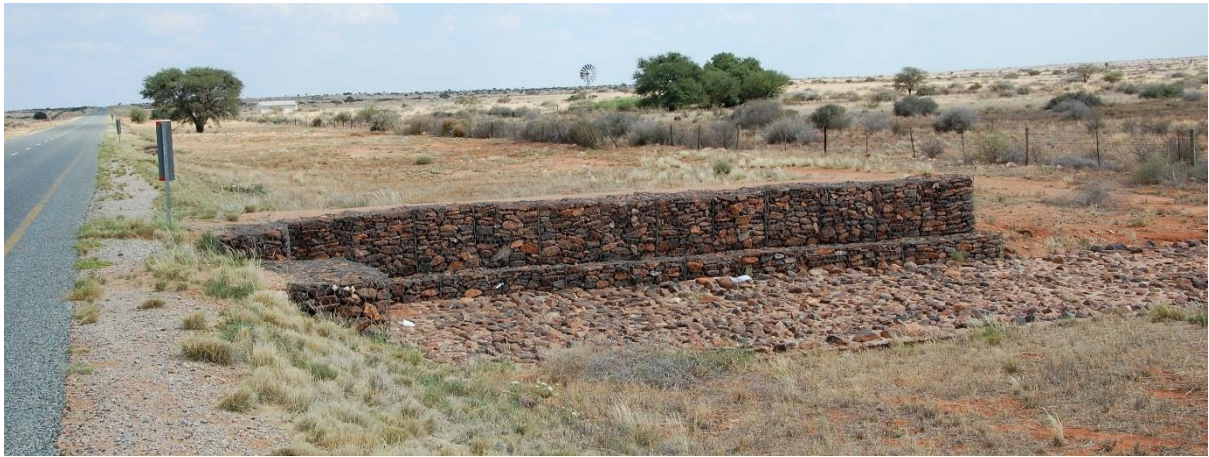
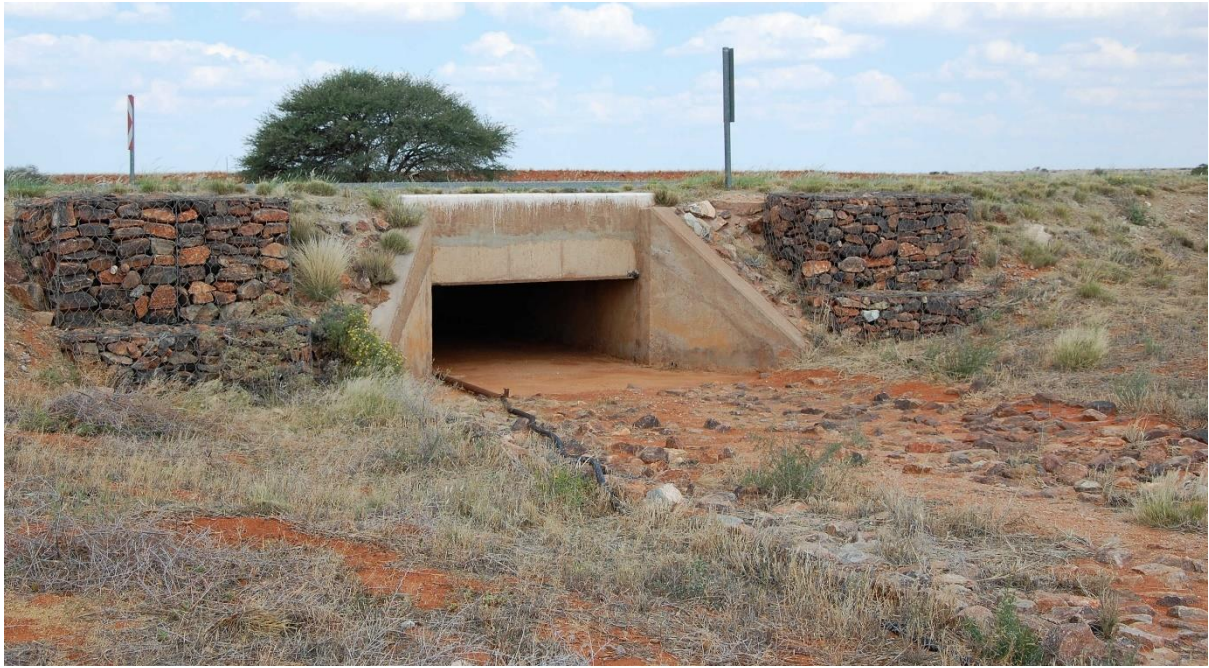
Figure 23 Point No.9 Box culverts

box culvert further on with a sandy drainage line floor shows signs of erosion (Figure 23).

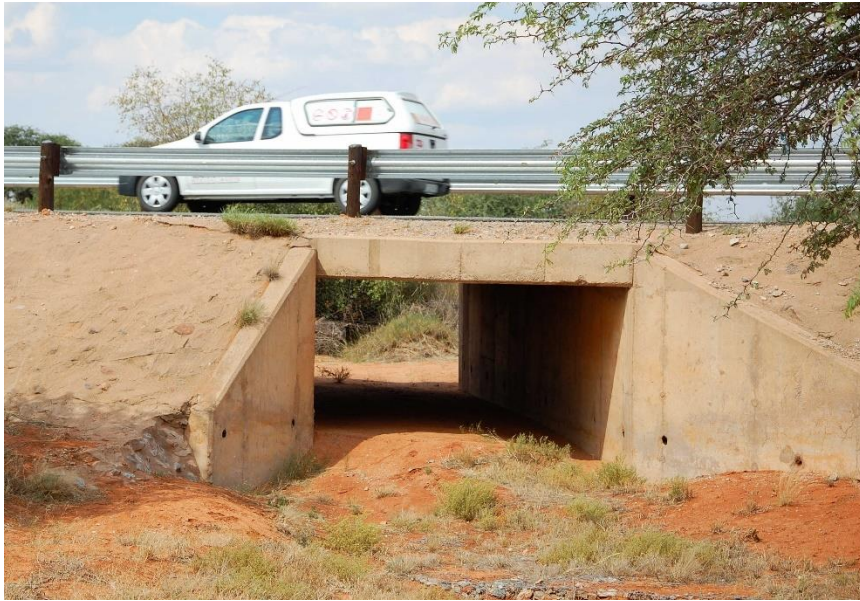
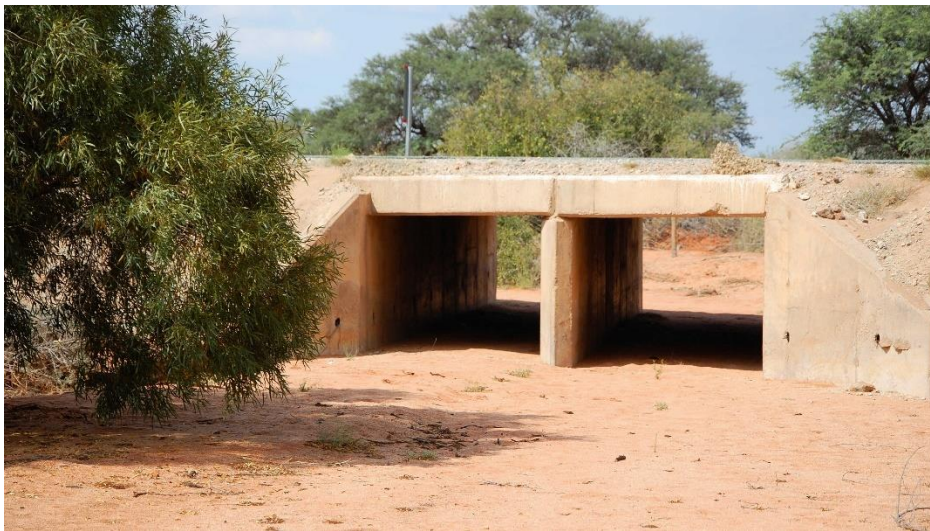
Figure 24 Cluster of culverts at Point No. 10

Point No.10 has a similar cluster of culverts (Figure 24). The drainage line is wide and sandy. This is a Class 4 drainage line.

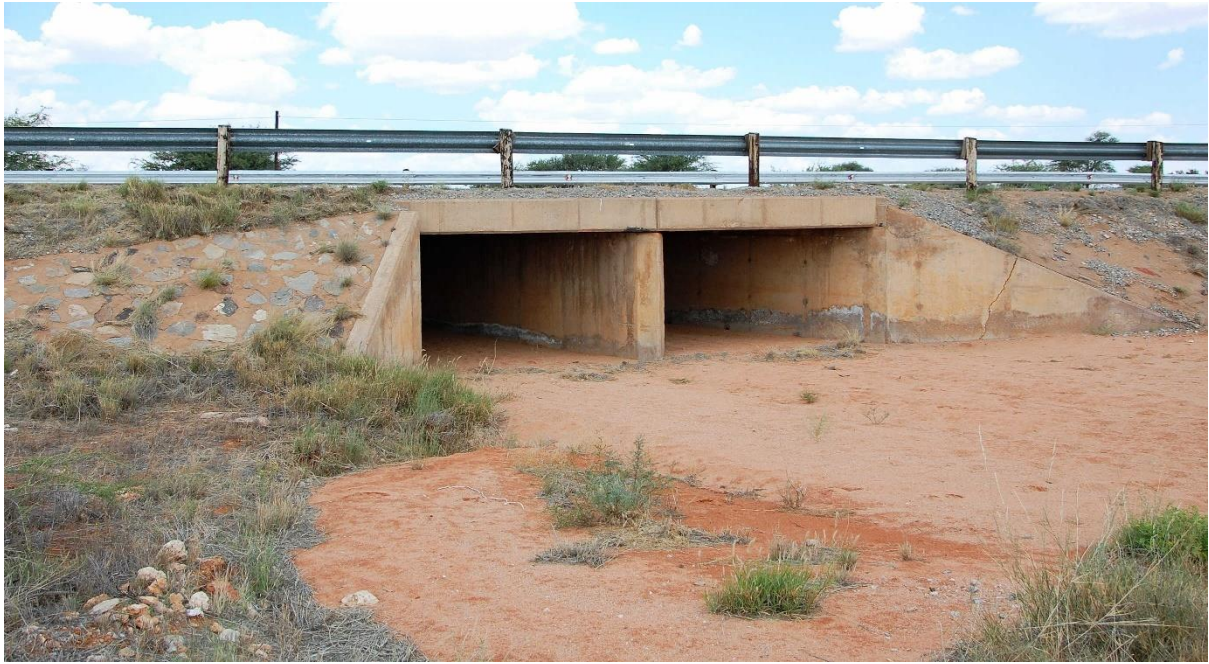
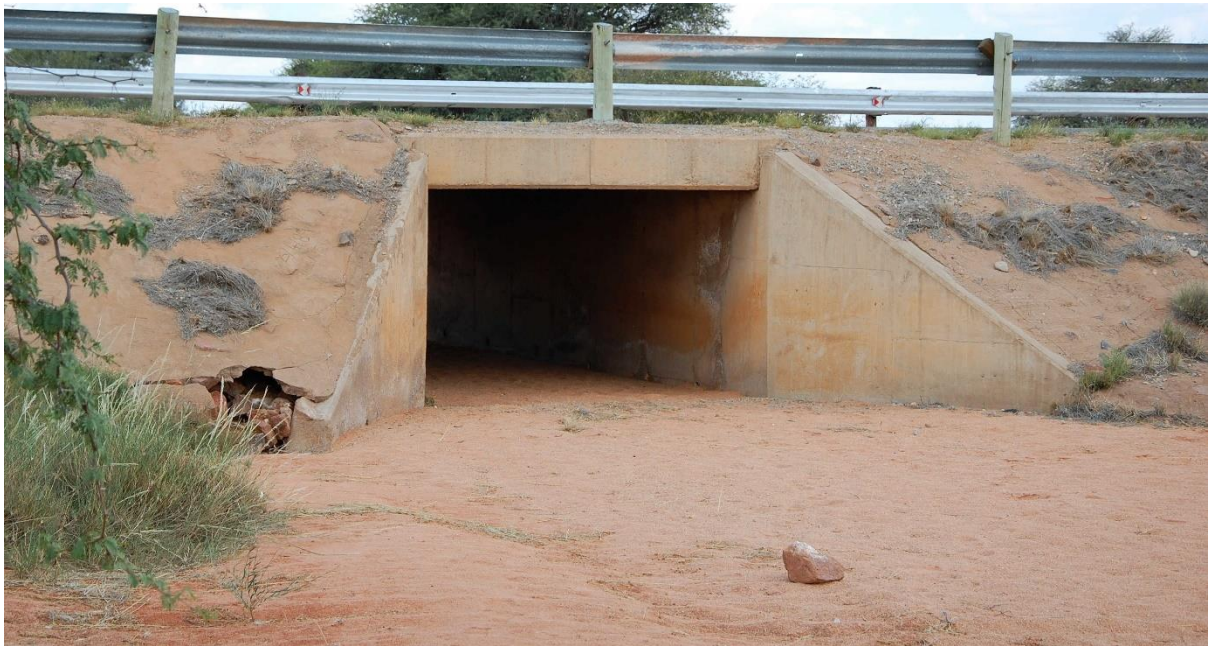
Figure 25 Culverts at Point No. 11

Point No.11 is marked by a wide drainage line (Figure 25) and the bottom is deep sand. It has two culverts, one with two boxes and the other with only one. These culverts are large, with space for a flood.

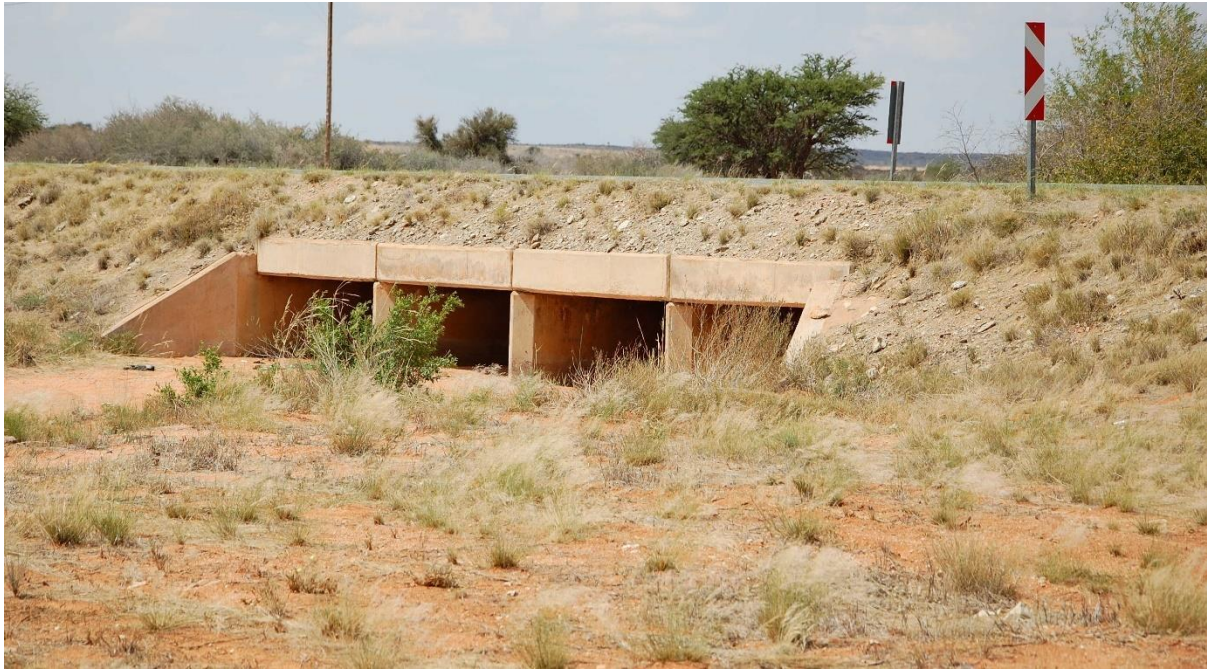
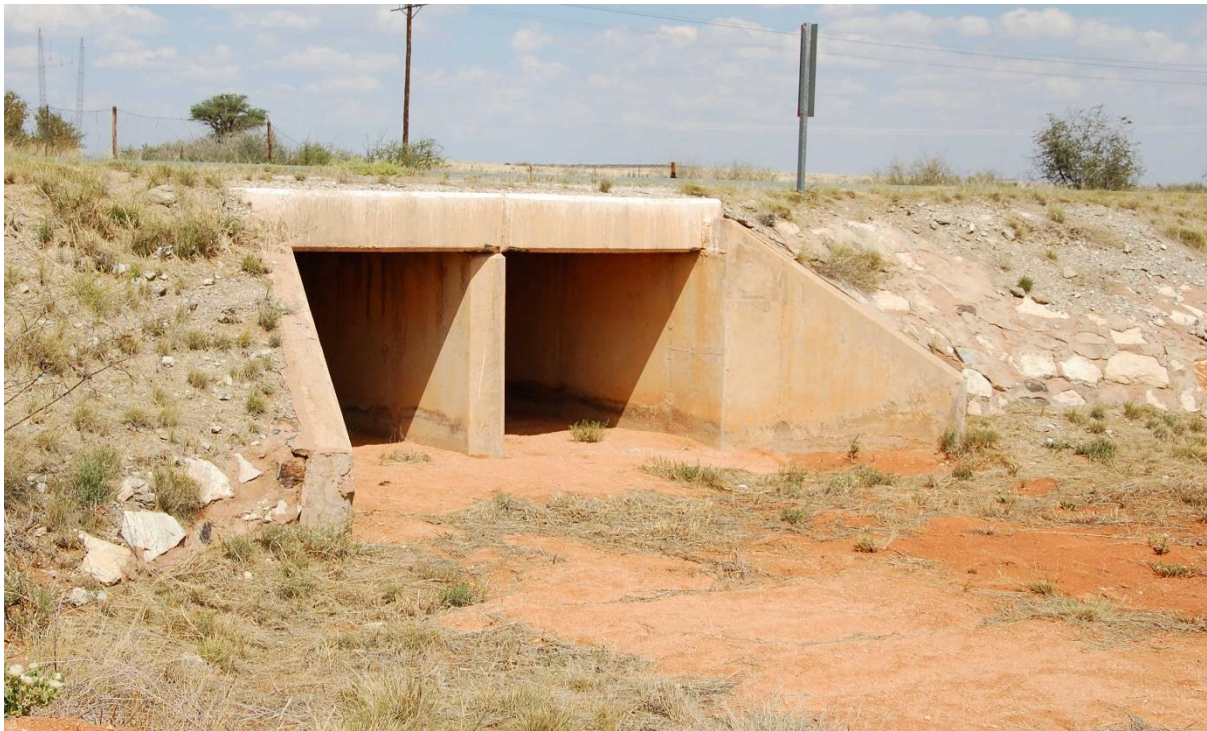
Figure 26 Culverts at Point No.12.

The culverts at Point No.12 (Figure 26) sizeable, with two boxes in the one and three in the next.

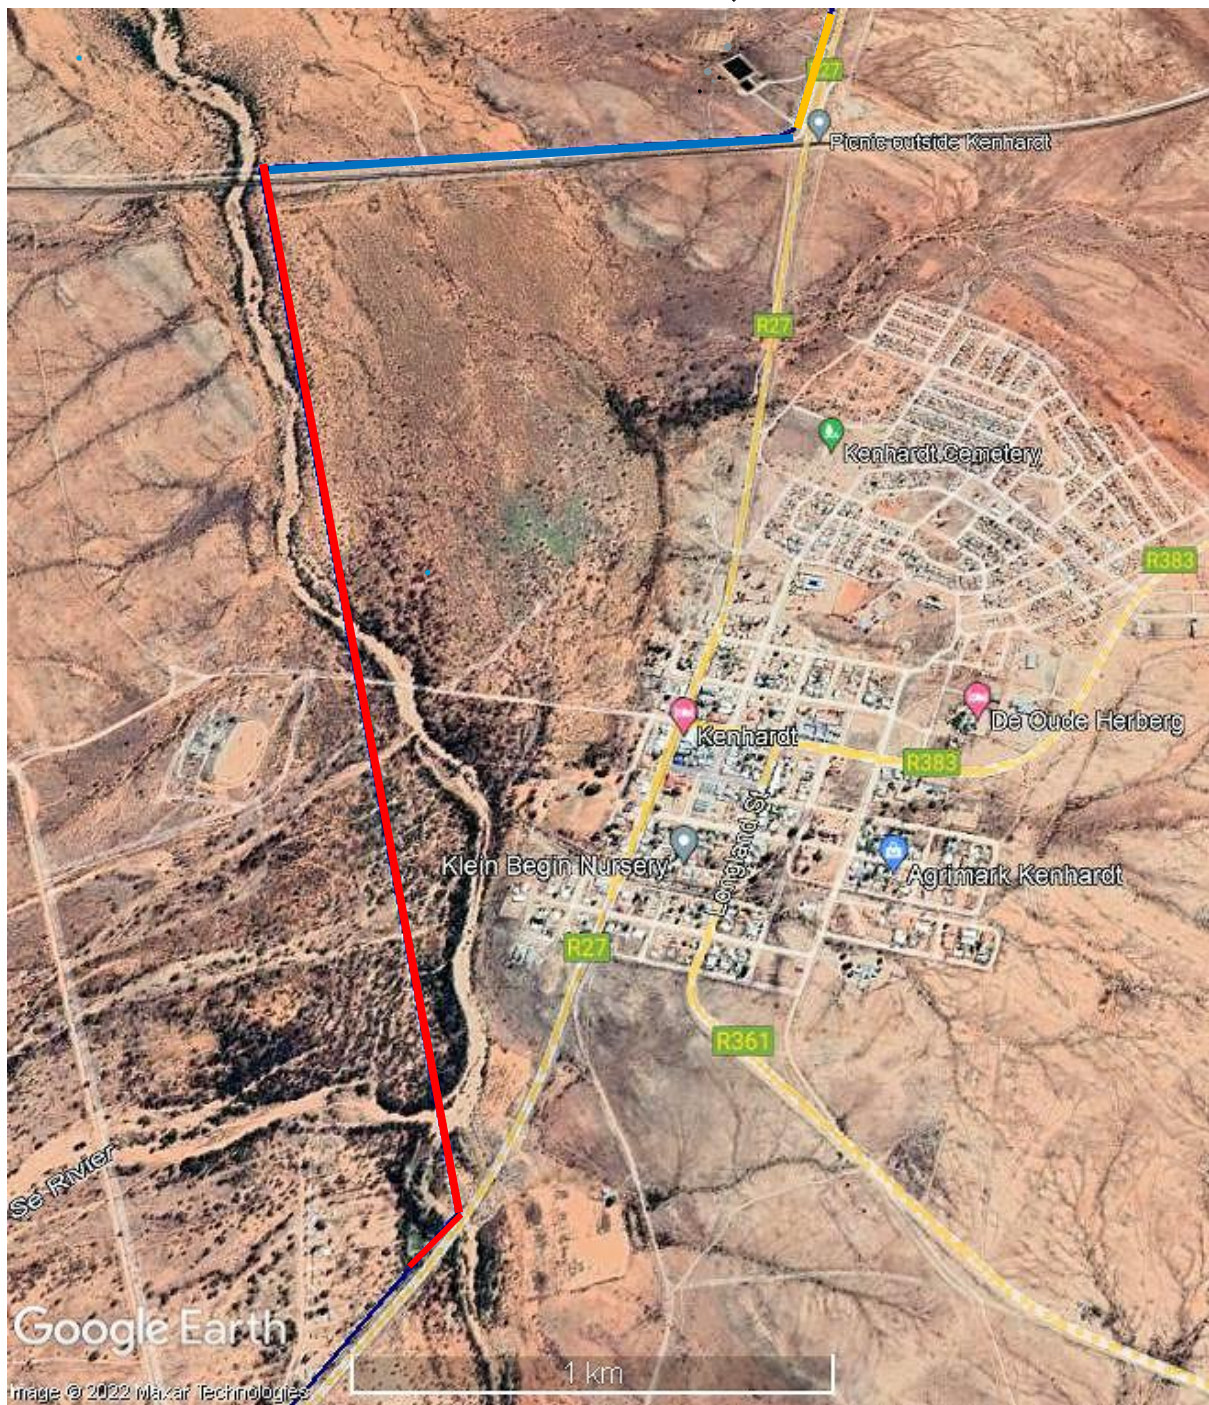
Figure 27 Route through Kenhardt

The proposed pipeline will swing to the west from the R27 (Figure 27) to follow the Sishen-Saldanha railway line to the railway bridge across the Hartbees River (Figure 28). The pipeline will swing towards the south underneath the railway bridge to cut across the riverbed on the west of Kenhardt to the R27 road bridge (Figure 29) south

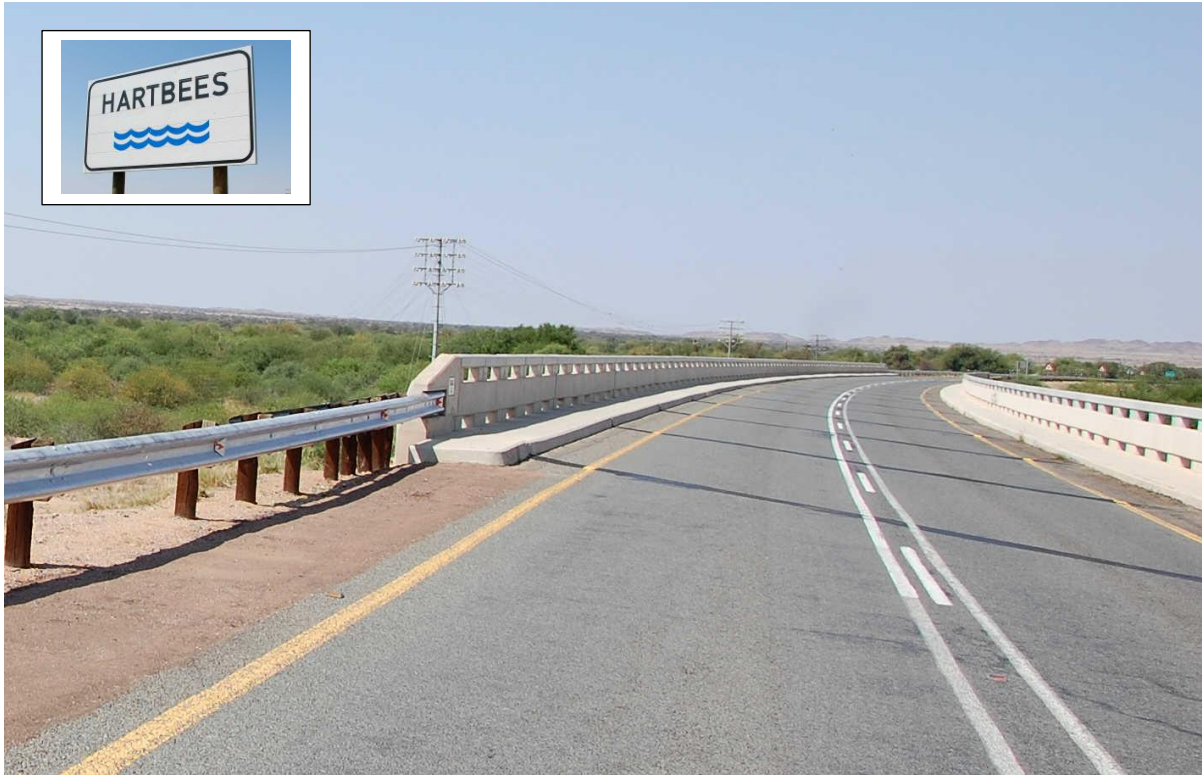
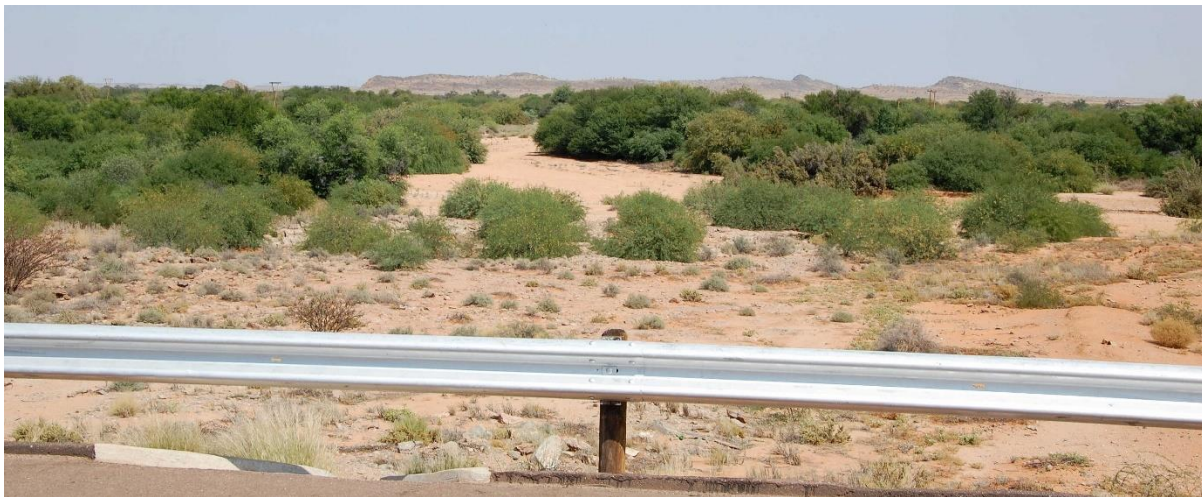
Figure 29 R27 Road bridge south of Kenhardt

The Hartbees Riverbed is wide and sandy, but heavily overgrown with *Prosopis* trees (Figure 29). These trees are declared weeds and are aggressive invaders in this part of the country.

At the R27 road bridge south of the town, the river is dry, as it is most of the time, with no trace of any sewage effluent. All of it dissipates in the river to the west of the town.

The pipeline will be trenched in the bed of the Hartbees River at Kenhardt. The backfill on top of the pipeline must be more than anywhere else along the route, probably 1.5m and deeper. The Hartbees River does not come down often in flood, but when it does it can be brutal. Under these conditions, the pipeline must be burrowed deep enough to escape any damage.

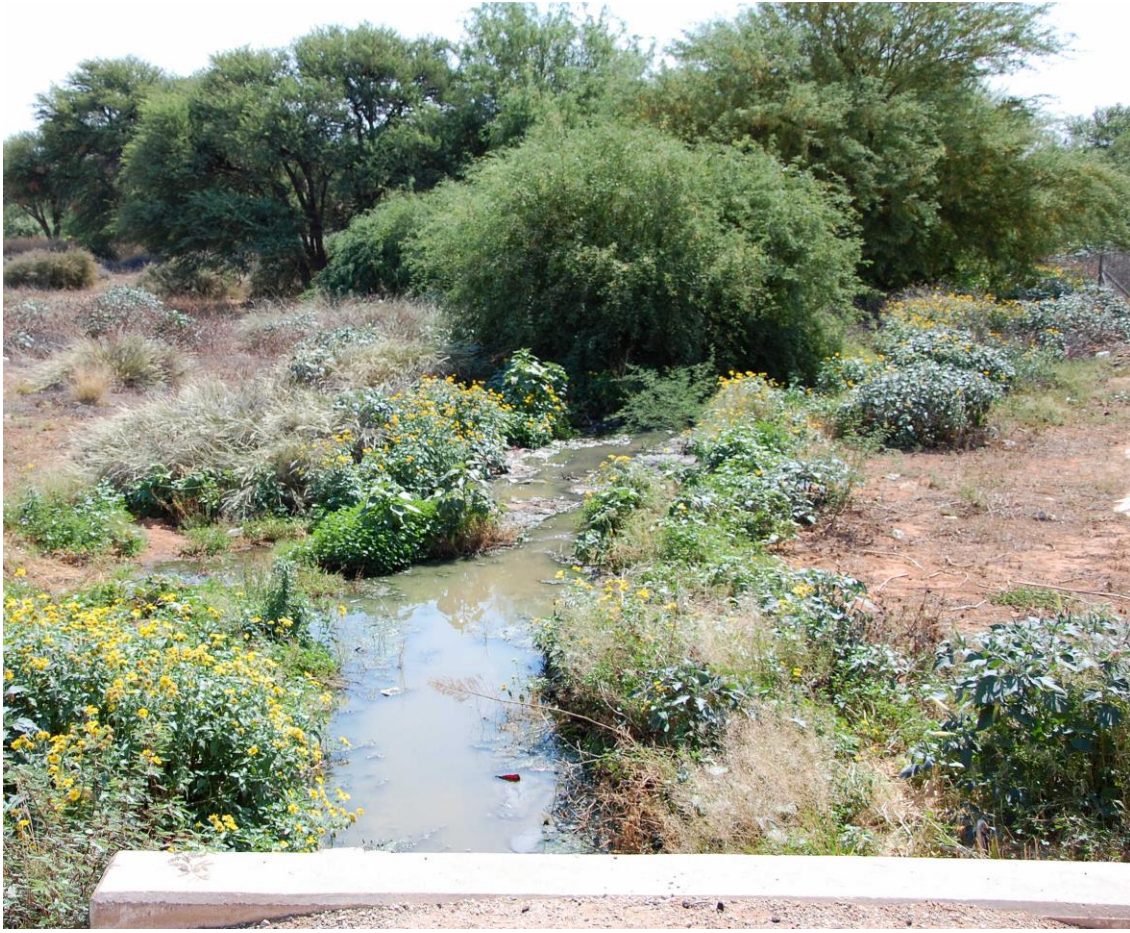
Figure 30 Sewage effluent

The invasive trees (Figure 31) are perpetually fertilized by the partly or even untreated sewage (Figure 30) out of Kenhardt that flows out of the dysfunctional wastewater treatment works, passes under the R27 through a culvert north of town and then down into the river.

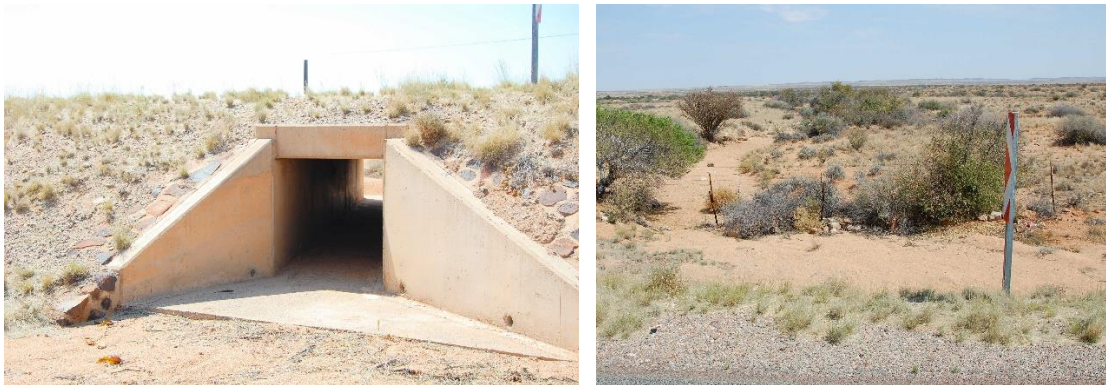
Figure 34 Point No.14 crossing

The culverts and the drainage lines at Point No.14 and 15 are similar (Figure 34 and 35). The drainage line is sandy underlain by granite.

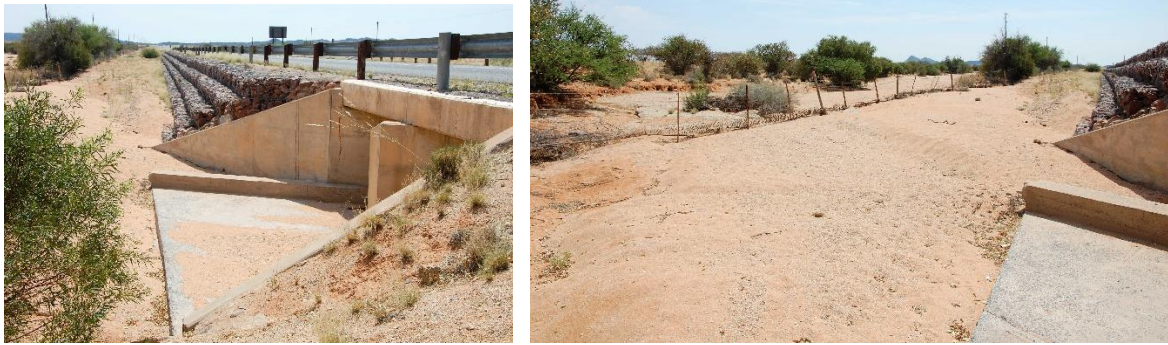
Figure 36 Point No.17 crossing

The drainage line at Point No.17 is a 2-box bridge (Figure 36). It has a sturdy row of gabions on the one side. This is of the larger drainage lines with a wide bed of sand and loose stones. If there is solid granite down below, it was not seen during the site visit and was covered by sand.

The bridge is flanked by pipe culverts. The one to the south is a concrete one into a gabion (Point 16). The one on the north is corrugated metal pipe (Point 18).

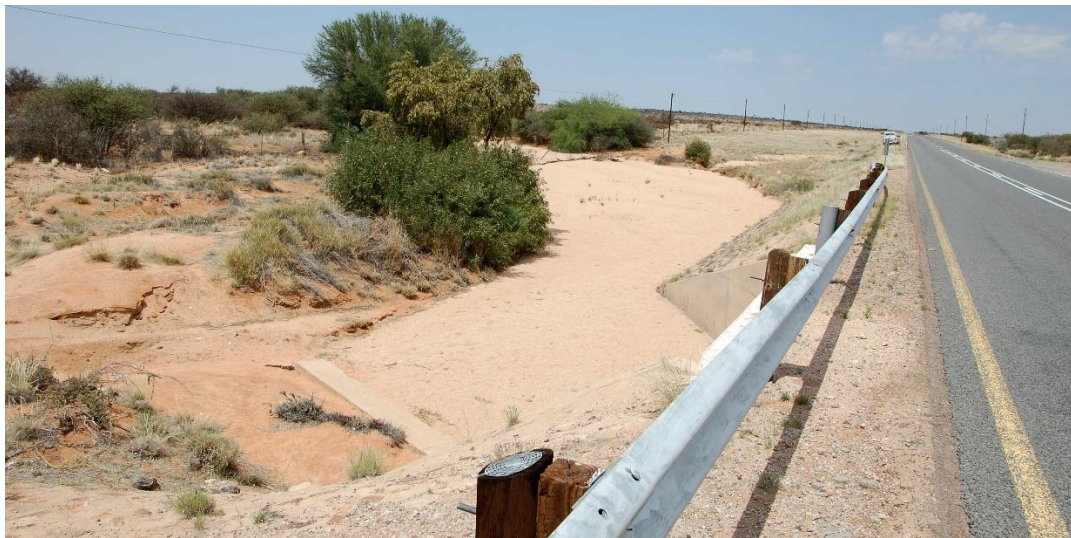
Figure 37 Point 19

To the north is flanked by another one-box culvert (Point 19, Figure 37) like the ones at Point 14 and 15. The embankment and floor next to the culvert is paved with stone and cement.

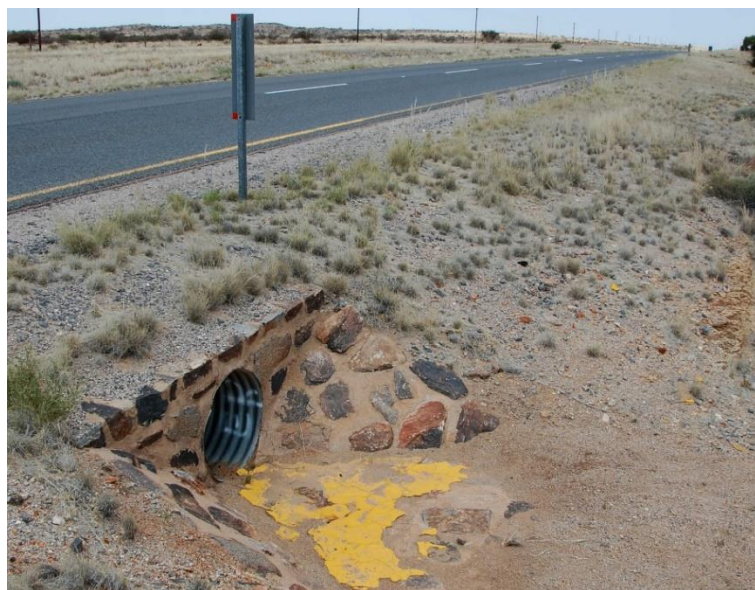
Figure 38 Pipe culvert at Point 20

Further on is another corrugated iron pipe culvert (Class 4, Figure 38, Point 20).

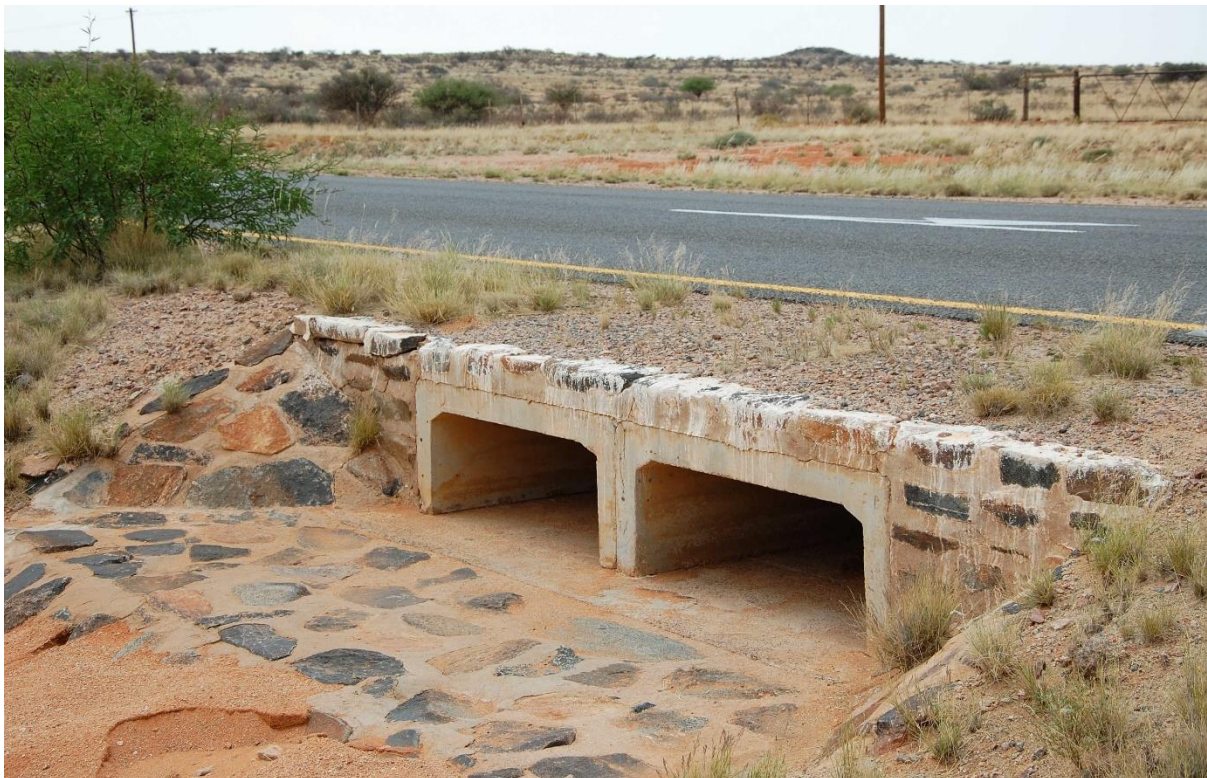
Figure 40 Culvert at Point No. 23

A smaller tributary of Driekop se Rivier breaks through the ridge just west of the R27. It gives rise to a cluster of drainage lines on the R27 (Figure 39, No. 21 to 24). No. 21 has a box culvert and No. 22 has a pipe culvert. No. 23 has a double box culvert with a paved exit floor (Figure 40). There is a paved gully of rock and cement next to the road that has broken up on places. This gully must be rebuilt after the new pipeline has been trenched. Point No. 24 has a single box culvert that resembles similar ones along the R27. These drainage lines are underlain with granite that is covered with a layer of fluvial sand.
