KOTULO TSATSI ENERGY (PTY) LTD

FRESHWATER REPORT

For the construction of a water provision pipeline from the Orange River at Keimoes to the Uitkyk Farm near Kenhardt, Northern Cape

November 2022
Version 3.0 March 2024

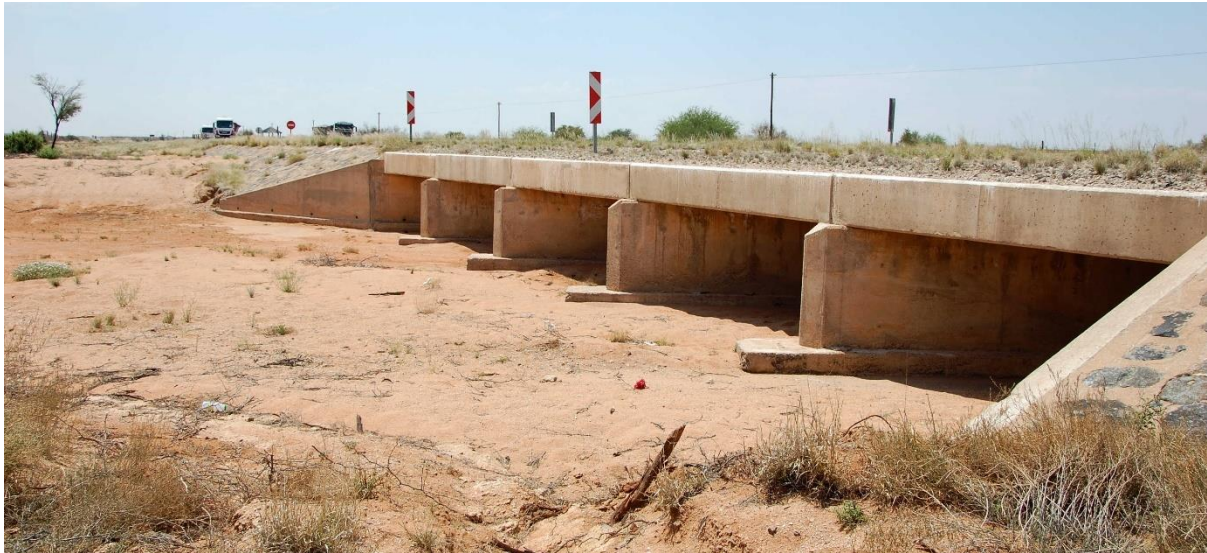
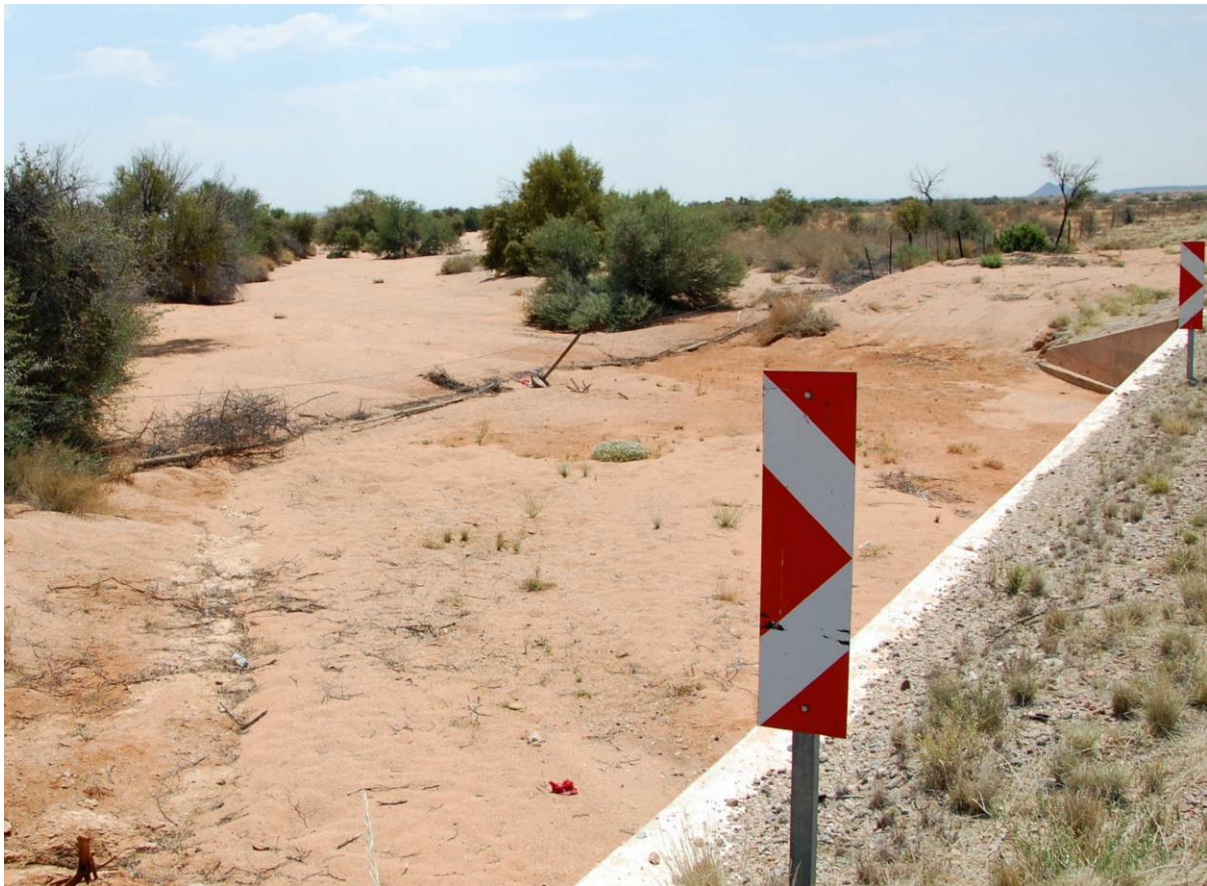
Figure 41 Class 5 at Point No. 27

Then follows a huge Class 5 drainage line (Point No.27 on Figure 41), which is from the second large tributary of Driekop se Rivier. It has five large box culverts.

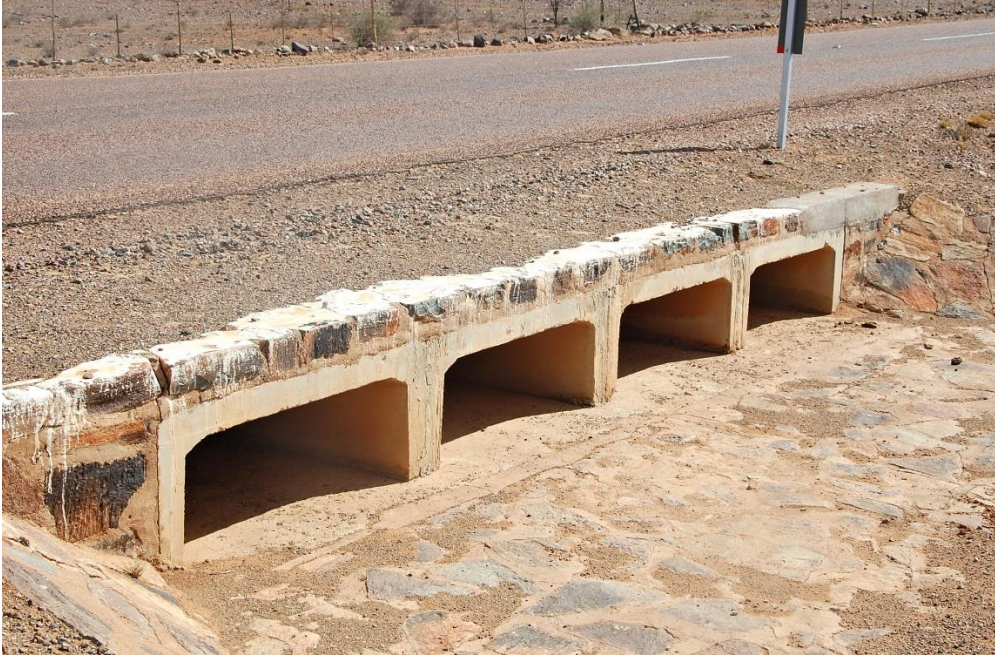
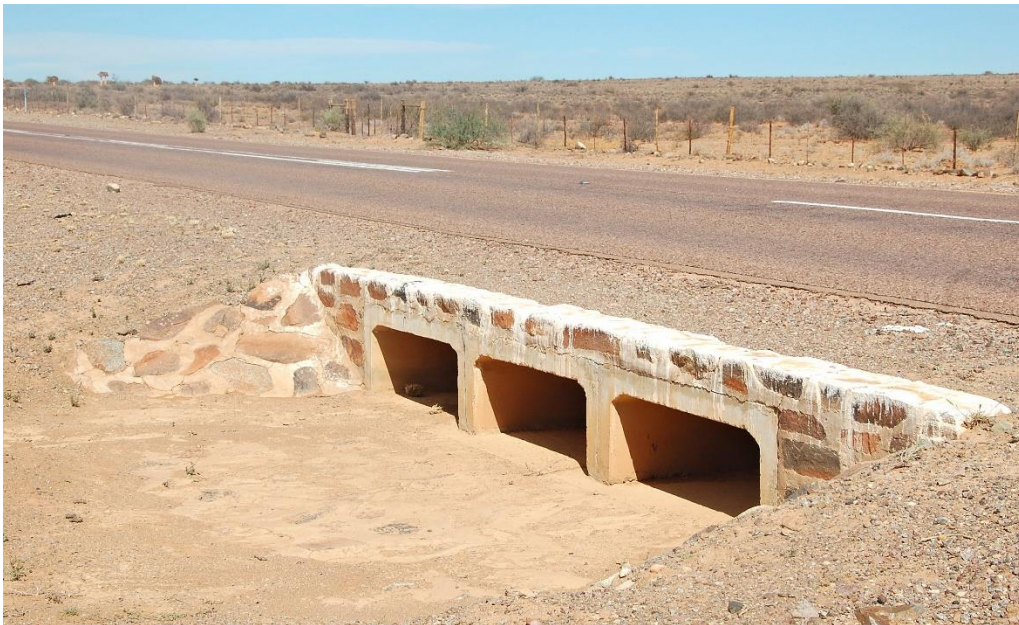
Figure 44 Class 4 at Point No. 28.

Point No. 28 on Figure 42 consists of a cluster of 5 culverts. The first one is only a Class 1 drainage line and is located at the 118.4km mark, as indicated on a signpost next to the road. The second one has 4 arches in the constructed culvert (Figure 44). The next culvert is a two-arch box culvert. The fourth one is 50m on and has two arches. The drainage line here was eroded the deepest and was classified as a Class 4. The fifth culvert in the cluster has three low arches (Figure 44).

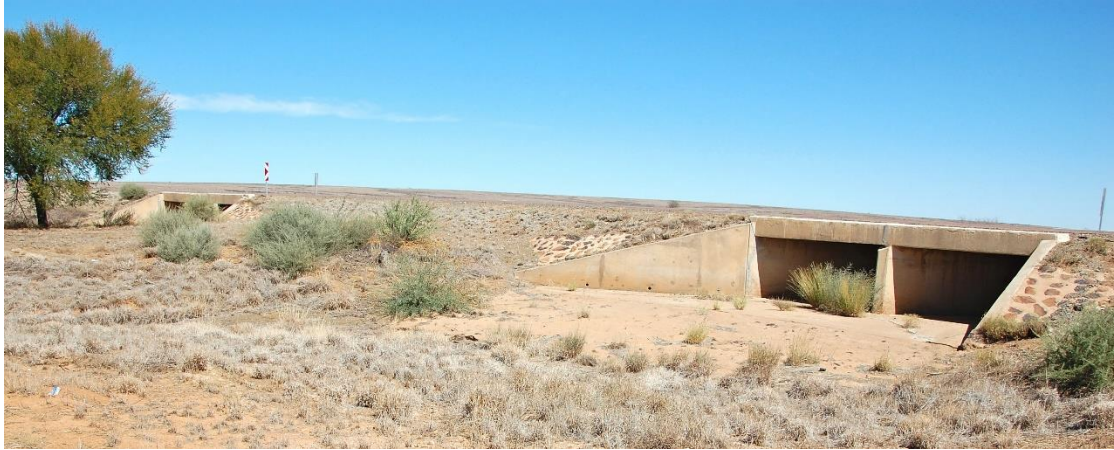
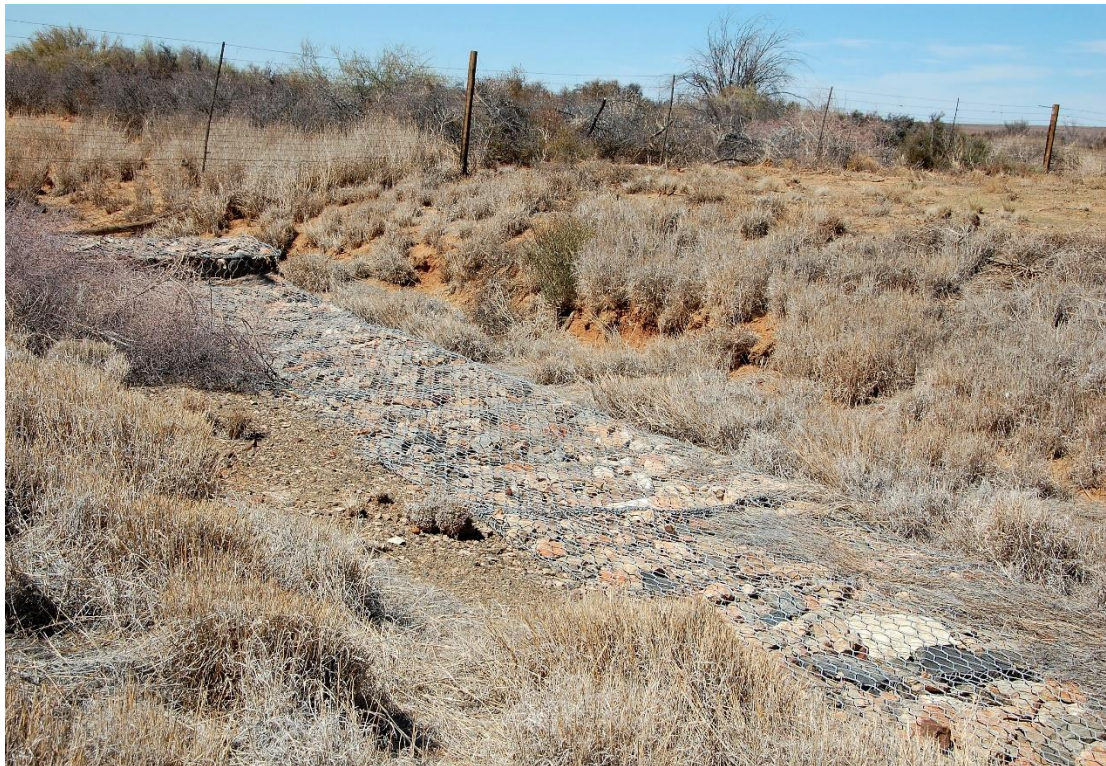
Figure 45 Point No. 29

The next drainage line of interest, Point No. 29, is just to the south of Rooipunt (Figure 45). There are two constructed culverts alongside one another, one with 2 arches and the other with three (Figure 1). Upstream is vegetated but with no visible drainage line. Downstream is marked by an eroded Class 4 drainage line. The drainage lines alongside the culverts, downstream, are protected by reno mattresses. Which must be restored if the pipeline passes on that side of the road.

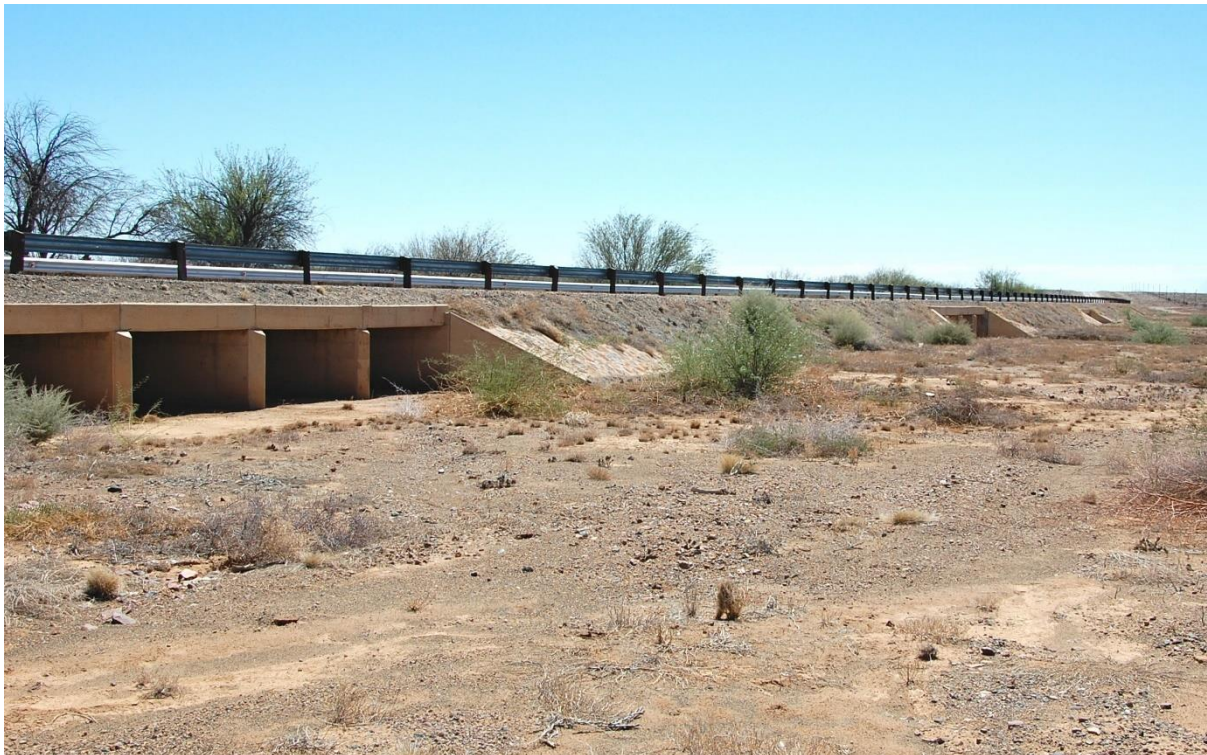
Figure 46 Point No. 31.

Likewise, Point No.31 (Figure 46) is marked by another very big drainage line where sediment transport is not apparent and therefore was designated Class 1. Because it is such a big drainage line, a WULA may be asked for, despite its classification. There are several large conduits under the R27 to let through occasional stormwater. The riparian zone is well-vegetated with trees. Downstream, pastures for agriculture were established in the drainage line bed, but since this is an arid area, it is questionable if these pastures still produce any notable harvest.

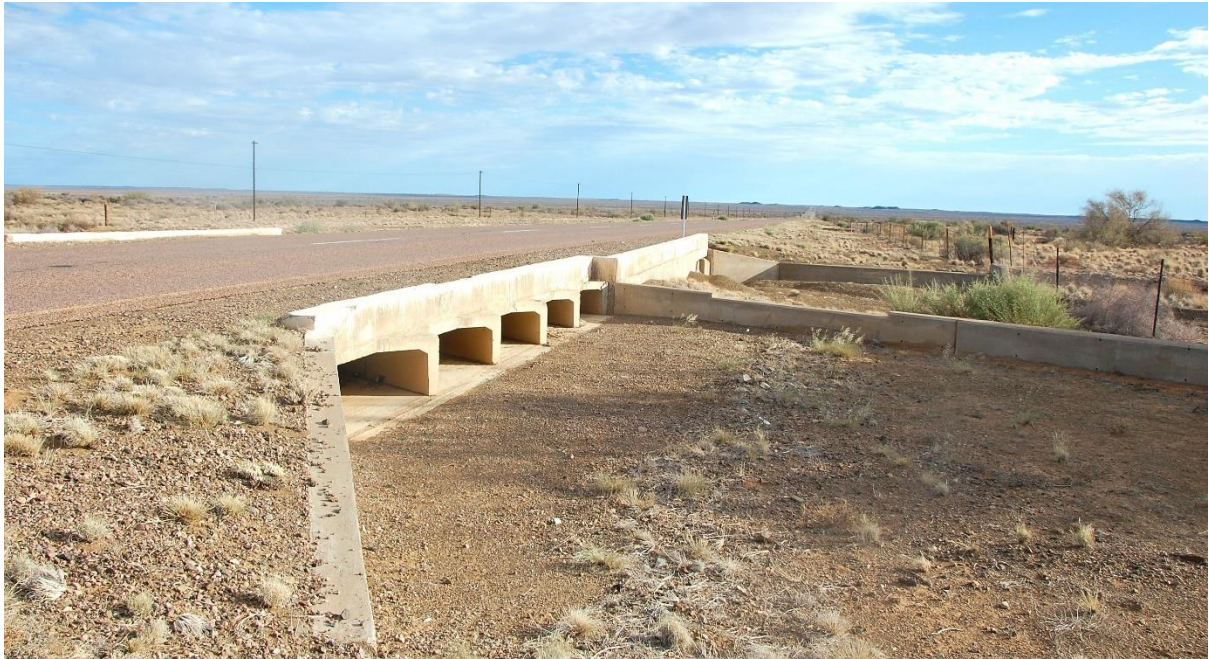
Figure 47 Concrete structure

To the south along the R27 from here is a dolerite ridge with smaller drainage lines. The rocks combined with the drainage lines represent some challenges for the construction of the pipeline. Further south, down the decline, on the west road shoulder, are 8 concrete stormwater management structures (Figure 47), which must be restored if the pipeline follows the west side of the road.

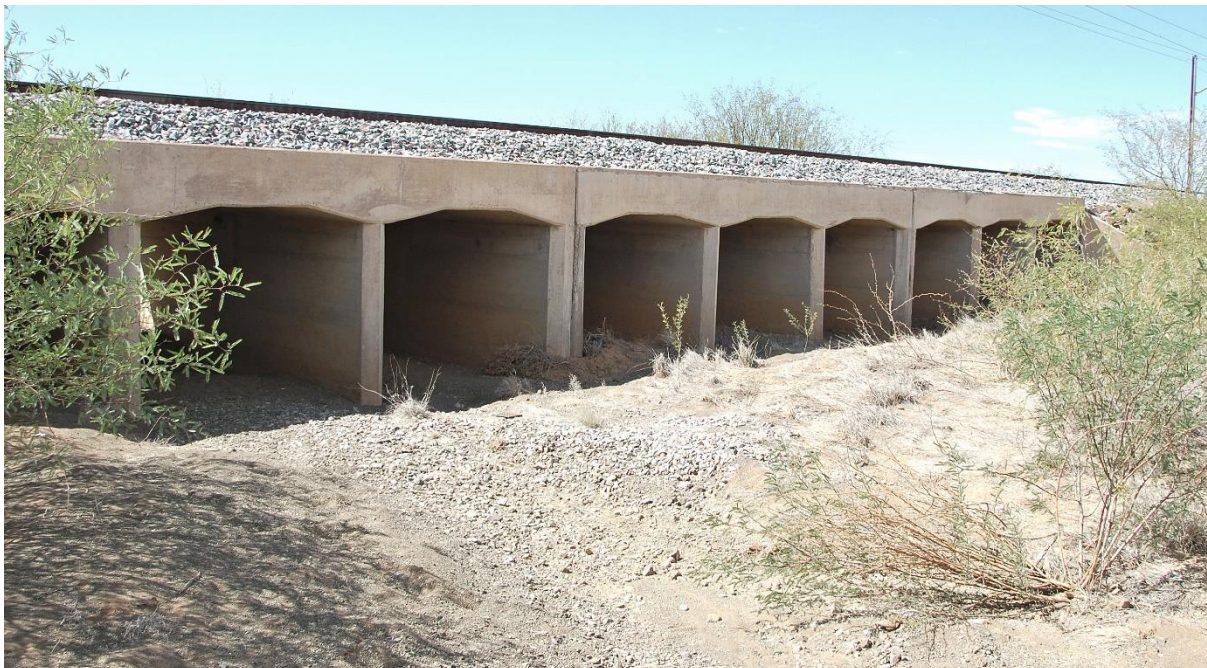
Figure 49 Railway culverts

The pipeline must cross the railway to reach the commercial part of the development to the west. The crossing will either be through the existing culvert (Figure 49) or through a directionally drilled passage through the fill underneath the railway, depending on the authority's approval. Both options will be through or near a Class 4 drainage line that passes underneath the railway through the set of large culverts (Figure 49).

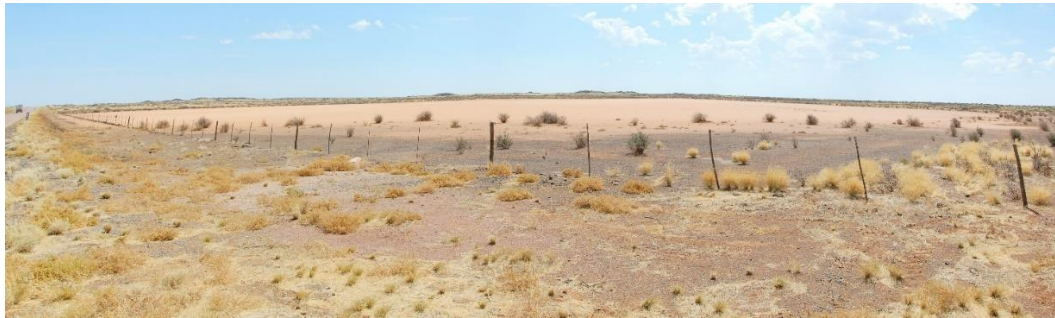
Figure 50 Pan along the R27

The one pan that stands out along the path of the new pipeline is right next to the R27 south of Kenhardt, close to the turnoff to Soafskolk / Uitkyk Farm (Figure 50). It is a bare pan, only 12.8 hectares. It is located at the coordinates:

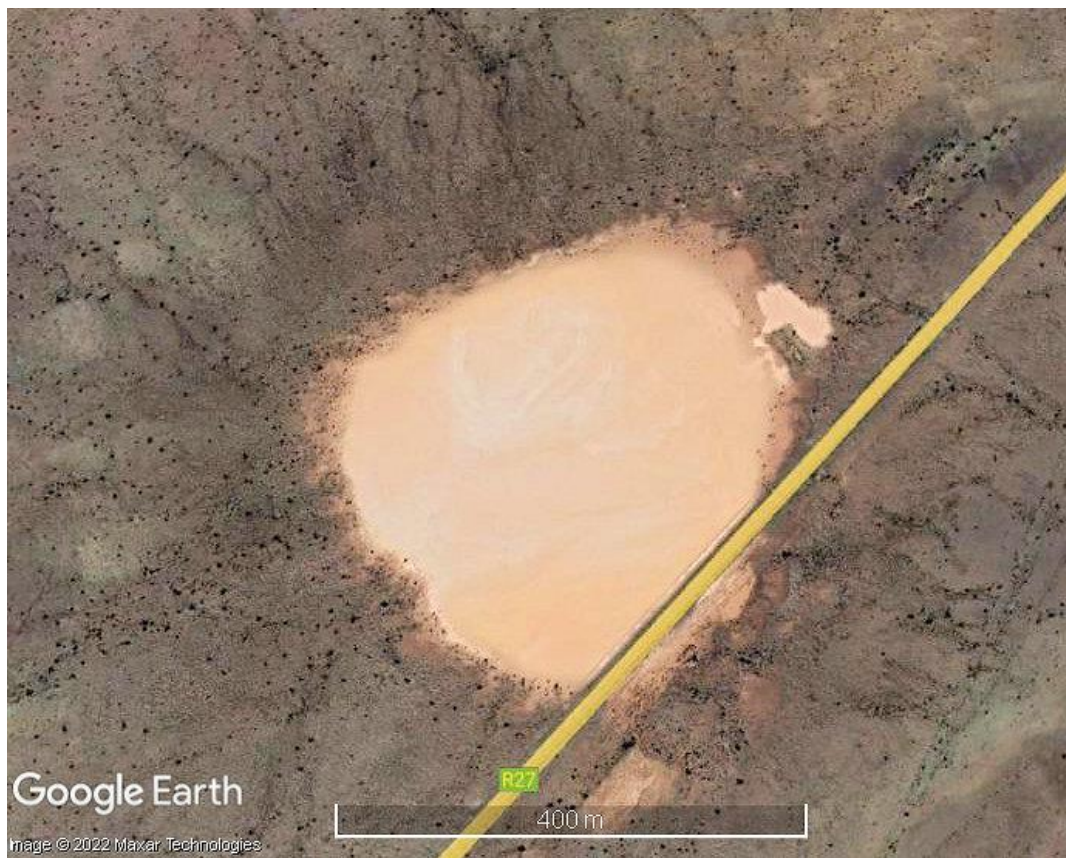
Figure 51 R27 bare pan Google Earth Image

It is on the western side of the R27 (Figure 51). A small portion passes underneath the R27 to the other side of the road. The new pipeline will pass through the side of the pan on the verge of the road.

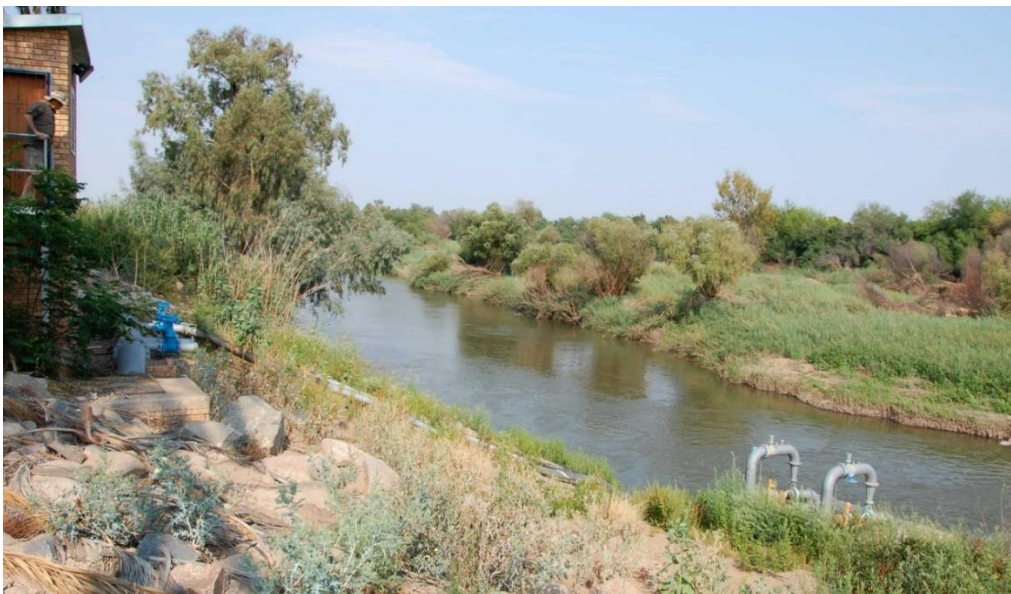
Figure 53 Orange River 3 at the sampling point

The sampling point was at the new abstraction point, or rather, at the addition of another abstraction point at the existing one. The sampling point was right at the anchored raft on which existing pumps are mounted in one of the arms of the braided Orange River branded as Orange River 3 (Figure 53). This is next to the R27 trunk road bridge to Groblershoop (Figure 54).

The river here was fast flowing with a velocity of more than 2ms^{-1} in the middle and somewhat slower against the banks. The banks are very steep and enforced with a layer of rocks and concrete. The rocks and the steel structure of the raft acted as bedrock and stones-in-current. The banks are lined with a thick stand of reeds, but reeds are kept short at the abstraction point. There was no emerging vegetation at the time of sampling. The bottom was muddy. The habitat was limited, with little variation.

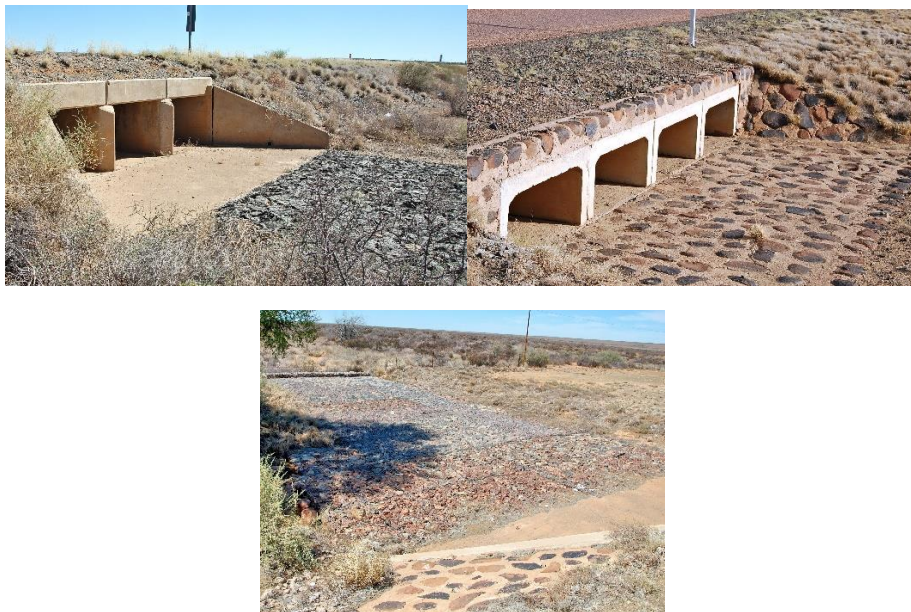
Figure 56 Stormwater calming infrastructure.

If it is necessary to even further pave culvert exits, it may be done so with rock and cement, with a special effort to create a rough surface with much flow resistance to slow stormwater down. At the far end, on the verge of the pavement, bigger rocks can be placed and cemented in to finally break up the current (Figure 56).
