KOTULO TSATSI ENERGY (PTY) LTD

FRESHWATER REPORT

For the construction of a water provision pipeline along the R27 trunk road to
Kenhardt, Northern Cape

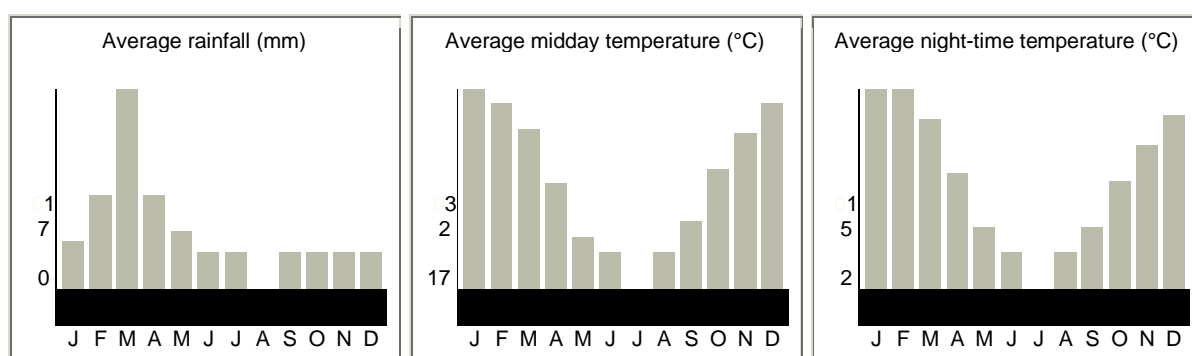
Figure 3 Brandvlei Climate

Brandvlei normally receives about 54mm of rain per year, with most rainfall occurring mainly during autumn. The chart below (lower left, Figure 3) shows the average rainfall values for Brandvlei per month. It receives the lowest rainfall (0mm) in August and the highest (17mm) in March. The monthly distribution of average daily maximum temperatures (centre chart below) shows that the average midday temperatures for Brandvlei range from 17.1°C in July to 32°C in January. The region is the coldest during July when the mercury drops to 2°C on average during the night.

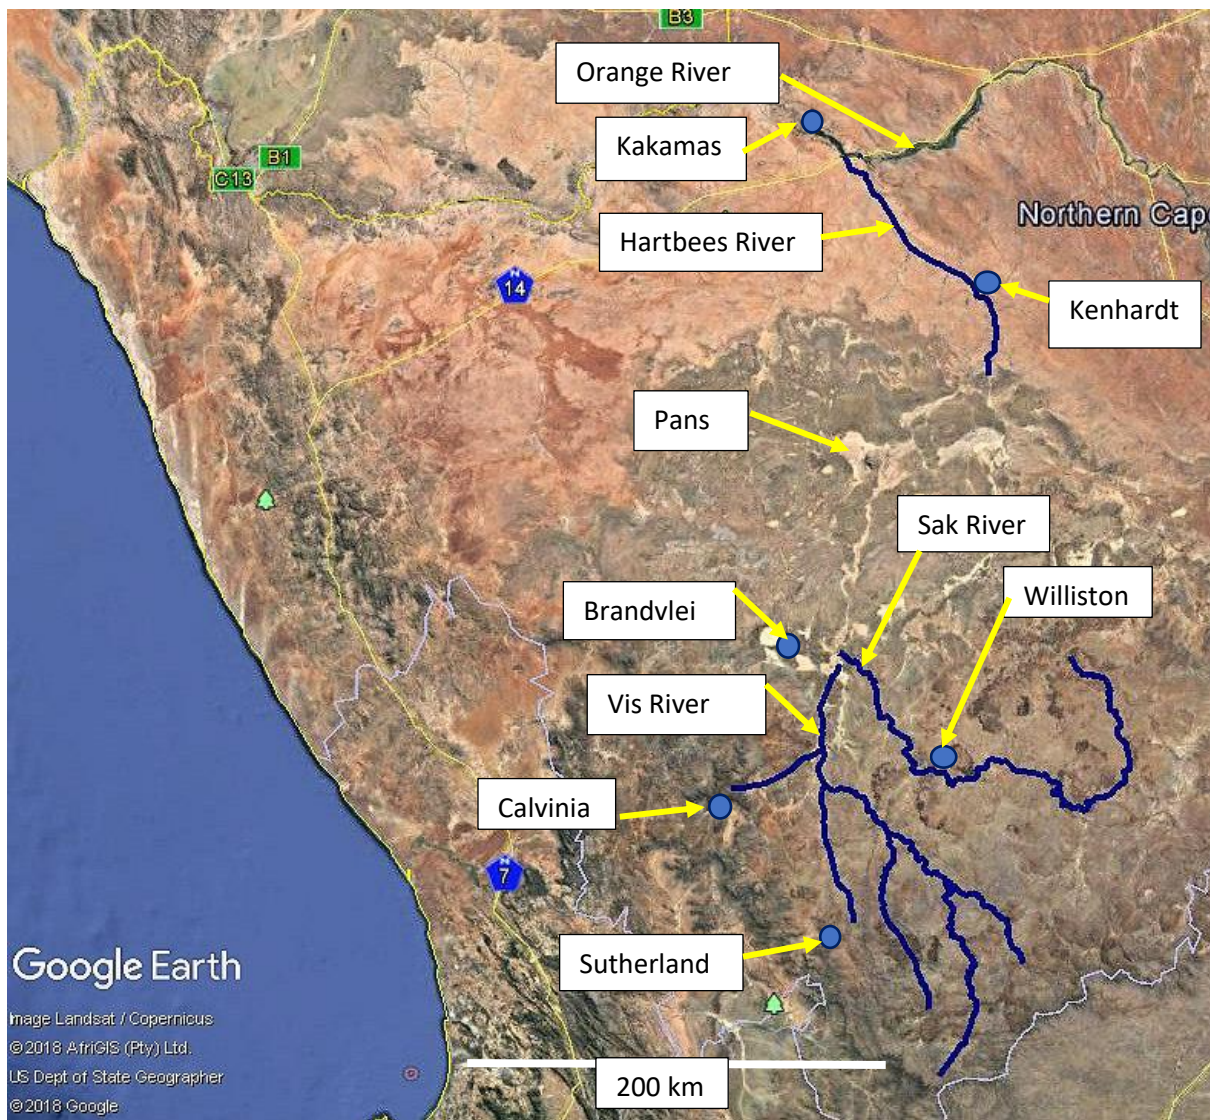
Figure 4 Sak / Hartbees River system

The Hartbees River rises as the Vis River on the highlands to the south of Sutherland more than 450km to the south (Figure 4).

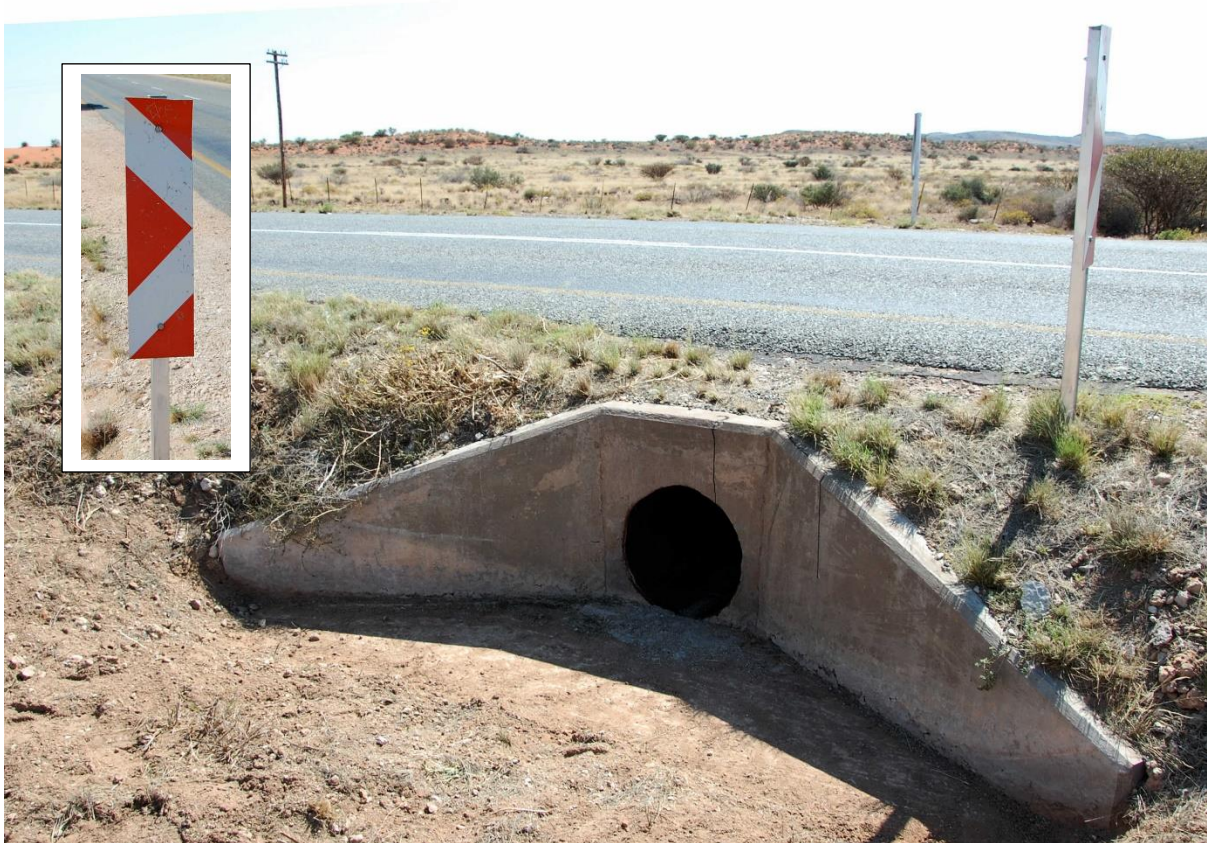
Figure 6 Class 1 drainage line with pipe culvert.

Classes 1 (Figure 6), 2 and 3 were only counted. Class 4 and 5 were marked, the coordinates were noted, using a hand-held GPS. These drainage lines were photographed, upstream and downstream of the road, as well as the culvert or bridge.

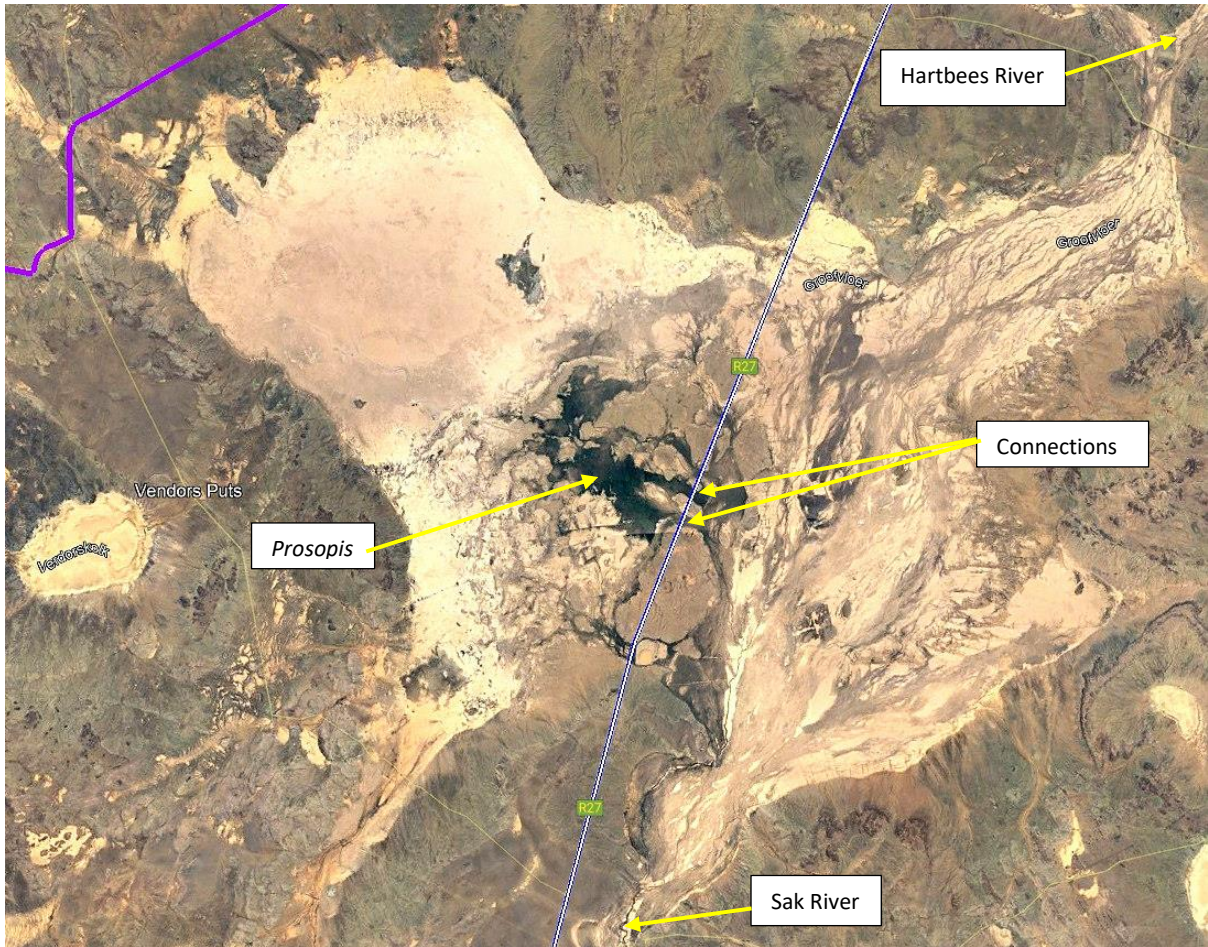
Figure 8 Grootvloer

The Grootvloer (Figure 8) is one of the bigger pans in the central Boesmanland and is a prominent feature on the landscape. It is roughly divided into a western part of 29000ha and an eastern part of 27000ha. This adds up to 56000ha. These two parts are connected. This connection in the north resembles the rest of the pan in the north. In the central part and further south, the connections resemble drainage lines (Figure 8).

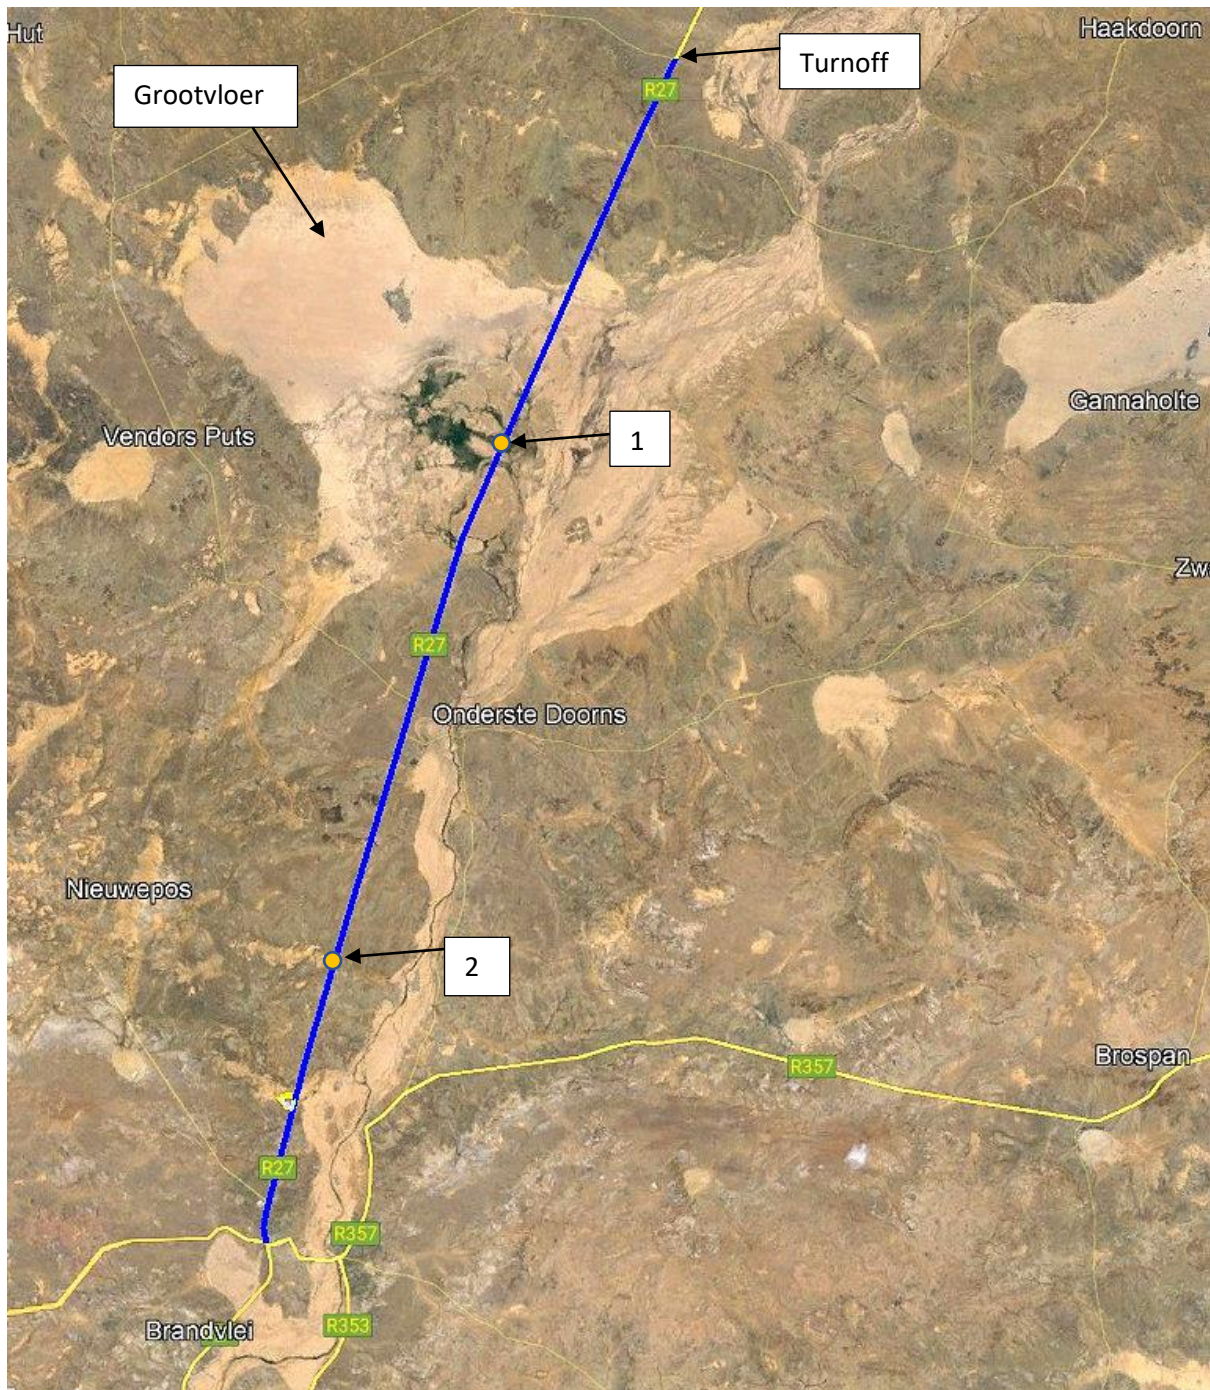
Figure 9 Proposed pipeline from the Turnoff to Brandvlei.

The R27 trunk road transverses a pan named Grootvloer. This is for the most a mixed grass pan. A large part is a scrub pan, with many variations between grass and scrub. The central part is heavily overgrown with *Prosopis* that is visible on Google Earth images a dark-coloured patch (Figure 9). Adjacent to the south is a stand of sweet thorn trees.

Likewise, the Class 4 drainage line at Oom Benna's (Number 2 in Figure 9) proved to be a connection of a much smaller pan sub-system (Figure 13). The diffuse line of pans to the west connect to the Vis River and its associated pan to the east. Again, water movement here seems to be in unison with the filling of the pans rather than a result of large thunderstorms. The pan and the connection were modified with 5 or more walls across for the retainment of water for agriculture. Water, when available, in the district is shunted around in pipelines with pumps. Perhaps the many small dam walls here are part of the same arrangement.

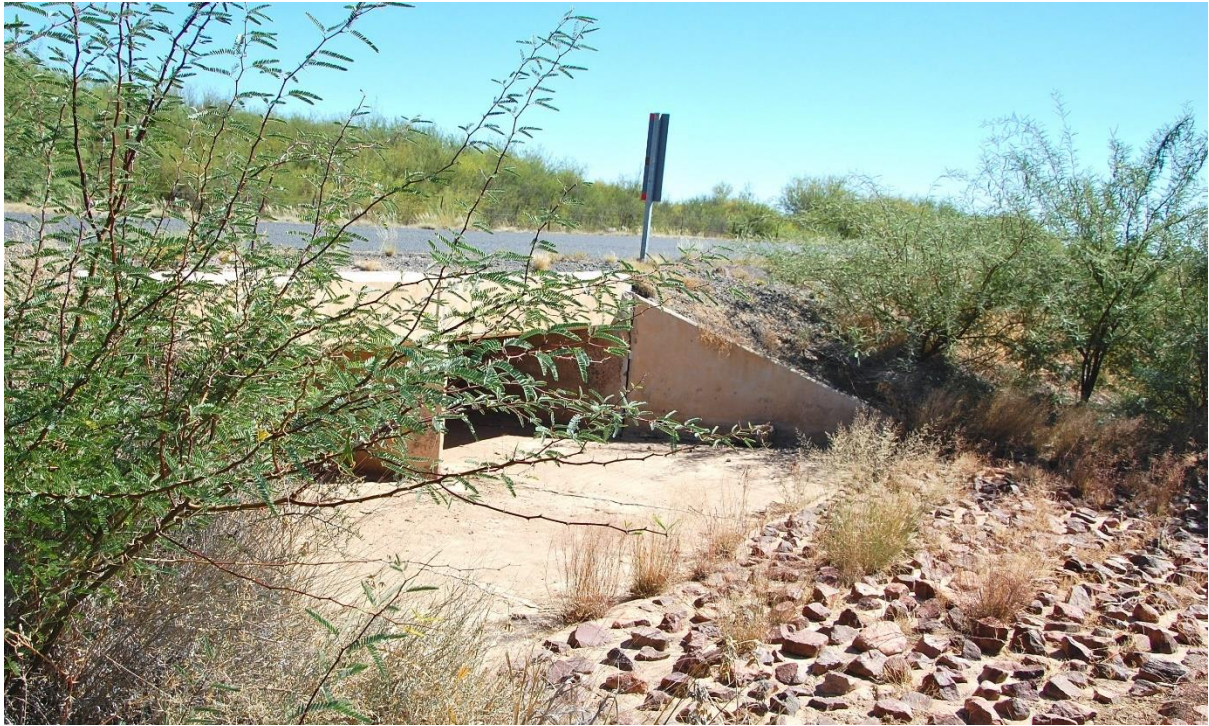
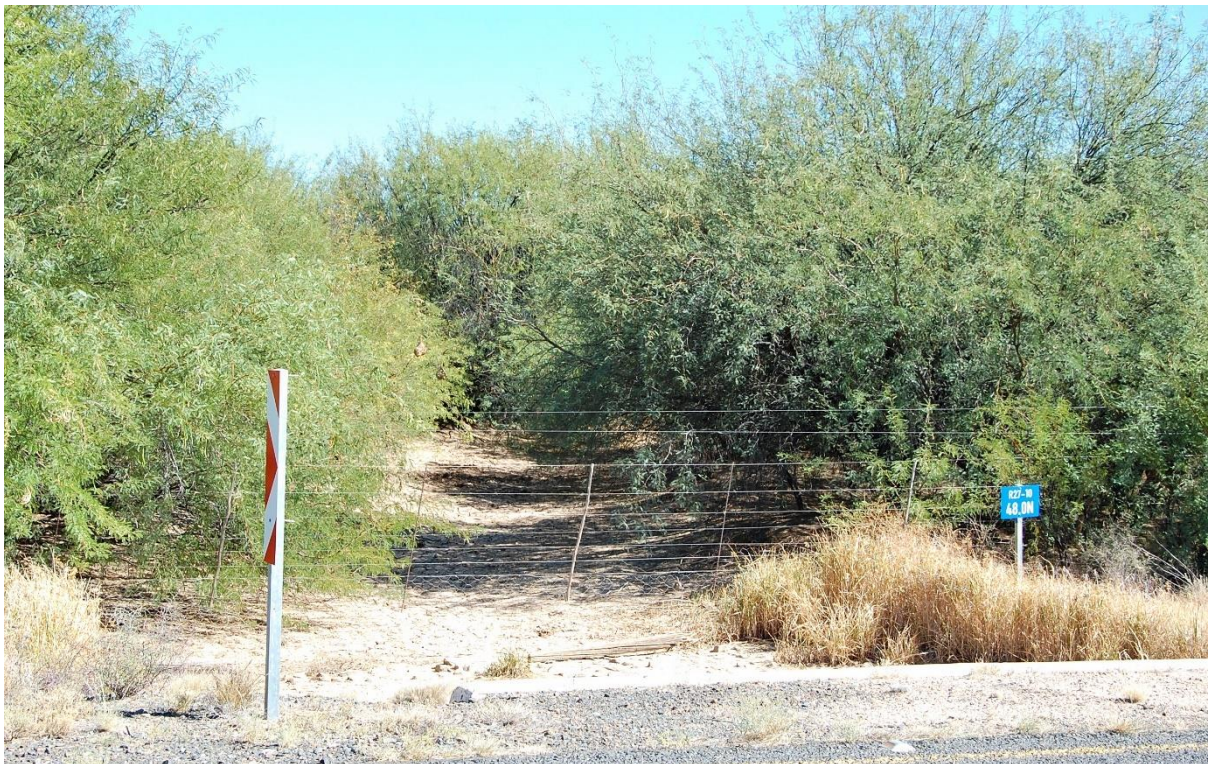
Figure 10 Point No 1

The first Class 4 drainage line (Figure 10) is a connection between two parts of a large pan on either side of the R27. The pan here is densely overgrown with *Prosopis* trees (Figure 10). The drainage line has a constructed two-arch culvert. Downstream and adjacent to the road is a concrete slab and a reno mattress-type reinforcement of the drainage line bed.

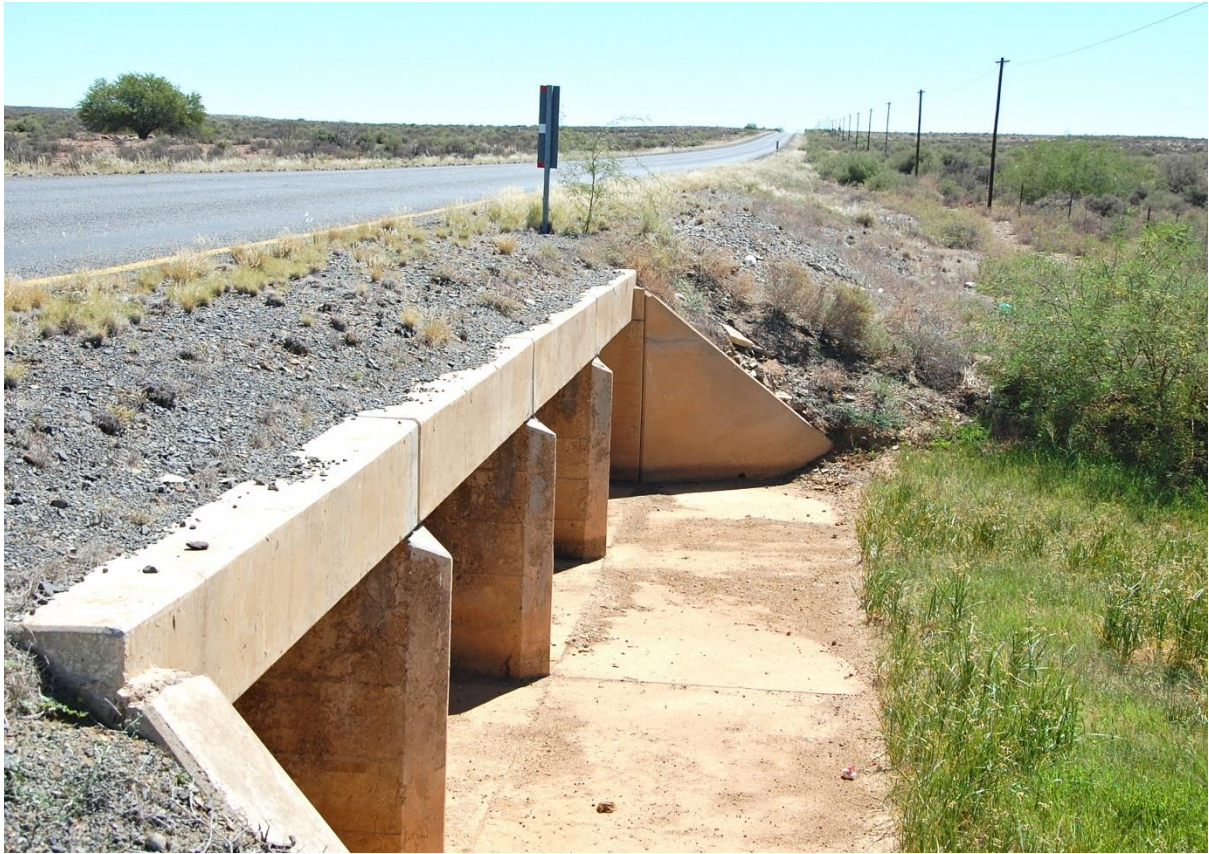
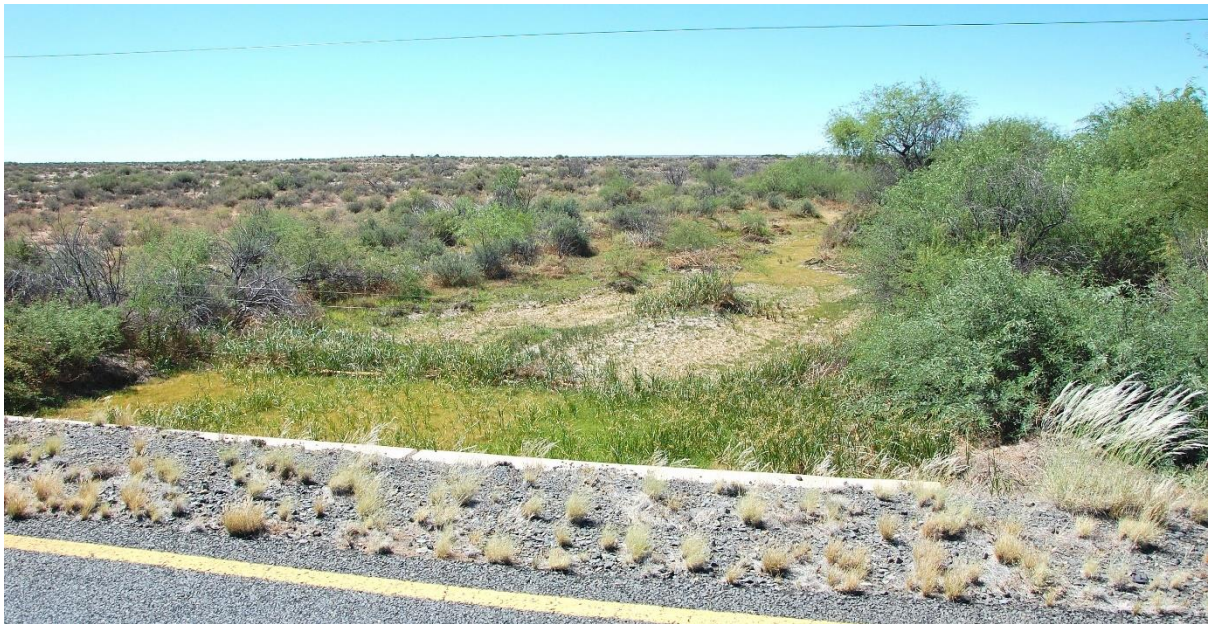
Figure 11 Point No.2

The second Class 4 drainage line is at the well-known Oom Benna's roadhouse. The drainage line is vegetated, with some aquatic plants in the bed (Figure 11). The one bank is overgrown with *Prosopis*.

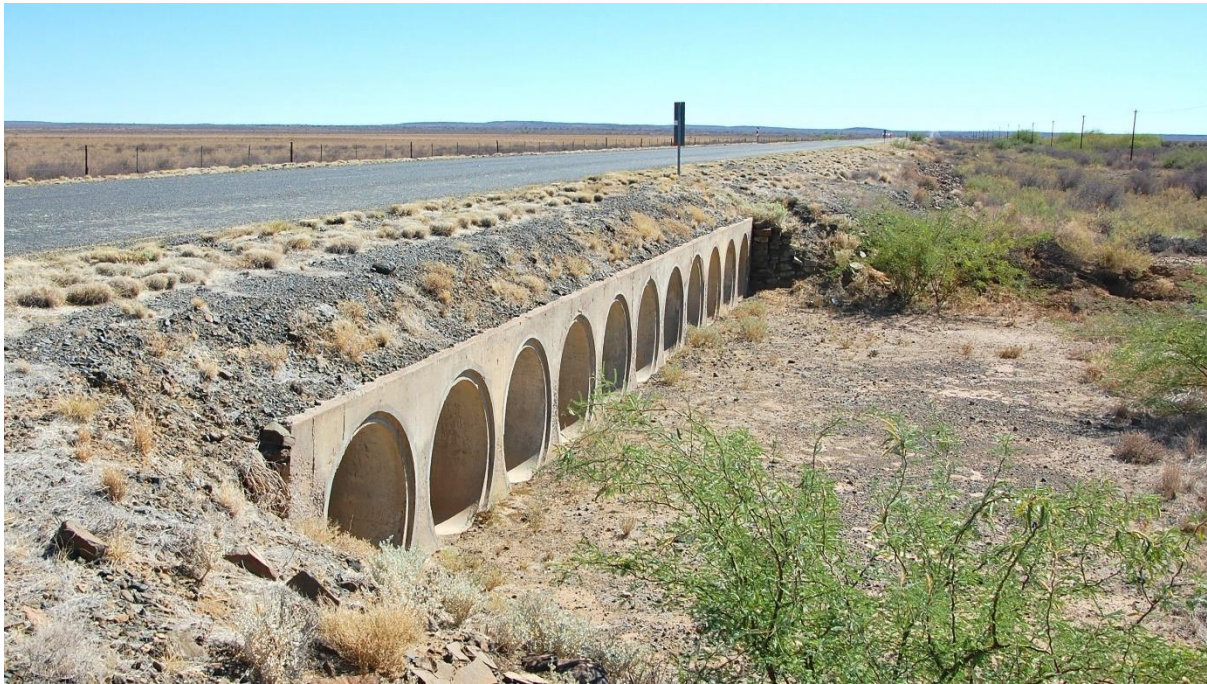
Figure 12 Grootvloer culvert

During rare occasions when the pan is under a shallow layer of water after heavy rains, wind-induced water movement can be expected, moving water over such a vast surface area from one end of the pan to the downwind shore. This could theoretically create enough velocity to bring about soil erosion. Such erosion would then be apparent at the many R27 culverts and the drainage lines. This, against expectations, does not occur. The water must be gently rising and falling with rainfall events without much wind-induced movement, as sediment transport is not apparent (Figure 12). The road engineers were probably expecting more movement as well, as some of these culverts are large (Figure 12).

This bodes well for the pipeline construction, as the points where the pan passes under the road can mostly be classified as Class 1. No extra construction or protection of the pipeline is required along most of the way to Brandvlei.

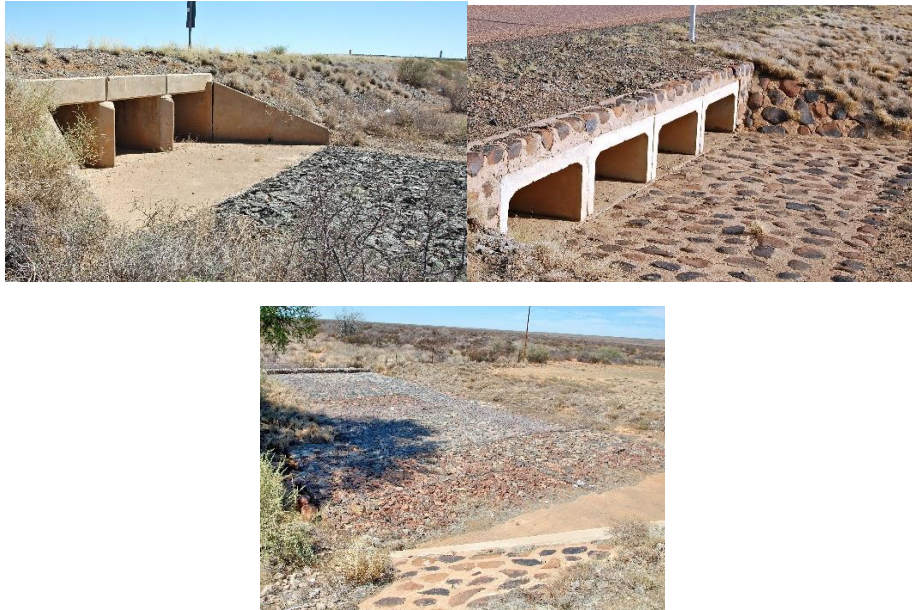
Figure 14 Stormwater calming infrastructure.

If it is necessary to even further pave culvert exits, it may be done so with rock and cement, with a special effort to create a rough surface with much flow resistance to

slow stormwater down. At the far end, on the verge of the pavement, bigger rocks can be placed and cemented in to finally break up the current (Figure 14).

Observations on the ground suggest that people drive their vehicles over drainage lines in the road reserves, for whatever purpose. The rock and concrete paving must therefore be of such a nature that the usual pickup truck can still drive over it.

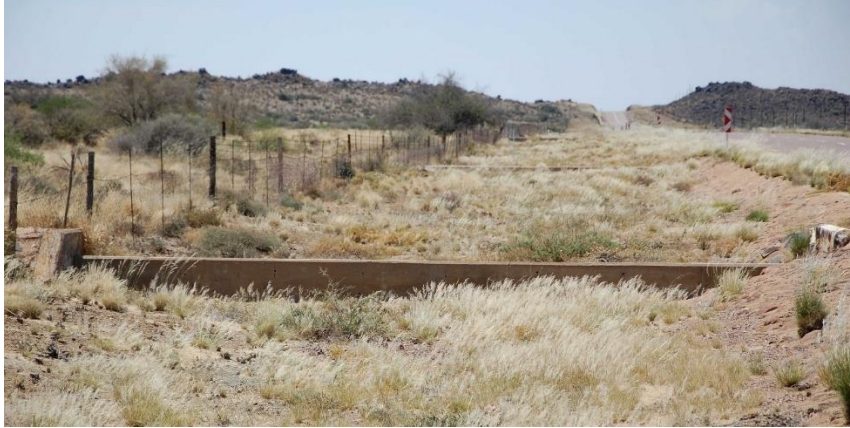
Figure 15 Flood control walls

To the south of Kenhardt, on the southern slope of a dolerite ridge, are 8 walls in the road reserve for the purpose of flood control (Figure 15). These will have to be demolished for the pipeline to be trenching and afterwards be fully restored.
