## **Freshwater Report**

for the further development of agricultural operations on

### **Farm 91, Riversdale**

A requirement of Section 21(c) and section 21(i) of the National Water Act (36 of 1998)

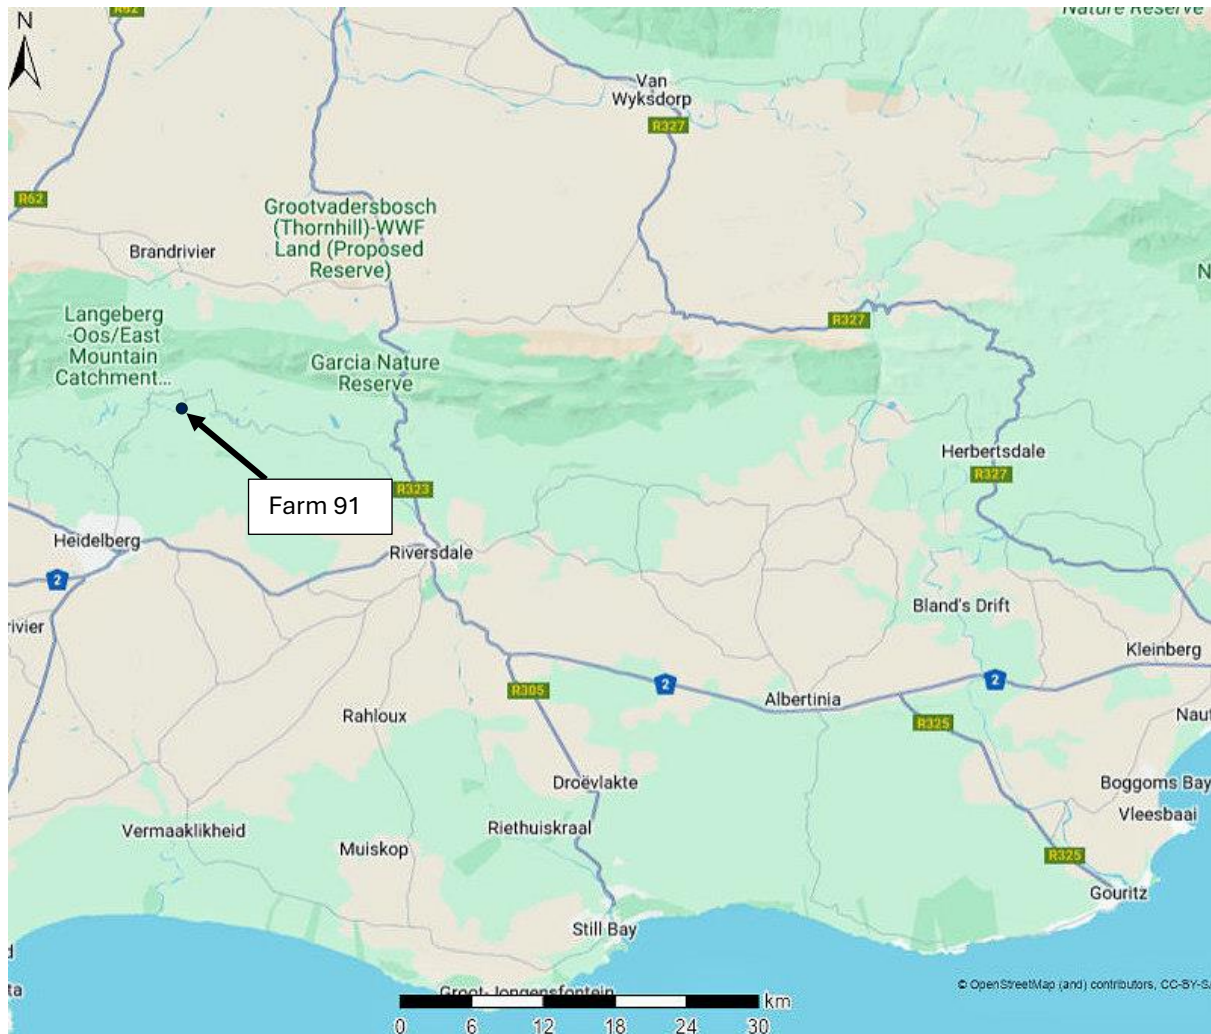
**Figure 1** Location

Farm 91 is located 15km to the northeast of Heidelberg on the N2 highway (Figure 1). The farm is on the northern banks of the Duivenhoks River and on the southern slopes of the Langeberg.

Figure 1 is a map of the property.

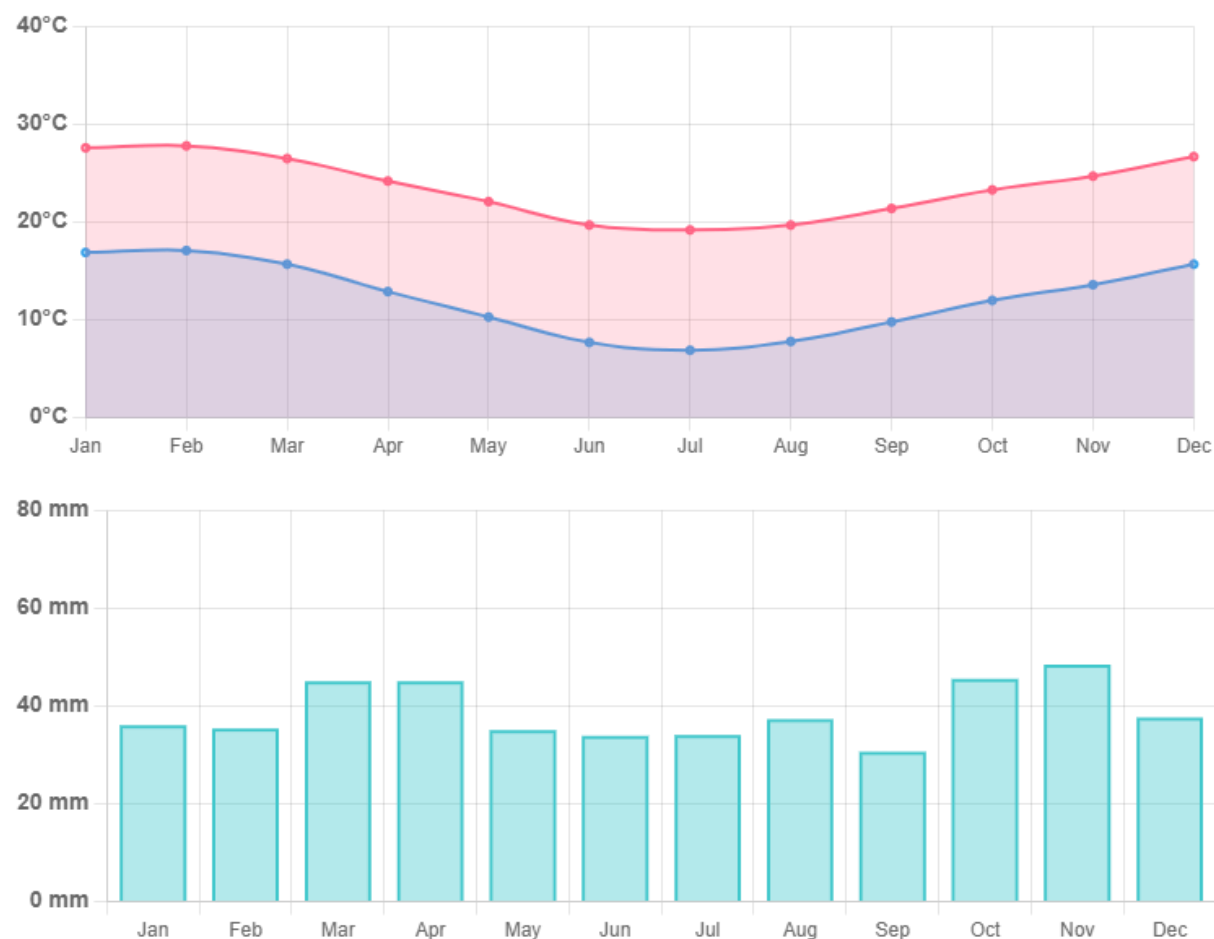
**Figure 2 Heidelberg climate**

Moreover, rainfall is highly variable, with period of abundance, but also with period of droughts. Some of these droughts predictably outlast the tolerance of permanent crops. The storage of water in farm dams when the rivers out of the mountains come down strongly is mandatory to outlast the times when the rivers run dry.

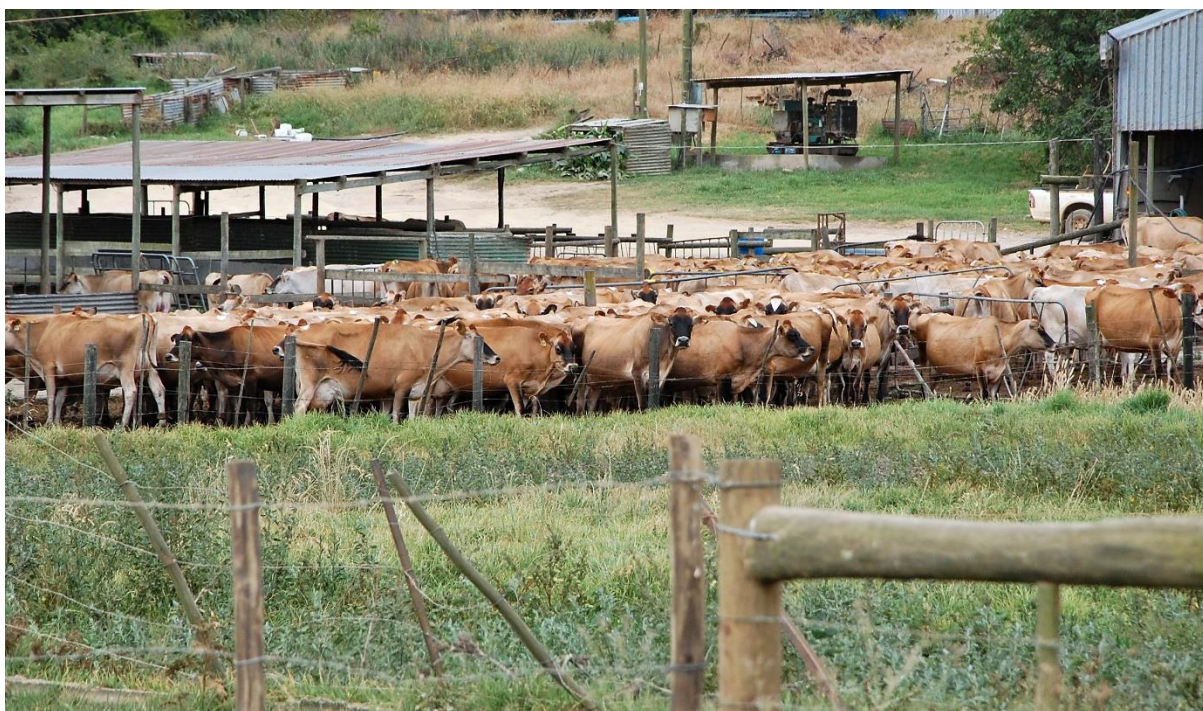
**Figure 5** Dairy in the upper catchment

The southern slopes of the mountains are proclaimed nature reserves and mountain catchment areas, with patches of Afromontane forests. The foothills and the upper catchment are heavily farmed with dairy (Figure 5), fruit and cash crops.

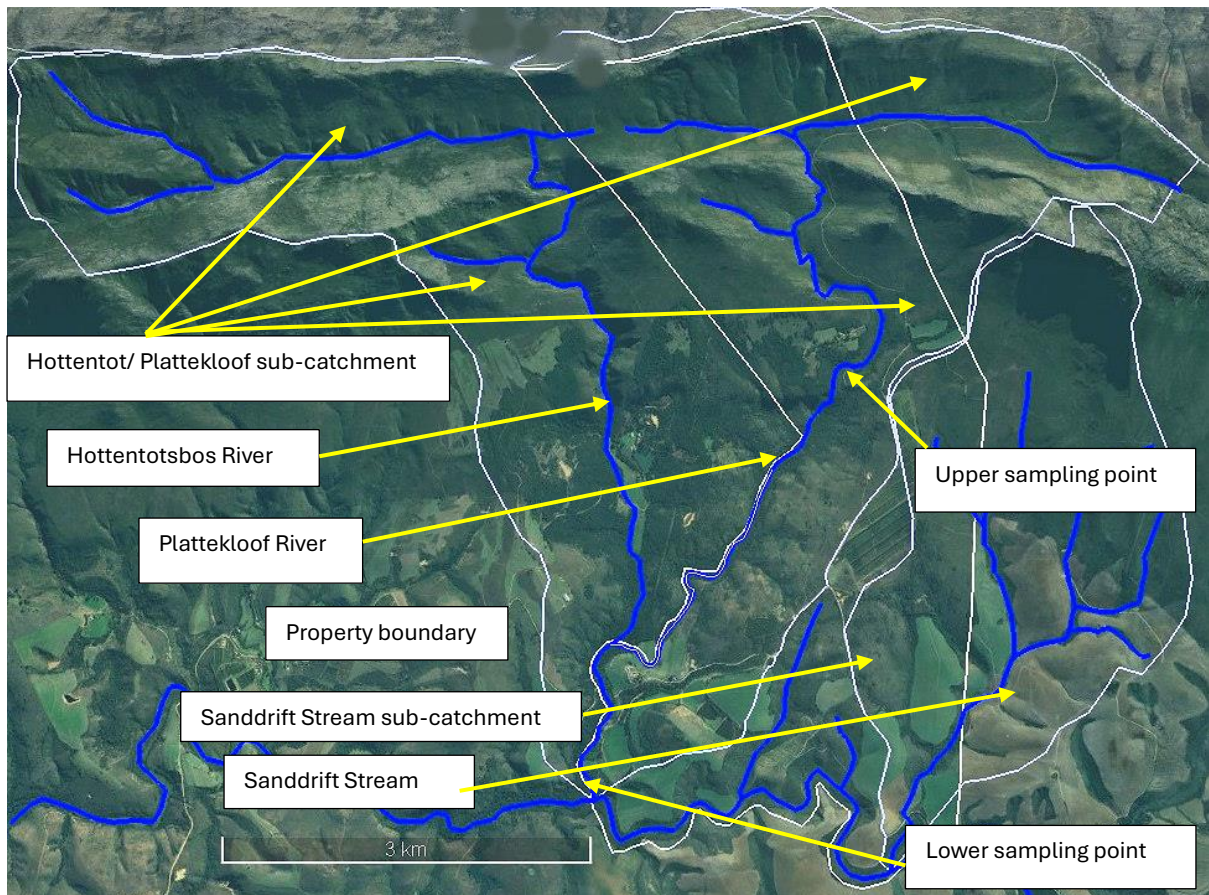
**Figure 9 Farm 91 Sub-Catchments**

The Sanddrift Stream (Figure 9) along the eastern boundary of the property is of interest since it has the dam that must now be assessed. It is a much smaller stream than the Plattekleof River, with a sub-catchment area of 848 ha. It was running at an estimated rate of  $5\text{l s}^{-1}$ .

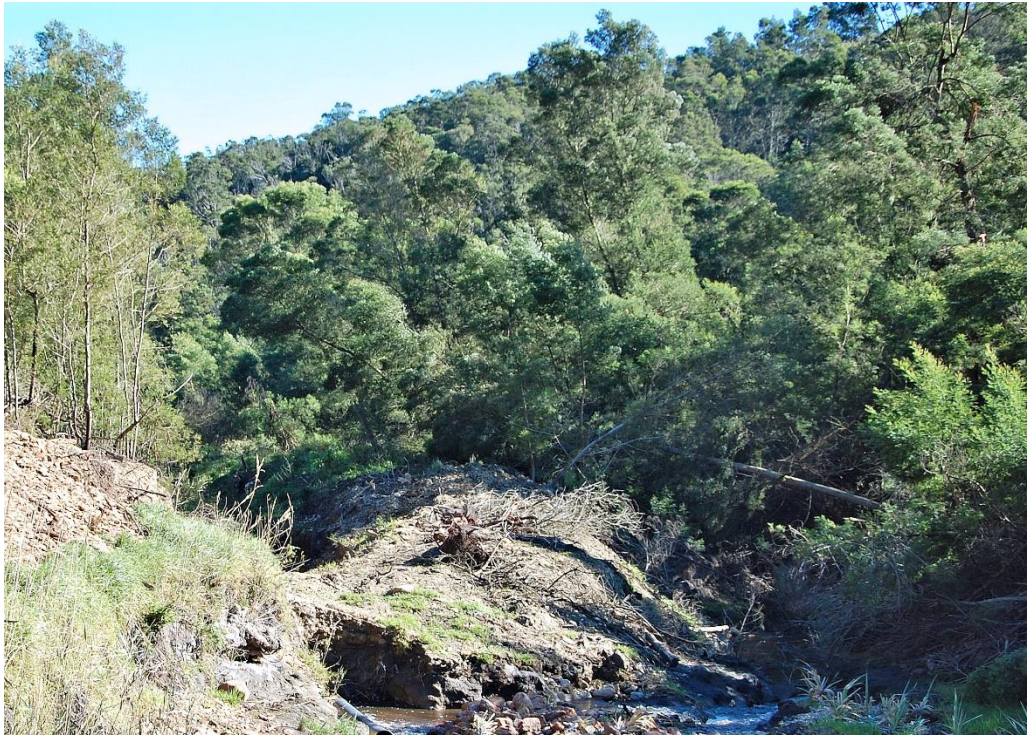
**Figure 10** Black wattle

The rivers are in deep valleys, entirely overgrown with a dense and mature stand of black wattle. This is the same as the district, the Western Cape and much of the country, where black wattle has become a serious environmental impediment. The monostand of black wattle completely replaced river Fynbos (Figure 10). Wherever it takes hold, the riverbanks erode, with the riverbed deeply incised.

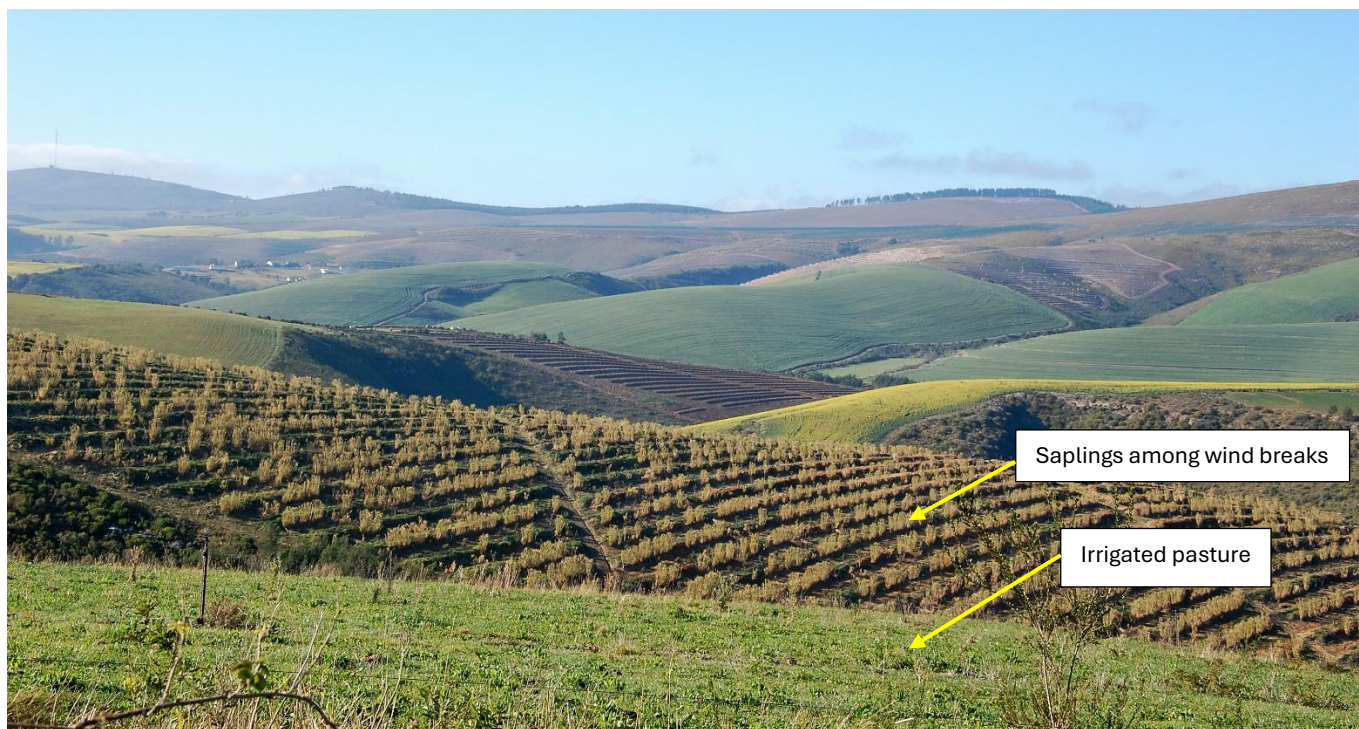
**Figure 11** Development

The landowner intimated that a small dairy operation that reached its optimum level of production with the land and resources available must change if growth and profitability were to be maintained. Following much deliberation and serious research, the first avocado trees were planted (Figure 11). The development of pastures for grazing cattle into orchards is now in full swing, with macadamia nuts added.

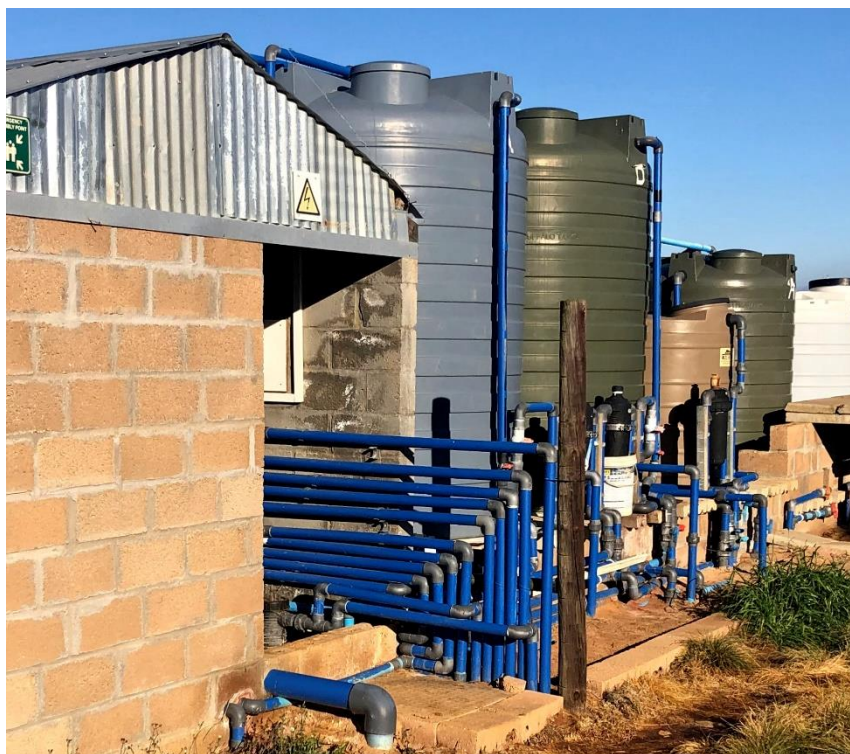
**Figure 12** Irrigation system

Drip irrigation significantly reduced the volume of water that is now applied to farming. This is a highly scientific and technical operation, uniquely developed and coded inhouse on the property, computerised and remotely controlled, with each tree receiving just enough water and fertilizer to maximise profitability. The elaborate system of pumps and conduits spread out all over the property bears testimony to the level of sophistication (Figure 12).

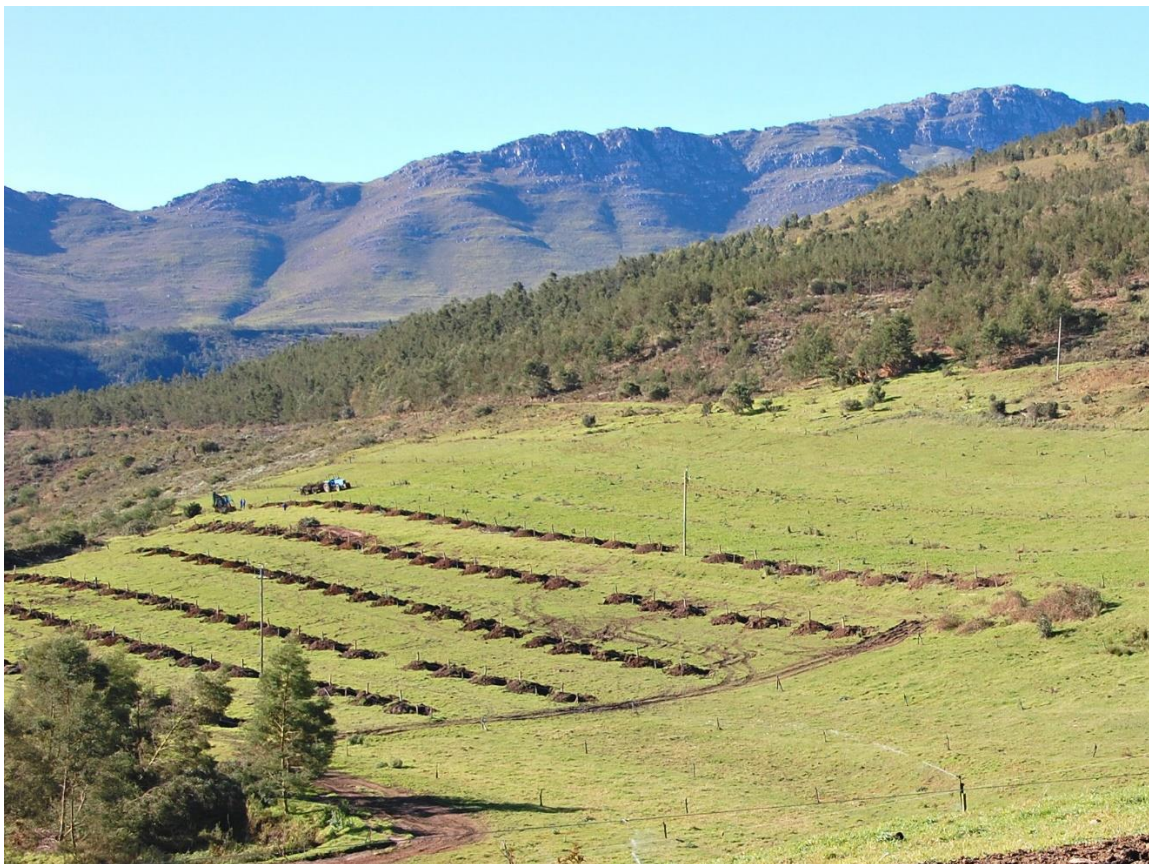
**Figure 13** Land irrigated with dairy effluent

The effluent out of this facility is collected in a series of holding ponds, where it is partially treated. From here the treated effluent is irrigated on land. This land is now being transformed into orchards (Figure 13), in support of the development policy for Farm 91.

A professional investigation was carried out on the quality of the effluent and the impact in the irrigated land. The impact proved to be acceptable. The report is available for official scrutiny and assessment.

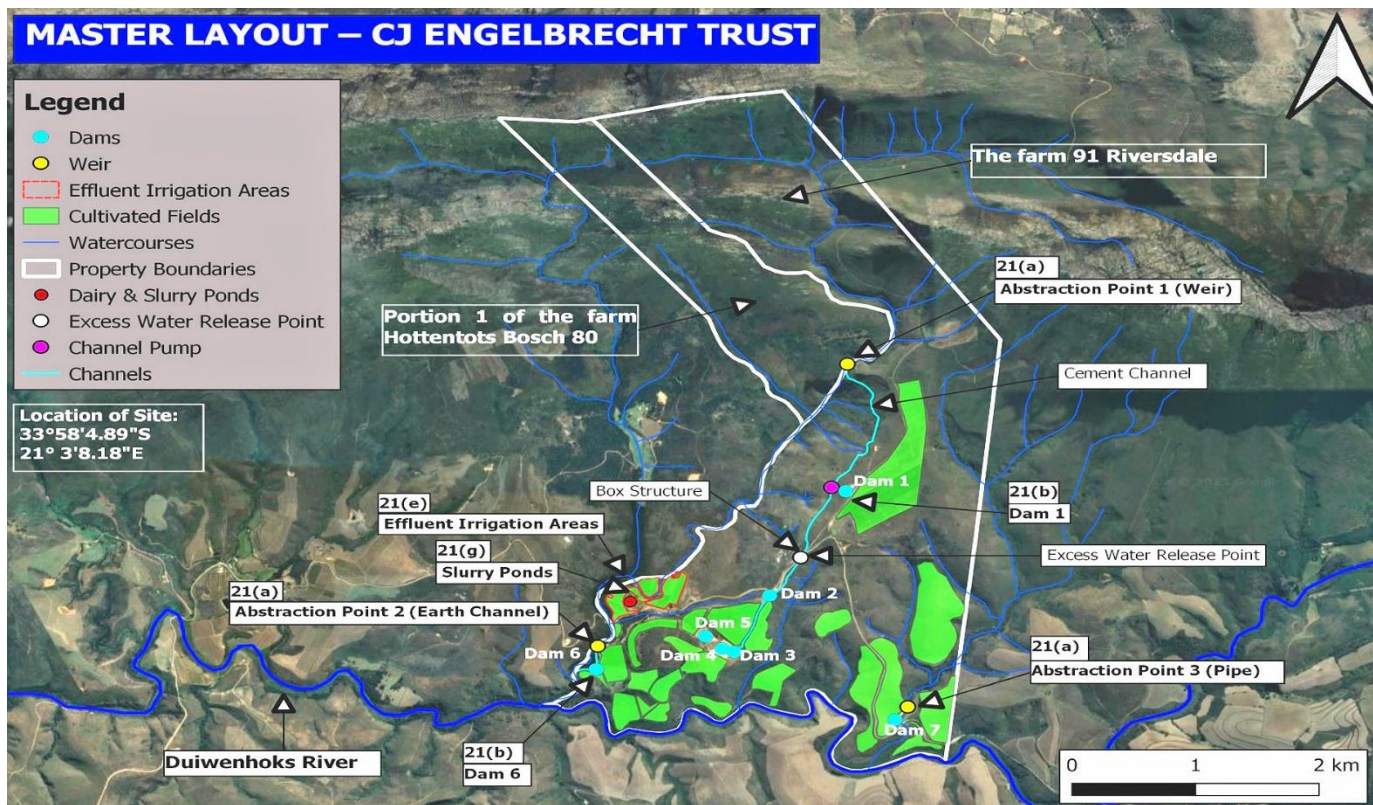
**Figure 14** Water infrastructure (Mr Albert Engelbrecht)

The water infrastructure (Figure 14), consisting of a dams, conduits and pumps will be fully dealt with in the water balance, as the BGCMA required. As can be seen on the diagram, this is quite an involved and integrated system. Some of the features are photographically recorded to enable decision-makers and officials to form an impression prior to conducting site visits. Only Dam No.7 is under discussion in this report, in accordance with the BGCMA notice.

There are three points on Farm 91 where water is taken out of the rivers. The main one is in the middle Plattekloof River (Figure 14). Here is a prominent concrete weir and two large pipe conduits that take water down the incline all the way to Dam No. 3, 4 and 5 (Figure 15).

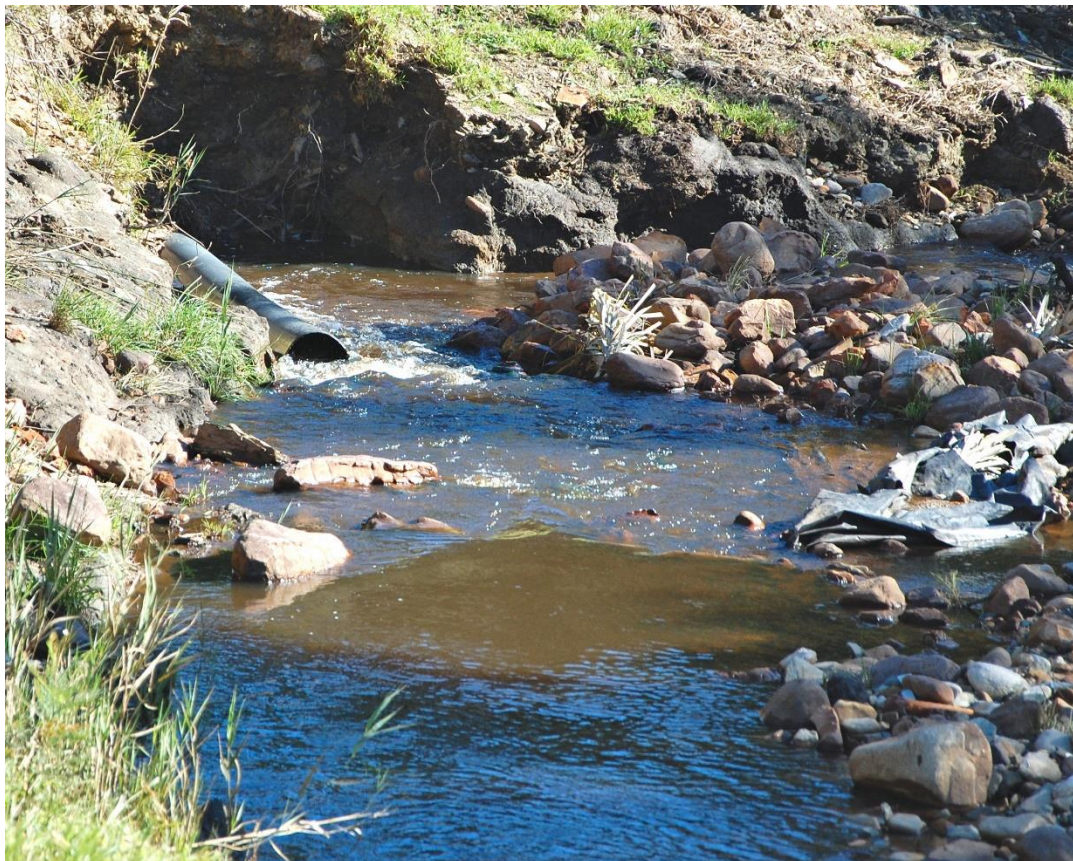
**Figure 17** Lower Platteklouf River take-off.

The next abstraction point is in the lower Plattekloof River (Figure 17) downstream of the confluence with the Hottentotsbos River (Figure 14). Downstream from the take-off point is a small dam (Dam No.6, Figure 18) that receives water from this take-off point and that serves as a reservoir for the pump that introduces this water into the irrigation system.

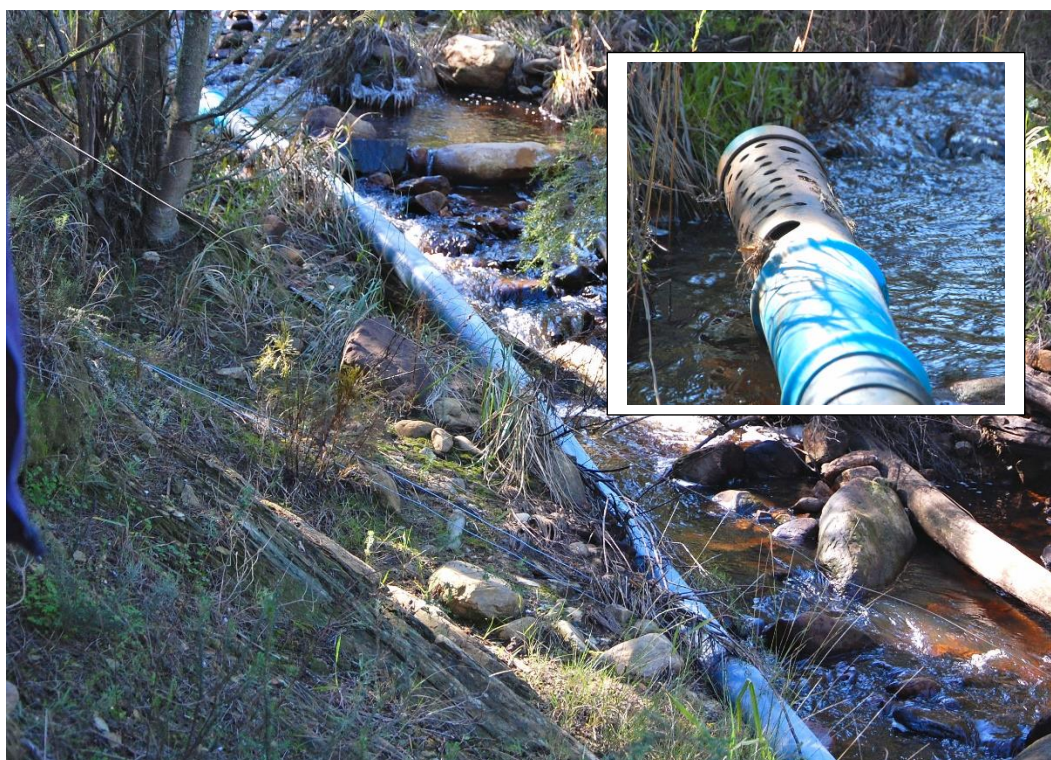
**Figure 19** Sanddrift River abstraction point

The abstraction point is in the lower Sanddrift River (Figure 19). It is a pipe with a screened opening lying in the river. Water entering the pipe is carried into Dam No. 7 (Figure 20). The pipe is dug in underground in the riverbank alongside the river. Water simply gravitates out of the river through the pipe into the dam.

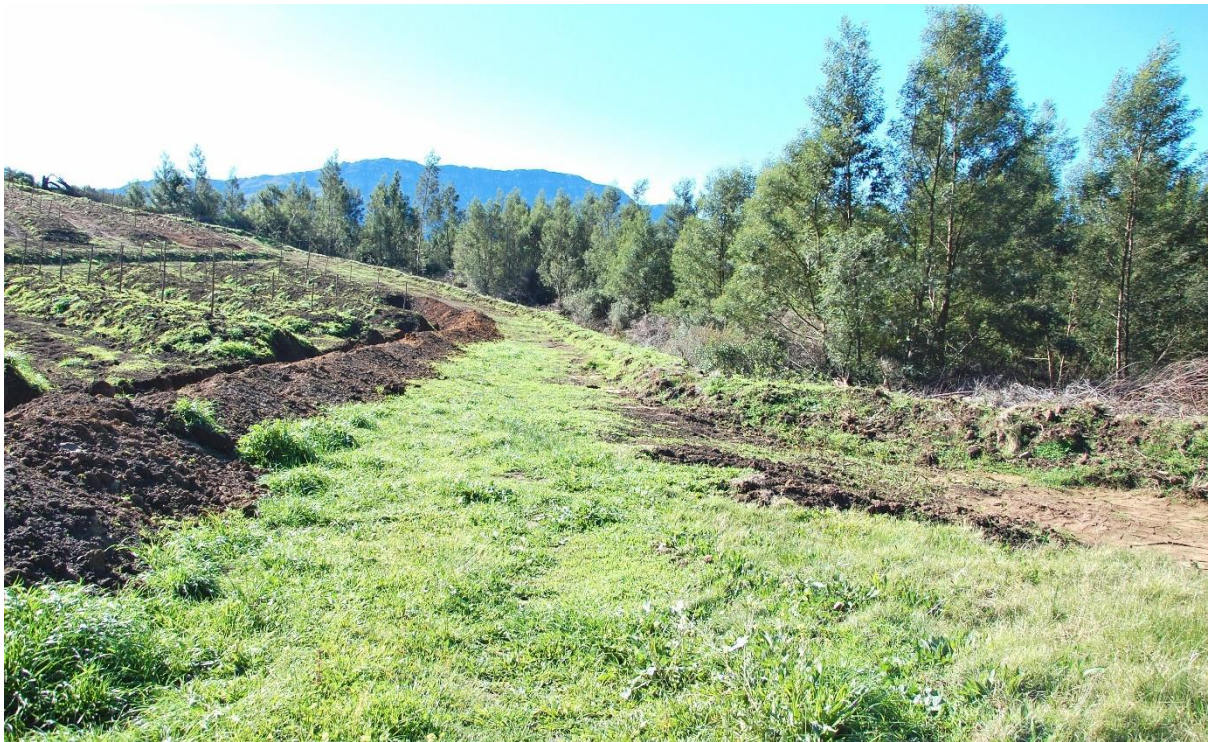
**Figure 21** Berm at Dam No.7

Figure 21 shows that the Sanddrift River at Dam No.7 is entirely overgrown with a mature and dense stand of black wattle. It shows that a new orchard was developed right next to the dam up the slope, with the samplings still small and with the ground still barren and devoid of cover.

A berm was constructed next to the new orchard (Figure 21) that follows the riverbank. Across the river, on the opposite bank, is an irrigated pasture (Figure 22).

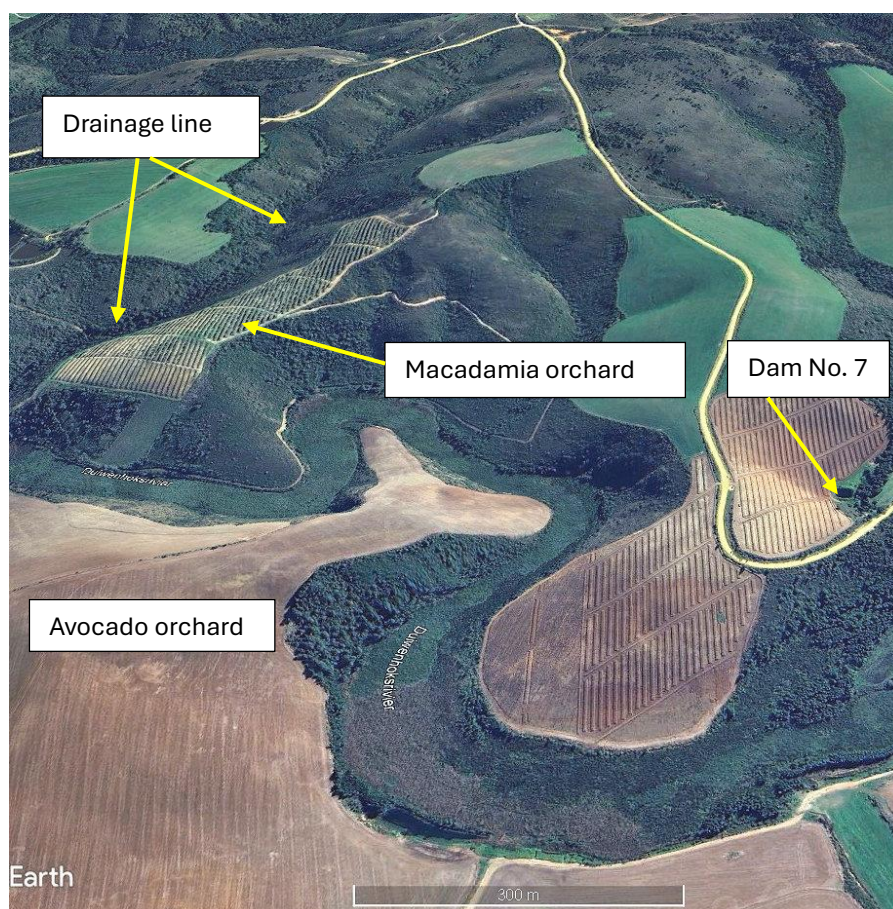
**Figure 23** Orchards

The two orchards under discussion are indicated in Figure 23. They are located close to Dam No.7. The avocado orchard is on the banks of the Duivenhoks River. The macadamia orchard is 140m away from the river but is flanked by a drainage line along its western boundary.

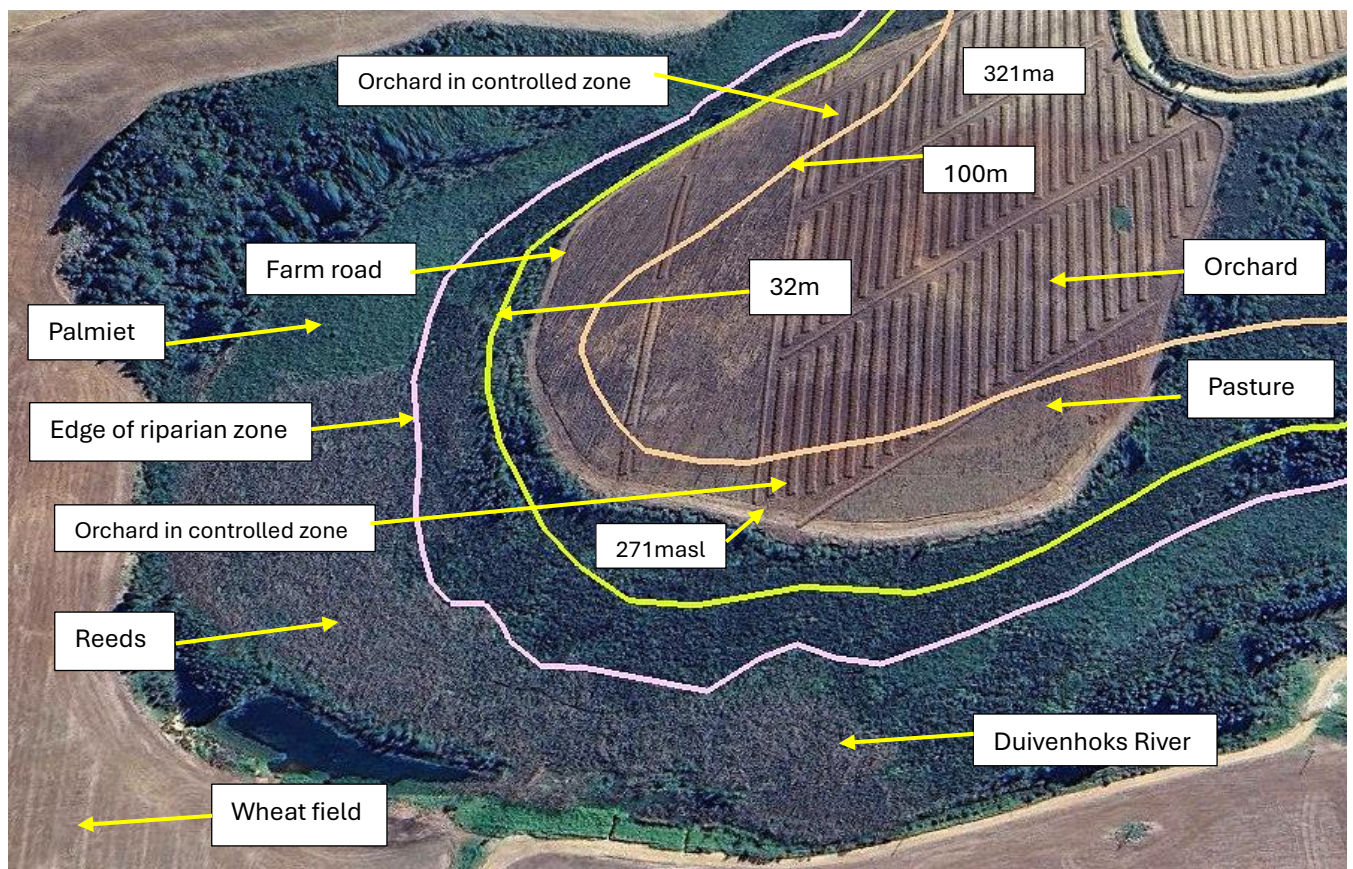
**Figure 24** Avocado orchard 32m and 100m regulated zones

The agricultural land under discussion (Figure 24) first was a wheatfield of 8.9 hectares. This was put under irrigation to serve as pasture for dairy cows. Only 5.7 hectares of this land was development into avocado orchards started in 2022.

The valleys between the orchard's constructed contours act as preferential flow paths, with runoff directed towards the lowest point. This is in the orchard's very southern tip in the bend of the Duivenhoks River. Moreover, even though the irrigation system does not leave any irrigation return flow, unforeseen accidents and problems do happen, with leaky pipes resulting in a soggiess in this area. The landowner offered a solution. A small earthen retaining structure can be constructed, fitted with a pump and a pipe to re-use this accumulation of irrigation water below the orchard.

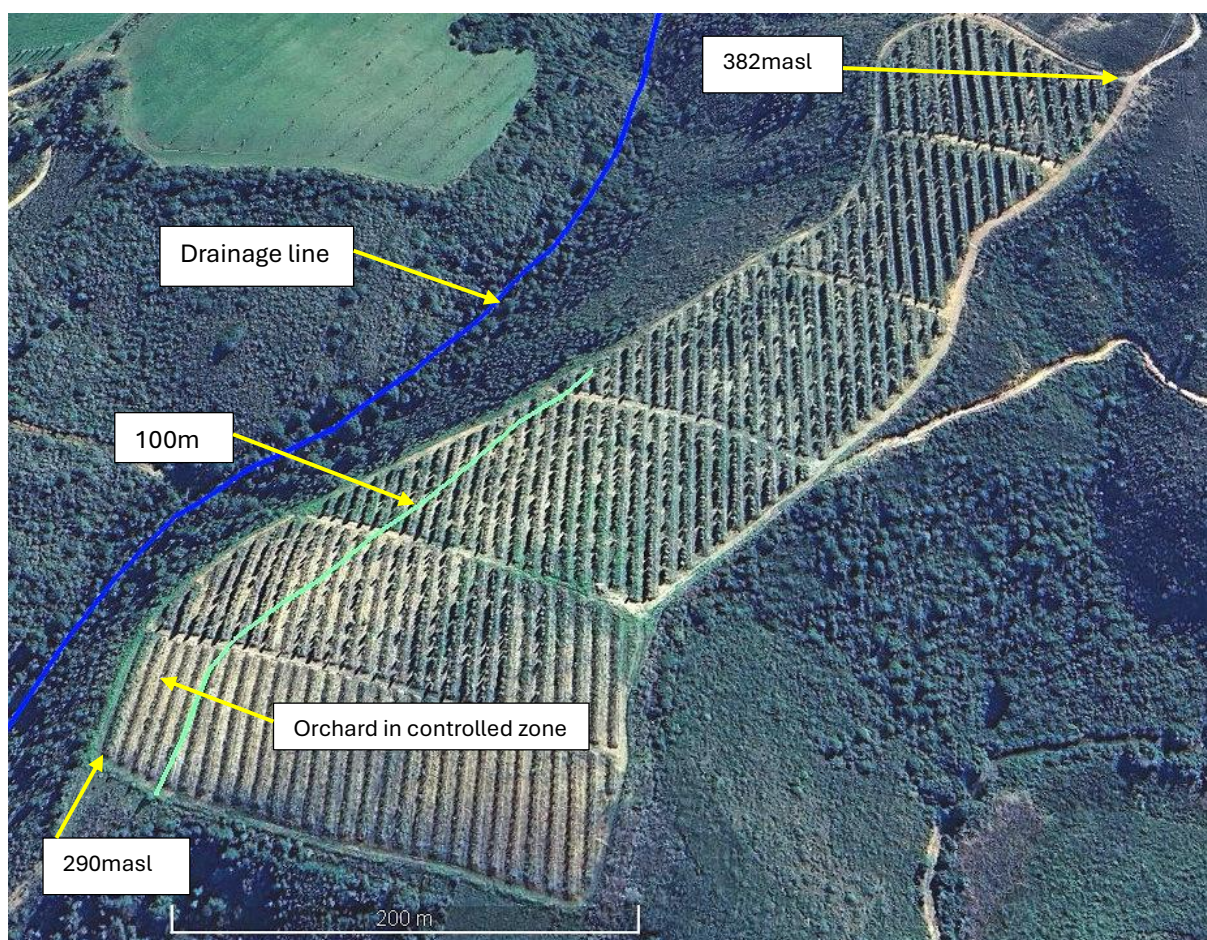
**Figure 25** Macadamia orchard 100m regulated zone

The block of macadamias (Figure 25) covers an area of 9.3 hectares. Only 1.1 hectare is in the 100m controlled zone (Figure 1), close to the drainage line than is a small tributary of the Duivenhoks River of only 1,7km long.

The macadamia block is 623m long, from top to bottom, with the highest point in the north at 367masl and the lowest in the southwestern corner at 290masl. This translates into an average slope of 14.8 vertical metres in every 100 horizontal metres. This is extremely steep, like a mountain side, hardly fit for the establishment and operation of a commercial orchard. Yet, despite these difficulties, it is farmed successfully.

The macadamia orchard is much further away from the river, with a reduced risk of runoff ending up in the river. However, if return flow accumulates at the orchard's bottom end, similar measures must be taken as with the avocado orchard. This wetness must be collected in a suitable and adequate earthen structure and then pumped back into the irrigation system for re-use in the orchard. This wetness is more likely to be the result of leaky pipes than return flow. These pipes must be fixed and maintained.

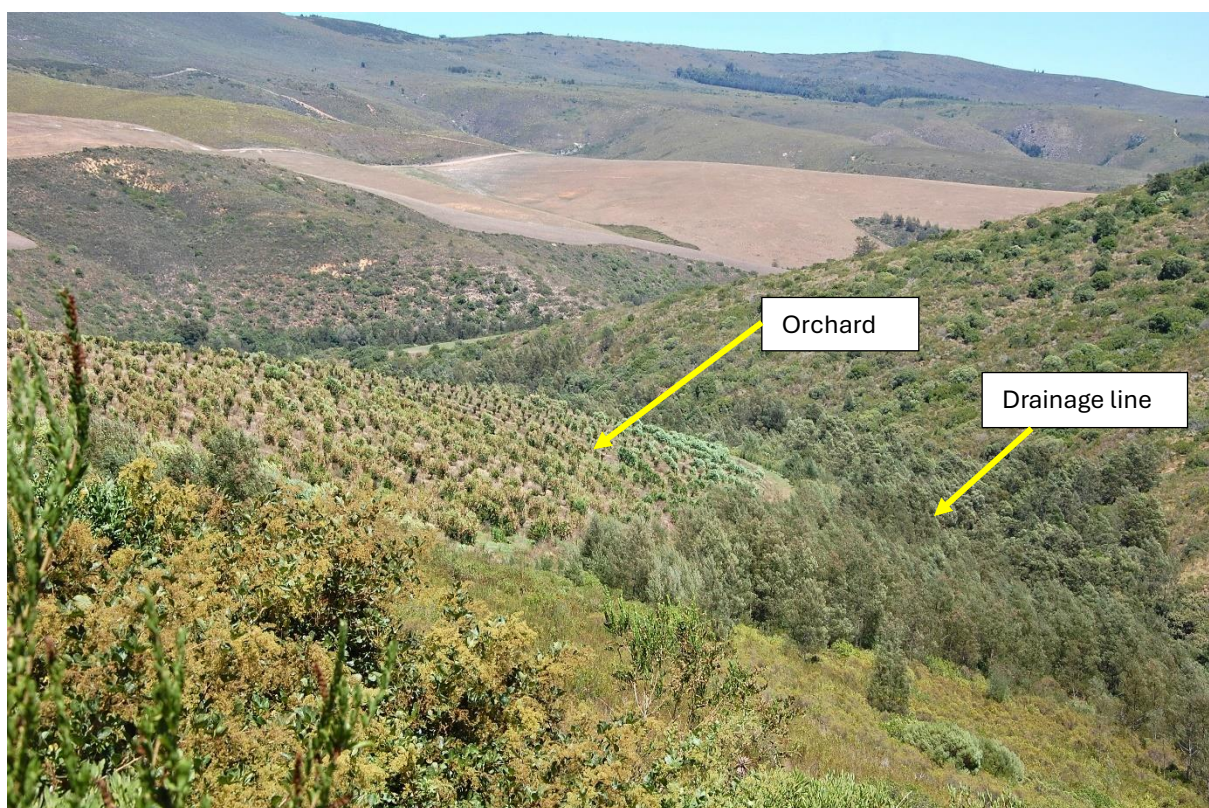
**Figure 26** Macadamia orchard drainage line

The drainage line is densely overgrown with a mature stand of mature black wattle (Figure 26). This stand obscures the real boundary of the natural riparian zone. The 100m controlled zone was measured from where the perceived middle of the stream ought to be.

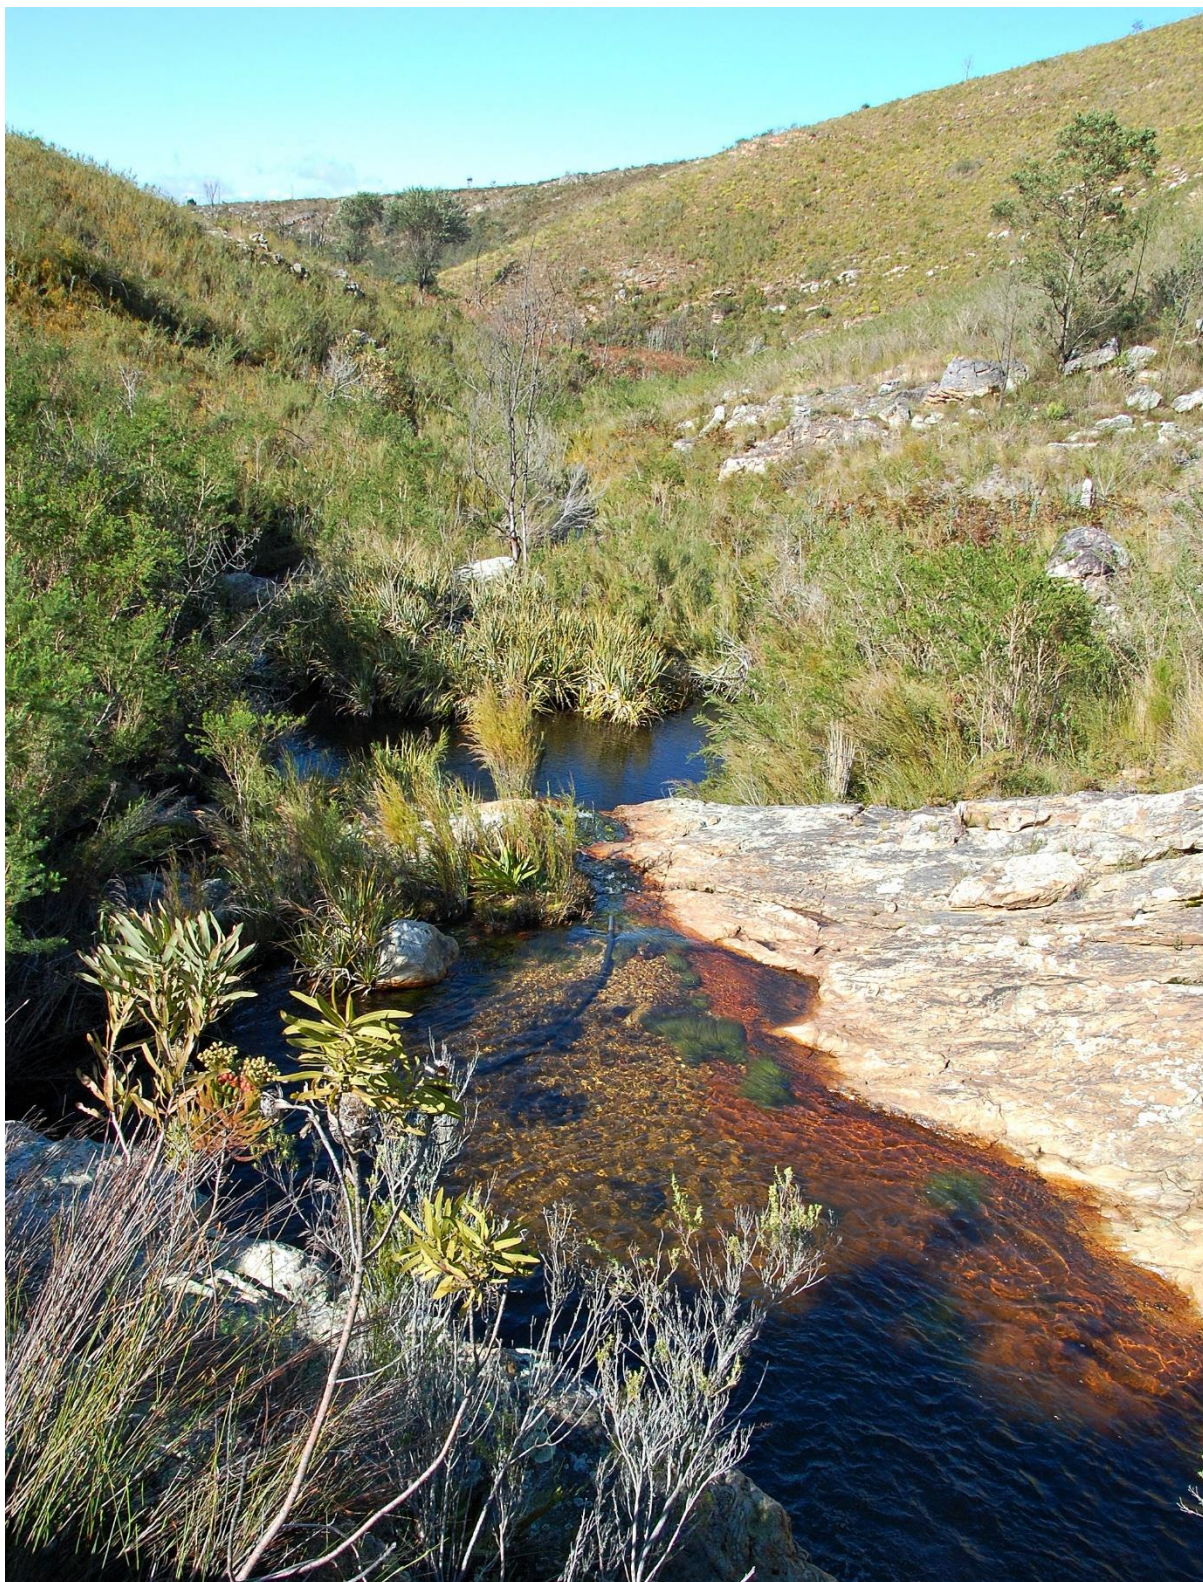
**Figure 27** Upper Platteklouw River landscape

The upper monitoring point in the Plattekleof River was chosen up the mountain side above any farming activities. This was to measure the quality of the river before agriculture had any impact. The river here flows in a deep valley with steep sides (Figure 27). The riparian vegetation is pristine Fynbos. It is higher than the surrounding vegetation, but other than that it does not differ much from the surrounding vegetation up the incline. A most notable difference is the clumps of palmiet (*Prionium serratum*) in the river.

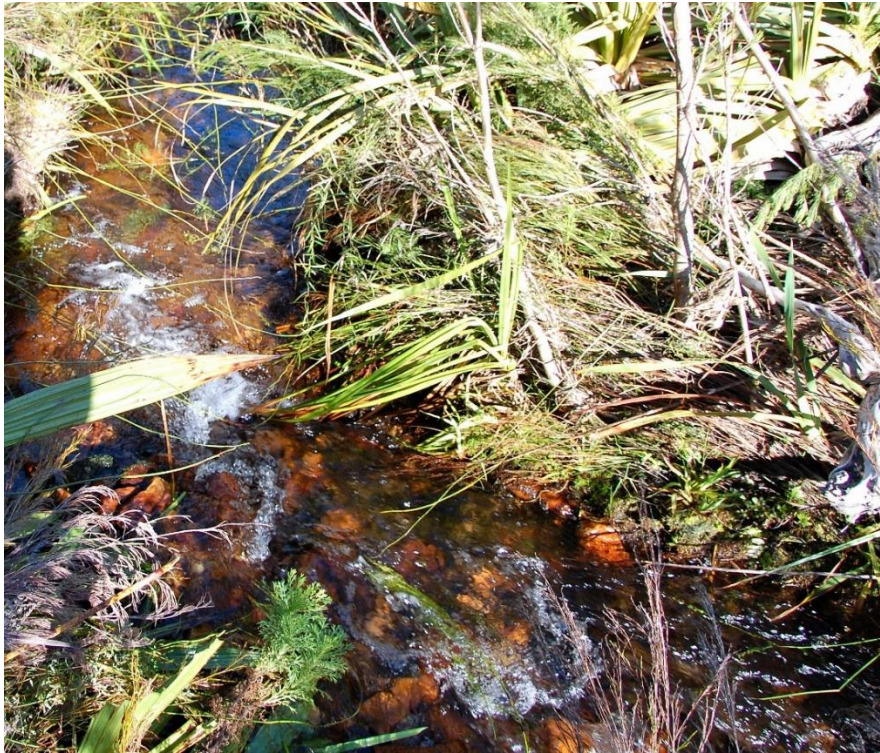
**Figure 28** Upper Platteklouf River sampling point.

The river here was fast flowing (Figure 28), a metre wide, 30cm deep, with riffles and rapids, down the sharp incline of the mountain side. The water was tea coloured, as water is out of the Fynbos. There were many stones-in-current, with some plant roots offering habitat, with overhanging vegetation but other than that, the habitat was not much varied. Just upstream from where the photograph was taken was a clump of palmiet.

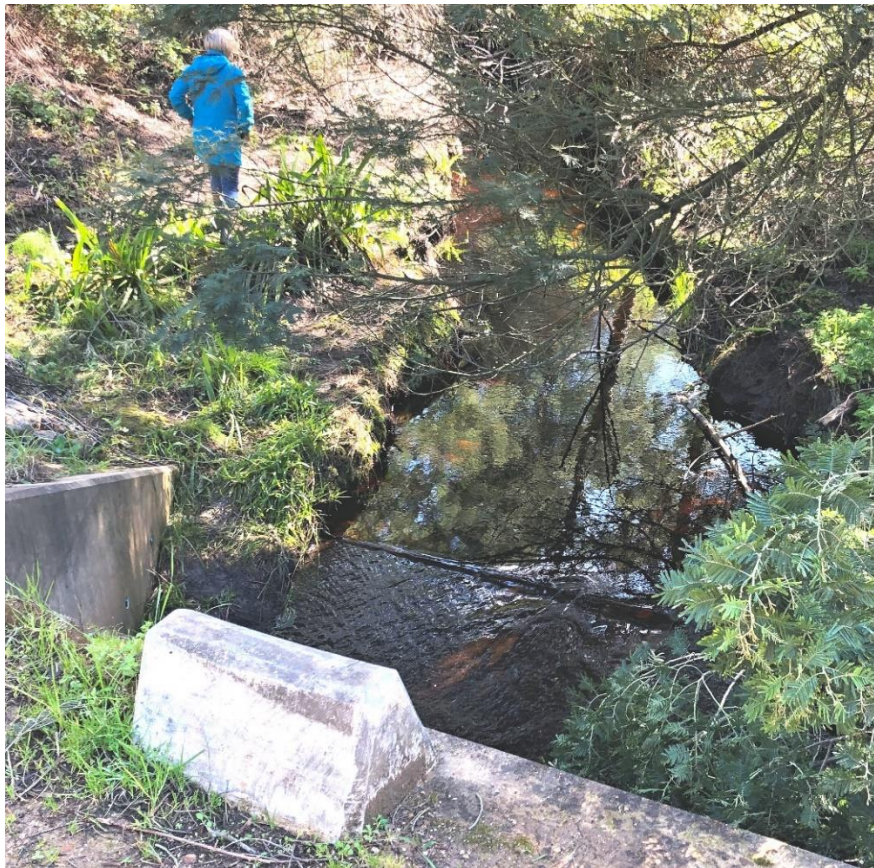
**Figure 29** Lower Platteklouf River sampling point

The lower sampling point (Figure 29) was chosen downstream and adjacent to Farm 91 and upstream of the Plattekleof River's confluence with the Duivenhoks River. The road together with the culvert over the river provided a break in the dense and mature stand of black wattle overgrowing the river. This allowed access to the river for sampling purposes.

The river here was fast flowing, tea-coloured, less than 2 metres wide, 40cm deep and with many-stones-in-current. The channel was straight, as if excavated, but probably only eroded in that way, with vertical muddy banks, with some overhanging vegetation but other than that, with no more variation. The bridge's wide and flat concrete slab provided bedrock habitat.

It was expected that the agricultural impact would show up in the lower sampling point. Much against expectation and surprisingly it did not. The lower sampling point had a significantly better score than the upper one. There was an improvement in the water quality, according to the biomonitoring results, despite the possible impacts of agriculture. It can only be deduced that the impact of agriculture on Farm 91 is negligible. The better score in the lower sampling point can be attributed to the addition of water out of the Hottentotsbos River, of which the confluence is just upstream of the lower sampling point.

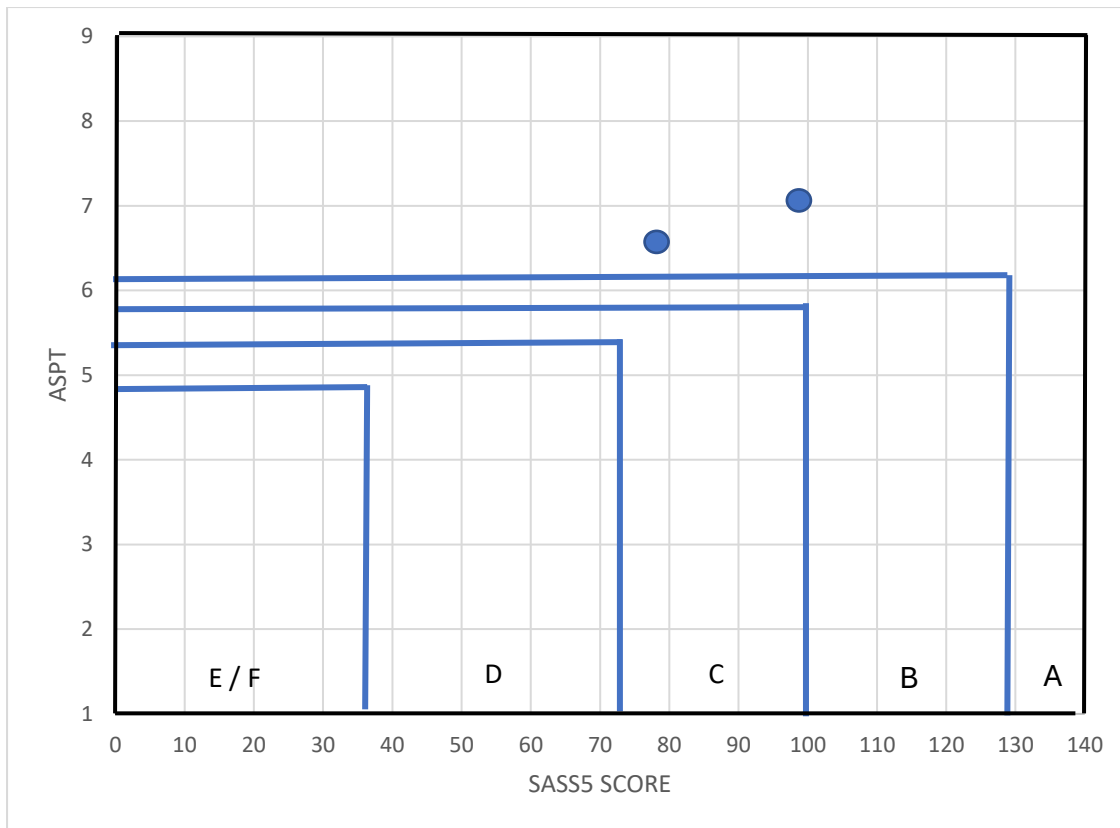
**Figure 30** Biomonitoring results

The water at both sampling points were acidic and very high in dissolved oxygen, as can be expected in Fynbos runoff.

Integrity Class	Description
A	Pristine; not impacted
B	Very Good; slightly impacted
C	Good; measurably impacted with most ecological functioning intact
D	Fair; impacted with some loss of ecological functioning
E	Poor; loss of most ecological function
F	Very Poor; loss of all ecological function
