## **Freshwater Report**

for the further development of agricultural operations on

### **Farm 91, Riversdale**

A requirement of Section 21(c) and section 21(i) of the National Water Act (36 of 1998)

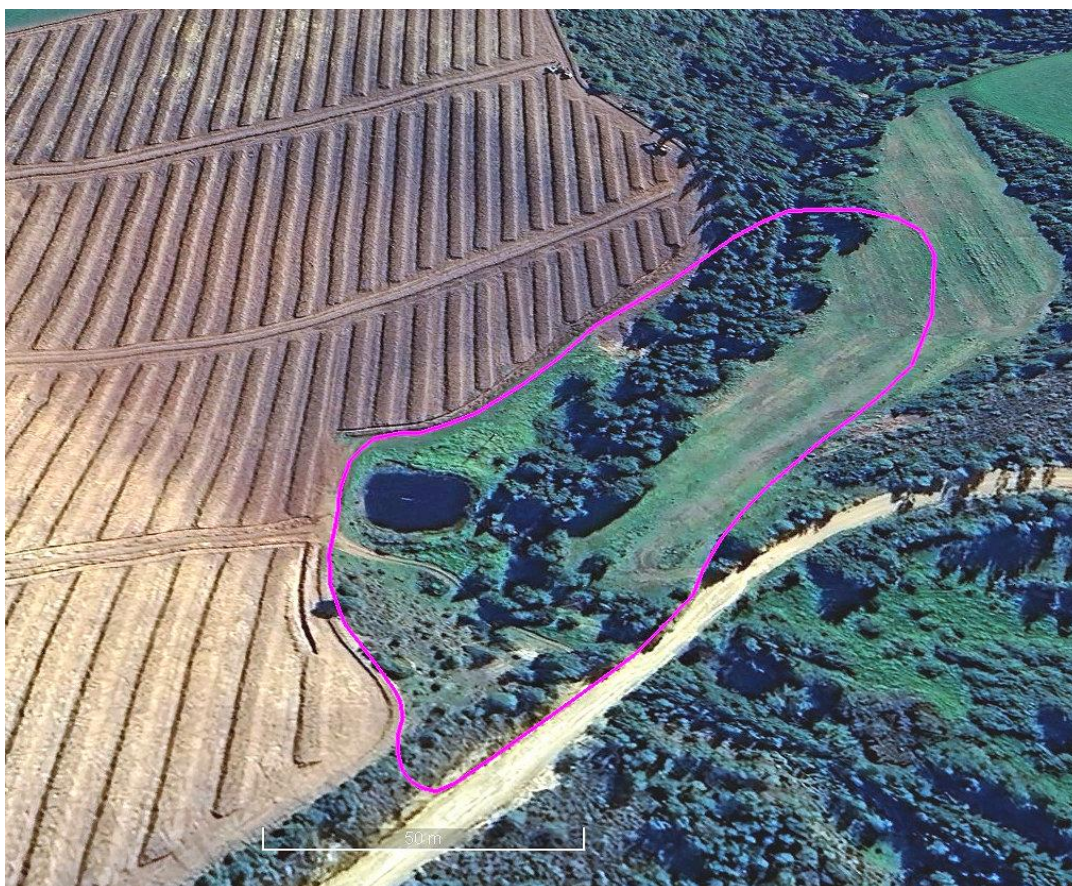
**Figure 31** Wetland demarcation

To further advance the assessment, the alleged wetland on both sides of the river around Dam No.7 was demarcated (Figure 31). It covers 1.7 hectares. This demarcation is arbitrarily, as there was no vegetation or other indications on the ground to mark the edge of the alleged wetland.

There are some flatter patches of land around the Sanddrift River that could in the past retain runoff to justify the identification of a wetland, as is indicated in Figure 31. In the past, before the river became entrenched in a narrow channel, as it is today, it could have regularly burst its banks to flood these relatively level areas to maintain wetland conditions. These conditions have since then been altered to its current-day status of inability to maintain wetland conditions. The hydraulic continuity of the river and its banks have long been broken, ever since agriculture took root, along with the black wattle infestation.

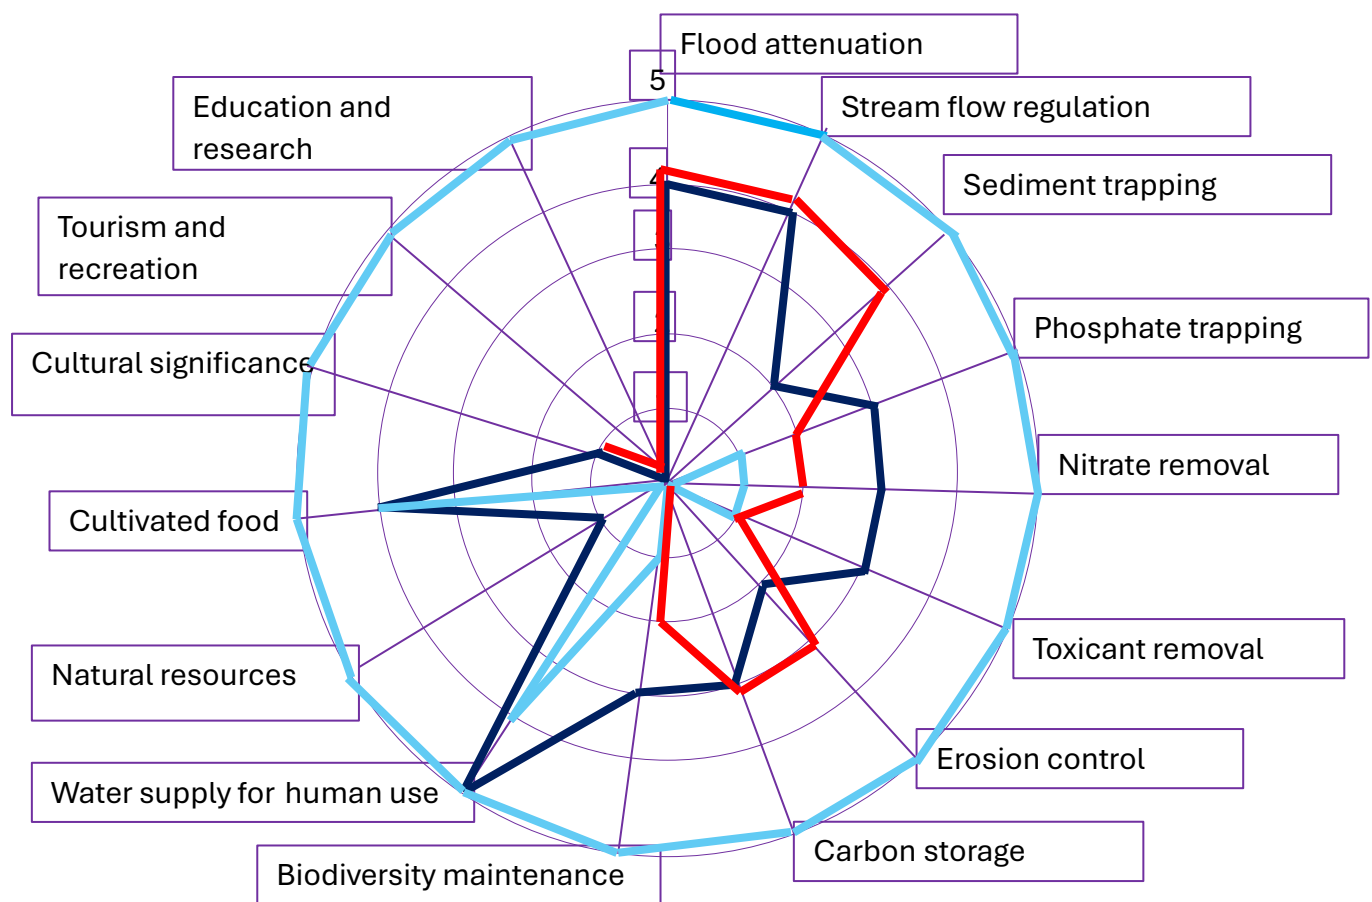
**Figure 33.** Resource Economics Footprint

Goods & Services	Sanddrift Stream	Duivenhoks River	Wetland	Drainage line
Flood attenuation	4	5	0	4
Stream flow regulation	4	5	0	4
Sediment trapping	2	5	0	4
Phosphate trapping	3	5	1	2
Nitrate removal	3	5	1	2
Toxicant removal	3	5	1	1
Erosion control	2	5	0	3
Carbon storage	3	5	0	3
Biodiversity maintenance	3	5	1	2
Water supply for human use	5	5	4	0
Natural resources	1	5	0	0
Cultivated food	4	5	4	1
Cultural significance	1	5	0	0
Tourism and recreation	0	5	0	0
Education and research	0	5	0	0

The goods and services delivered by the environment is a Resource Economics concept as adapted by Kotze *et al* (2009). The methodology was designed for the assessments of wetlands, but in the case of the river, the goods and services delivered are particularly applicable and important, hence it was decided to include it in the report.
