**Botanical Assessment  
for the proposed Harmony Dam and  
agricultural areas at Farms Houdenbek 415  
and Winkel Haak RE/224, near Op-die-Berg,  
Witzenberg Municipality,  
Western Cape Province**

**Prepared for EnviroAfrica**

**February 2026**

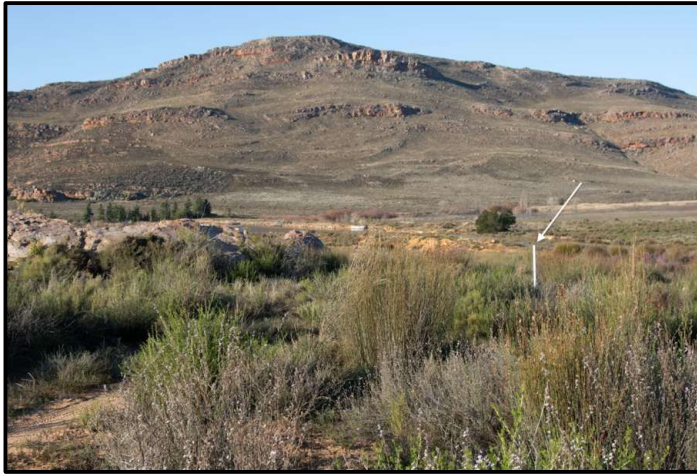
**Figure 11.** Marker for the dam wall (white arrow) on the west side at the overflow location.

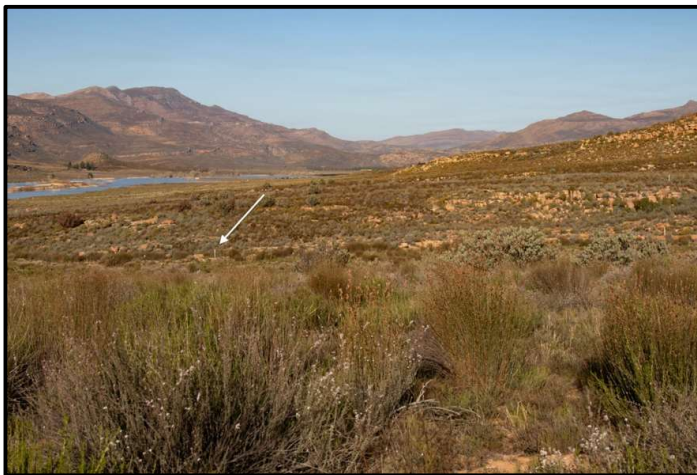
**Figure 12.** Lower edge of the proposed Harmony Dam wall would reach (arrow).

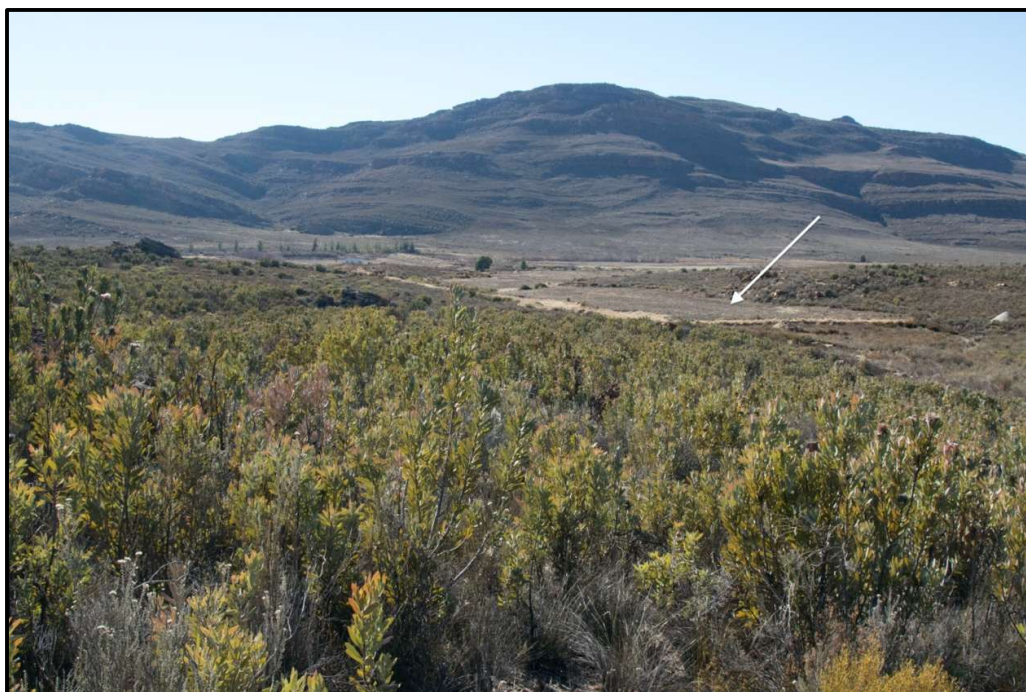
**Figure 14.** The disturbed area at the lower end of the catchment that would be impacted by the wall of the Harmony Dam.

The Option 3 site, which is now the preferred, however, is much more disturbed. From historical images obtained from Google Earth Pro™ that there has been some agricultural activity in the area where the dam wall would be constructed (Figure 10). Given that Option 3 (preferred as of 2024) is being pursued, the dam water would flood an area that has partly been disturbed (Figure 14) and is partly undisturbed fynbos (Figures 15—17).

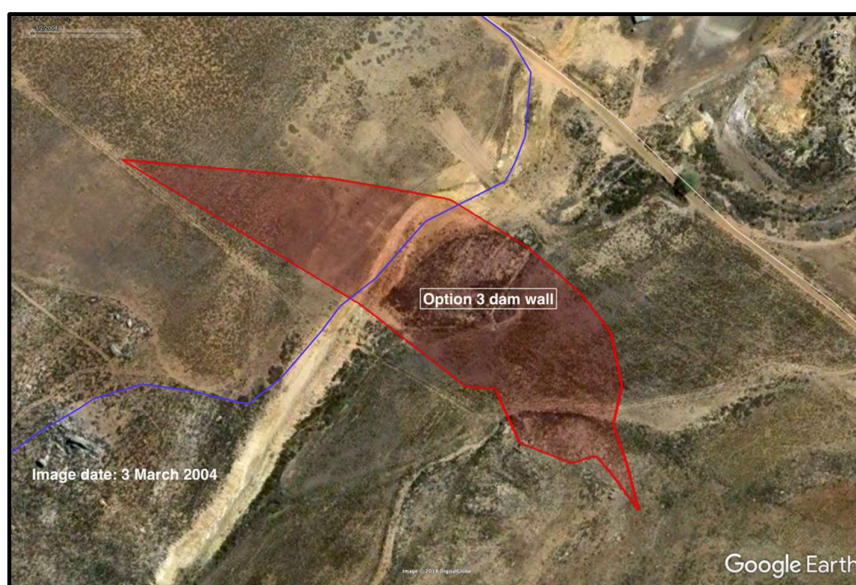
**Figure 15.** Aerial image (Google Earth™ of 3 March 2004 with the Option 3 dam wall superimposed.

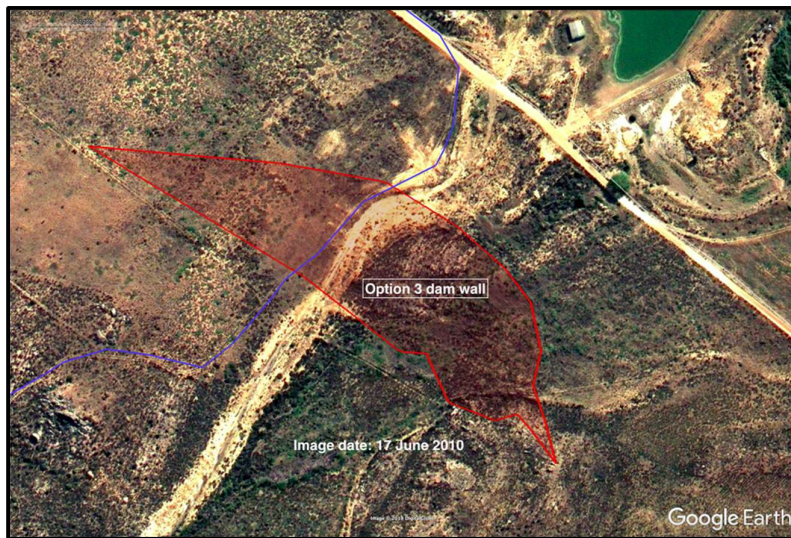
**Figure 16.** Aerial image (Google Earth™) of 17 June 2010 with the Option 3 dam wall superimposed.

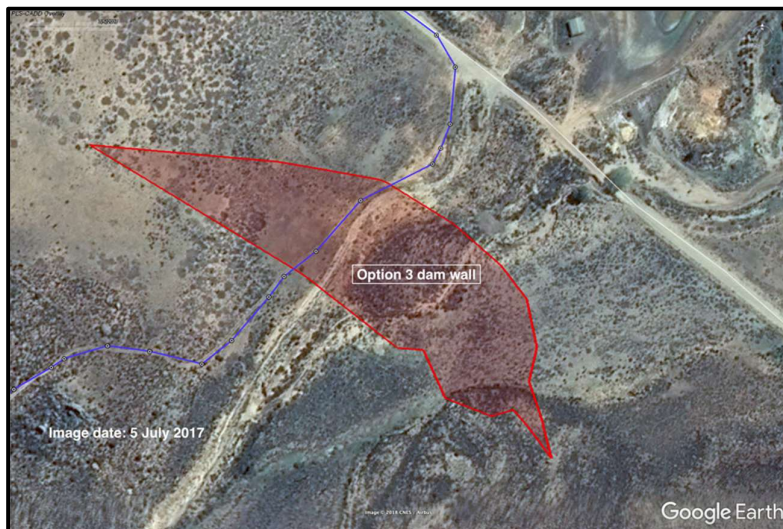
**Figure 17.** Aerial image (Google Earth™) of 5 July 2017 with the Option 3 dam wall superimposed.
