## **Freshwater Report**

## **Harmony Agriculture**

**On the Farm Winkelhaak 224, Koue Bokkeveld, Ceres District**

A requirement in terms of the National Water Act (36 of 1998)

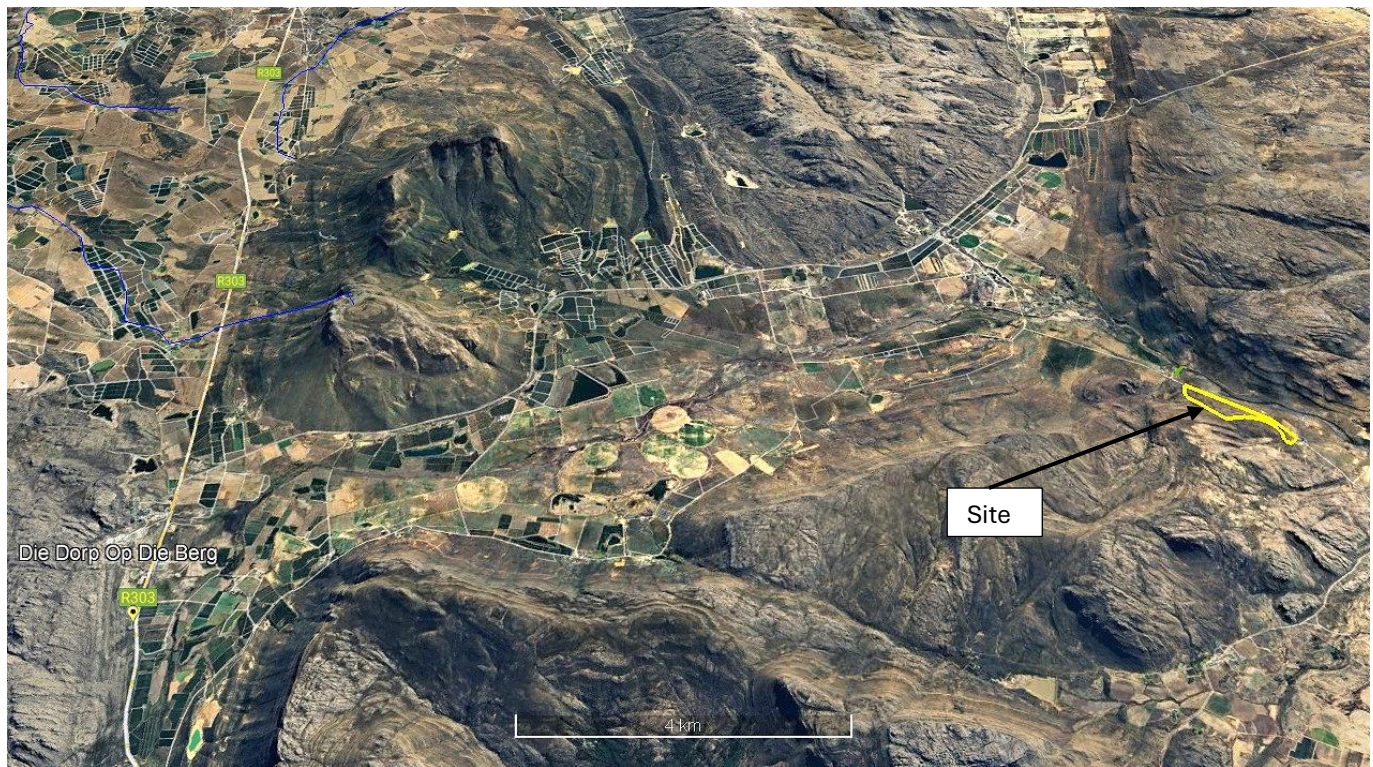
**Figure 2 Location continued**

Take the R303 to the north out of Ceres, through Prince Alfred Hamlet and over the Gydo Pass to Dorp of die Berg where a turnoff to the right (west) must be taken. The Morestêr Farming offices are 14.5km from the turnoff on the right-hand side of the road where one must report for entry onto the property and further directions to the site.

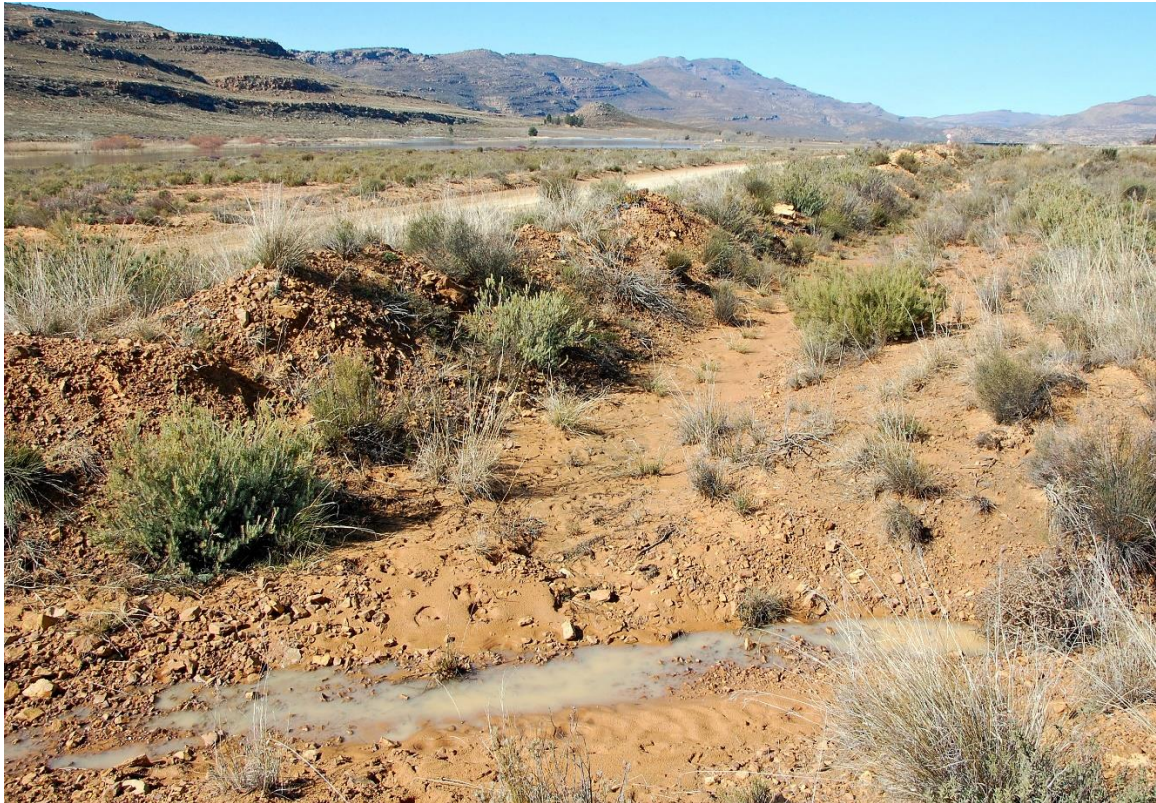
**Figure 7** Trench and berm along the farm road.

The one aspect of the drainage lines that stands out is the trench and berm (Figure 7) that were constructed along the farm road. The trench prevents runoff from Drainage Line No.1 and No.2 (Figure 6), as well as any runoff from the sub-catchment above the farm road, to cross the farm road, over the land below the farm road and into the Houdembek River. The trench and berm are designed to protect the road from washing away. It was designed to prevent flood damage to the agricultural land below the farm road. Runoff now collects in the trench and flows down the incline towards Drainage Line No. 3 at the middle of the demarcated agricultural area, where it passes underneath the farm road through a pipe culvert (Figure 8). Downstream of the culvert, the drainage line was still visible, even though it was disturbed.

During the time of the site visit, there was still standing water in the trench after the rains.

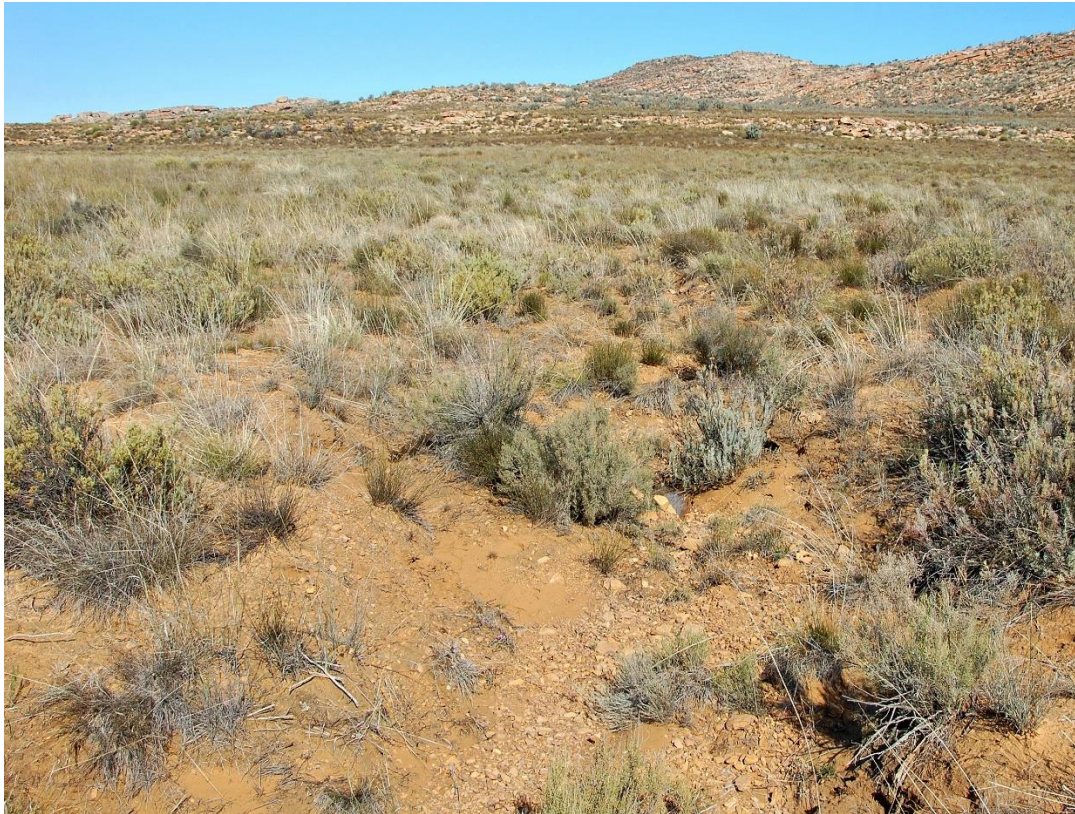
**Figure 9** Drainage Line No. 3 above the trench

The drainage lines above the trench up the incline are visible on Google Earth images, but on the ground are hard to distinguish from the surrounding ground (Figure 9). The vegetation resembles that of the surrounds and is not noticeably higher or any different, devoid of wetland indicator species. It appears the runoff is inadequate during hot summer months to allow for riparian vegetation to take root.

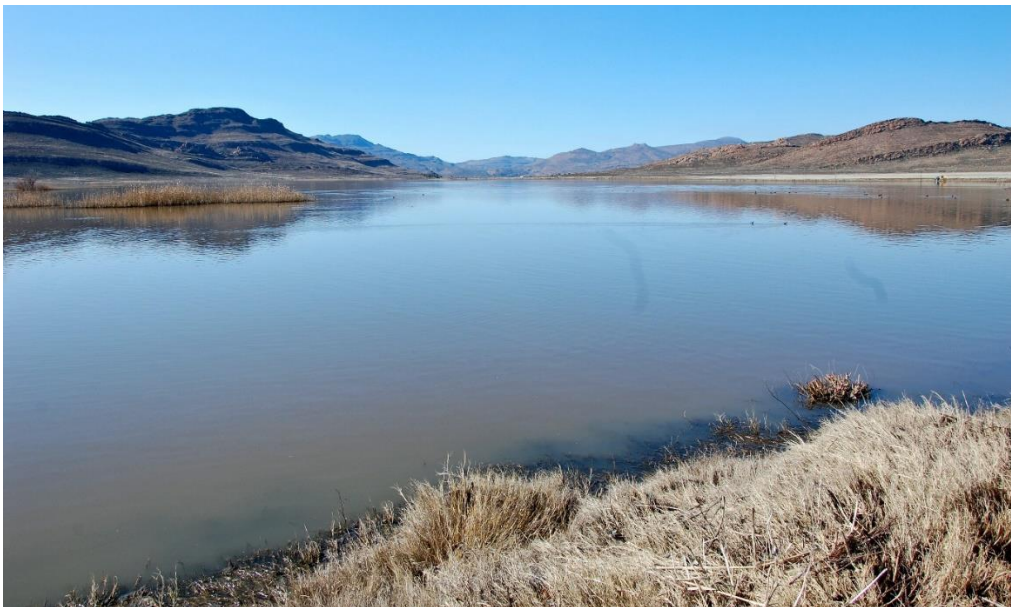
**Figure 13** Houdenbek River flood conditions

The proposed agricultural area is outside of the 100m controlled zone of the river during low flow conditions. That changes dramatically during the rainy season when the river turns into a wetland (Figure 13), pushing up against the dam walls and flooding the area well into the 500m controlled zone. This necessitated, among other, the WULA, Freshwater Report and completed Risk Matrix.
