**Freshwater Report**  
for the enlargement of the  
**Helpmekaar Dam**  
on the Farm Rietrivier 202 Ceres

A requirement of Section 21(c ) and (i) of the National Water Act (36 of 1998)

October 2025

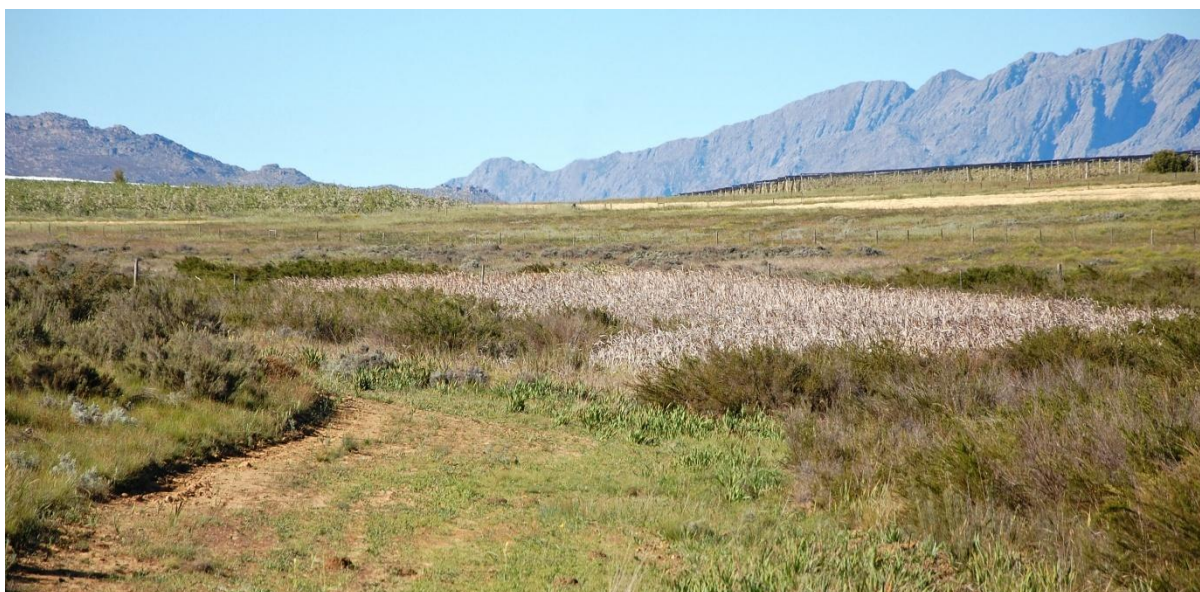
**Figure 7** Helpmekaar Dam Floodplain

The Helpmekaar Dam floodplain (Figure 7), the additional area that will be flooded when the new addition to the dam fills up, it heavily impacted by runoff from the large-scale upstream agriculture. The vegetation on the floodplain is mostly *Typha* reeds. A secondary growth of low Fynbos shrub holds out on the verges of these reeds. There is very little if anything left of the alluvial vegetation. There is no channelled valley bottom wetland with a densely vegetated riparian zone, as can be expected in the region. It looks more like a wider seep that has been filled in with sediments out of the surrounding orchards.

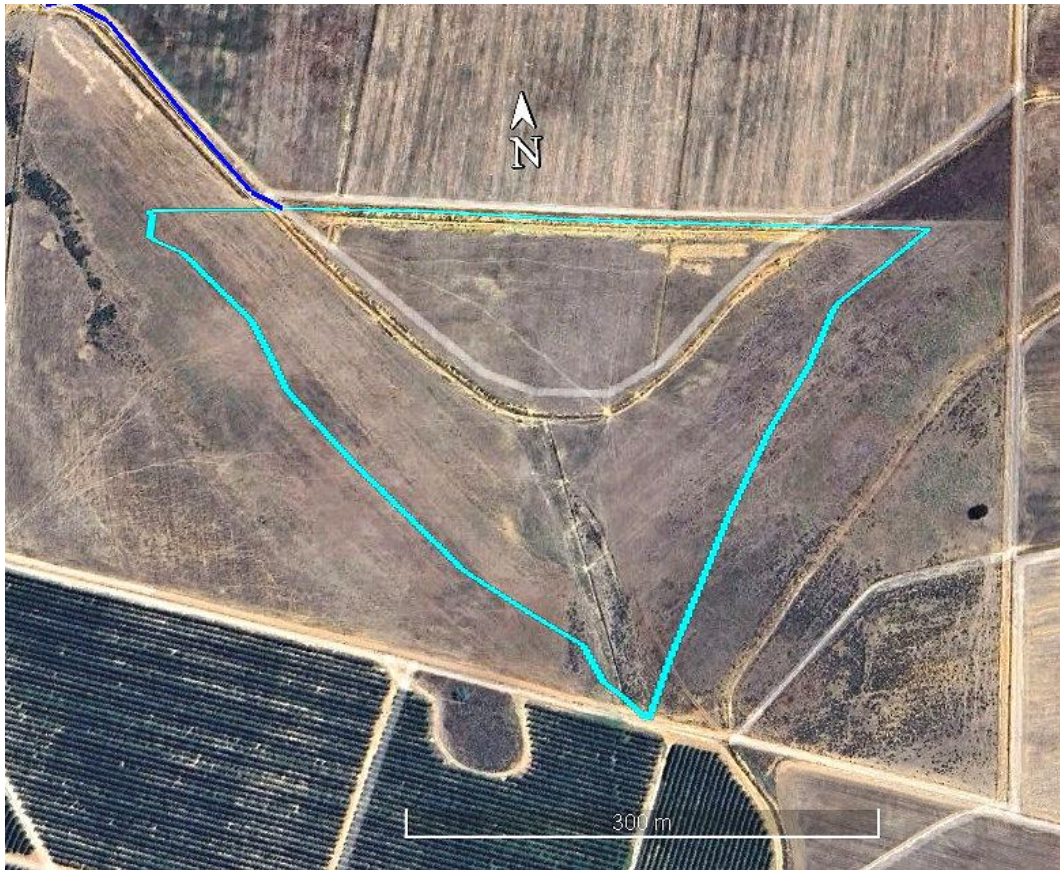
**Figure 8** Balancing Dam

This dam has very little catchment area. Runoff is intercepted by several upstream farm dams. Farm roads and several drainage trenches divert runoff away from the proposed dam. This dam will be filled only with water out of a pipeline.

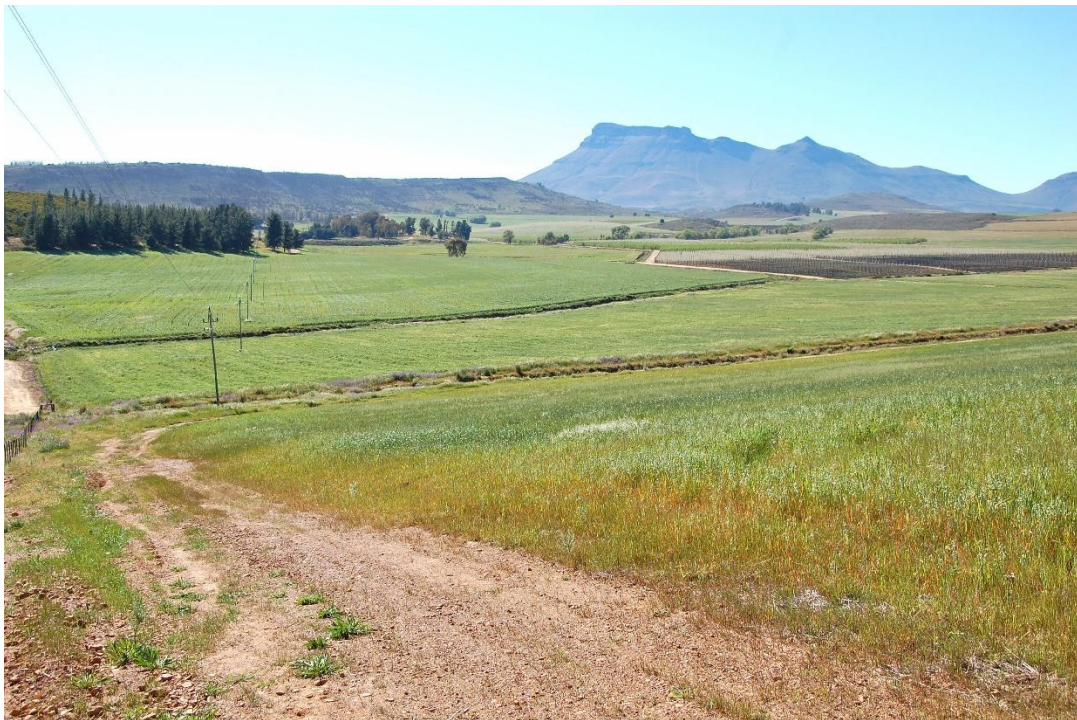
**Figure 9** Balancing Dam Terrain

There is no more natural vegetation, no more Fynbos, on the terrain where the balancing dam is to be constructed. It has all been transformed into pasture for farm animals, currently grazing for sheep.

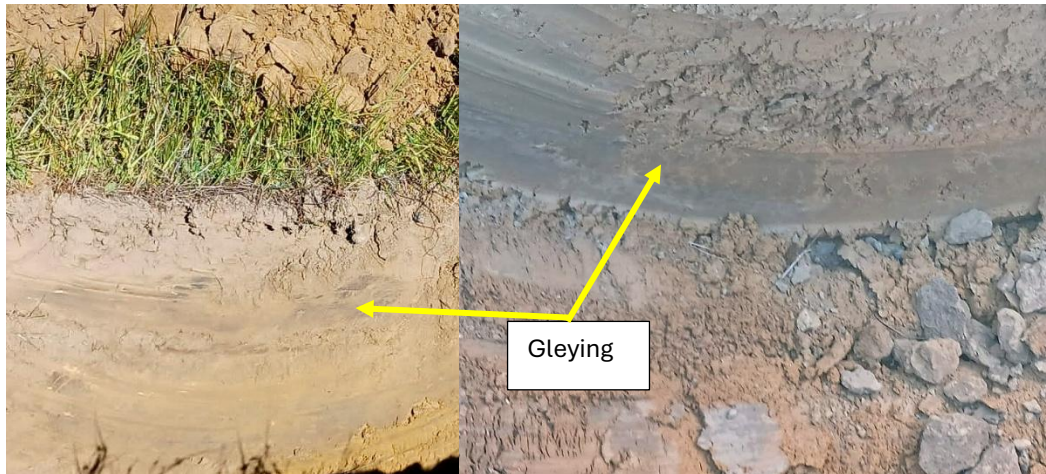
**Figure 10** Gleying (Photo JPP Fourie, Sterkwater Boerdery)

Wetness, landform, vegetation and the soil profile are the indicators for the demarcation of wetlands (Anonymous, DWS).

This location probably was a wetland, with all the attributes of a wetland. Topography and soil profile supports the presence of a wetland. The absence of wetland vegetation and the dry nature of the site indicates that this historic wetland is no more. It is now drained, transformed into a pasture for grazing farm animals.
