# UPGRADE OF THE KLAARSTROOM OXIDATION POND WASTE WATER TREATMENT SYSTEM

on the Remainders of Portions 32 & 34 of the farm Klaarstroom no. 178 PRINCE ALBERT LOCAL MUNICIPALITY, WESTERN CAPE

# NEMA COMPLIANCE AUDIT REPORT

# DATE: 25 OCTOBER 2021

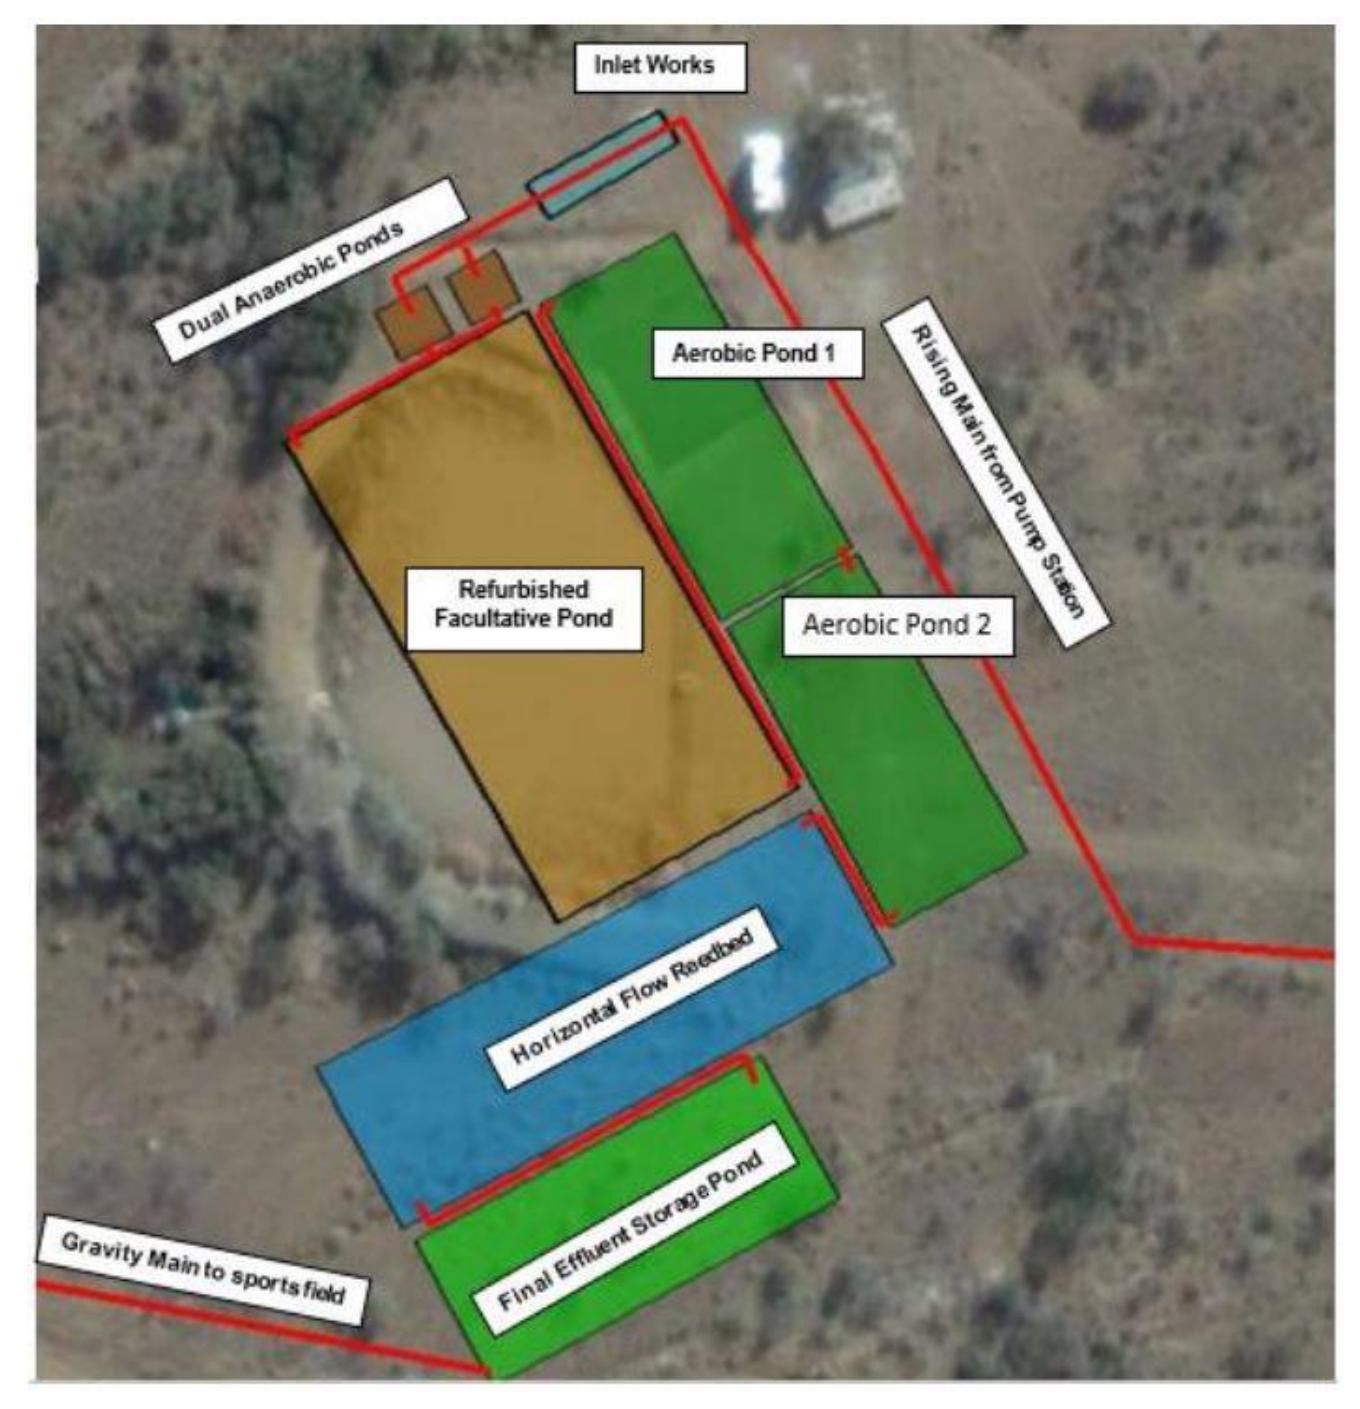
Figure 2: Google image of the existing works, overlaid by the layout design of the new WWTW (Bvi)

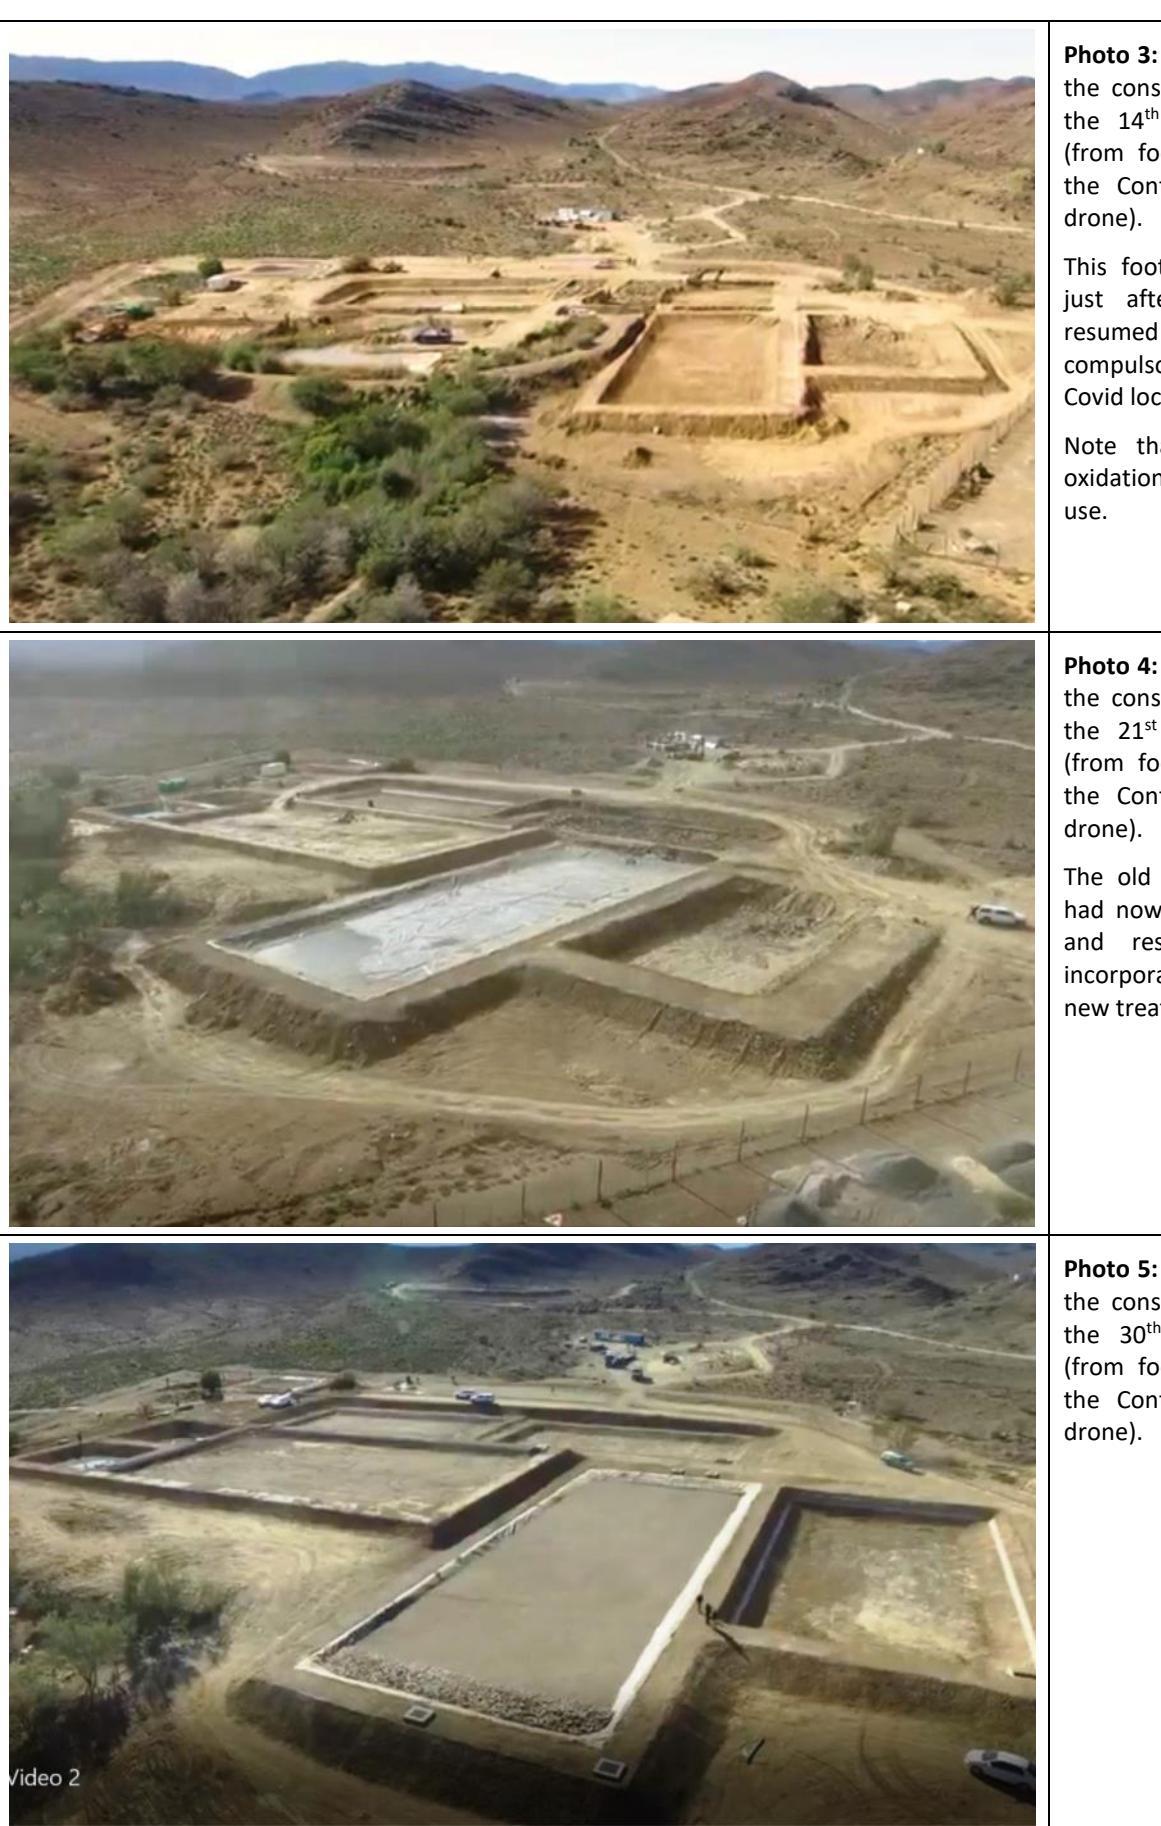
**Photo 3:** An overview of the construction site on the 14<sup>th</sup> of May 2020 (from footage taken by the Contractor using a drone).

This footage was taken just after construction resumed (after the compulsory national Covid lockdown came).

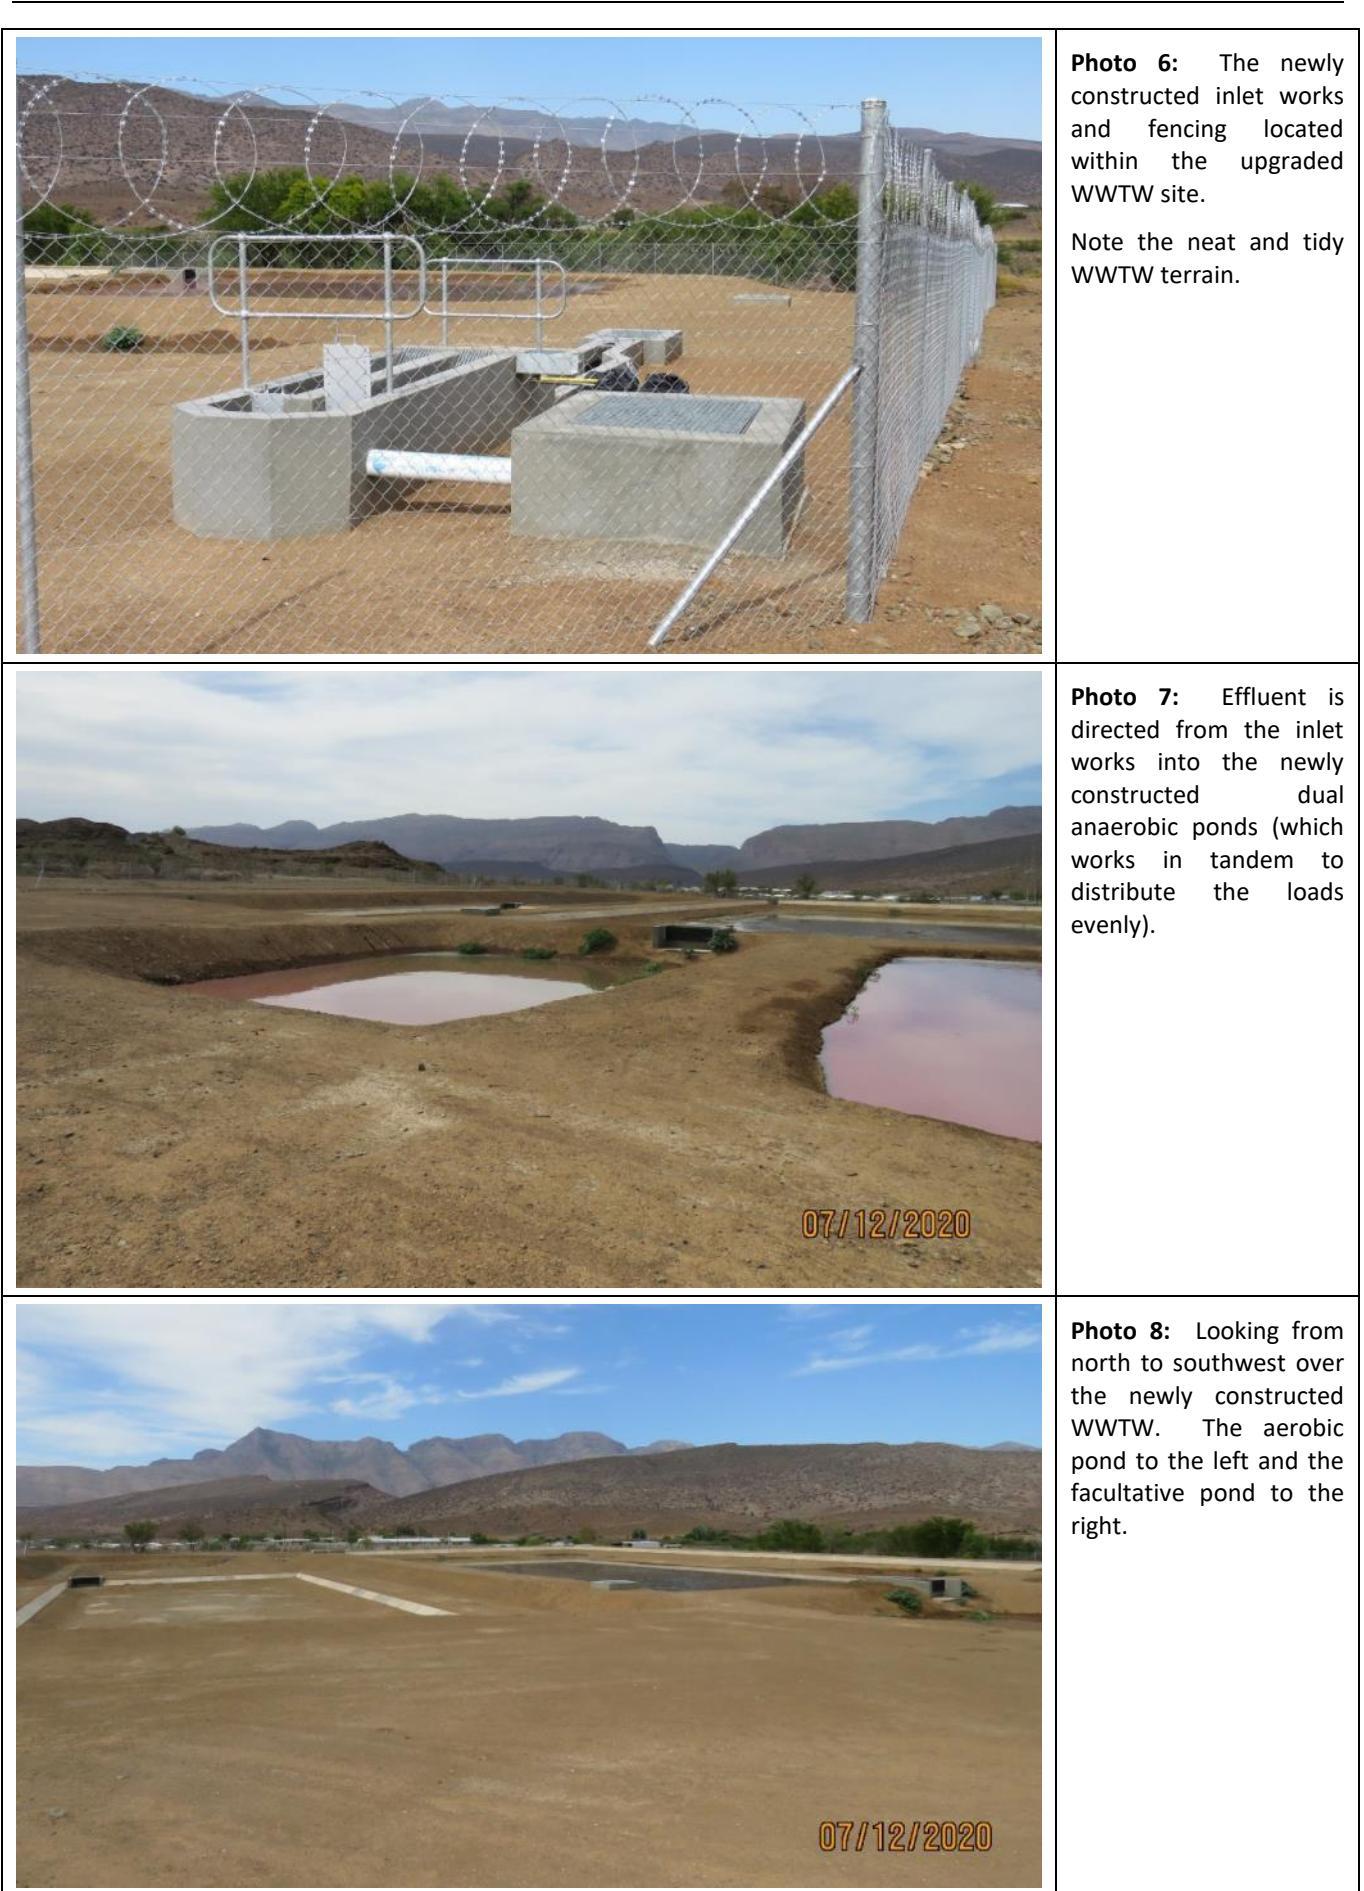
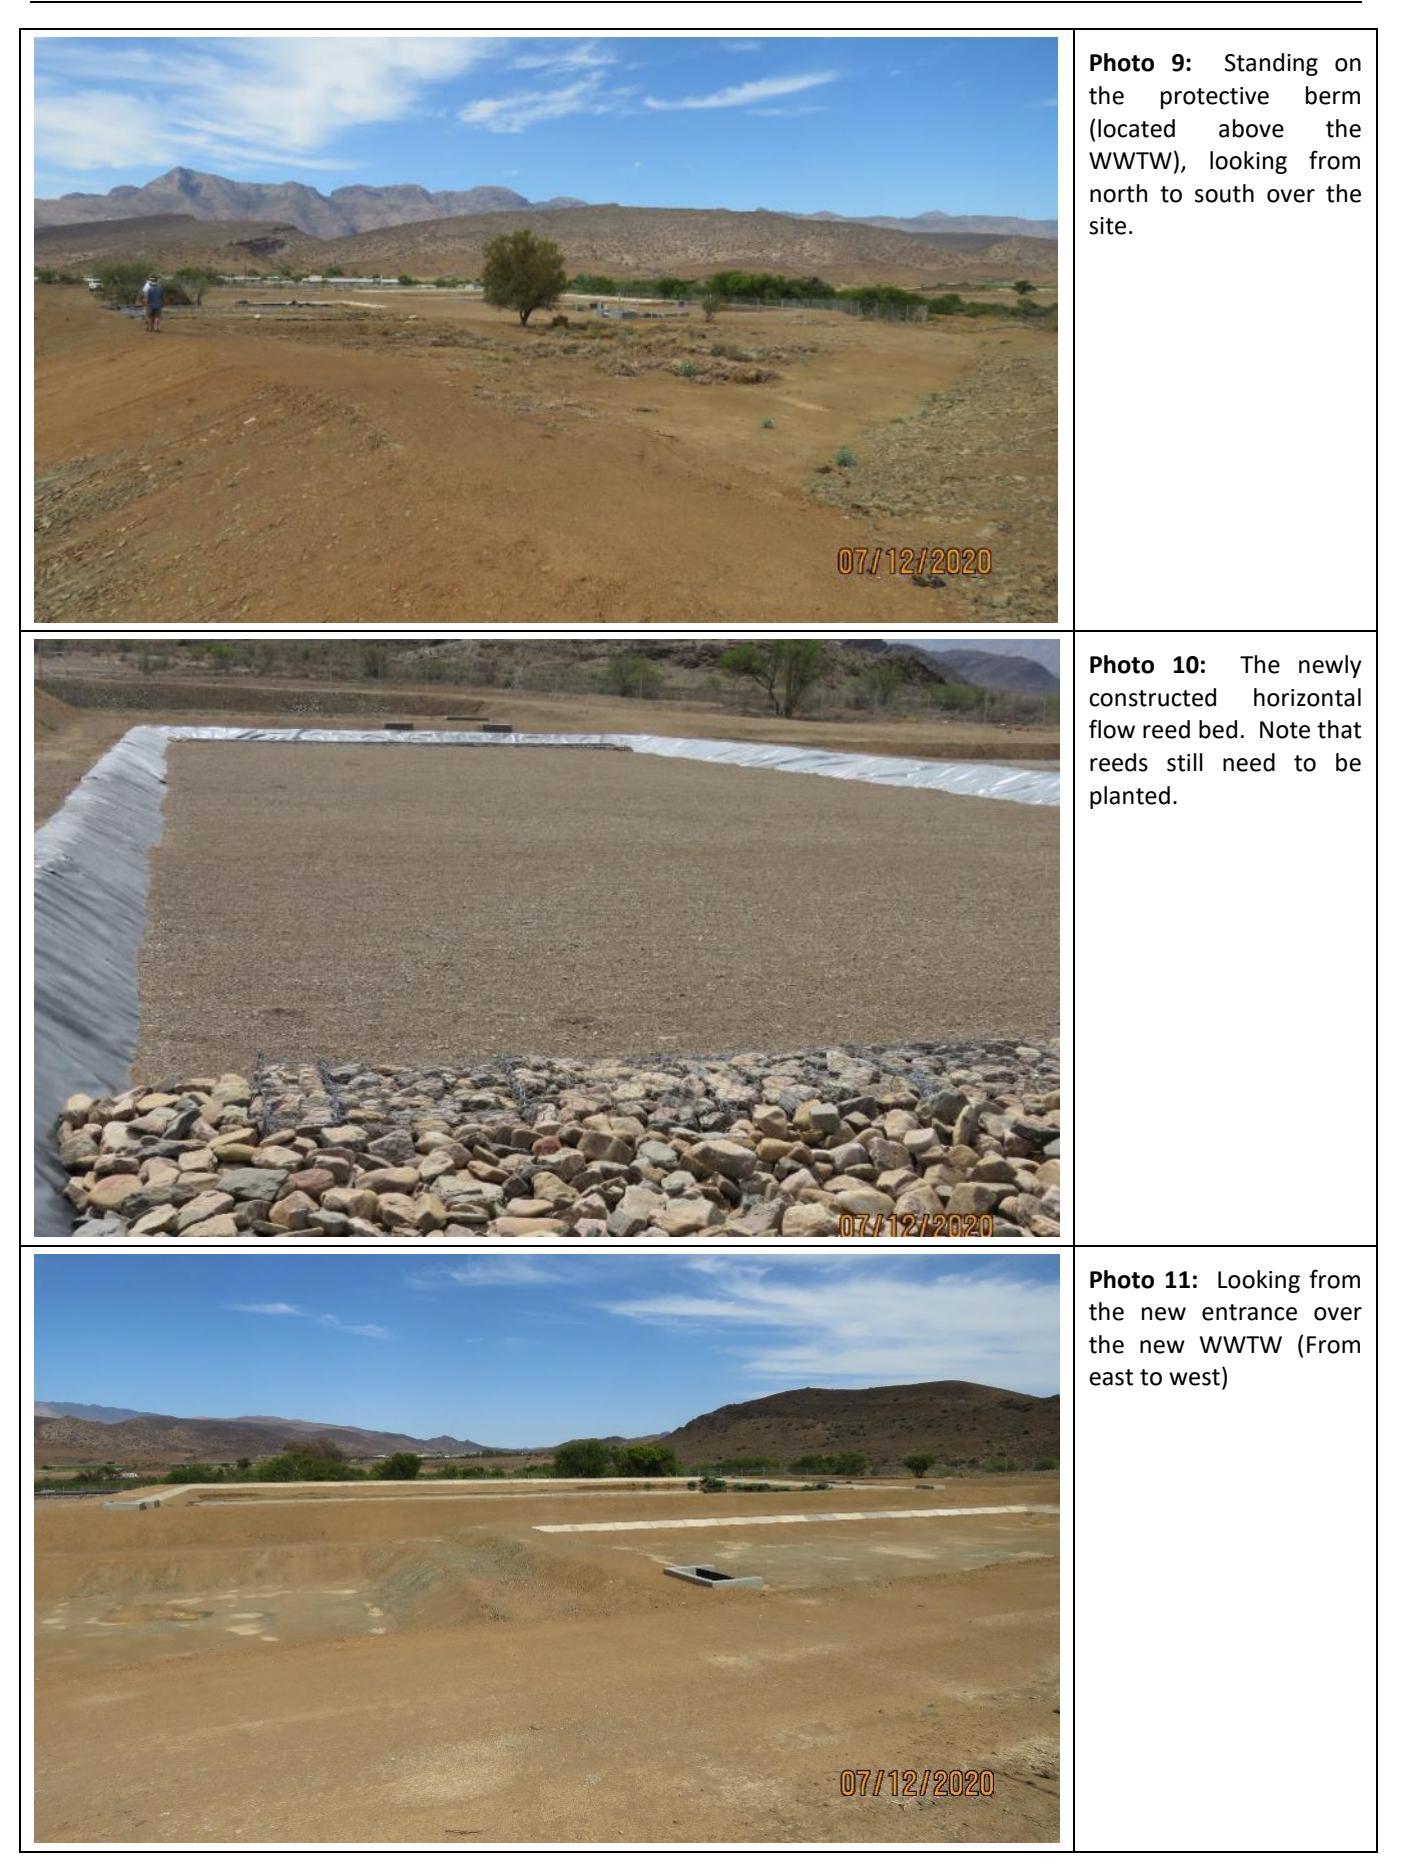
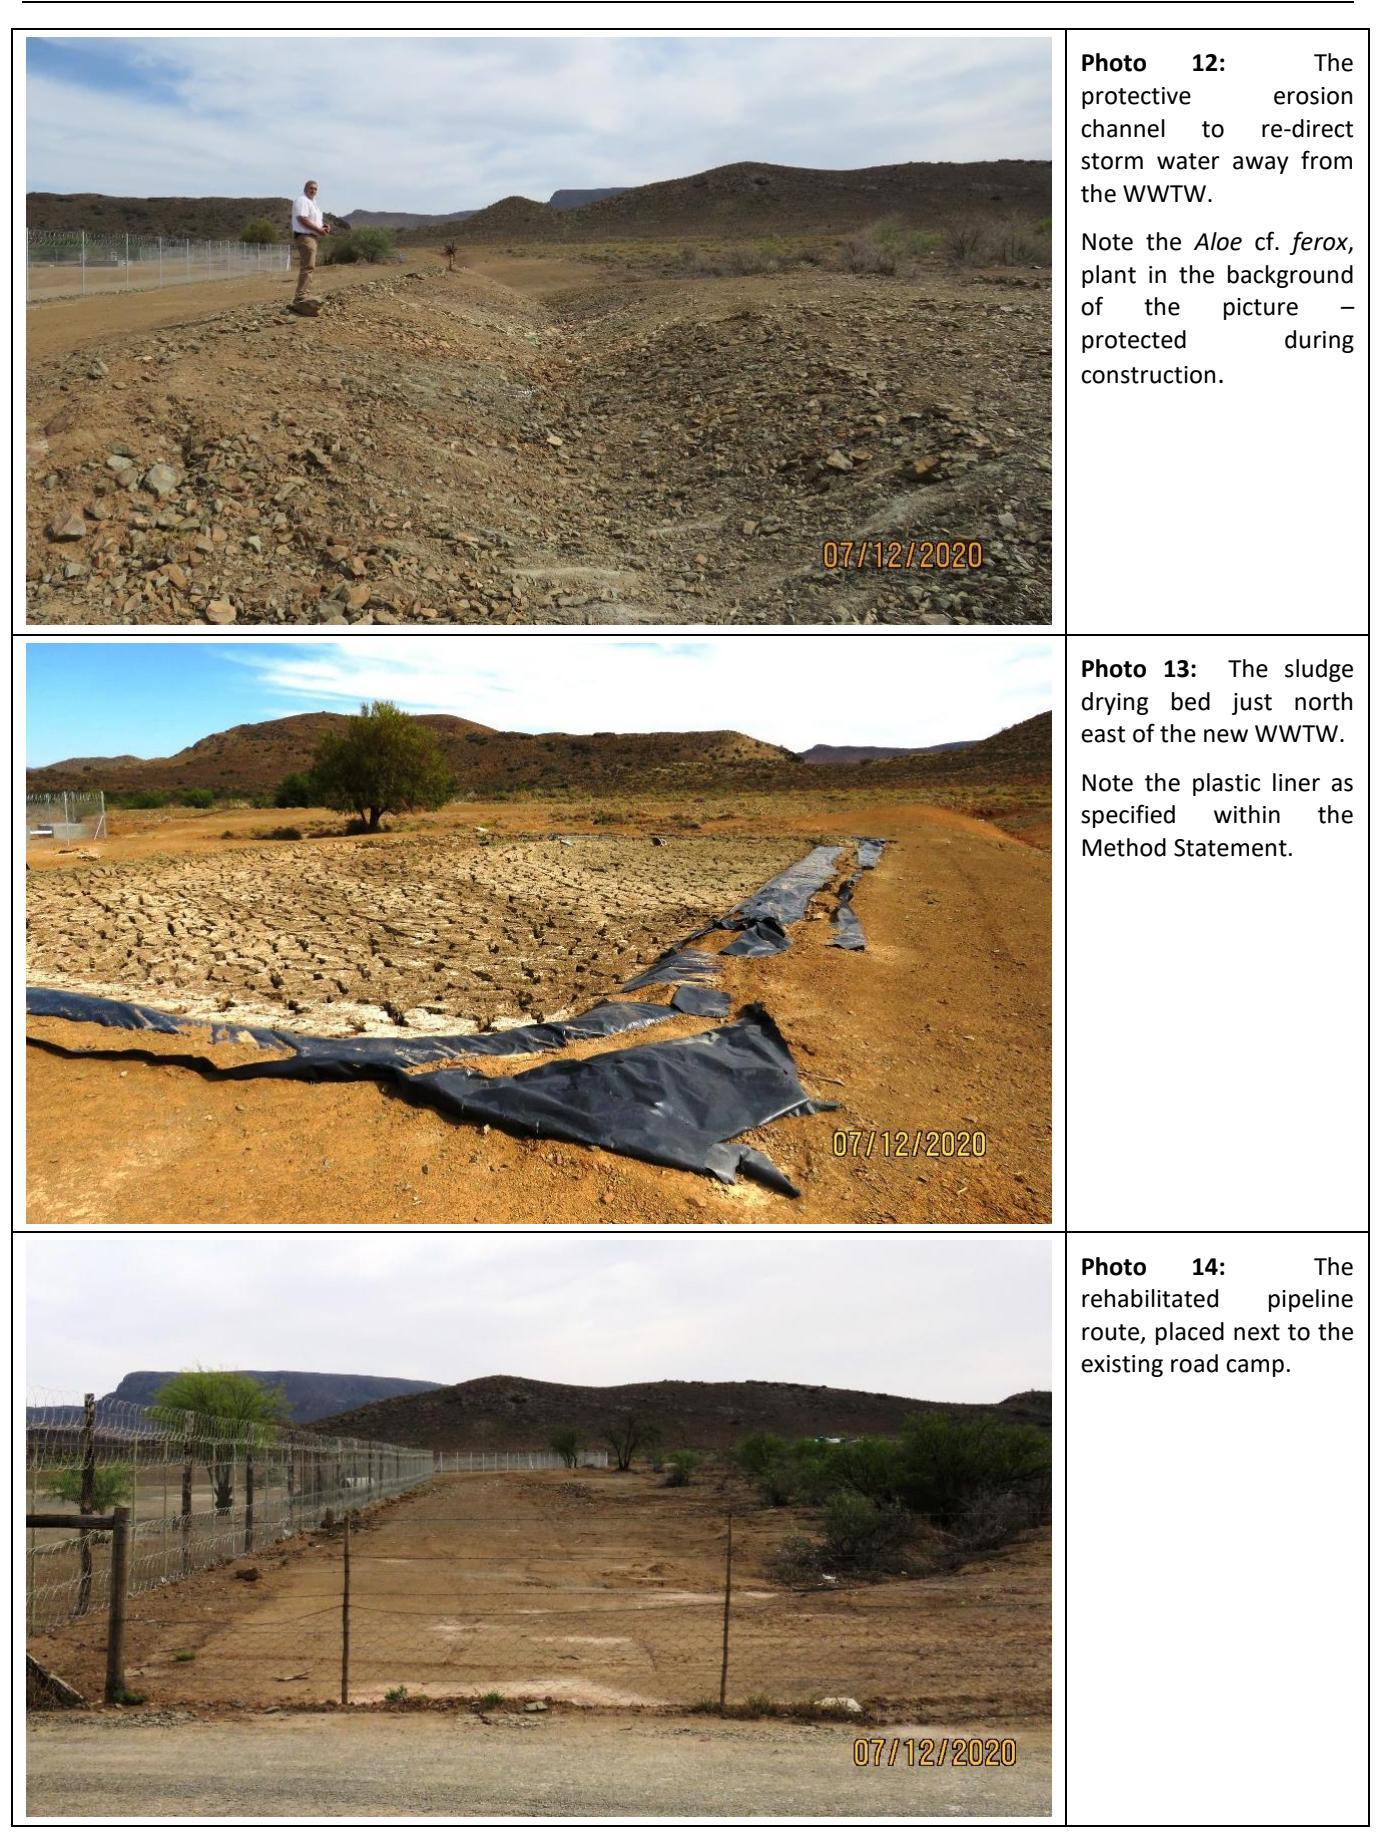
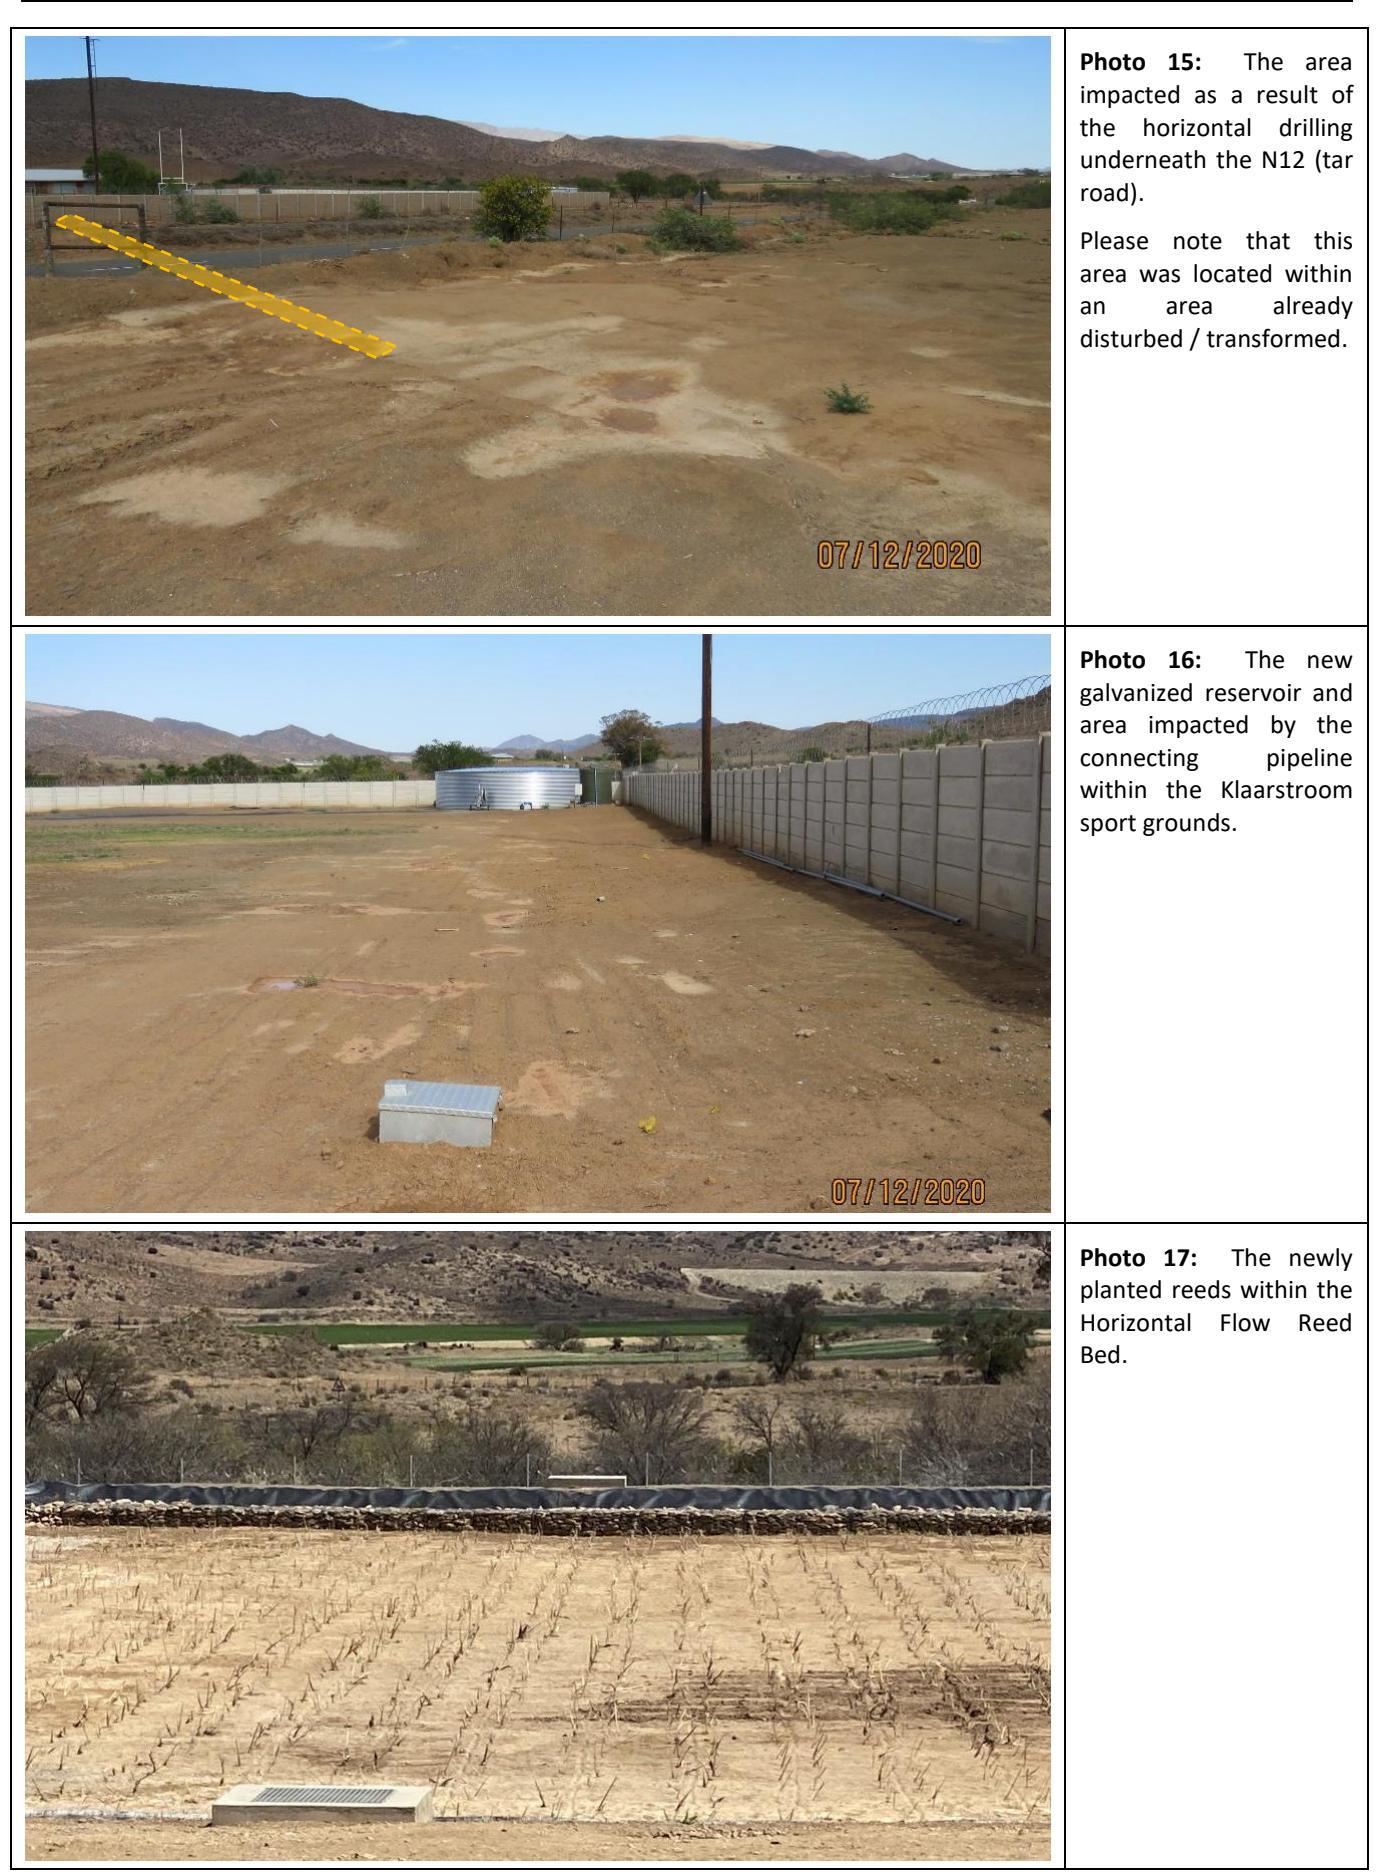
According to the evidence seen during the day of the site visit, excellent re-instatement and rehabilitation was done. The site was neatly fenced and all work seems to be of a high standard.

No non-compliance or obvious non-conformities were observed. EnviroAfrica is known for implementing excellent rehabilitation practices and this seems to be the case on this project again. Both the ECO and Engineer should be commended for a neat and tidy terrain post-construction (Refer to the site photos underneath).
