**Prince Albert Municipality**  
Water Use License Application  
**Fresh Water Report**  
for expansion of the  
**Klaarstroom Wastewater Treatment Works**  
30 July 2019

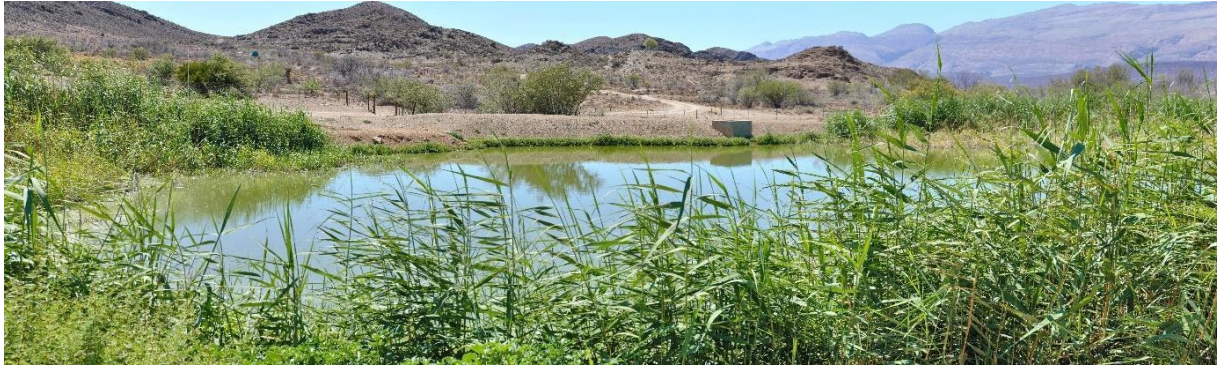
**Figure 3** Current Pond

The existing WWTW (Figure 3) straddles a drainage line (Figure 4).

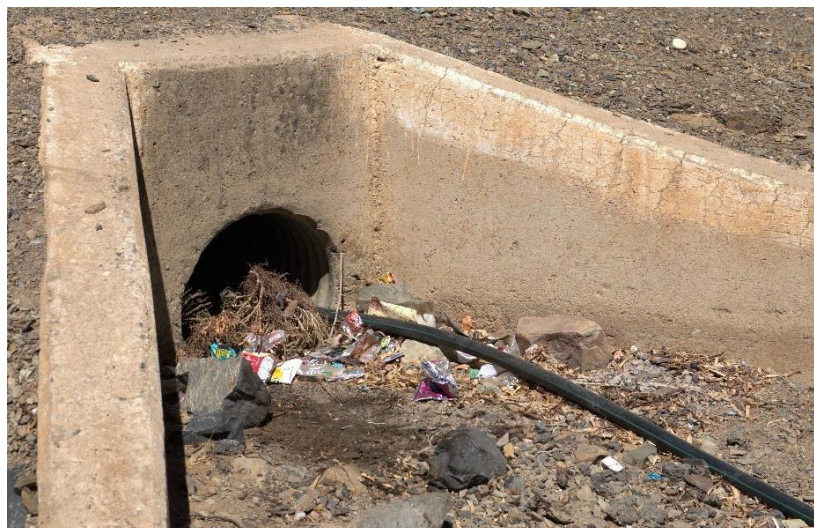
**Figure 7 Culvert**

The location of the culvert is indicated on Figure 4. It is to the east of the drainage line, as indicated on the Cape Farm Mapper.

An electrical power line is routed through the culvert underneath the N12 trunk road toward the WWTW.

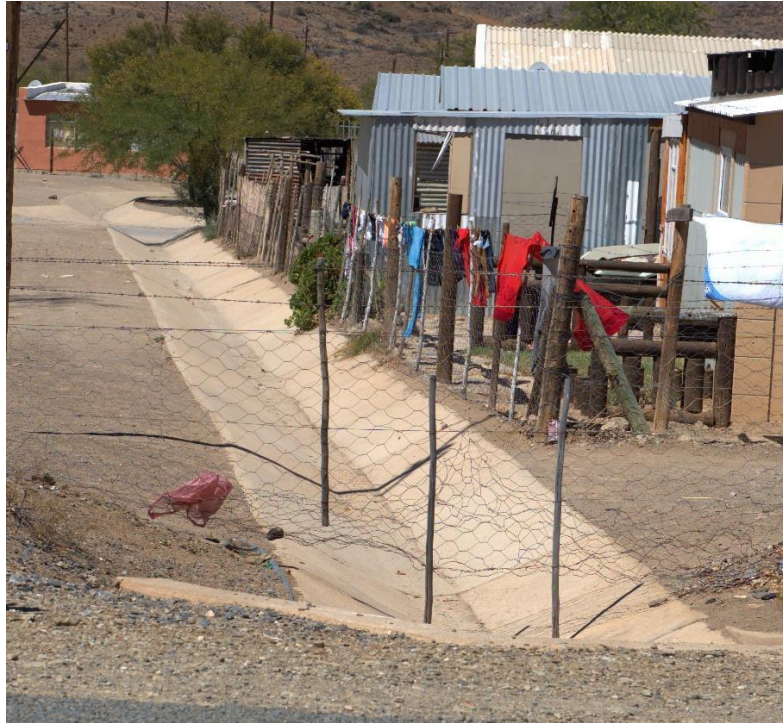
**Figure 8 Swale**

A swale with a hard surface stretches from the culvert to the south into the Klaarstroom township (Figure 8). This is part of the storm water system that releases its water into the Sand River south of the township.

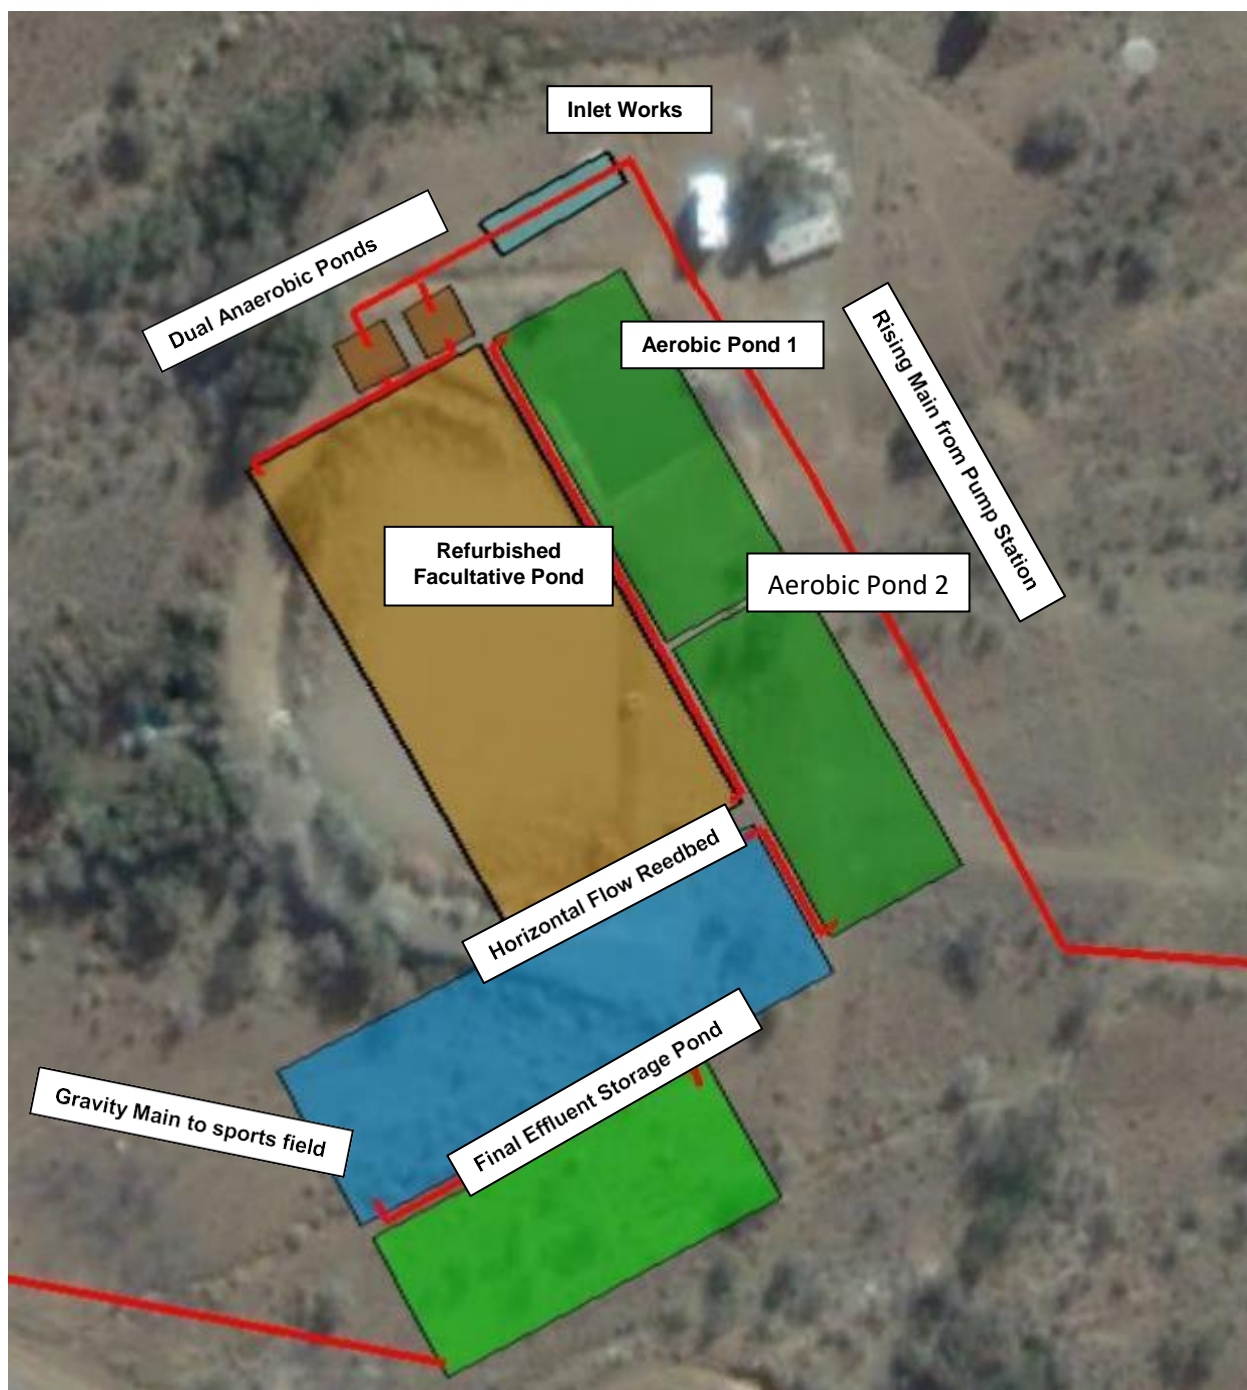
**Figure 9** New Klaarstroom WWTW (BVi)

The existing WWTW is to be expanded from the current system as depicted in Figure 4 to an upgraded works as depicted in Figure 9. The surface area of the existing works will be incorporated in new works. The new works is fully described in the BVi report.

The footprint of the new works would be small, less than 5000m<sup>2</sup>. To visualise the area, it would be 50m wide and 100m long.

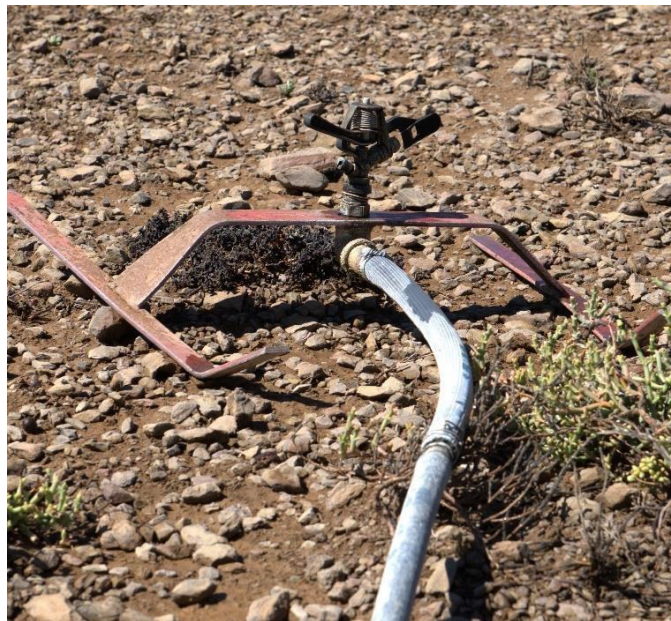
**Figure 10** Sprinkler

Currently the treated wastewater is irrigated on land adjacent and to the north east of the WWTW. Two sprinklers (Figure 10) are used, which are moved about to spread the wastewater over a larger area. The circles of irrigated areas can be seen on the Google Earth Image (Figure 4).

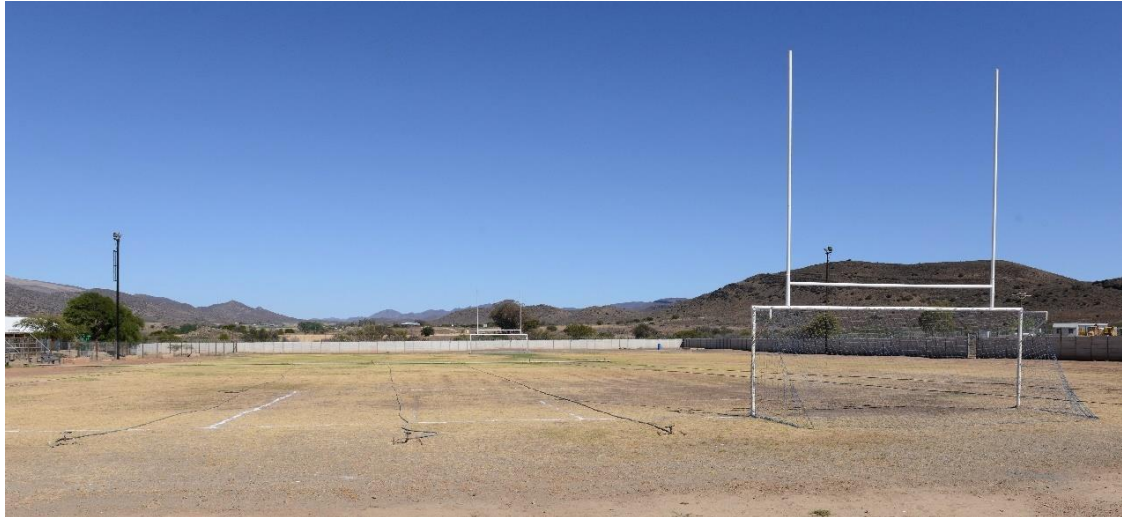
**Figure 11 Sports Field**

It is now planned that some of the treated sewage effluent be used for irrigation of the sports field in the township (Figure 11). Obviously, the treated effluent is going to be sanitized by chlorination to render it safe for humans.

The sports field is planted with kikuyu lawn grass and was extremely dry and dying during the site visit. The Klaarstroom community stand to benefit from a well irrigated and green sports field. Already a significant investment has been made towards irrigation equipment (Figure 12), but so far water has been lacking for most part of the year.

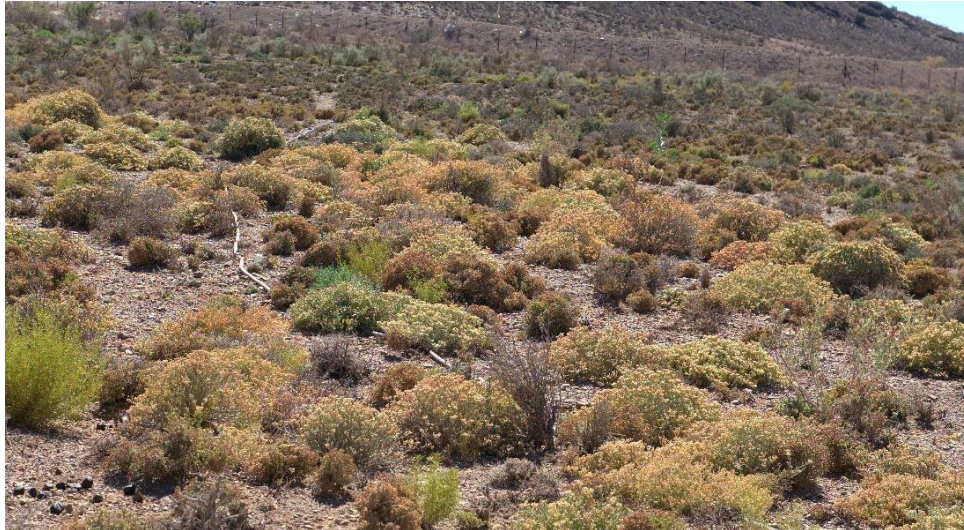
**Figure 13** Irrigated flowering vegetation

The irrigated vegetation out in the veldt is visibly different from that in the surrounding dry and arid area. The plants are greener and some were even flowering (Figure 13), out of season. Since the irrigated area is inconspicuously small amidst a vast landscape, this unnatural situation is not much to worry about.

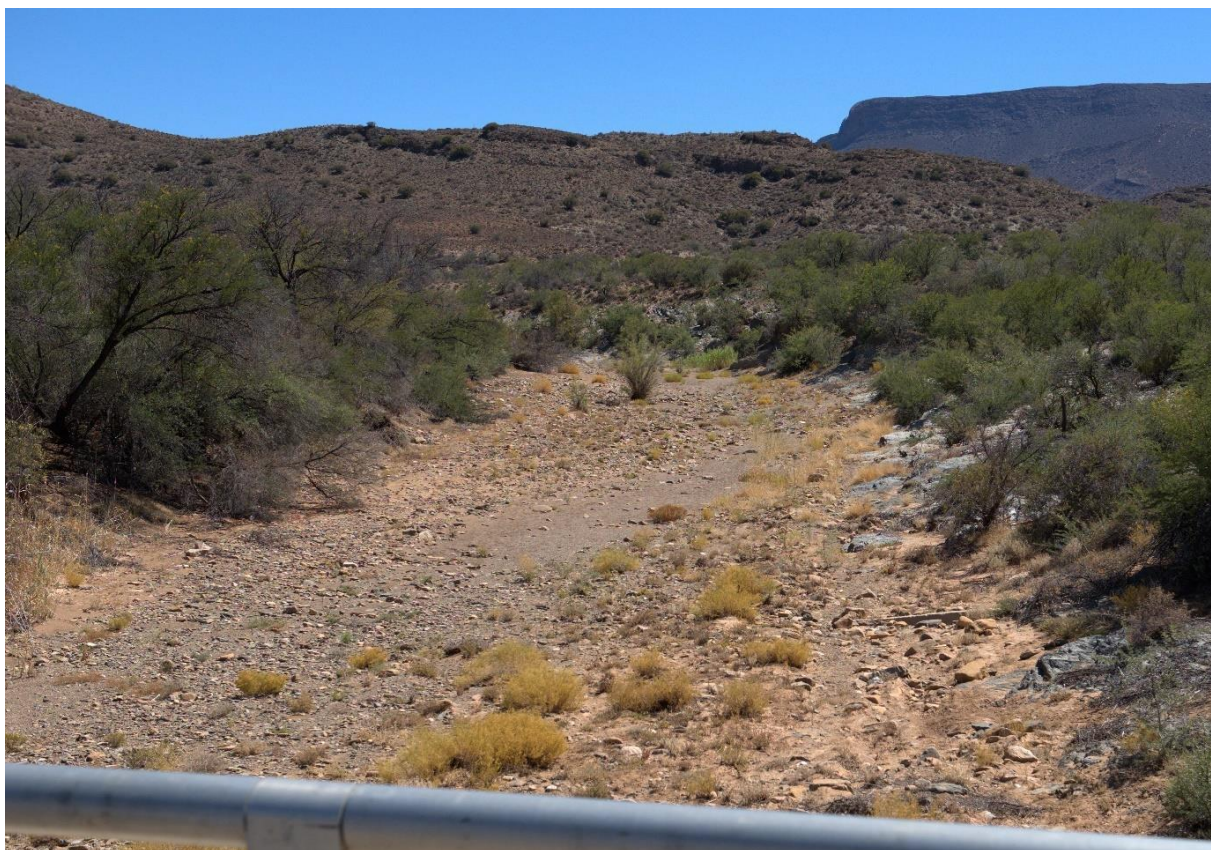
**Figure 15** Sand River at the N12 road bridge.

The river reach of interest is upstream from the N12 road bridge (Figure 15). This bridge is to the west just out of Klaarstroom on an elevation of 731m. This reach is 16 km long. The sub-catchment area is 1055 hectares.

The Sand River reach upstream from the N12 road bridge is near-pristine, albeit dry. The only impacts are farm roads and 4 small farm dams. The river is incised and well demarcated at the N12 road bridge (Figure 15). The banks are steep and overgrown with *Vachelia karoo* (soetdoring) trees, which were just starting to flower at the time of the site visit. A patch of *Phragmites australis* reeds, then very dry, indicated that there is water indeed, from time to time.

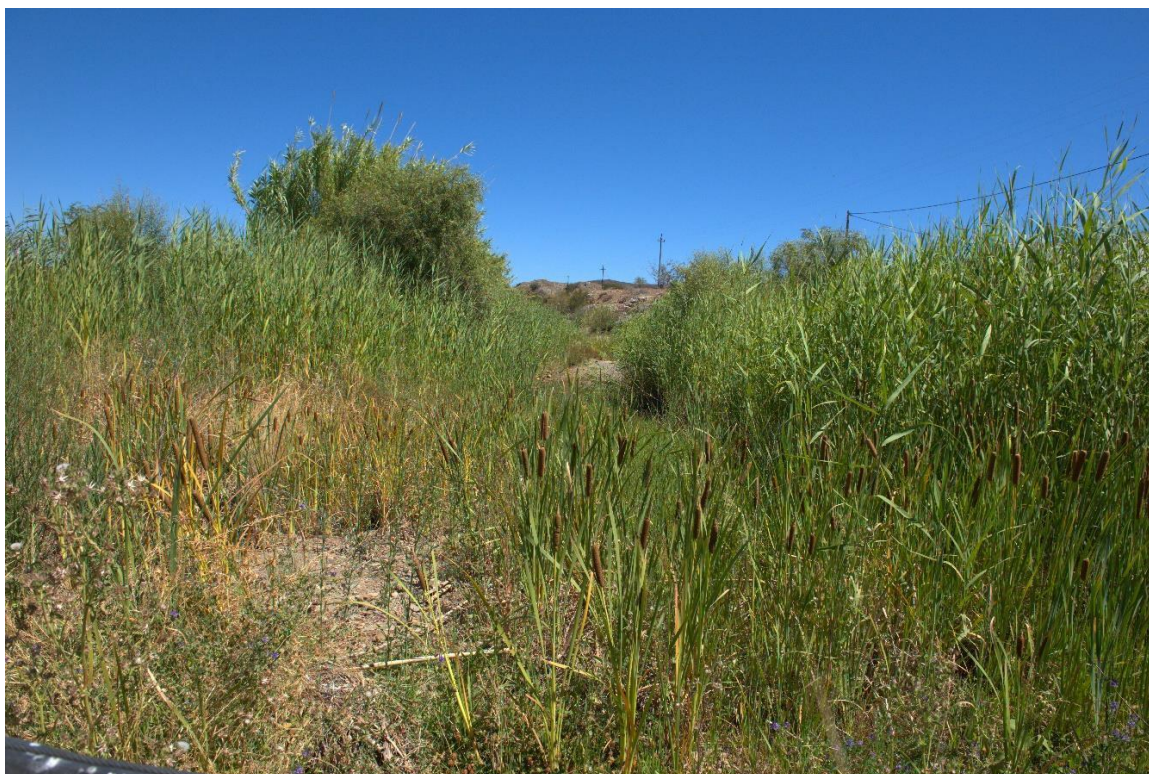
**Figure 16** Sand River south of Klaarstroom

The PES of the river further downstream, adjacent and to the south of Klaarstroom, the Sand River has been impacted (Figure 16). The river bed was densely overgrown with bulrush *Typha capensis*. The riparian zone was densely overgrown with *Phragmitis* reeds. These were green and obviously not drought stricken like those upstream. There was a small pool of water, probably return flow out of Klaarstroom. Higher up the slope the land has been transformed into a lucerne field.
