# **VANRHYNSDORP, PORTION OF FARM 258: SOLAR ENERGY FACILITY**

## **VISUAL ASSESSMENT**

### **ADDENDUM A**

**Addendum A (March 2017) to original Report (2012)**

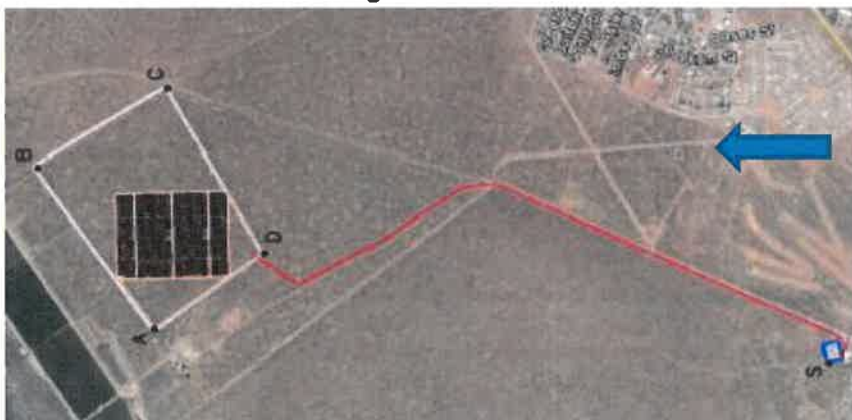
Figure 1: Site boundary

The preferred site in the original assessment was site 2 which is further north from the neighbourhood. This site was assessed and found to hold no significant visual impacts to deem the development undesirable. Therefore the previous assessment of receptors remains unchanged. The solar facility link to the adjacent Vanrhynsdorp substation with 22kV power lines and thus add no additional elements to the original assessment.

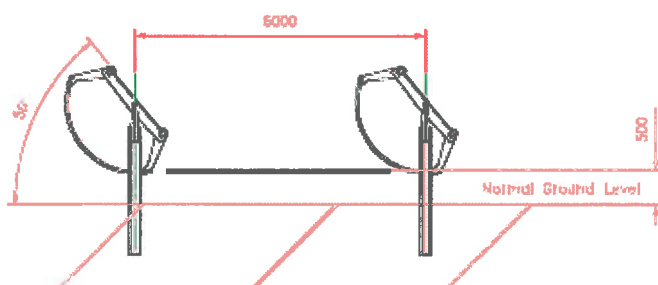
**Figure 3: Single axis mounting system**

The technology currently proposed, comprise is a crystalline PV single axis plant. It has 18540 solar modules connected to 7 central inverters, and makes use of Exosun single axis trackers. The facility will be connected to Eskom's Vanrhynsdorp Substation.

This proposal result in significant downscale in the size of infrastructure being less intrusive. The original proposal comprise units of up to 6m in height where the PV single axis system is approximately 2m.

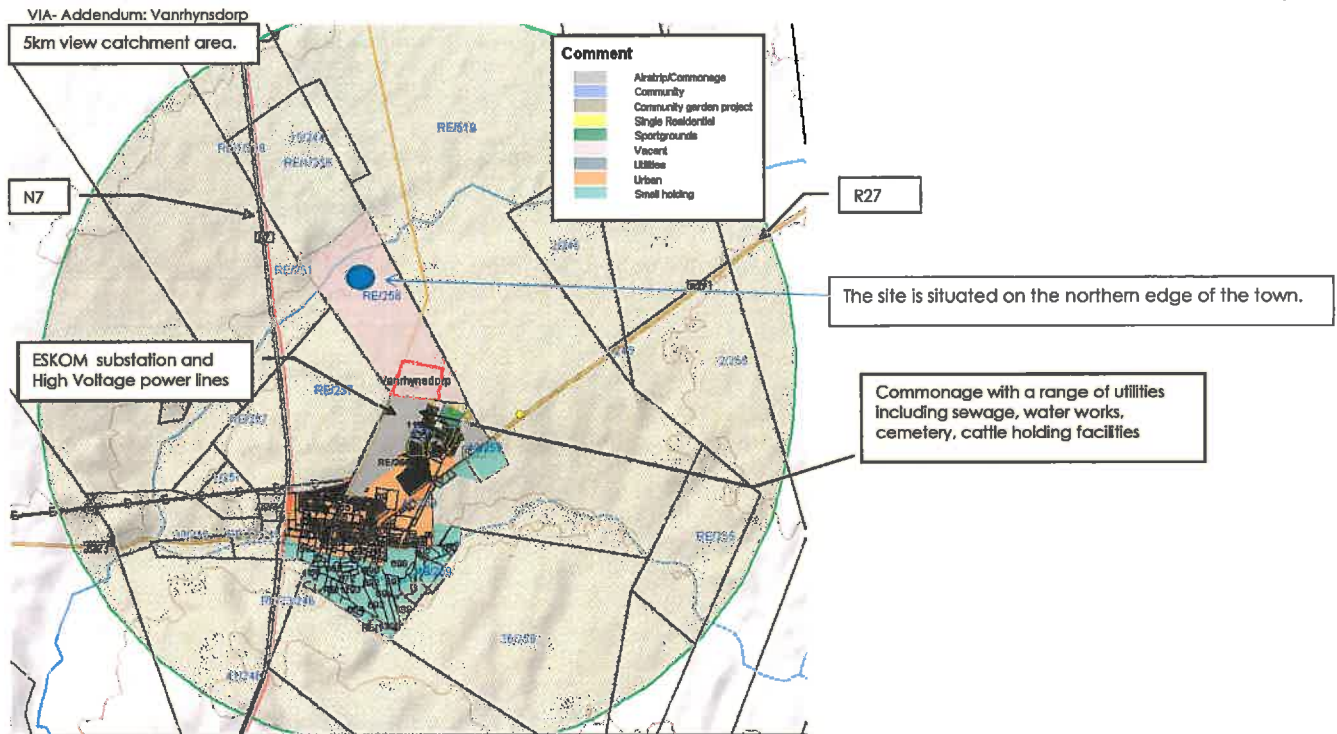
Figure 4: View catchment

In the original assessment it was determined that the viewshed does not extend as far as the Moedverloor Reserve. In the direction of the town the landscape slope upwards and the town is located on this high ground and on the down slope of the Troe-Troe valley. The current site is approximately 1,5km from town, but behind the rise in the land

This thus concluded that the catchment area does not extent to the 30km radius. Other energy production sites within a 30km radius is spatially removed from the application erf and will therefore not result in any space crowding effects.

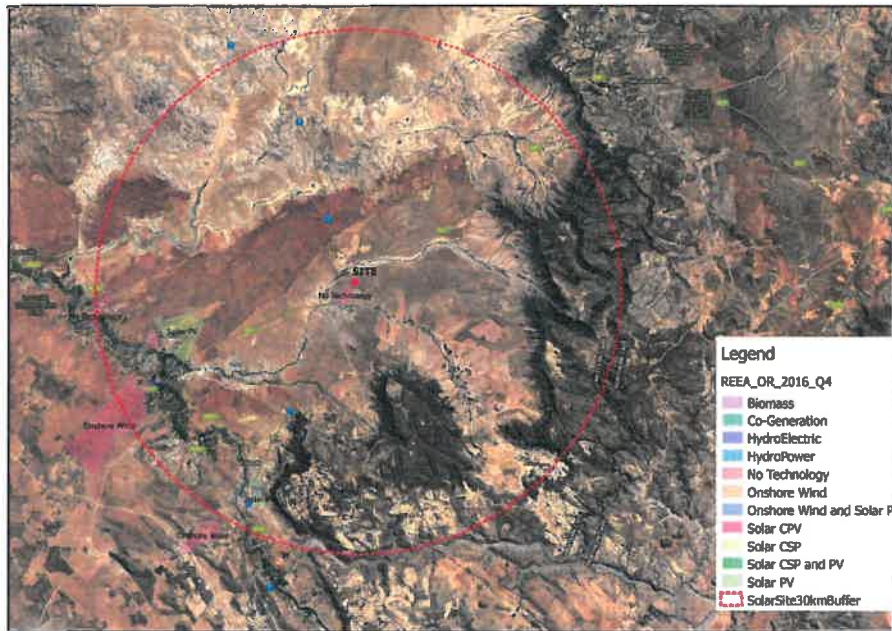
Figure 5: 30km radius

DEAT also require that cumulative impacts of all energy projects within a 30km radius be assessed.

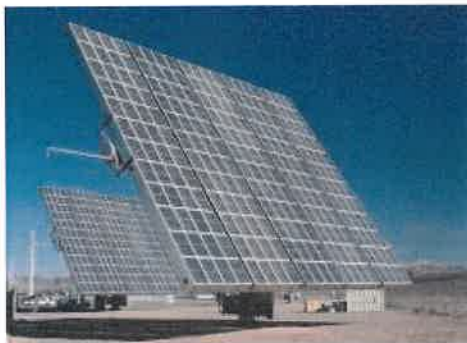
Figure 4: Typical CPV Unit

Construction of Solar energy production facility ("Solar Farm") with a 10Megawatt capacity, consisting of 140 tracking CPV units, on approximately 20ha. Each unit have approximately 30m tracker clearance zone. Units are typically positioned in rows with access roads between every second row. Unit spacing typically varies between 43x37 and 33x30m.

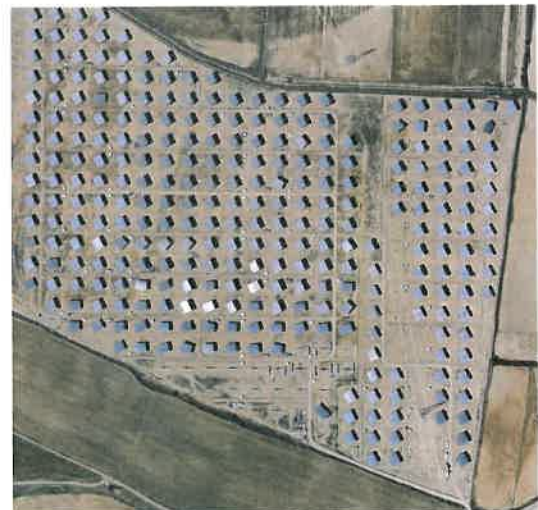
Figure 3: Typical Solar Farm layout

The Solar Farm include supportive infrastructure which consists of 2-4 concrete transformer pads approximately 20x15m respectively, a fence construction staging area, maintenance shed and a switch panel for connection to the grid and transmission line from the transformers to the closest ESKOM substation.

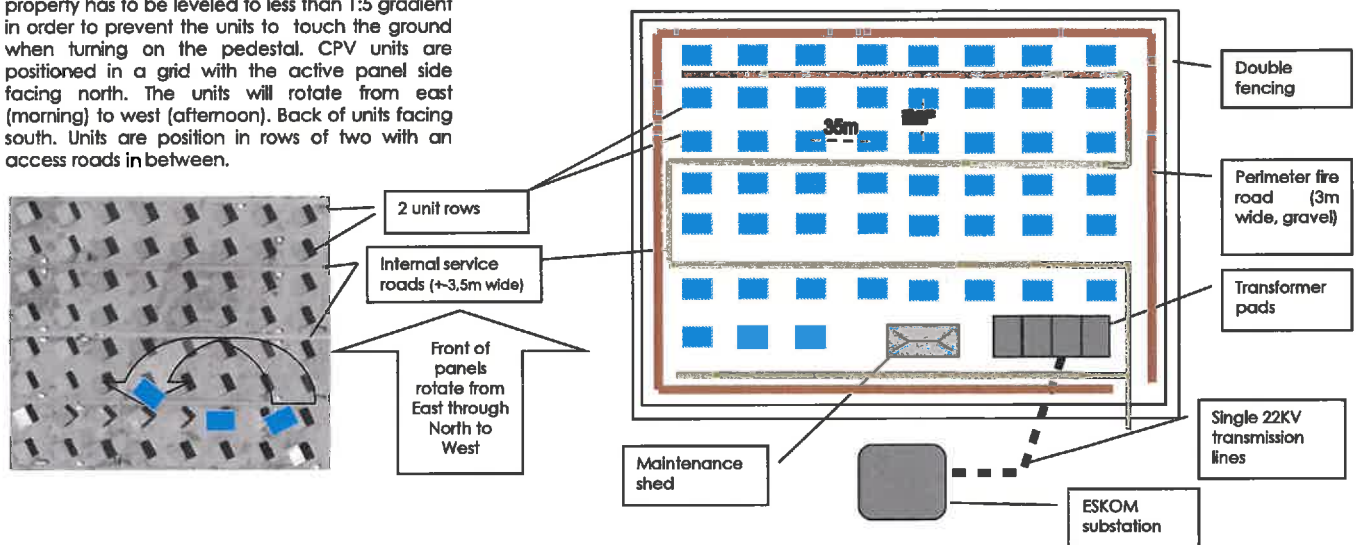
Figure 5: Typical Layout configuration

The Solar farm will occupy approximately 20ha. The nature of the tracking CPV units are such that the property has to be leveled to less than 1:5 gradient in order to prevent the units to touch the ground when turning on the pedestal. CPV units are positioned in a grid with the active panel side facing north. The units will rotate from east (morning) to west (afternoon). Back of units facing south. Units are position in rows of two with an access roads in between.

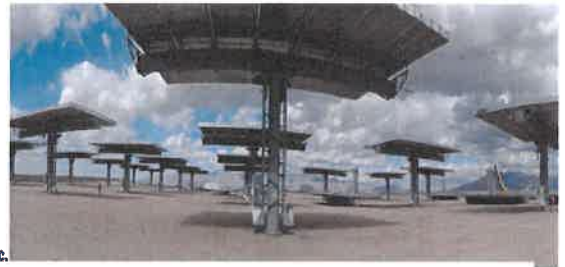
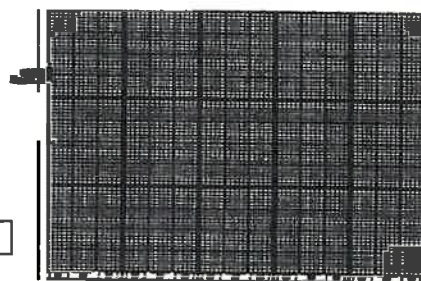
In stow: >28 mph, >10 sec. Out of stow: <28 mph, >300 sec.  
Figure 6: Storm Stow position

Front view

17m

In the Night  
stow position it  
equals the  
facade of a 5  
to 6 storey  
building

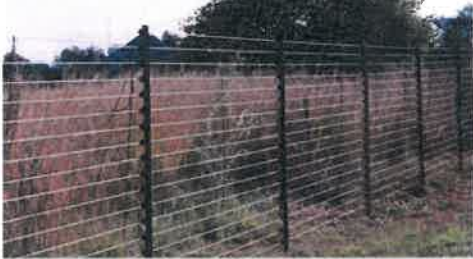
**Figure 9: Typical electrical fence**

Double fencing with inner fence consisting of galvanized palisade fence and outer an electrified fence of 2.4m in height.

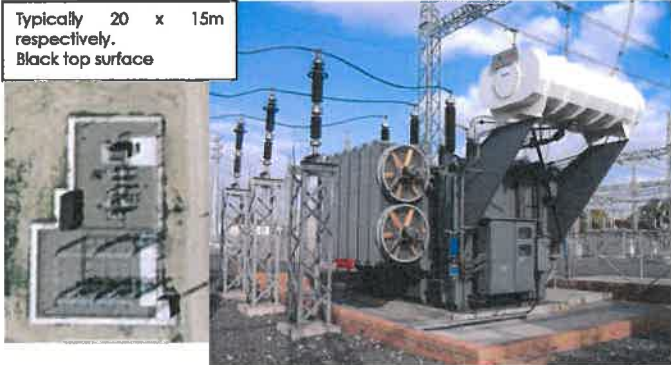
**Figure 12: Transformer Pads and typical transformer**

Typically 20 x 15m  
respectively.  
Black top surface

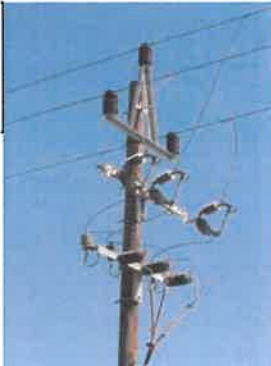
**Figure 11: Typical 22KV single Powerline**

Single 22KV Power  
lines will feed from  
the transformers to  
the ESKOM  
substation

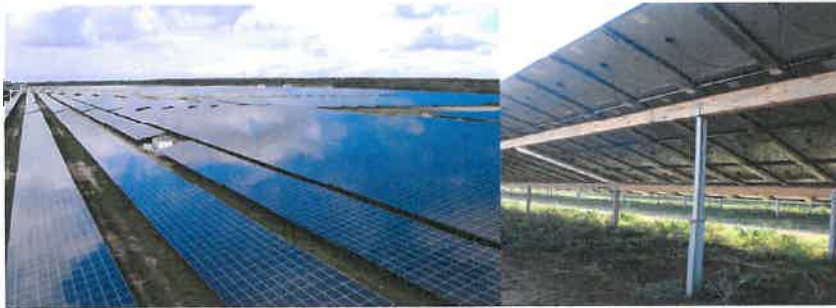
Figure 13: Example of PV arrays

The development will consist of solar panels mounted on steel supporting array structures and are configured into 33 sub array systems. The development consists of the following elements

Site needs some leveling. Expected height 2.4m but maximum height for any structures assumed at 3m above ground. Arrays orientated north.

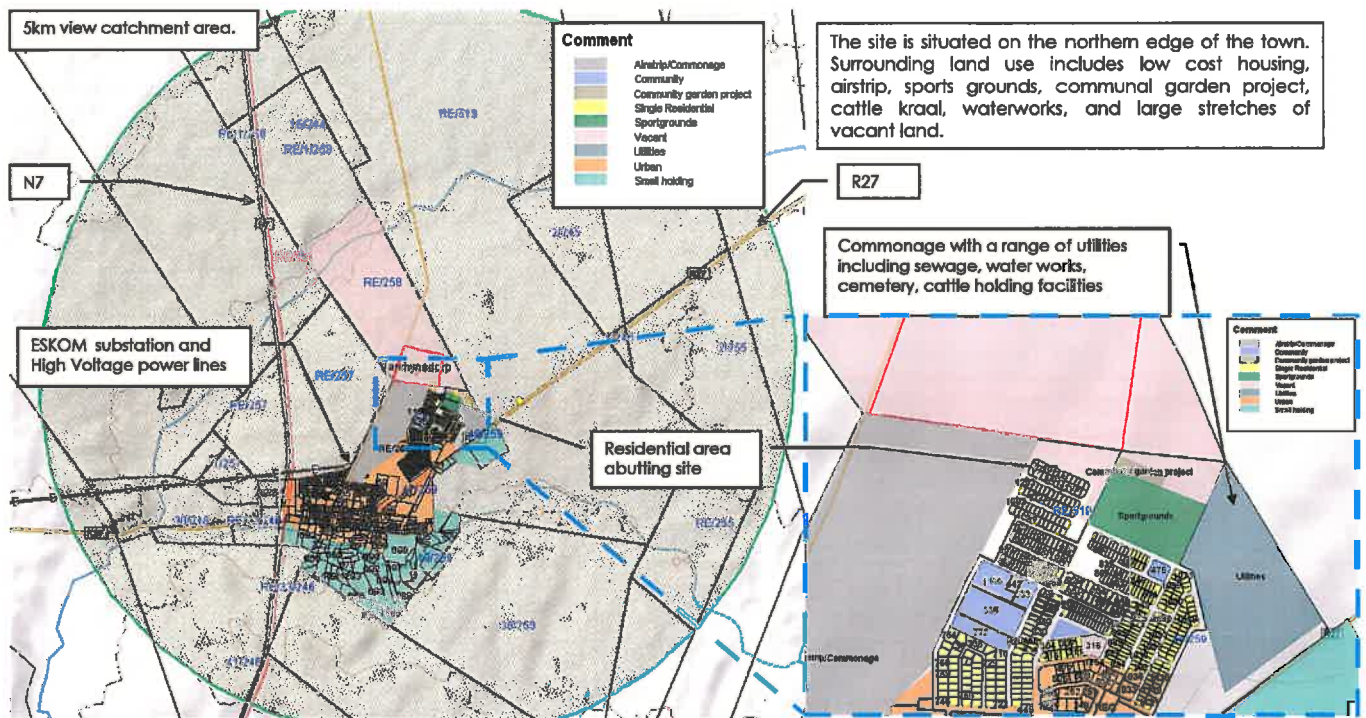
Figure 17: View catchment and land use elements

The Western Cape Biodiversity Framework included an initial viewshed analysis based on the Knersvlakte core conservation area. This viewshed indicated that the site falls within the view catchment of the Knersvlakte core conservation area. It should be noted that parameters for this viewshed analysis is not provided in the WCBF and simply serve as a note to consider visual impacts due to the low elevation variation of the region and the importance of tourism to the Knersvlakte. indicates that the Moedverloor Reserve is not within the view catchment of the proposed sites. The catchment in this direction is restricted to approximately 5km by the high ground, which rises to approximately 180m ALS.

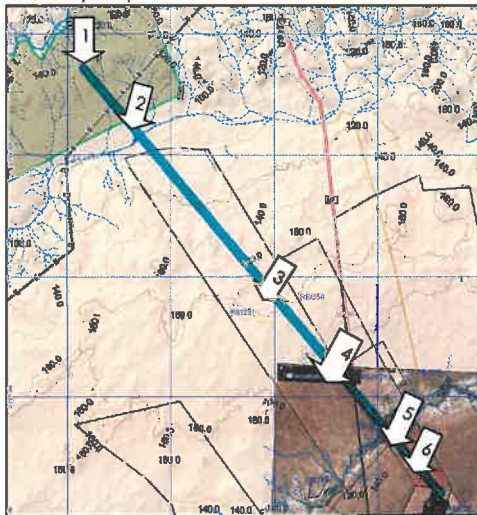
- 1 = highest point in Moedverloor Knersvlakte Reserve (139m)
- 2 = Valley
- 3 = High ground
- 4 = N7 highway (142m)
- 5 = New site (126 – 136m)
- 6 = Previous site (146 -150)

The height on the watershed, which represents the highest area of the Moedverloor Knersvlakte Reserve is at 139m ASL. The two sites are between 126m and 150m at a distance of approximately 15km. The sites are thus slightly higher than the reserve and should there be no obstructions in between, a viewer at the reserve would look down onto the site. However, a higher lying area which rise to 170m and in some places 180m is between the reserve and the sites. This means the view from the reserve to the south east is obstructed by this high ground to such an extent that the sites are not visible from the reserve. The reserve is thus not within the view catchment of the sites.

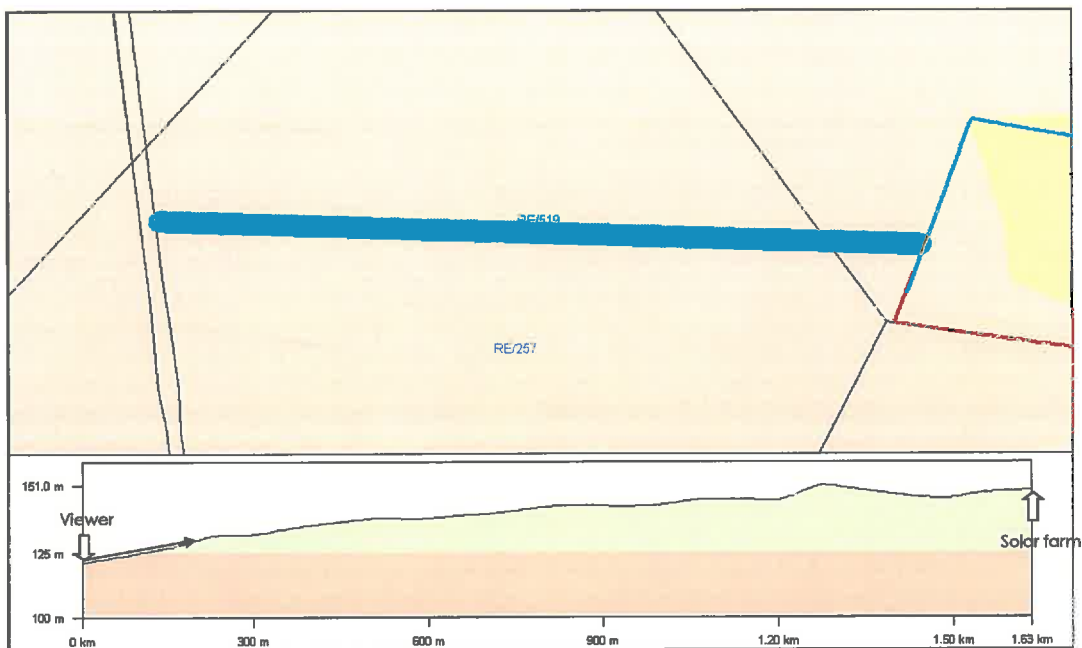
Figure 21: N7 Southbound as receptor

The viewer is significantly lower than the site (26m) and therefore the view to the site is obscured by the landscape topography. CPV units may be briefly visible in the distance but PV units will be totally out of view.

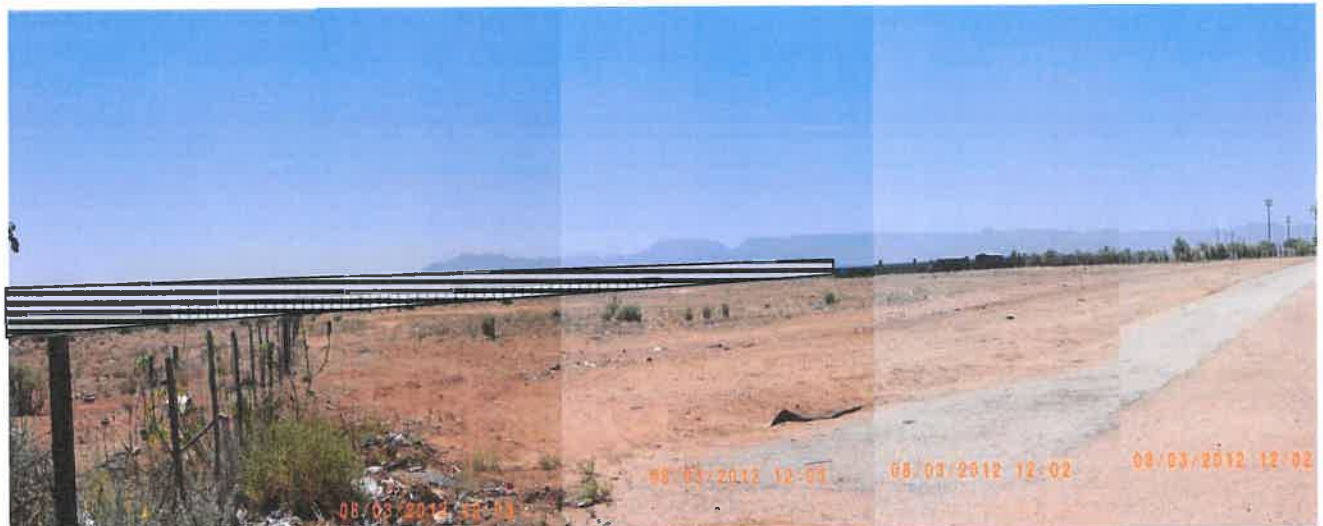
**Figure 22: Graphical presentation of PV units seen from northern residential area**

In the case of PV units, the perimeter fence will most probably screen the units from site and the residents will simply observe a security fence around the site. The maximum shadow cast by such structure, based on the maximum height of 3m is approximately 87m at sunrise in the middle of winter. The shadow then quickly shorten within 30min to 23m. The closest house boundary to the site boundary is 60m. The afternoon shadow is slightly shorter with a maximum around 17:30 of 58m just before sunset.

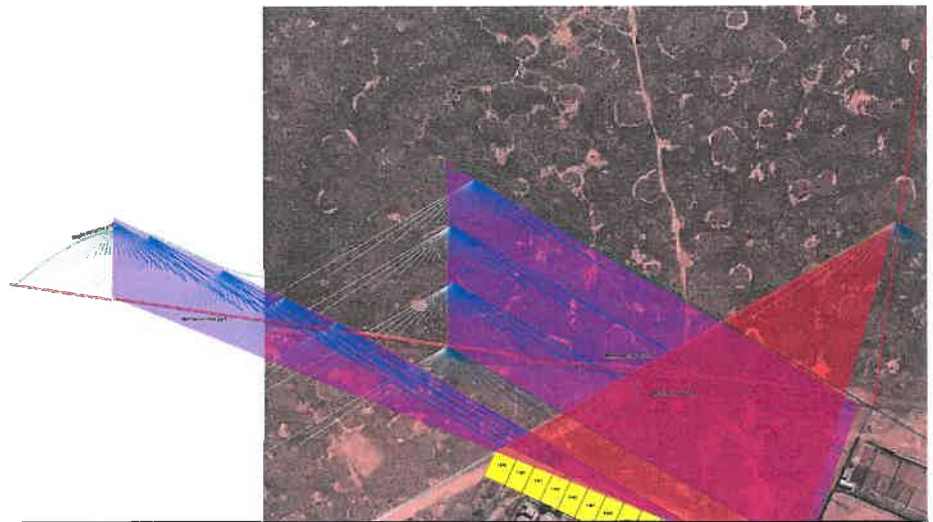
Figure 25: Shadow lines for CPV units

CPV units positioned south of the green dotted line will cast a morning and afternoon shadow onto the last row of houses. The winter shadow is of particular importance to income groups who live in small houses with little if any heating. Reduction in early morning and late afternoon sun can cause these houses to become extremely cold and even damp during the winter. Summer shadows are significantly shorter and will not impact on the houses. As this can impact on the living conditions of the residents, it is recommended that should CPV units be considered, it be positioned north of the exclusion line.

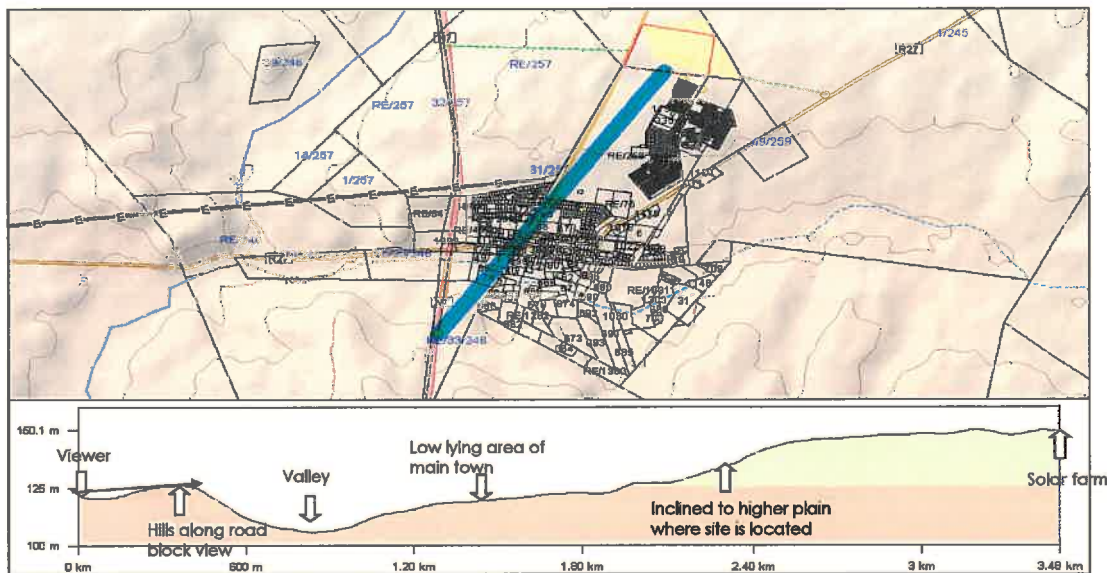
Figure 28 : N7 northbound as receptor

As traveller approach town in northbound direction, hills to the east block view to the town and the traveller only becomes aware of the town when approximately 1km from town. Facilities on the opposite higher plain is above the viewer's line of sight. Landscape elements blends the landscape and the viewer may be aware of CPV units briefly and intermittent. Due to the speed limit identification of actual facility would be low.

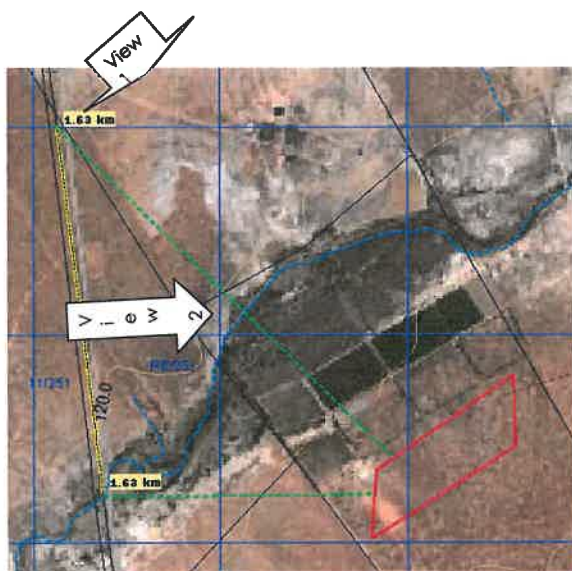
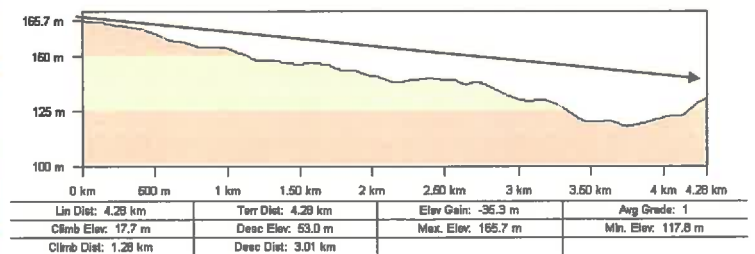
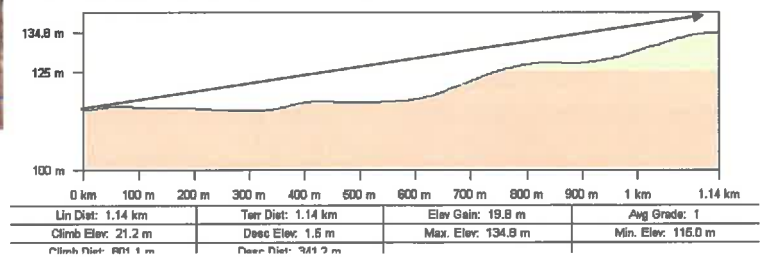
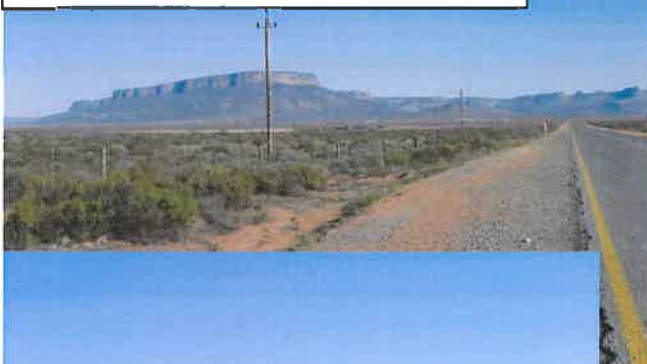
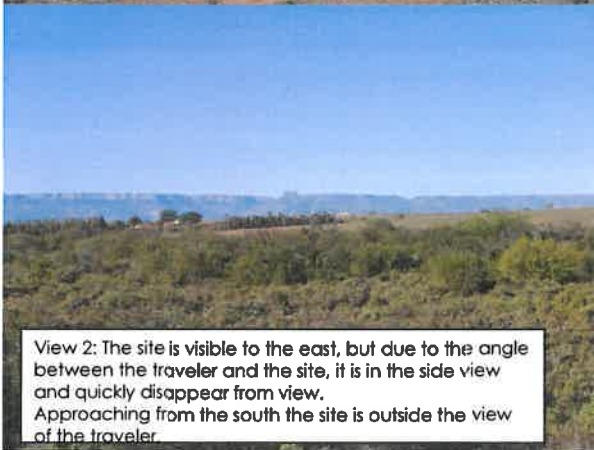
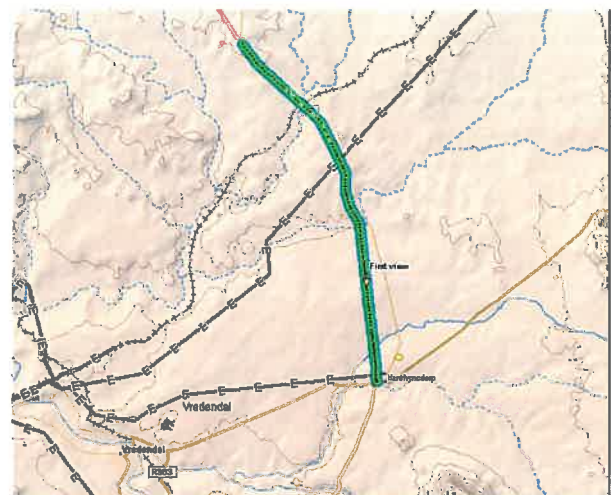
**Figure 30: N7 profile and viewpoints**

Approaching from the north the traveler will first observe the site at "view 1". The site will remain in view until "view 2". The site will thus be in view for 1,6km. At a speed of 120km/hour the view will last for about 1min before the site disappears in the side view of the traveler.

Approaching site from north. Undulating topography create high level of visual absorption and Vanrhynsdorp is not visible. The site is barely visible in the distance for a brief moment before it again disappears as the road slopes down

View 2: The site is visible to the east, but due to the angle between the traveler and the site, it is in the side view and quickly disappear from view. Approaching from the south the site is outside the view of the traveler.

Profile: The green line is an actual track recorded along the N7. It corresponds with a high level of accuracy with the elevation model used in the analysis and therefore confirm the accuracy of findings made in the Draft Report version 1.2
