PRINCE ALBERT MUNICIPALITY

**TECHNICAL REPORT FOR THE
UPGRADE OF THE KLAARSTROOM OXIDATION POND
WASTEWATER TREATMENT SYSTEM
(REVISION 2)**

30 September 2018

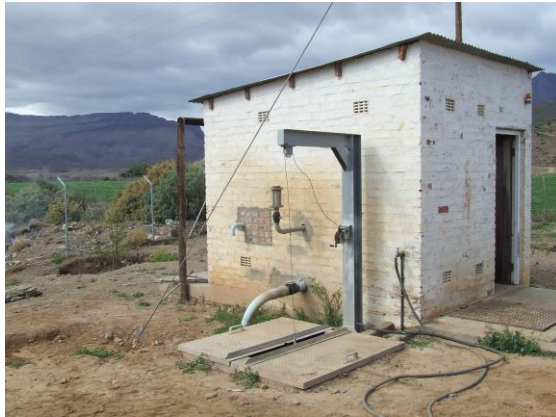
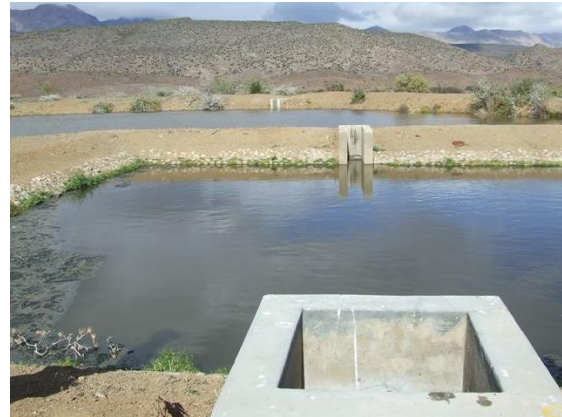
Figure 2: Existing Wastewater Pump Station and inlet to Anaerobic Pond

The village of Klarstroom is fairly well serviced in terms of water, sewage, electricity and roads. The wastewater is collected at a central pump station in the village and then pumped through a 100mm diameter rising main over a distance of 800m to the wastewater treatment plant.

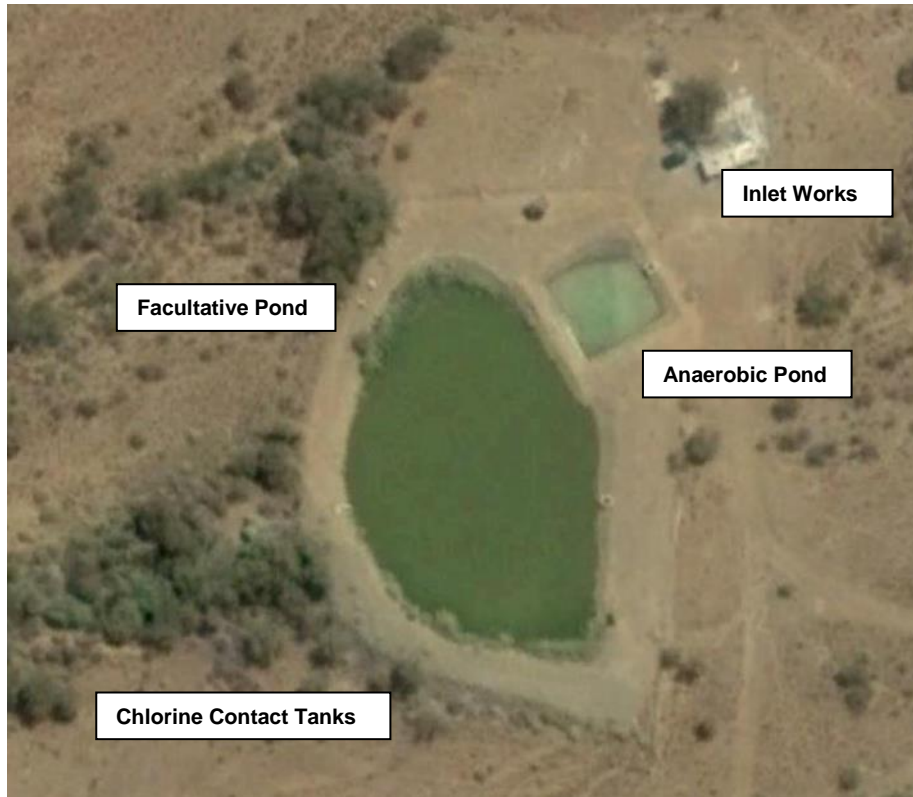
Figure 4: Existing Klaarstroom Oxidation Pond System

The existing wastewater treatment plant comprises only two ponds. The first pond is an anaerobic pond followed by a single facultative pond from where the final effluent is discharged into two 5000 liter tanks where the water is chlorinated.

An analysis of the treated effluent dated August 2015 indicates that the current effluent is basically non-compliant with all the important parameters. The Total Suspended Solids on the final effluent is very high at 88mg/l and far exceeds the allowable minimum of 25mg/l. Similarly, the COD and Ammonia levels are much higher than the allowable limits. It is therefore clear that the Klaarstroom WWTP is both hydraulically (flow) overloaded, as well as organically (chemical load) overloaded.

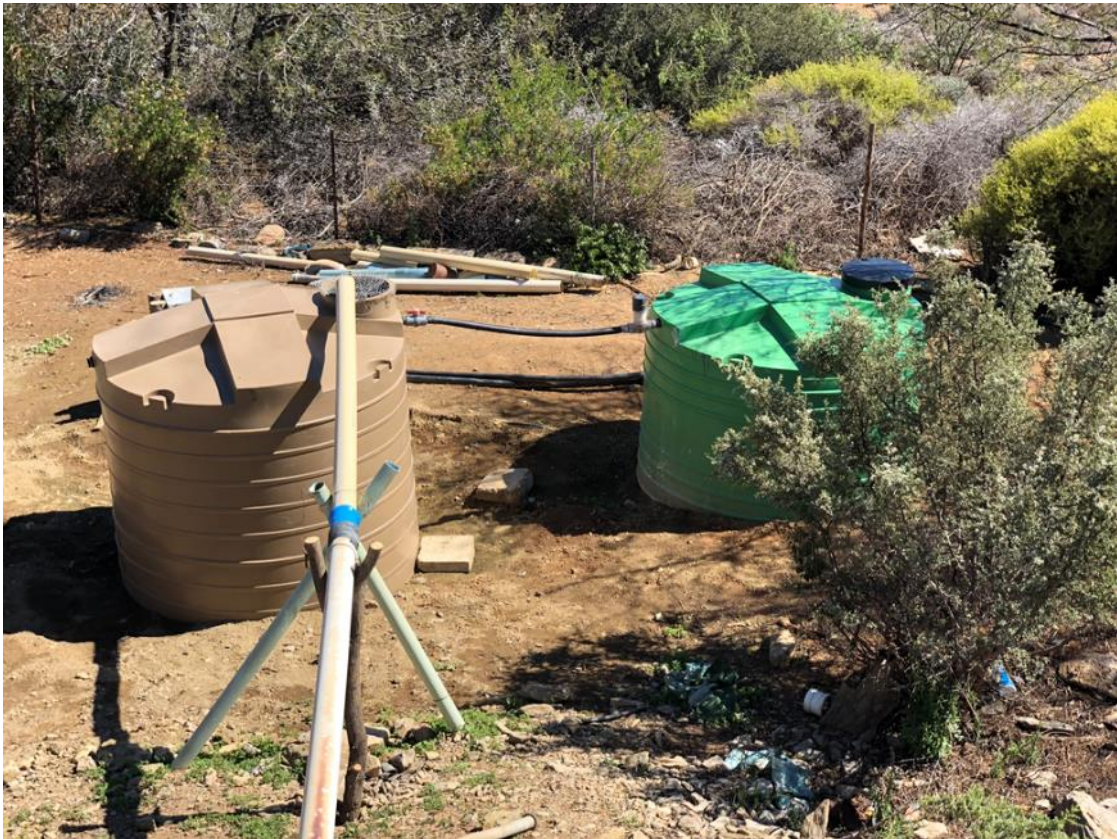
Figure 5: Chlorine contact tanks for treated effluent

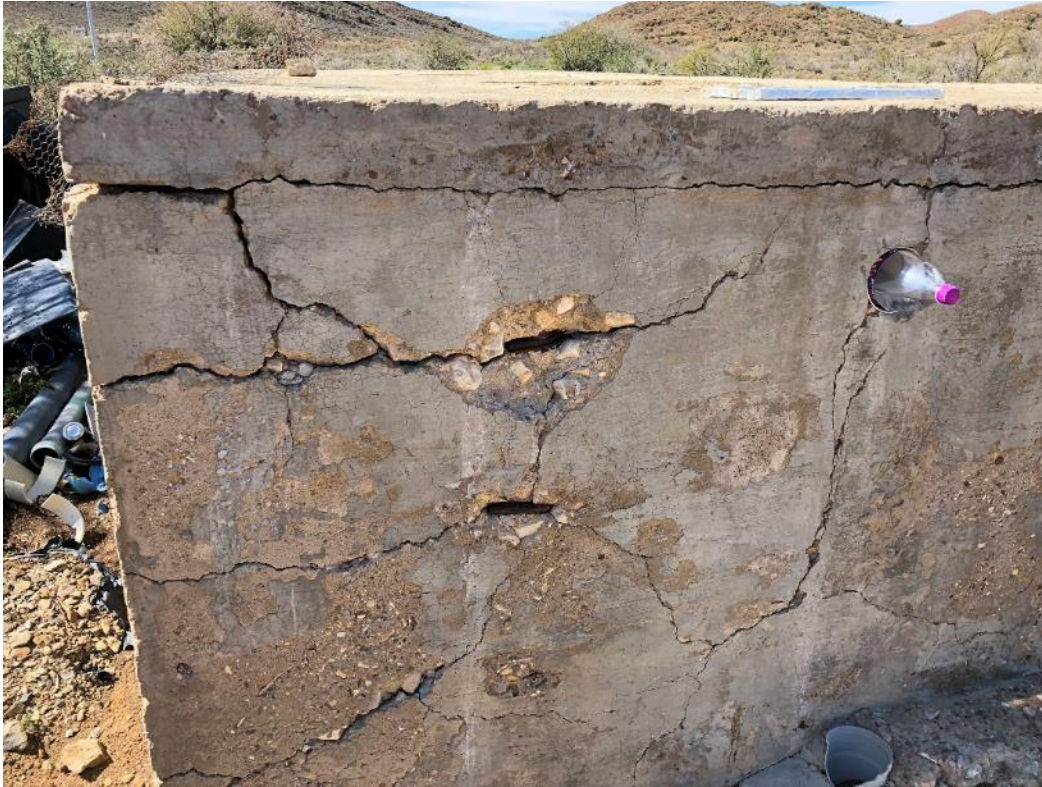
Figure 6: Existing Septic Tank structurally very unsound; not used

The existing septic tank has not been in use for many years and is structurally beyond repair. The current rising mains appear to be in reasonable condition with isolating valves in place to control the outlet flow.

1. Construct a new Inlet Works to provide for screening, dual grit removal channels and flow measurement.
2. The existing old septic tank (approximately 23 m³) has a retention period of less than 24 hours. In addition, it is in a very poor structural condition and no longer in use. It is therefore suggested that both this tank be omitted from the process and demolished upon completion of the new works.
3. As the depth of the current single anaerobic pond is unknown, and the volume thereof probably completely filled with sludge, it is suggested that two new anaerobic ponds are constructed. The

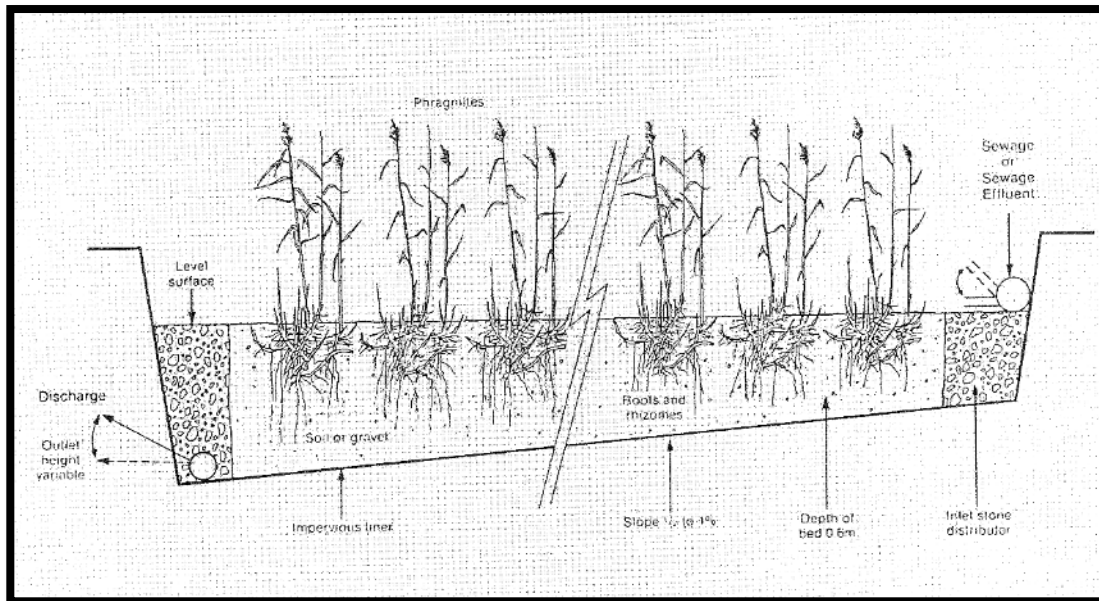
Figure 7: Typical Cross Section of a Horizontal Flow Reedbed

Reed beds or constructed wetlands are large areas of land inundated with water typically not deeper than 600 mm, that support the growth of emergent plants such as cattail, bulrush, reeds and sedges. The most popular of these plants being the common reed or *phragmites australis* hence the name “reed bed treatment system”. The plants, or more specifically their roots, in combination with the growth media they are planted in, act as natural biological filters. The aerobic zones around their roots are the habitat for a multitude of microorganisms that utilize the nutrients found in wastewater as food.

Typically reed beds are shallow basins filled with a growth medium such as soil, sand or gravel which has an impervious layer that retains the water and prevents contamination of the natural ground below. The media is then planted with distinct plant communities such as reeds, sedges, bulrushes, etc.

In Horizontal Flow Reed Beds the wastewater flows horizontally through the substrate below the surface. The fact that there is no visible water ensures that vectors such as mosquitoes cannot breed. The horizontal flow reed beds are utilized as a secondary treatment or polishing stage to remove the suspended solids which the oxidation ponds inherently cannot do.

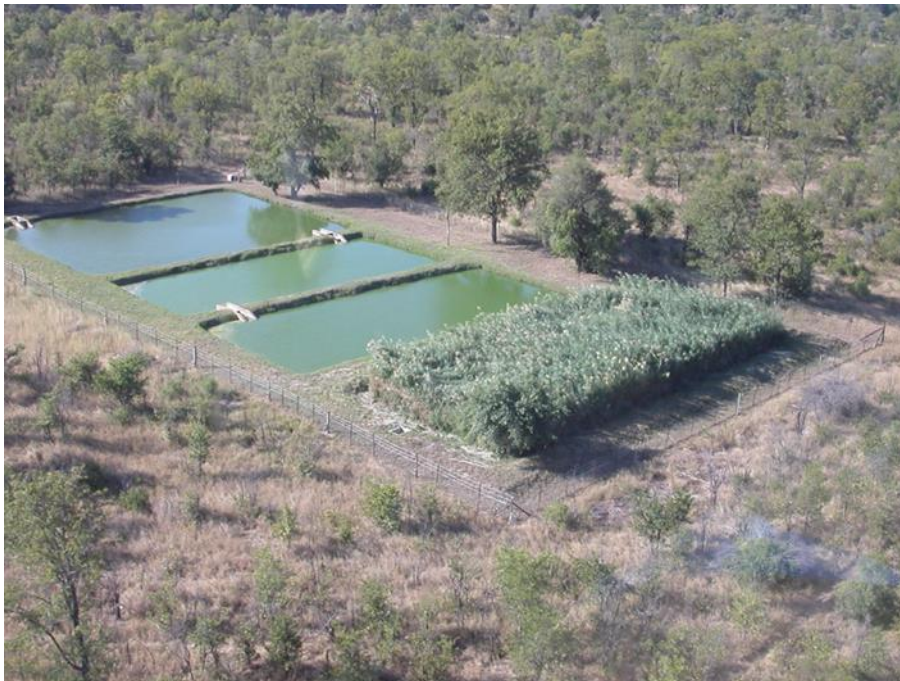
Figure 8: Example of an Oxidation Pond and Reedbed in the Kruger National Park

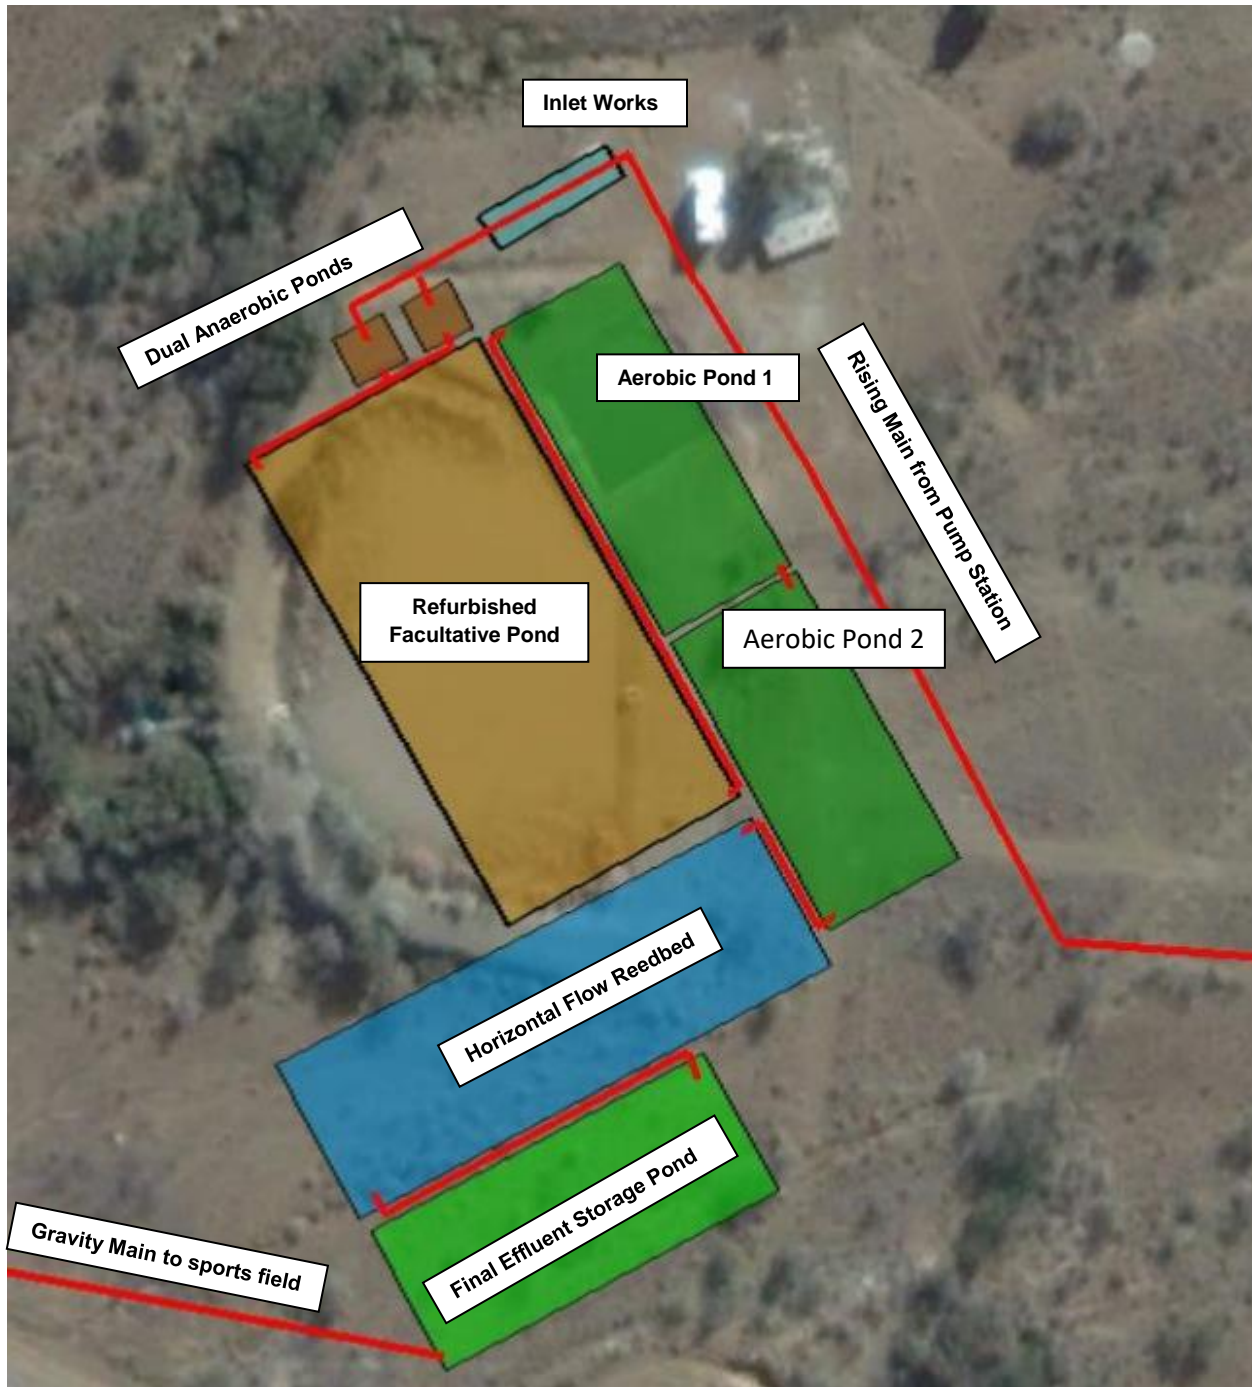
Figure 9: Proposed Layout of Refurbishment and Improvement works for Klaarstroom WWTP

Given the existing layout of the plant and the analysis results of the Final Effluent received, , it is proposed that the existing plant be converted to a system comprising conventional oxidation ponds with a single horizontal flow reedbed in series, followed by a storage pond.

anaerobic ponds are suggested to have a combined retention period of 24 hours. This should be sufficient to break down the organic fraction (COD) of the wastewater by at least 50%. Dimensions of 5.5m x 5.5m x 3.5m depth are suggested for each pond. The incoming wastewater is to enter the dual ponds at floor level and are to be operated in parallel. Only the primary ponds are to be lined with an HDPE Lining to prevent seepage of raw sewage into the water table below.

4. The existing facultative pond (large pond) is to be refurbished and reshaped to encourage plug flow to have final dimensions of 58m x 30m x 1.20m deep. The area is approximately the same as what the existing pond is at the moment. A total retention period of 25 days is provided for. The provision of oxygen by means of algal photosynthesis and wind action allows the ammonia to be nitrified and converted to nitrates and nitrites in this pond.

5. The existing anaerobic pond is to be modified and reshaped to create a new secondary aerobic pond with dimensions of 38m x 15m x 1.00m deep.
6. Construction of a 2nd secondary aerobic pond of 38m x 15m x 1.00m deep. Each of the secondary ponds to provide a retention period of 5.5 days or a total of 11 days.

7. Construction of a single Horizontal Flow Reed Bed with dimensions of 60m x 20m x 0.60m deep for polishing of the final effluent and to facilitate denitrification. Denitrification is achieved by allowing the nitrate/nitrite rich water from the ponds to flow through the reedbed where anoxic conditions exist. In addition, the reeds will also take up a percentage of the nitrates/nitrites as nutrition for plant growth. The reedbed will need to be lined with an HDPE membrane to contain the growth of the plants.

8. Construct a Storage Pond with capacity to store at least 7 days of flow. Typical dimensions will be 40m x 20m x 1.50m deep.
9. The water from the last pond can then be utilized for irrigation of parks and sports fields. At Klaarstroom, this will be possible to do using a gravity system as the wastewater treatment plant is located at a higher elevation than the village. It is proposed to construct a 160mm dia uPVC pipeline of 300m in length which would terminate in a 6m dia x 1.8m high lined galvanized dam at the sports fields.

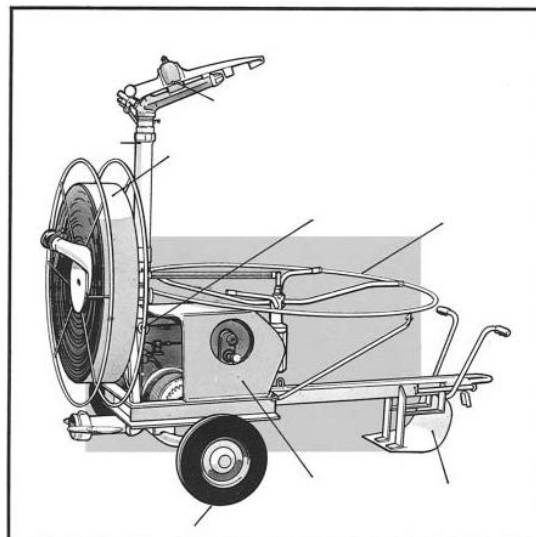
Figure 10: Illustration of a typical crawling irrigator

A small pump station will be required to pressurize the water to a crawling irrigator. Typically, a flow of 4.5l/s at a minimum pressure of 3.5bar is required.

The reason for this is that the crawling irrigator utilizes the energy from the water to drive a small Pelton wheel turbine which in turn drives a reduction gearbox allowing the crawling irrigator to propel itself across the length of the sports field. This is the simplest possible system to irrigate medium to large areas and ideally suited for sports fields.

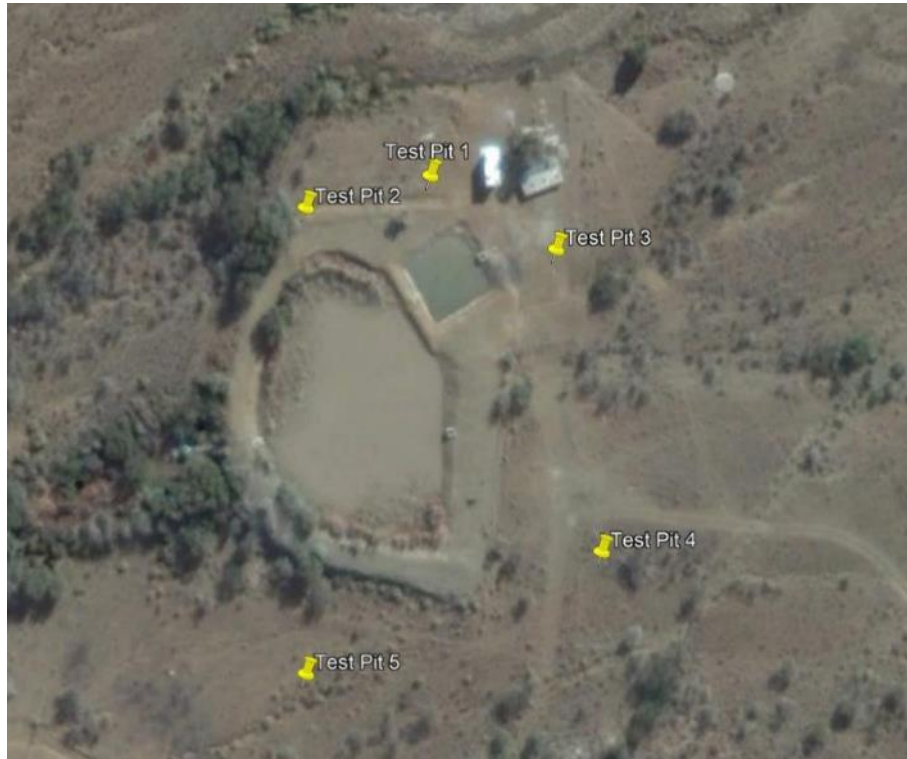
Figure 11: Position of test pits for geotechnical investigation

A basic geotechnical investigation was conducted by means of the excavation of test pits. Five number pits were excavated by means of a digger loader. Each pit was excavated until failure, or until the excavator reached its maximum depth.

- TP1: Excavator reached a depth of 1.70m before hitting hard rock
- TP2: Excavator reached a depth of 3.0m before hitting hard rock
- TP3: Excavator reached a depth of 0.8m before hitting hard rock
- TP4: Excavator reached a depth of 2.50m before hitting hard rock
- TP5: Excavator reached a depth of 2,0m before hitting hard rock

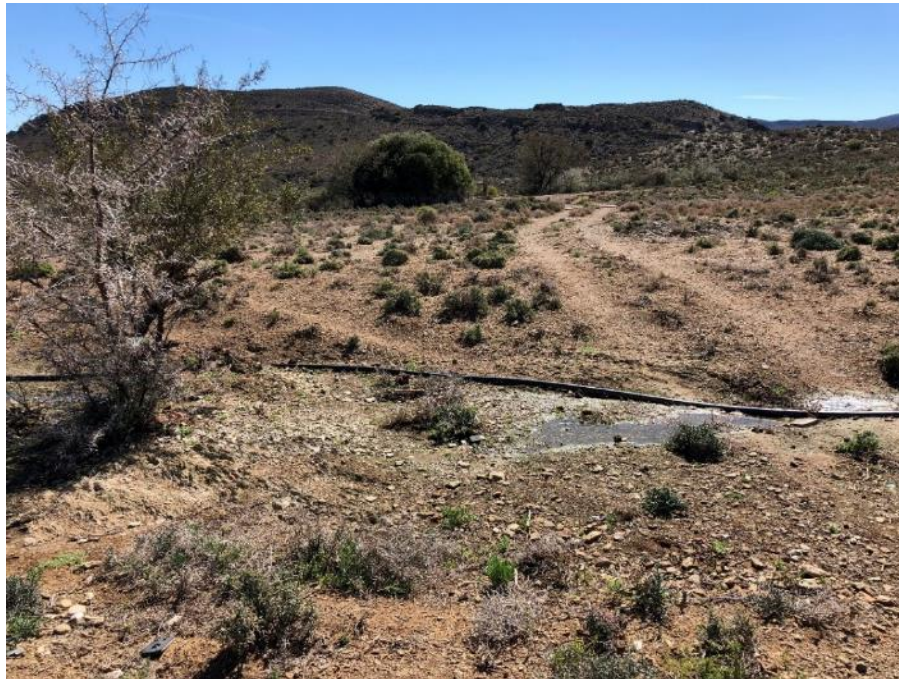
Figure 12: Photograph of site from south looking north

Although the site is located on the slope of one of the foothills of the Swartberg Mountains, it appears as if the upper layers are heavily weathered and only the deeper (>2.0m) layers become harder. The site has a natural slope from north to south which is conducive to this type of construction where every effort is made to balance the volume of excavated material with that required for fill. In this case, we were able to balance the cut to fill within 95%.

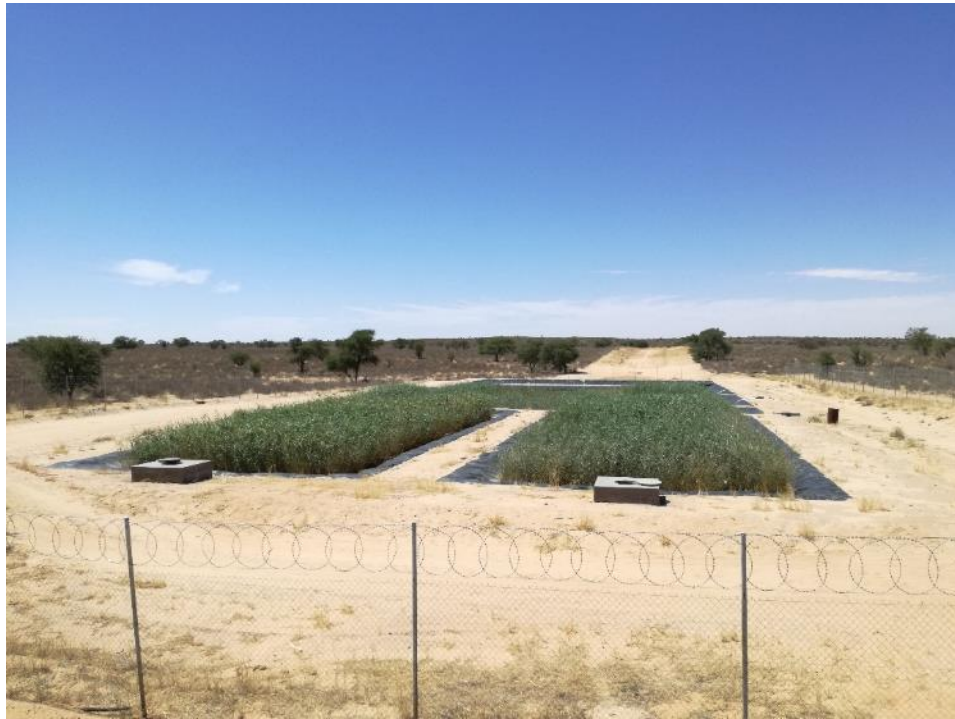
Typical Reedbed System: Nossob Rest Camp, Kgalagadi Transfronteir Park

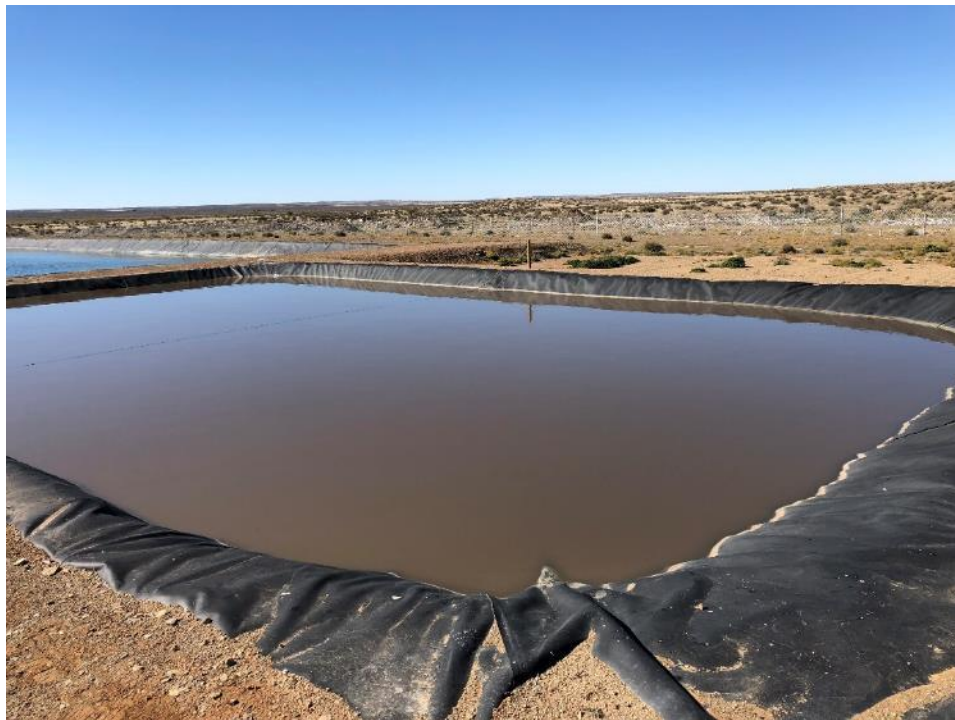
Typical Primary Anaerobic Pond with full HDPE Lining, Brandvlei Northern Cape

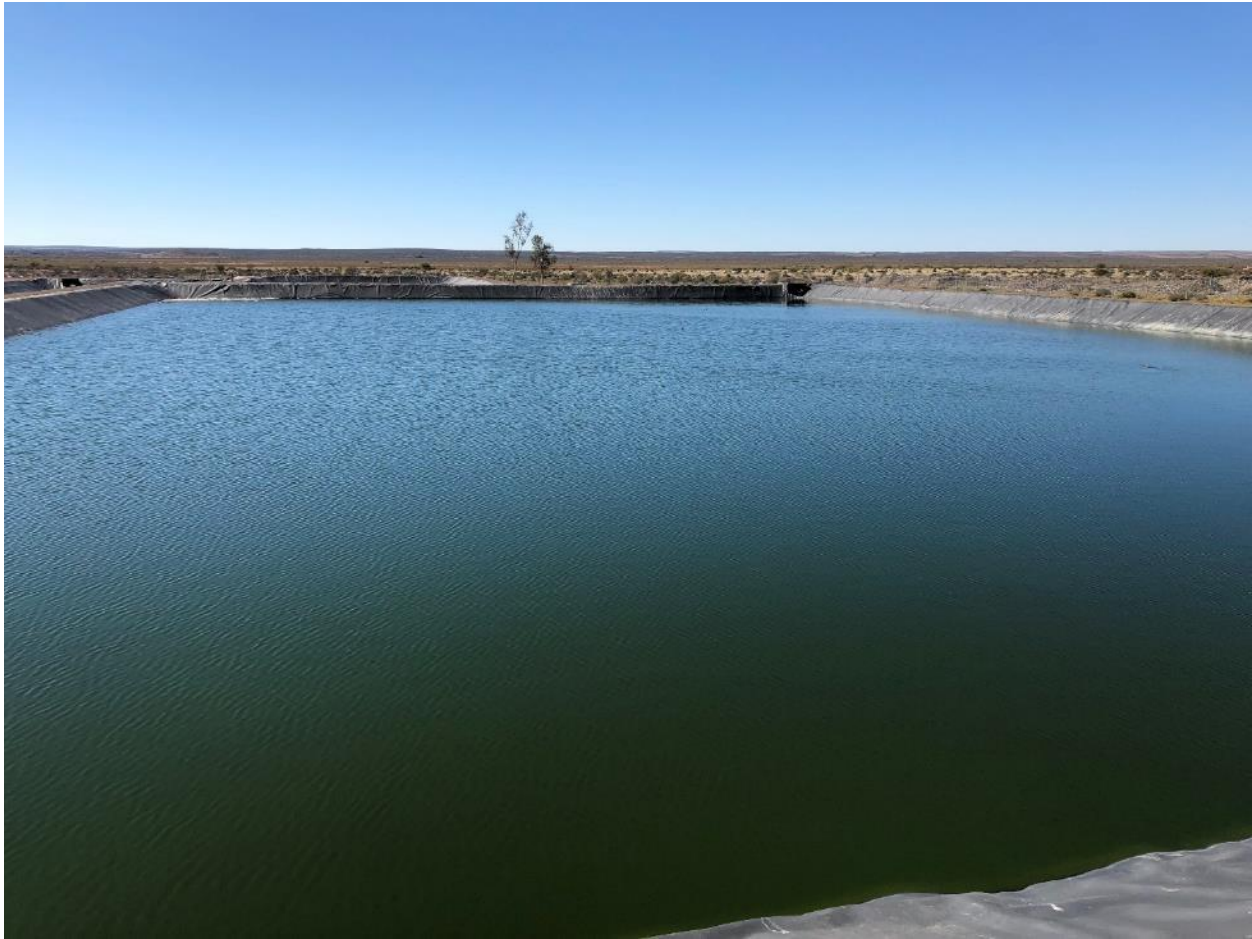
Typical Facultative Pond with full HDPE Lining, Brandvlei, Northern Cape
