DESTINATION RIVER RESORT

BULK AND INTERNAL SERVICES REPORT FOR CIVIL AND ELECTRICAL ENGINEERING SERVICES

30 September 2019

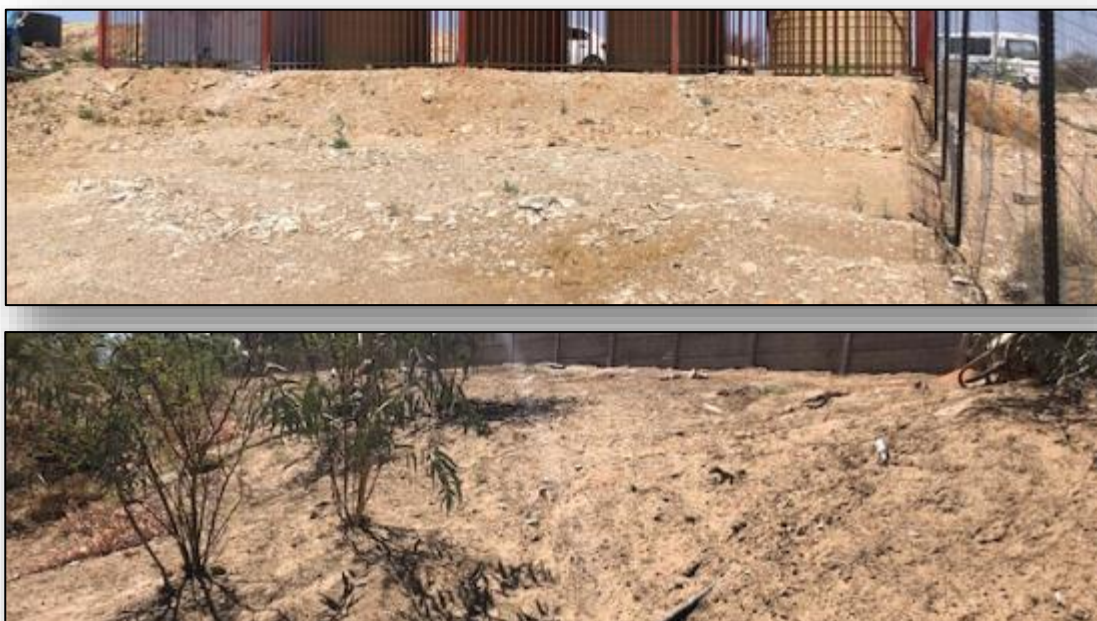
Figure 2: Typical terrain on property

The geological composition of the area forms part of the Gordonia formation, Kalahari group. In the higher areas away from the river. Calcrete of various thickness can be found that is overlaid with sandy dune sand. A yellowish sandy silt deposit can be found closer to

the river.

Excavated material visible close to old trench excavations varied from soft to hard.

The site topography with regards to permanent buildings areas was found to have a downward slope towards the river of about 1 in 45. This makes it easy for civil services to be designed and constructed. Surface water drains across this area in the direction of the river.

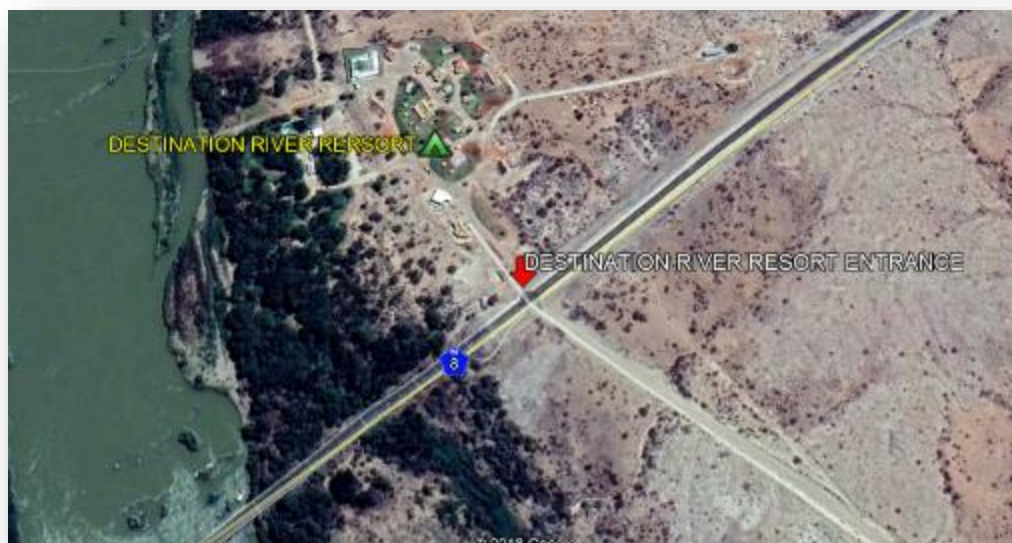
Figure 3: Access from N8

The N8 National Road runs along the South-Eastern boundary of the site. Entrance to the Destination River Resort development from the N8 National Road will be from the South-East, as indicated on the Google image below. A separate process to obtain SANRAL approval for access from the N8 to Destination River Resort is under

way.

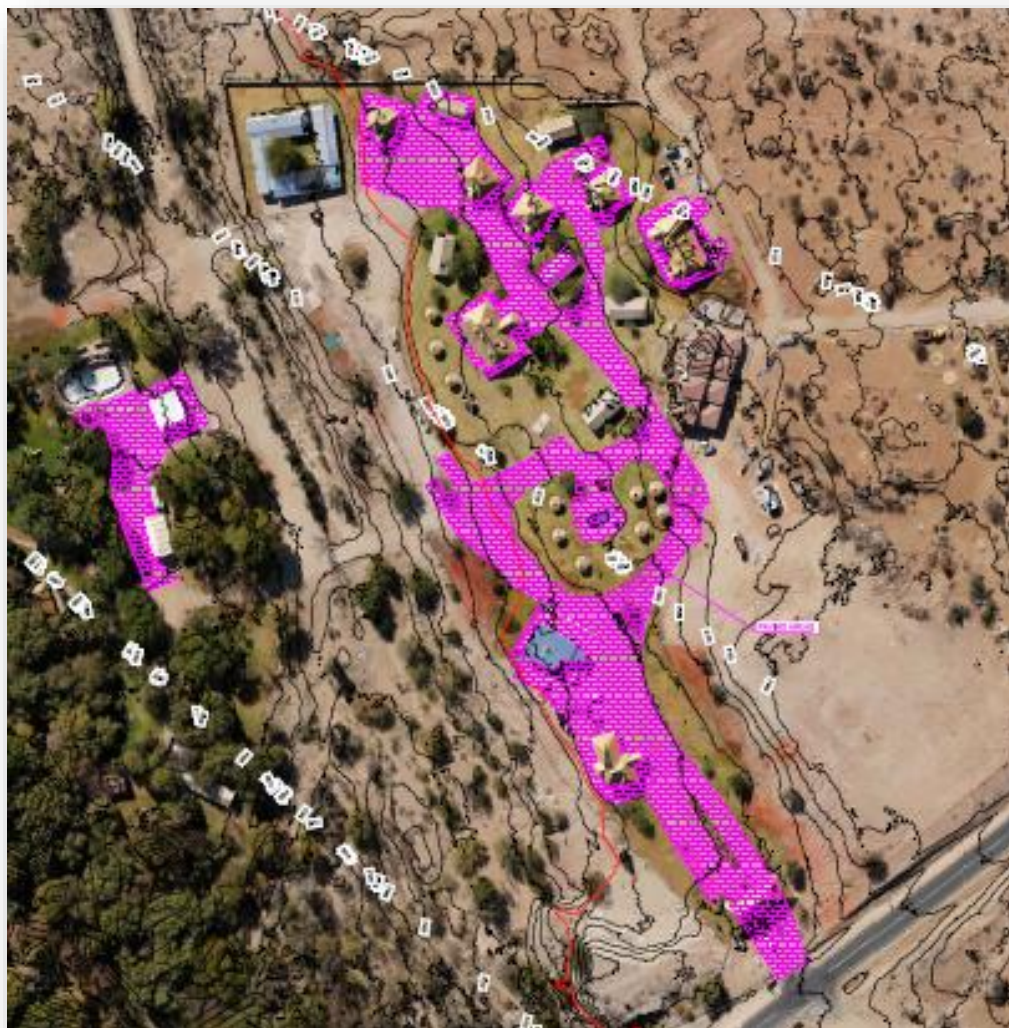
Figure 4: Access and Internal roads

The access roads from the access gate to the accommodation and restaurant area as well as a small portion of the Day Visitors Area are paved with cement brick paving blocks. The rest of the roads (access to the day area and service roads to pumps and water treatment plant) are gravel roads. Information with regards to the construction of road layers was no available. No problems with regards to collapsing of paved areas were observed. *(See layout in Annexure A & Figure 4 below)*

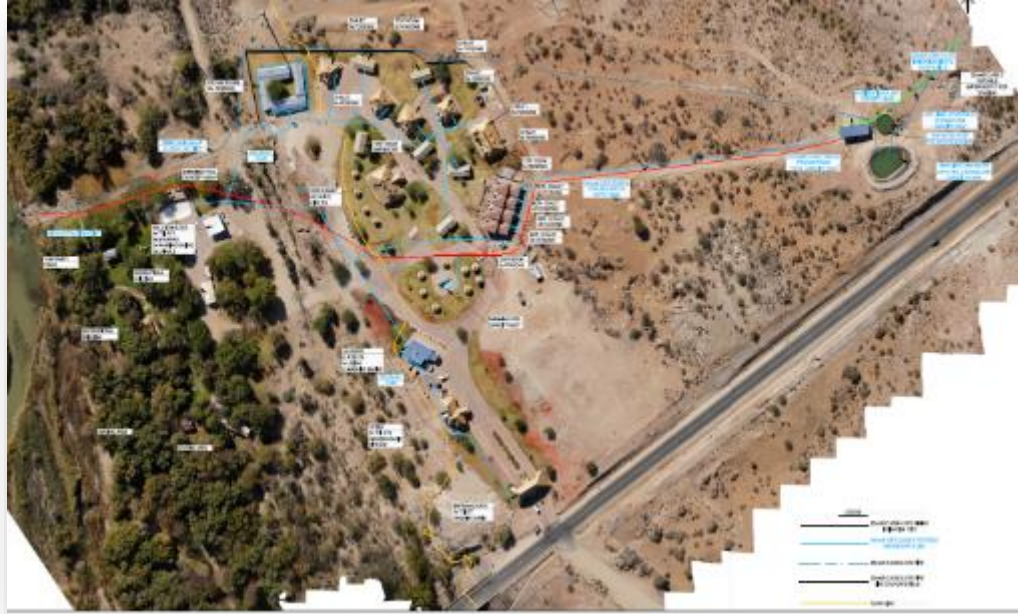
Figure 5: Destination River Resort water supply system

Figure 5 below (as well as Annexure B) shows the position, details and capacity with regards to components of the water supply system.

Destination River Resort pumps raw water directly from the river through an 80mm diameter Class 6 LDPE pipe to raw water HDPE lined storage reservoir. From there the water is treated in a water treatment package plant, stored in 5 x 10 m³ plastic tanks and this potable water is distributed through a 50mm diameter Class 4 LDPE pipeline to buildings and pools that forms part of Destination River Resort. Small booster pumps provided pressure to the western part of the accommodation buildings as well as the laundry.

Potable water is also pumped through a 32mm diameter Class4 LDPE pipeline from the 5 x 10 m³ plastic tanks to the sports field development.

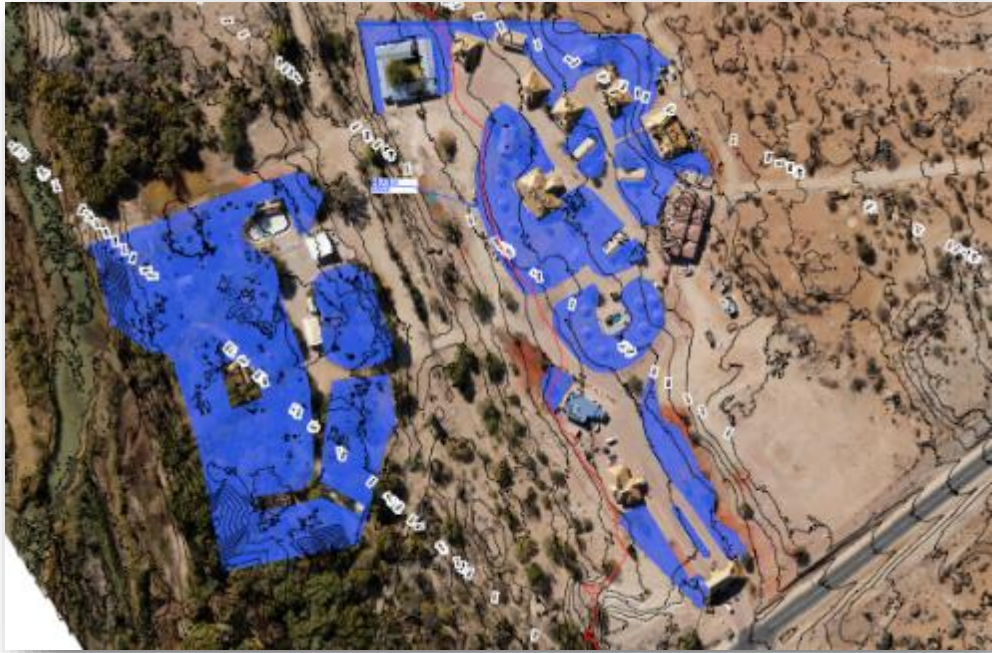
Figure 6: Destination River Resort irrigation areas.

Raw water for irrigation is fed under gravity from the HDPE lined raw water storage dams through a 50mm diameter Claass4 LDPE to the 2 Ha gardens and lawns. The map below shows the garden and lawn areas that are irrigated.

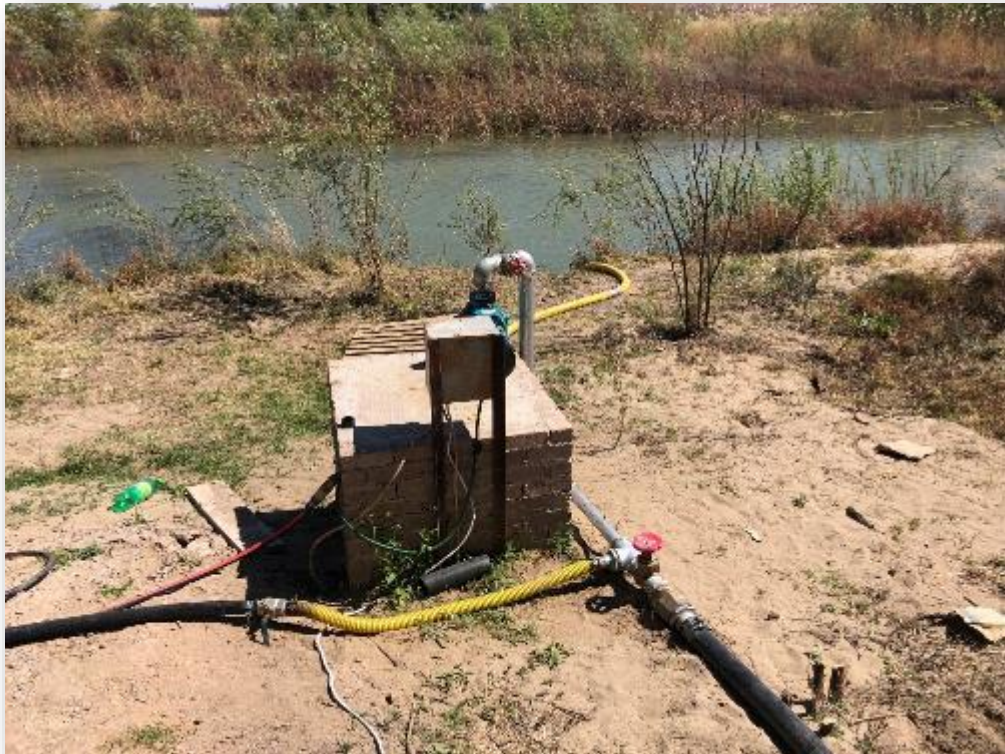
Photo 1: River pump

The photos below shows components of the water supply system.

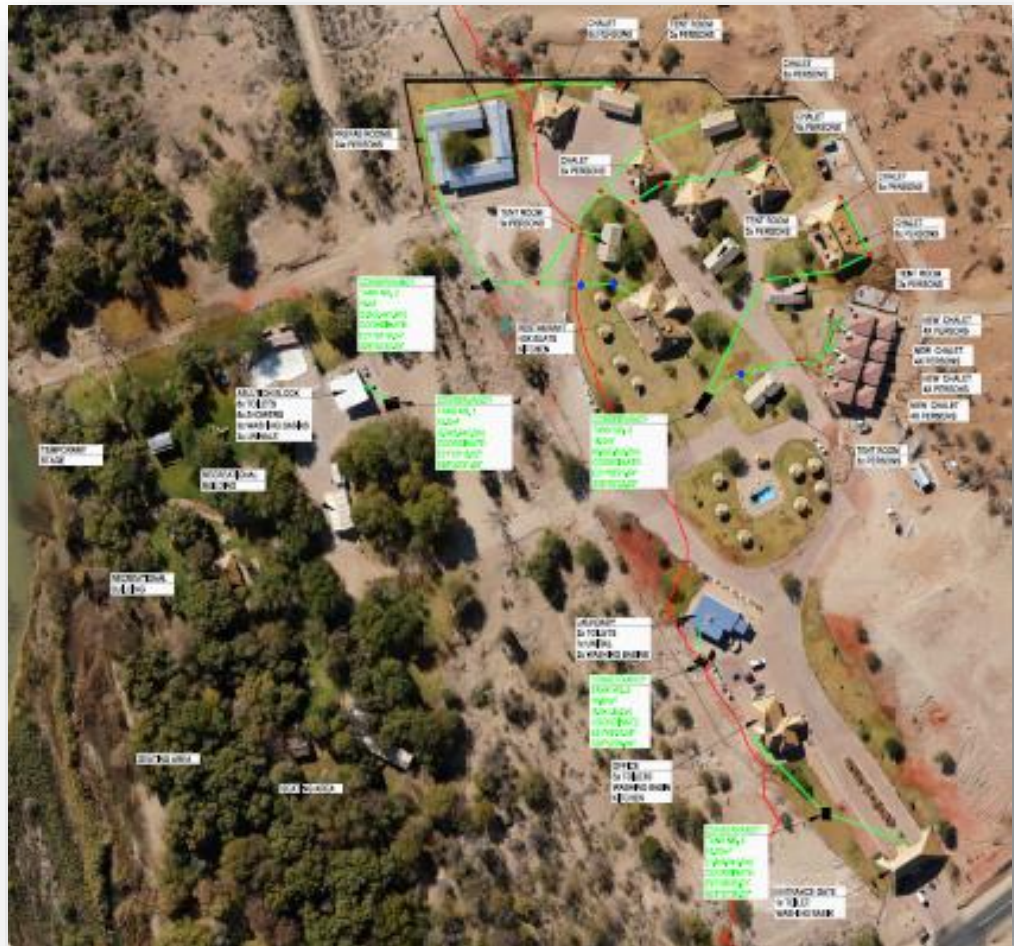
Figure 7: Destination River Resort sewer network & position of conservancy tanks

Destination River Resort development discharge sewage from all buildings to five conservancy tanks through The internal sewer system consist of 110mm Ø uPVC

Class 34. (green lines) as indicated on die drawing. (Figure 7 & Annexure E)

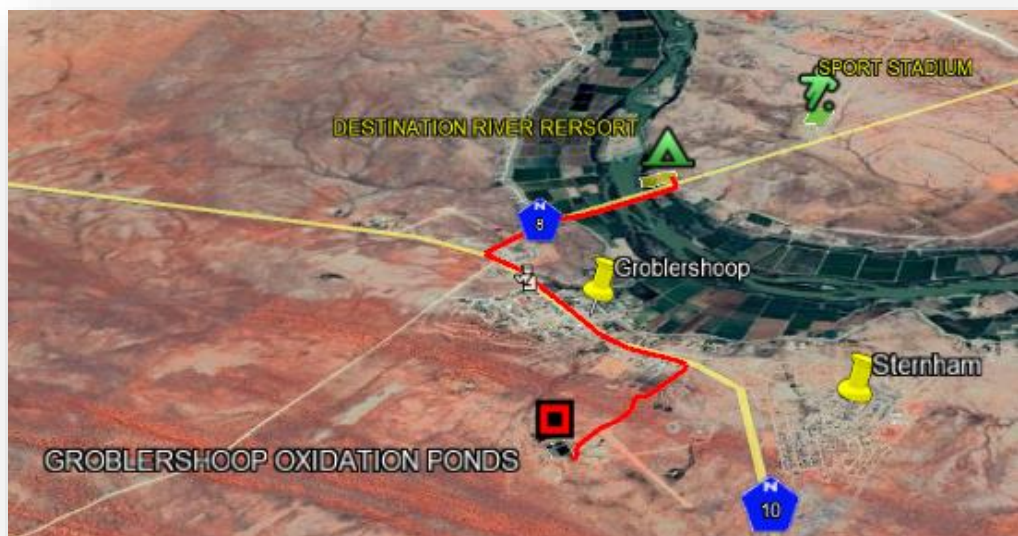
Figure 8: Groblershoop Oxidation Ponds

The Groblershoop Sewage Treatment Works (Oxidation Ponds) was upgraded recently. Kheis municipality has confirmed in a letter (*See Annexure G*) that the capacity of the oxidation ponds are sufficient to accommodate sewage load from Destination River Resort. **Figure 8**, shows the position of the Oxidation ponds in

relation to Destination river resort 5.5 km away

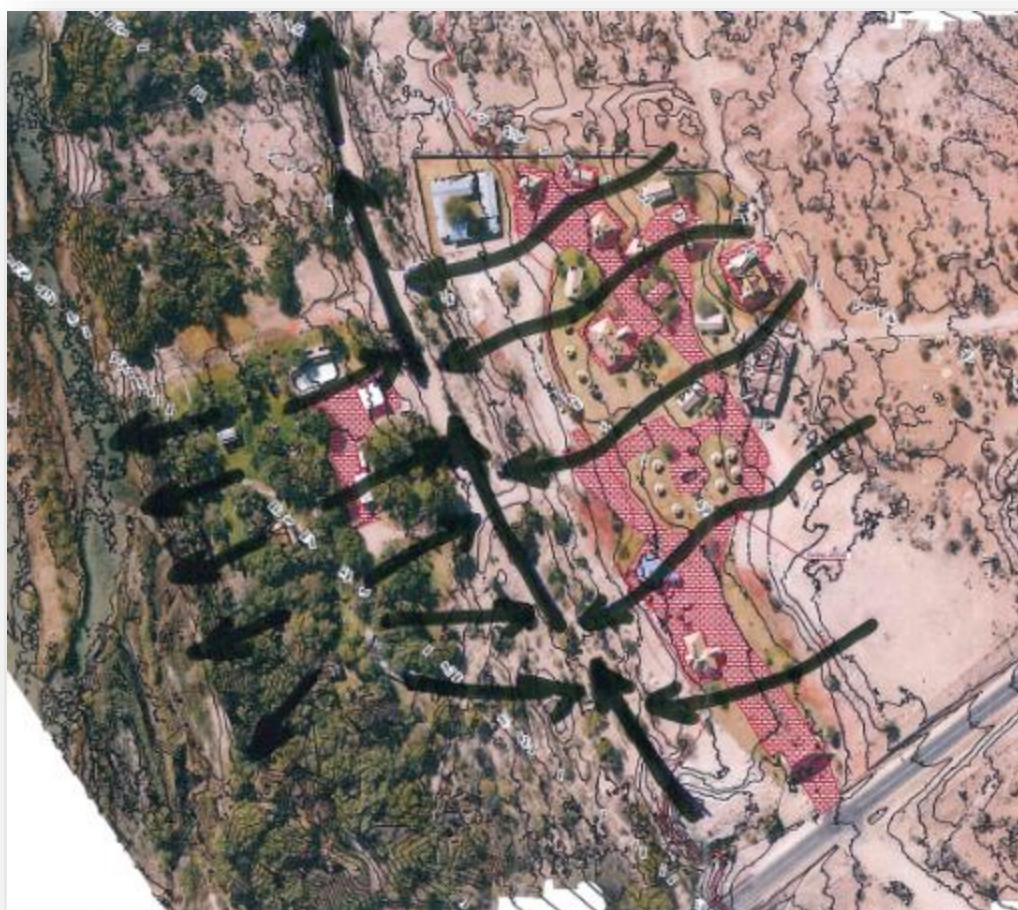
Figure 11: Drainage of the targeted area

The area's storm water drainage is shown in **Figure 11** below. The area is relative

small and flat and no problems are foreseen in this regard.

Drainage through the accommodation and offices area generally occurs in a south western direction over the property into the dry river parallel to the main stream of the Orange River. The day facility drains from the middle to the main stream of the Orange River and to the dry river

Storm water run-off are be handled overland and accommodated within the proposed roads while complimenting the existing natural drainage scenario within and around the property. Storm water will therefore generally still follow current drainage paths to existing natural features. Areas at risk of erosion due to storm

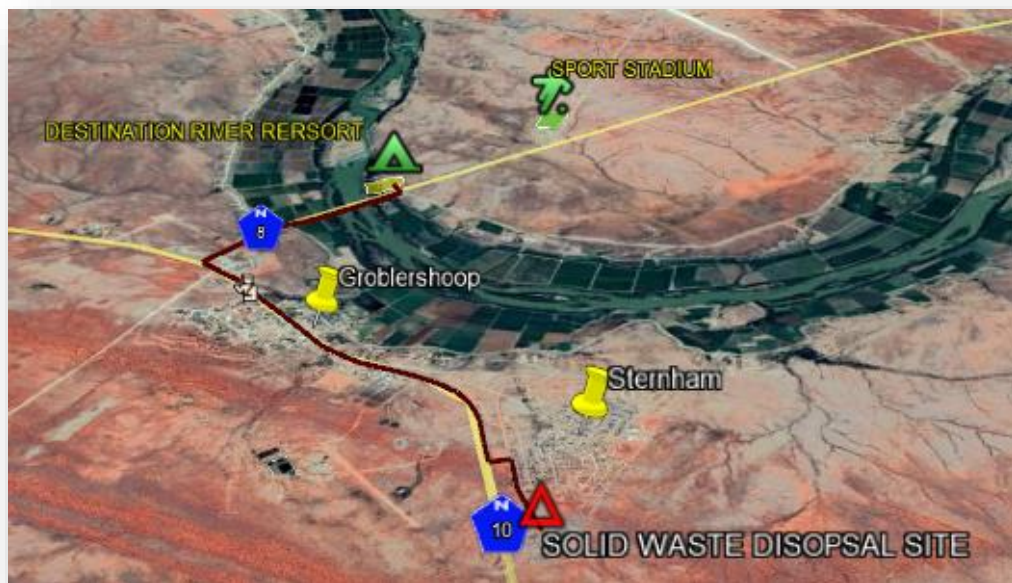
Figure 13 : Groblershoop Solid Waste Disposal Site

The image below (**Figure 13**) shows the position of Destination River Resort in relation to the Groblershoop solid waste disposal site as well as the connection road

(6.2 km) between the resort and the solid waste disposal site.
