**VISSERSPAN PV FACILITY
PROJECT 4
FARM 40, DEALESVILLE, FREE STATE**

VISUAL ASSESSMENT

Final Report

10 Feb 2020

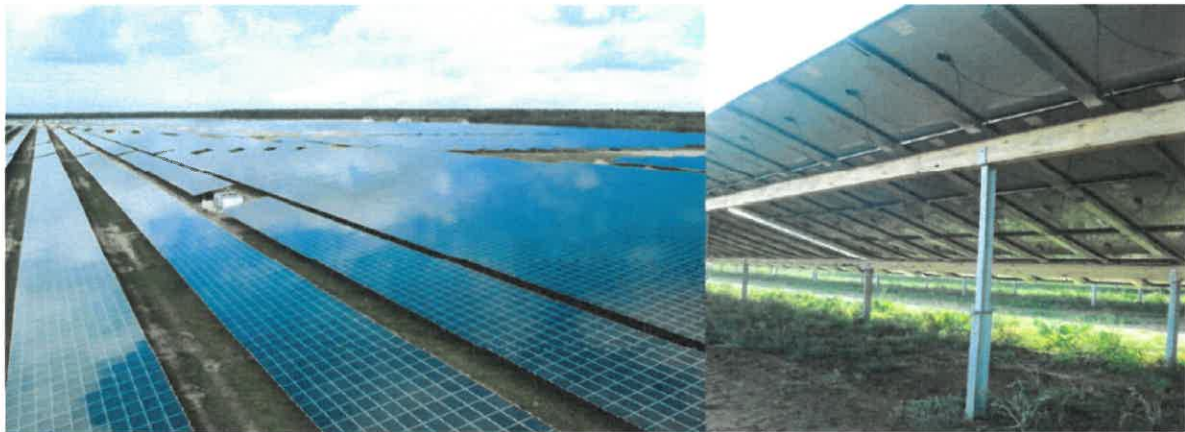
Figure 3: Typical single axis PV arrays

Site needs some leveling. Expected height 2,4m but maximum height for any structures assumed at 3m above ground. Arrays orientated east-west with horizontal movement north-south

The development will consist of solar panels mounted on steel supporting array structures and are configured into a number of sub array systems. The units will be able to tilt up and down but not rotate with the sun. The units will thus always be positioned in a northerly direction.

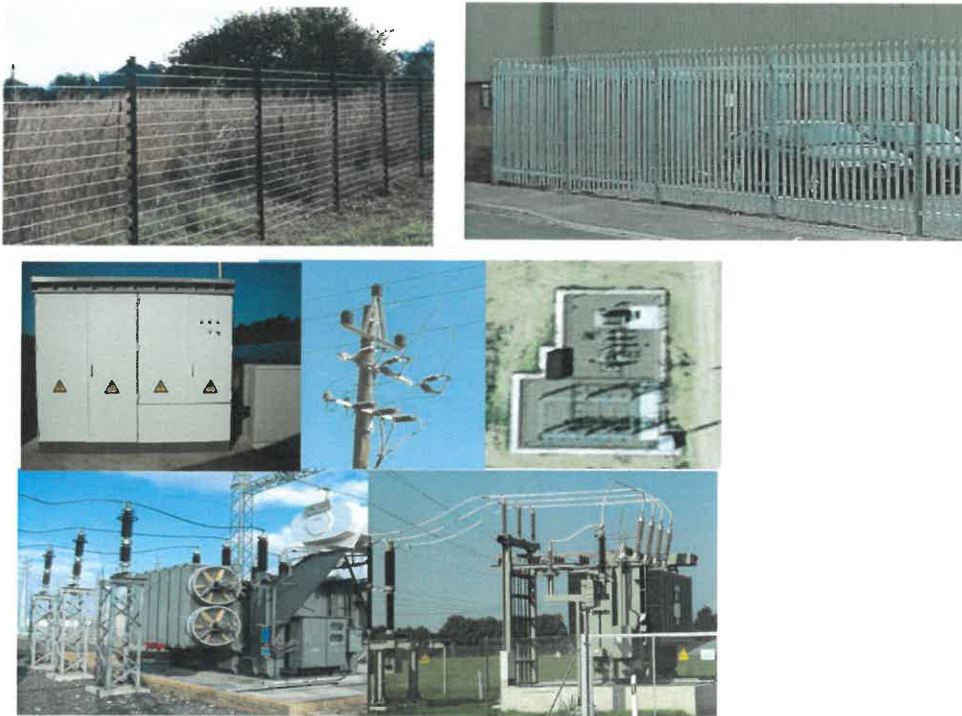
Figure 3: Typical support infrastructure i.e. power lines, substation & switches, fences

Site circumscribed with fire access road and fence. Probably consisting of electrified, galvanized palisade fence of 2,4m in height.

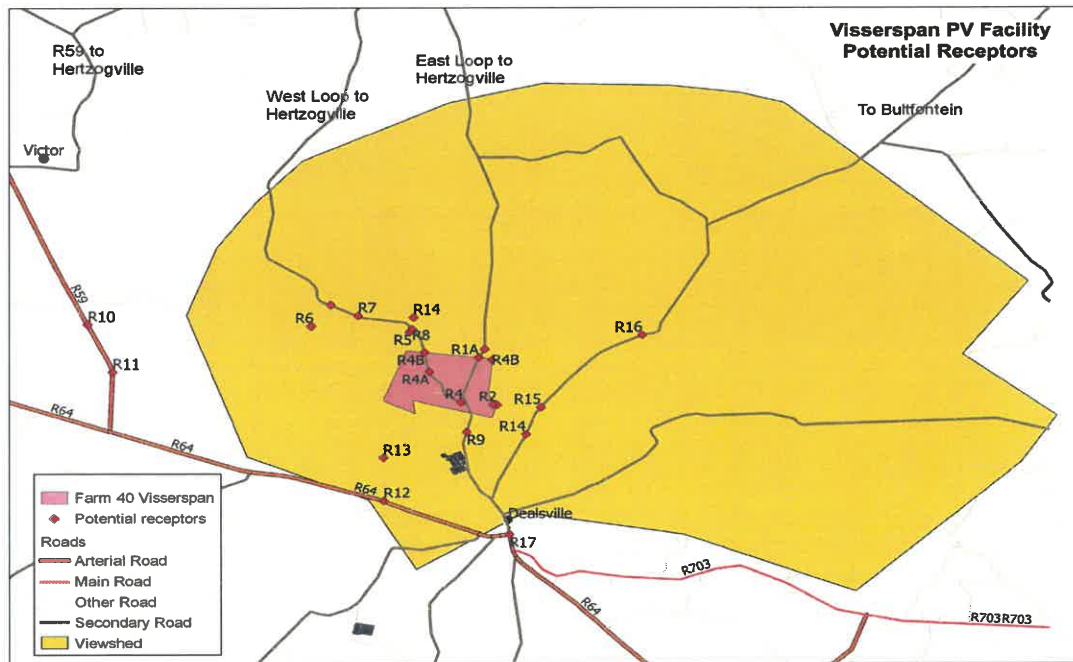
Figure 4: Viewshed

The catchment area is limited to the 1300 to 1320 relief line resulting in a fairly limited viewshed. The viewshed extend to the north as the area south of Dealesville slopes down towards the Modder river valley.

The viewshed of the site is limited by the topography which is characterized by low undulating rises and valleys which created a medium level of visual absorption. Due to the low vertical extent of the proposed development, this absorption rate is sufficient to reduce the viewshed for the particular project proposal.

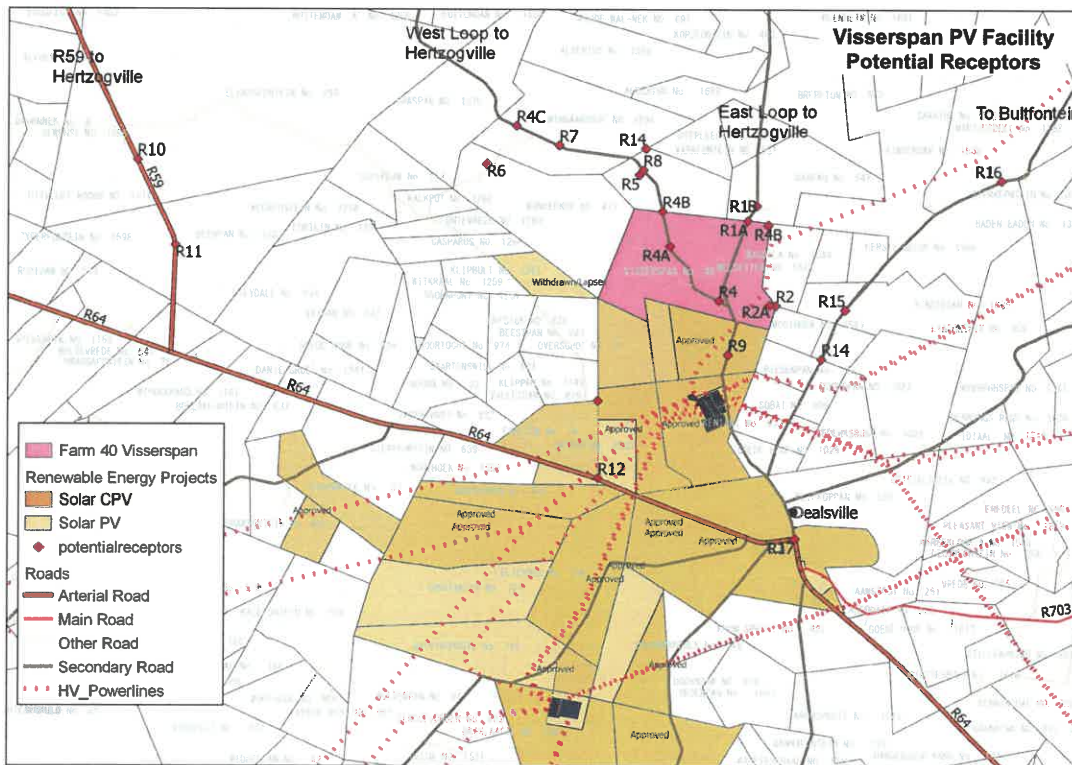
Figure 5: Potential Visual Receptors

Potential Receptor	Comment	Screening
R64 connecting Bloemfontein and Boshof	Situated to the south running in an southeast-west direction, view is only directed in the direction of the site, south of Dealesville from where it turn westward. Screened by the landscape and dominated by HV power line	Assess profile. Low visibility expected (R12)
R59 to the west connecting the R64 with Herzogville	The road is running north-south direction but 12+km to the west. It is screened by low ridges. Not a high order road	The R59 is outside the viewshed.
Gravel road from Dealesville to Bultfontein	Low order road with low traffic volumes.	Not a sensitive receptor. Low visibility expected. Assess profile (R15, R16)
Gravel road from Dealesville to Herzogville (east loop)	Low order road with low traffic volumes. The road split in an east and west loop. Project 4 West is situated between these loops. Project 4 East is east of this loop	Assess profile. Not a sensitive receptor. High visibility expected

Gravel road from Dealesville to Herzogville (west loop)	Low order road with low traffic volumes. The road split in an east and west loop. Project 4 west is	Assess profile. High visibility expected (R4, R8, R7)

Potential Receptor	Comment	Screening
loop)	situated between these loops. The site abuts both loops and thus has a potential high exposure	
R703 to Soutpan	The road is on lower gradient and thus outside the viewshed	Outside viewshed.
Visserspan Homestead	Homestead to the west but surrounded by Project 1 and 2.	Medium sensitivity. Owner of property
Rooirand Homestead	Close to the site on same gradient. View directly towards PV arrays	Assess profile. Homestead of medium sensitivity (R5), medium exposure expected
Wonderkop Homestead	Towards the north on higher ground	Assess profile. Homestead of medium sensitivity (R6)
Melsetter homestead	Abutting eastern boundary of farm 40. P4 east borders Melsetter farm	Assess profile. Homestead of medium sensitivity (R2)
Mooihoek/Kinderdam Hunter's cottage	Mooihoek indicated tourism accommodation but on inquiry it was indicated the only unit is the Hunter's cottage to the east of the Bultfontein road	Assess Bultfontein road profile. Hunters cottage on same gradient (R14, R15)

Dealesville	The town is on a lower altitude and screened by the landscape and landscape elements	Not visible

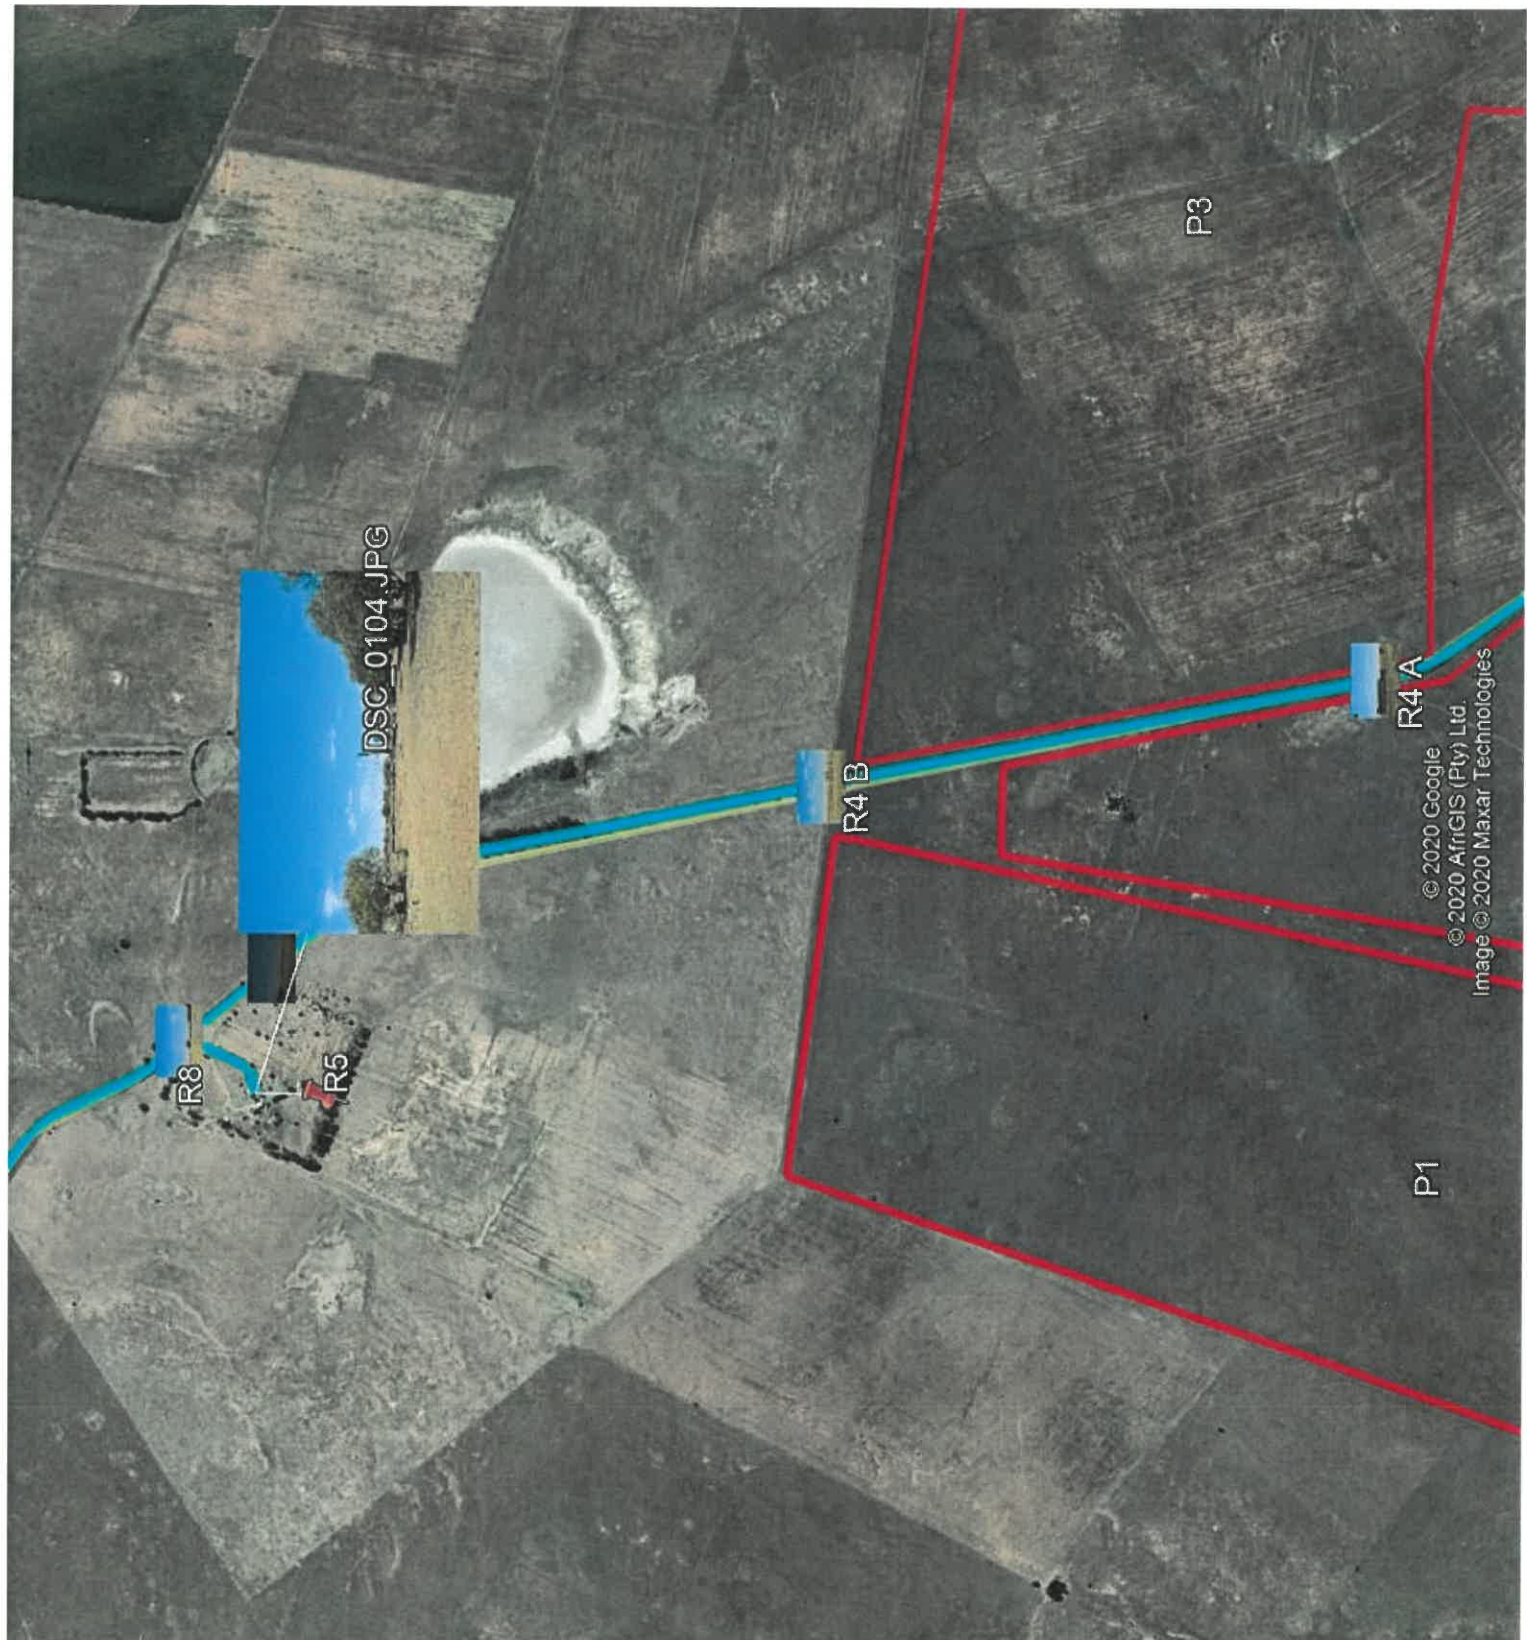
R5 Rooidam Homestead

P1 arrays will be behind trees

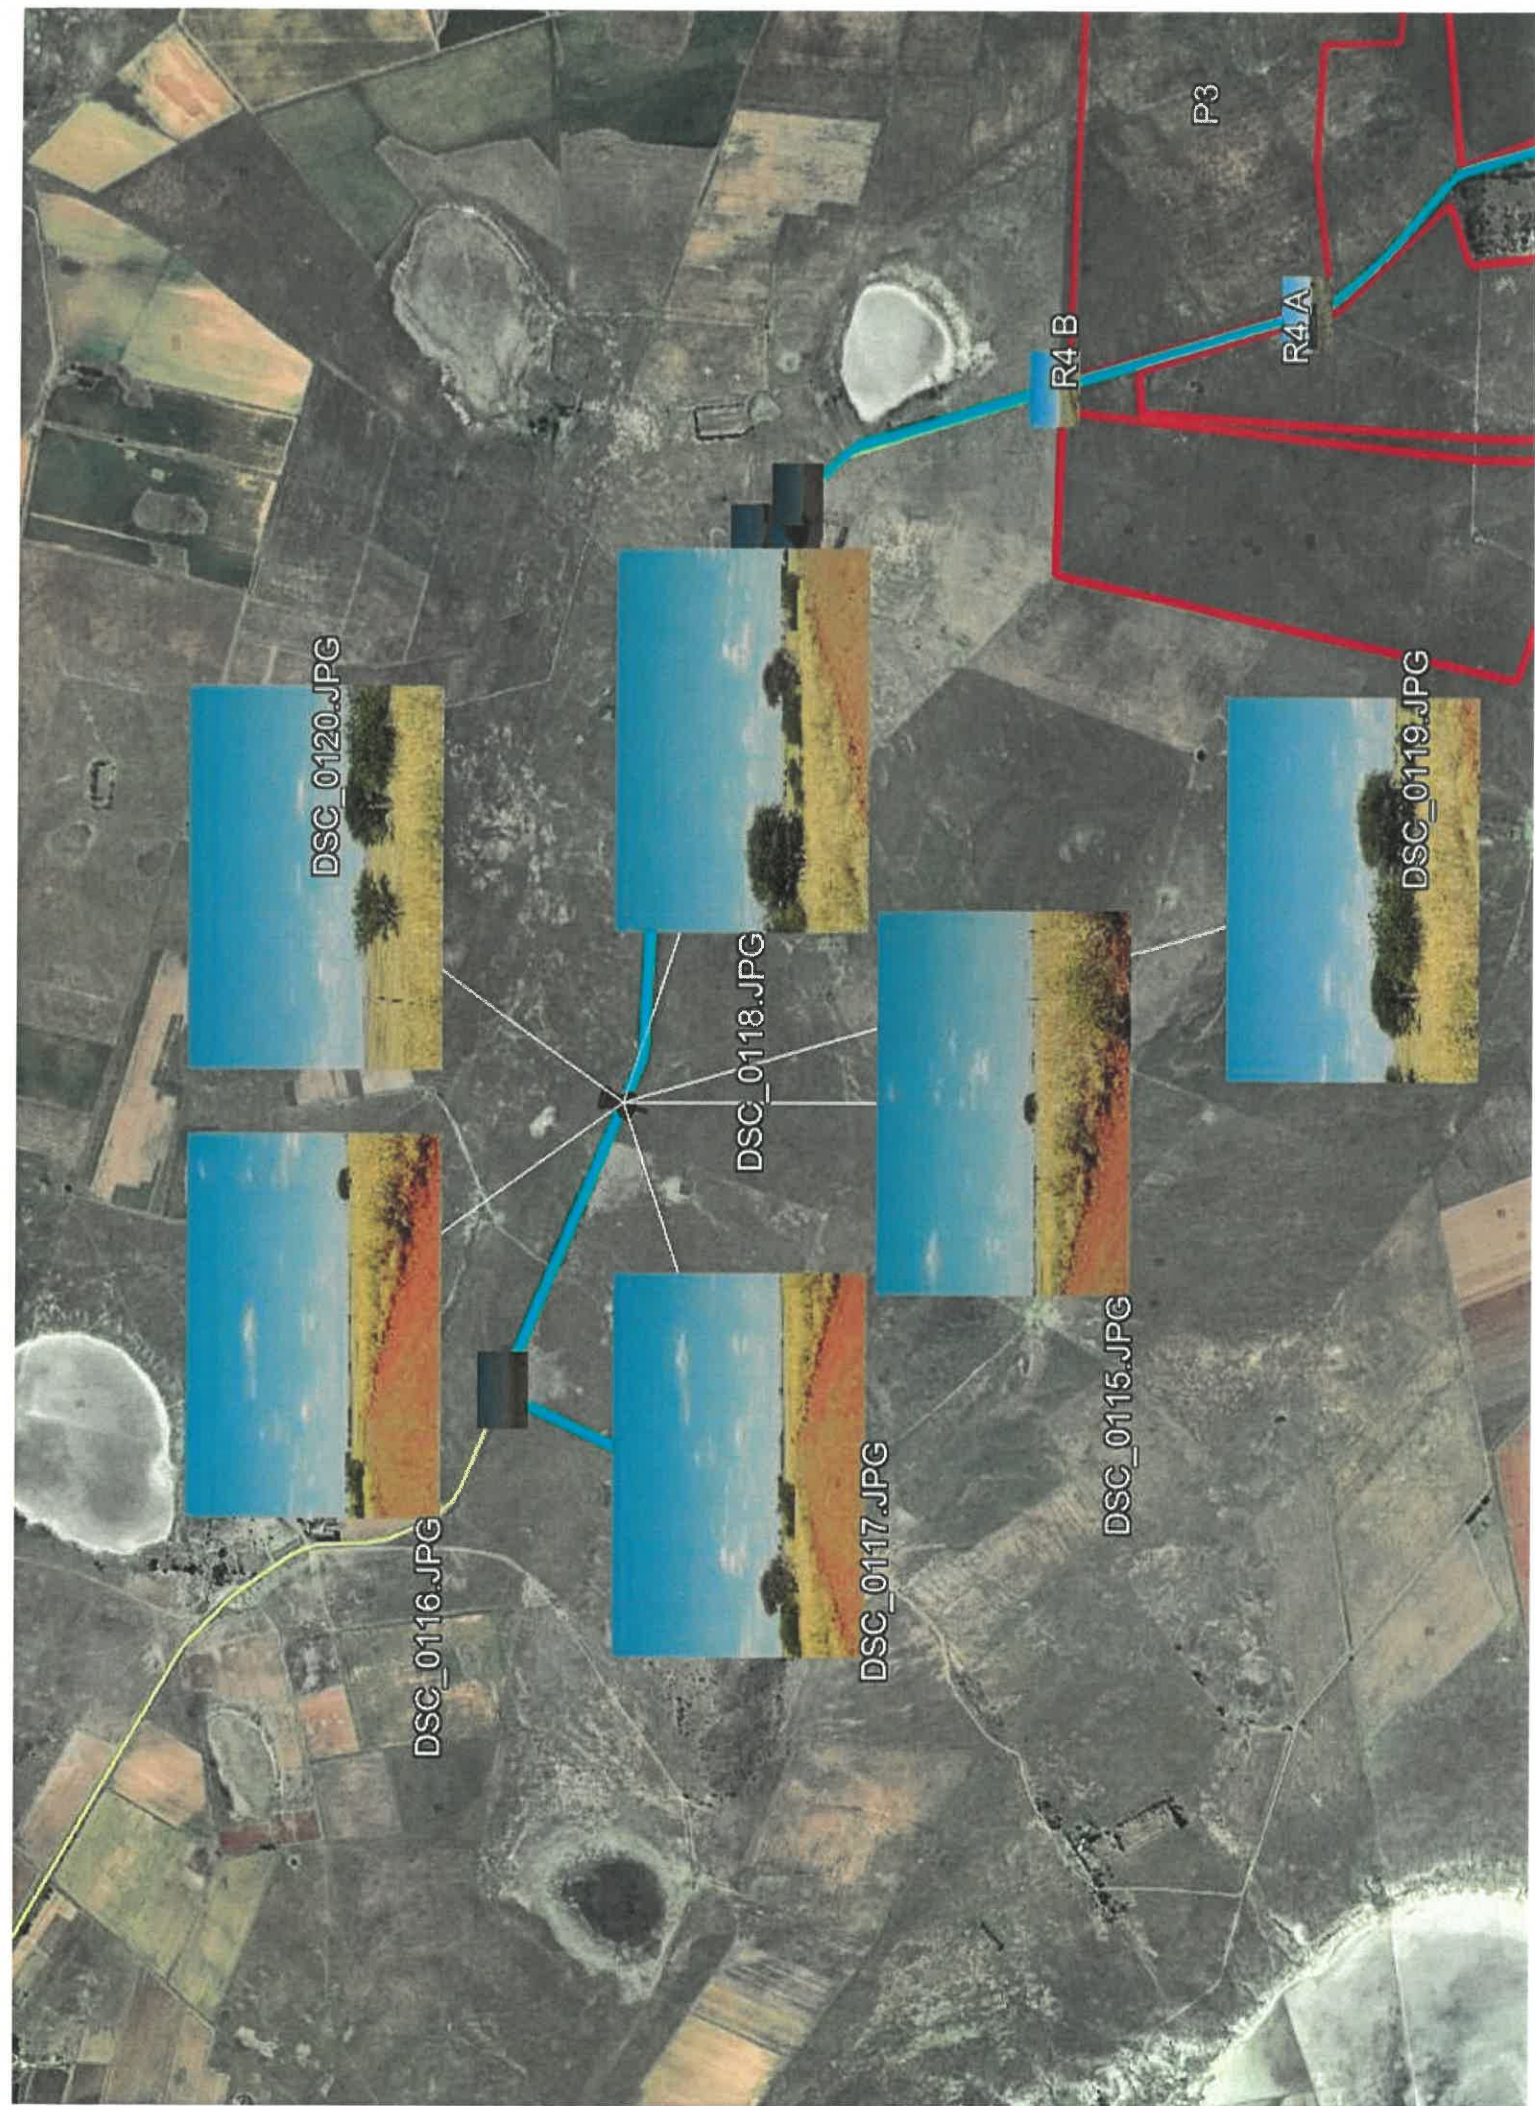
R6 Wonderkop Homestead

Low hills screen site

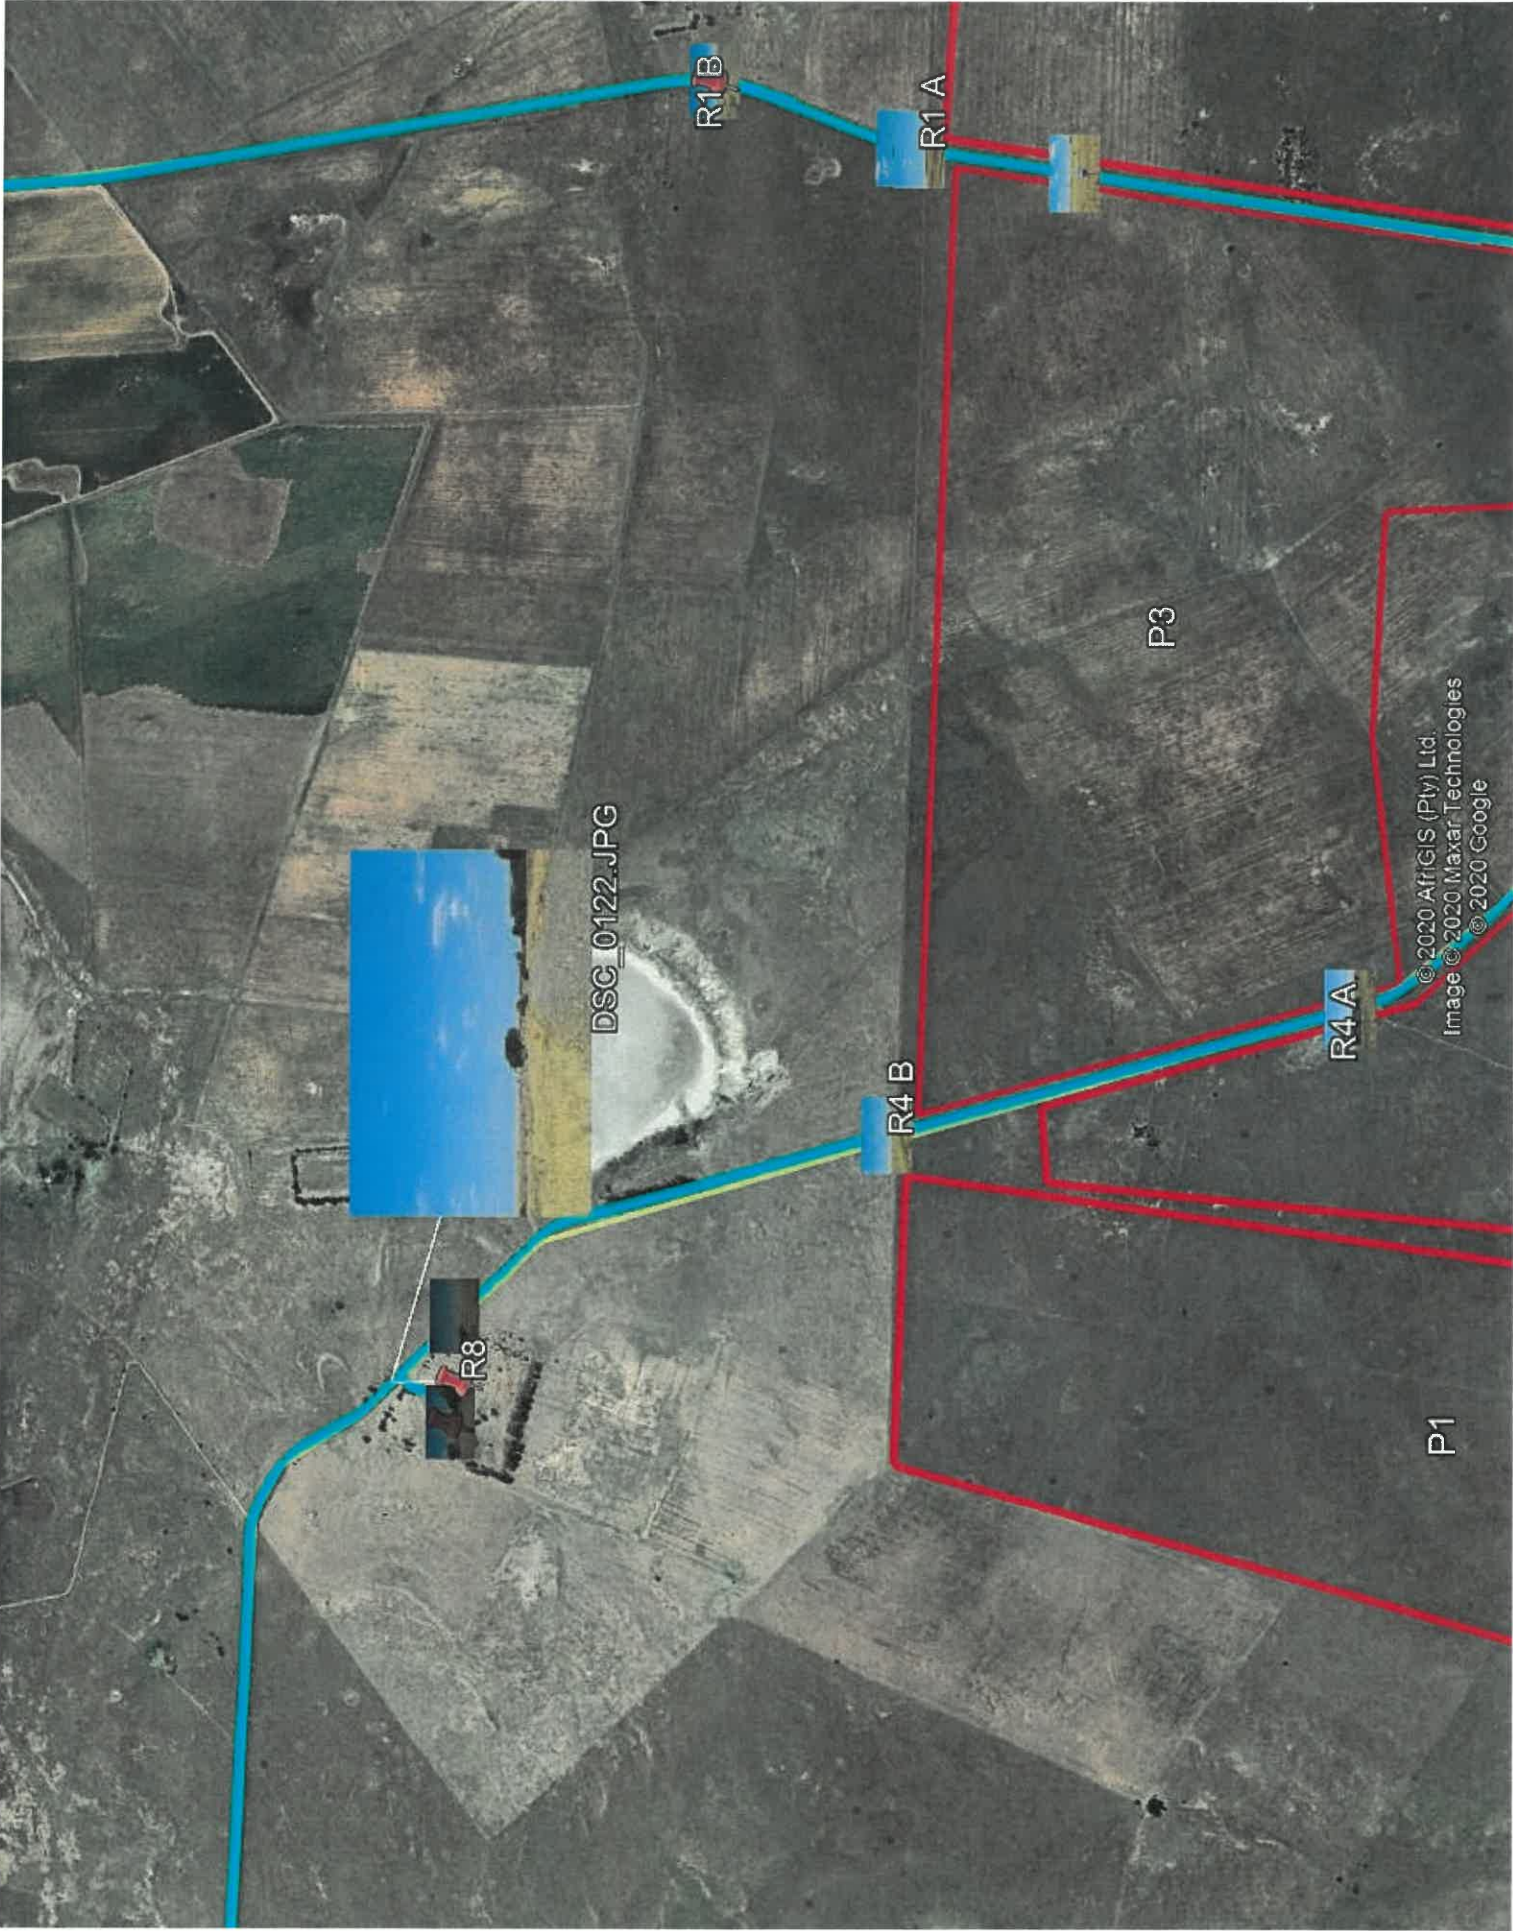
R7 View to south

P1 screened from observer

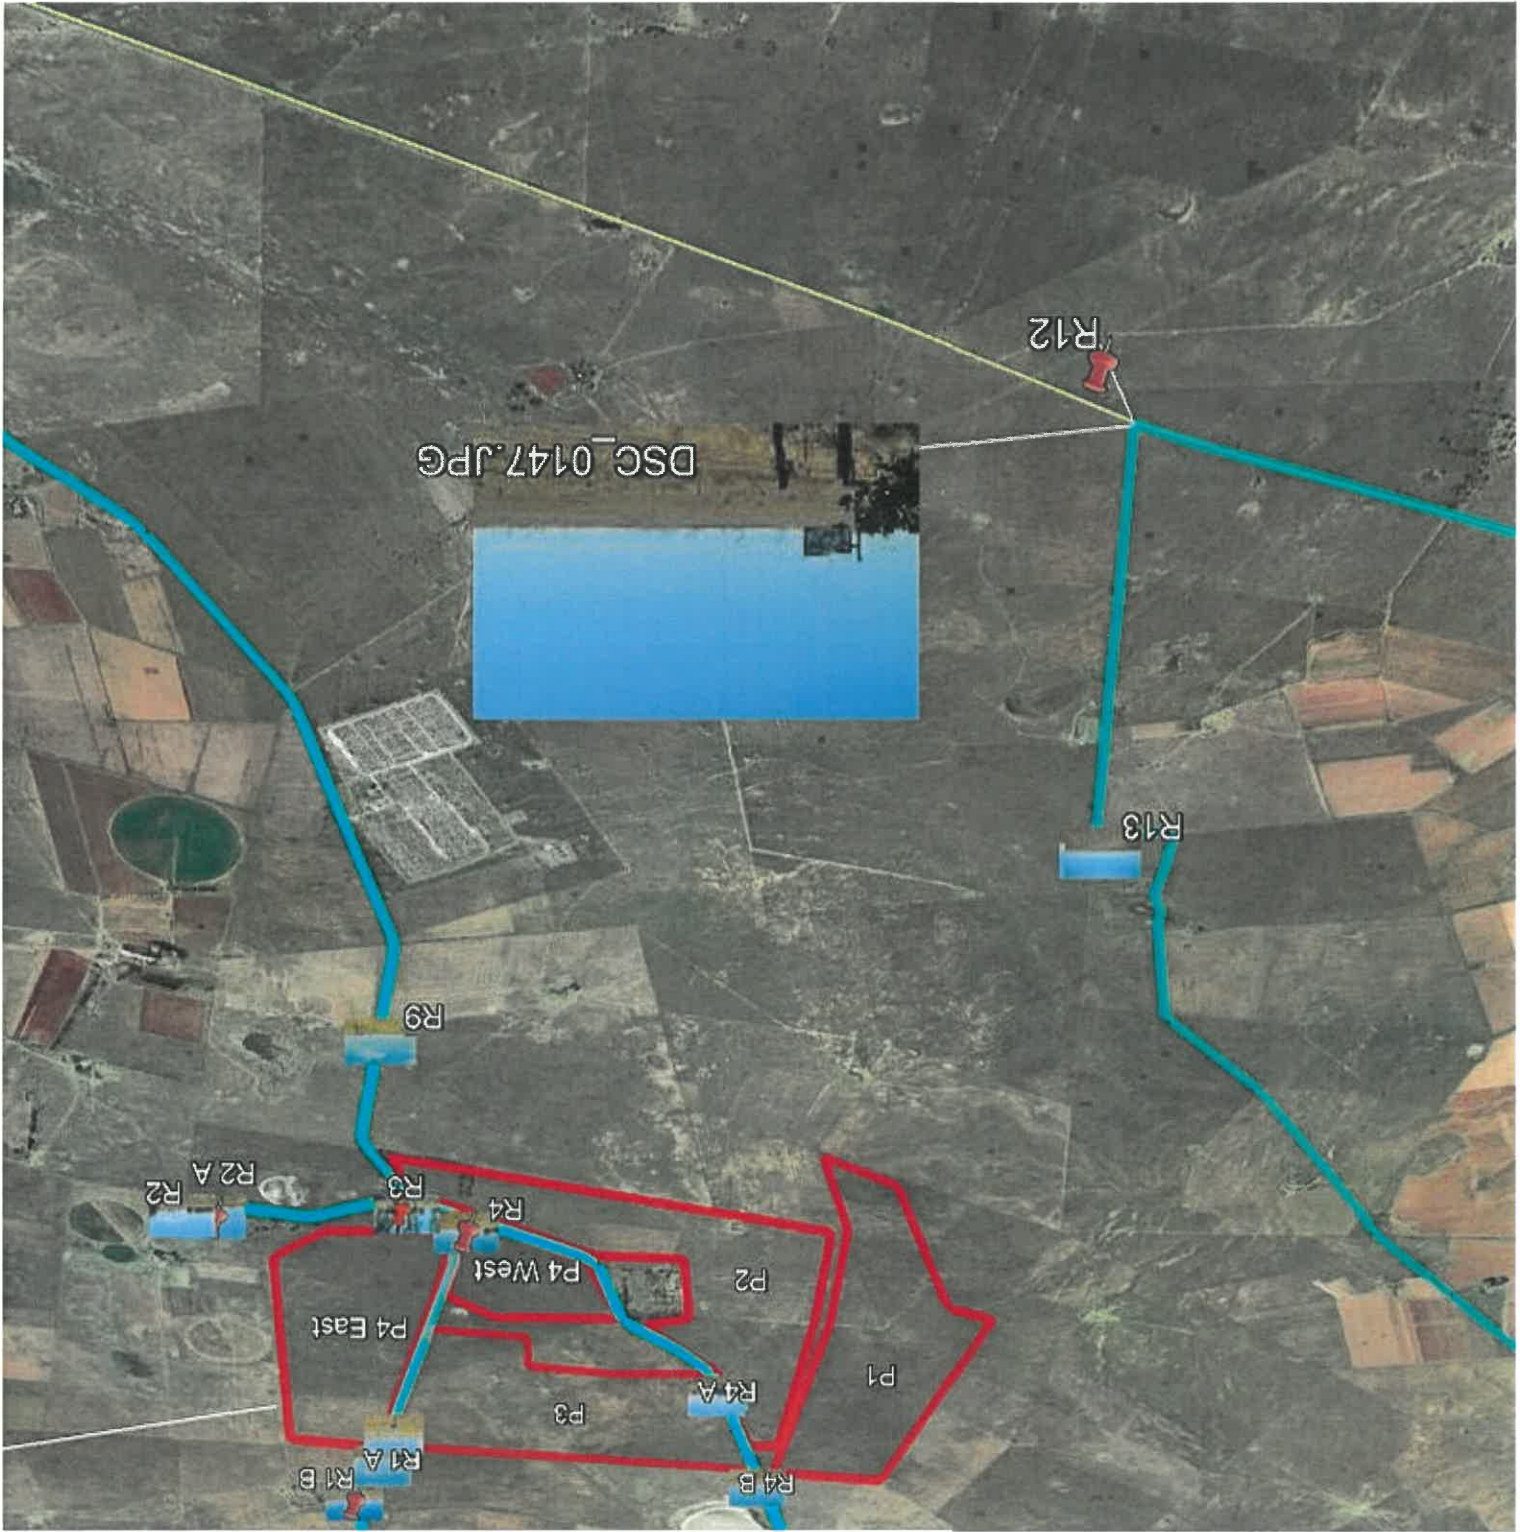
R9 Hertzogville Rd northward

P2 behind trees

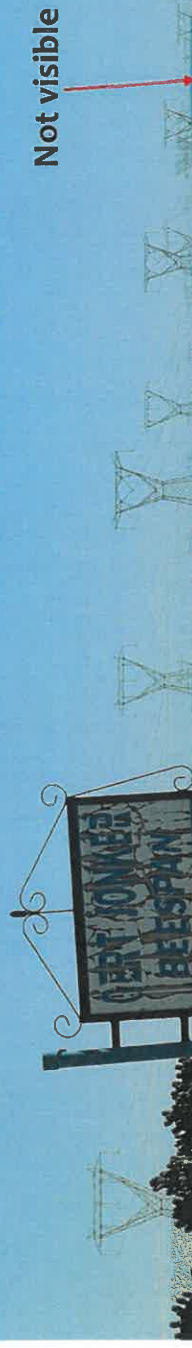
R12 View from R64

Not visible

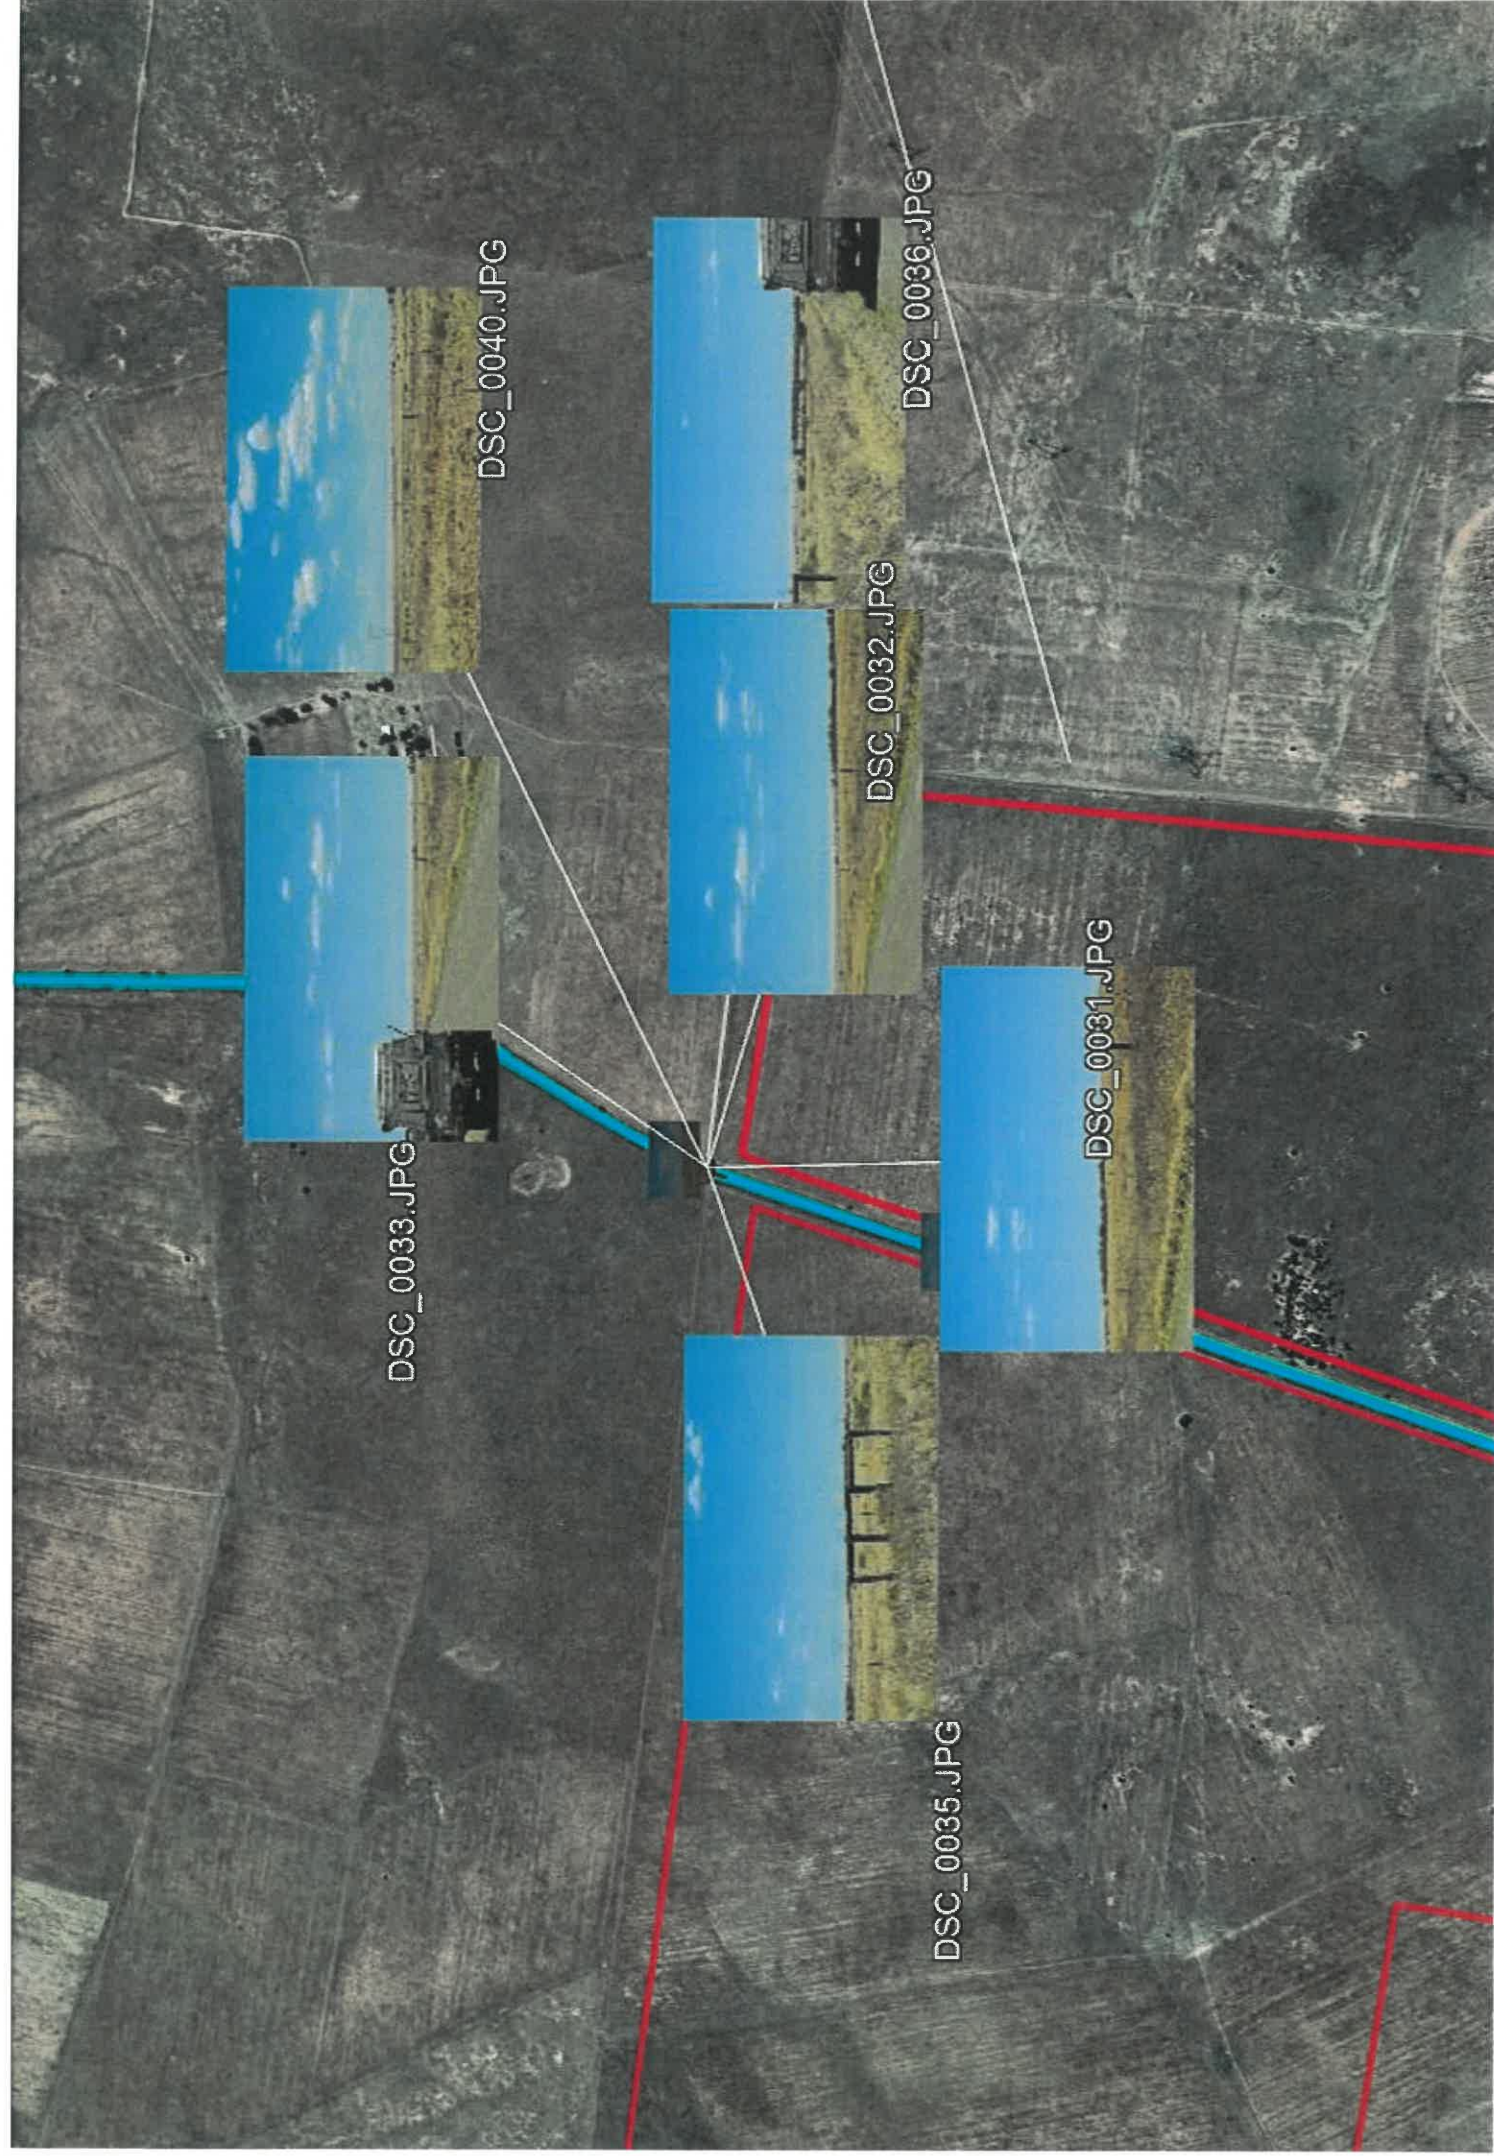
R13

Visserspan in the distance
PV arrays not visible

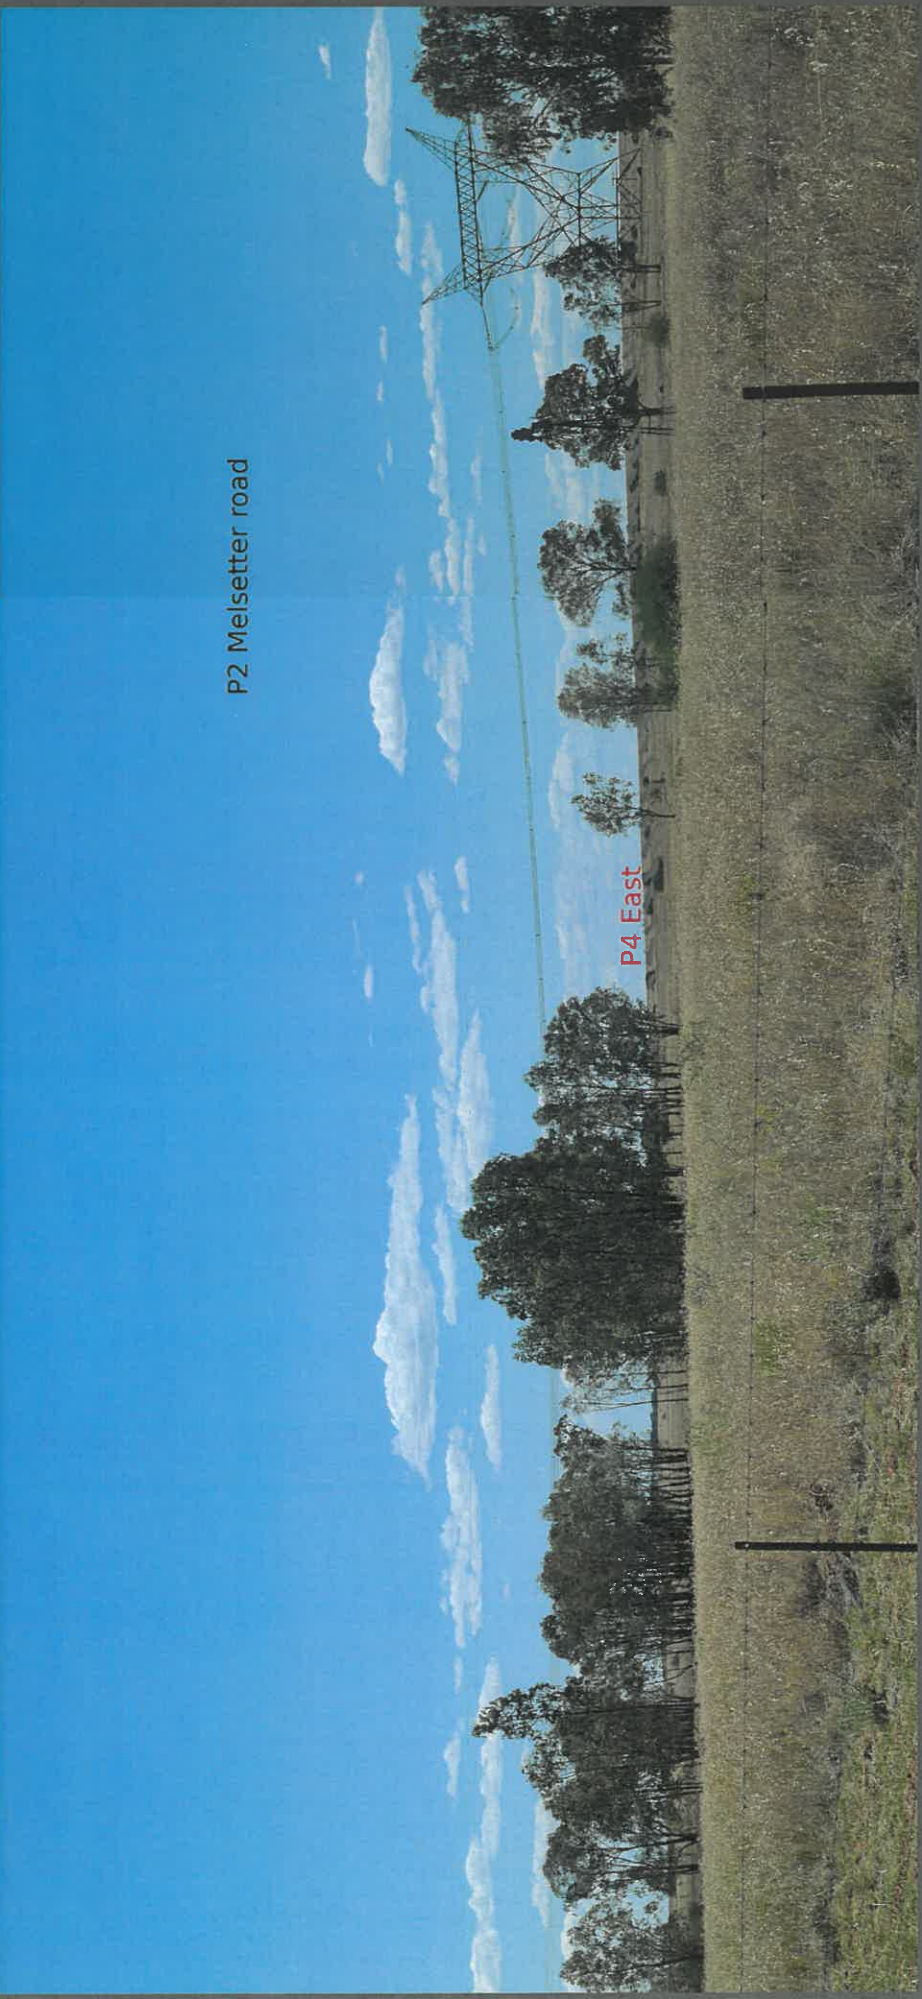
R2 Melssetter Homestead

PV arrays behind trees with sideview to observer

HV Powerlines
