**VISSERSPAN PV FACILITY
PROJECT 4
FARM 40, DEALESVILLE, FREE STATE**

VISUAL ASSESSMENT

Final Report

10 Feb 2020

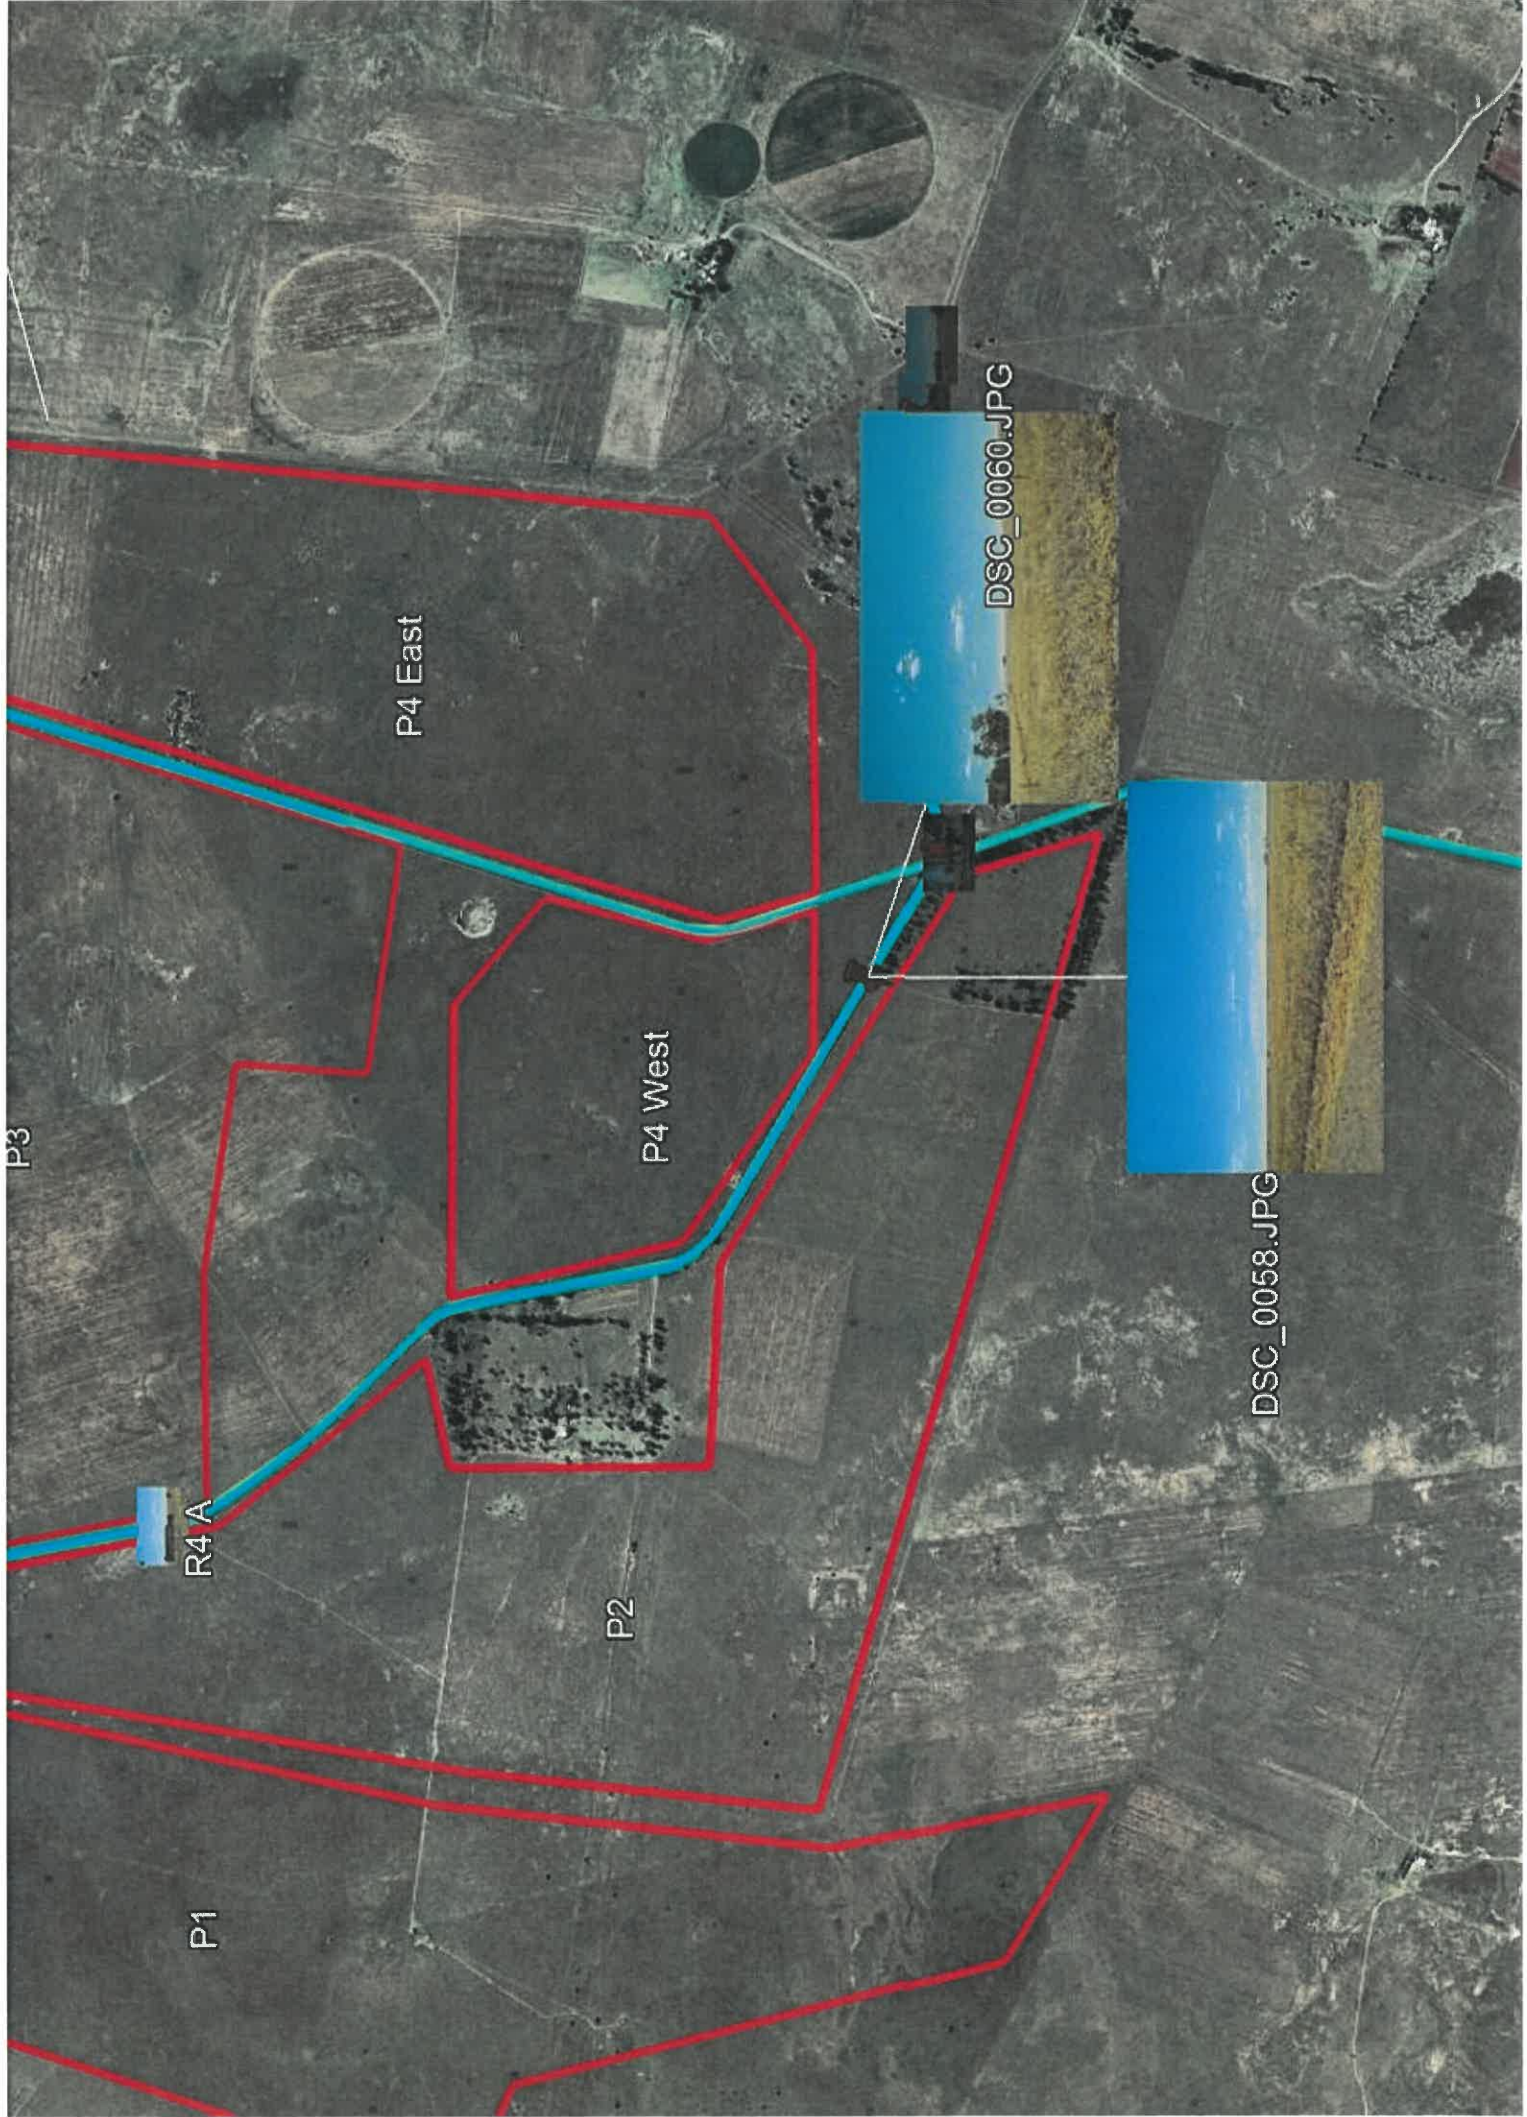
P2 Melsetter intersection with Hertzogville Rd

Trees to be removed

Sideview of arrays
