**VISSERSPAN PV FACILITY
PROJECT 4
FARM 40, DEALESVILLE, FREE STATE**

VISUAL ASSESSMENT

Final Report

10 Feb 2020

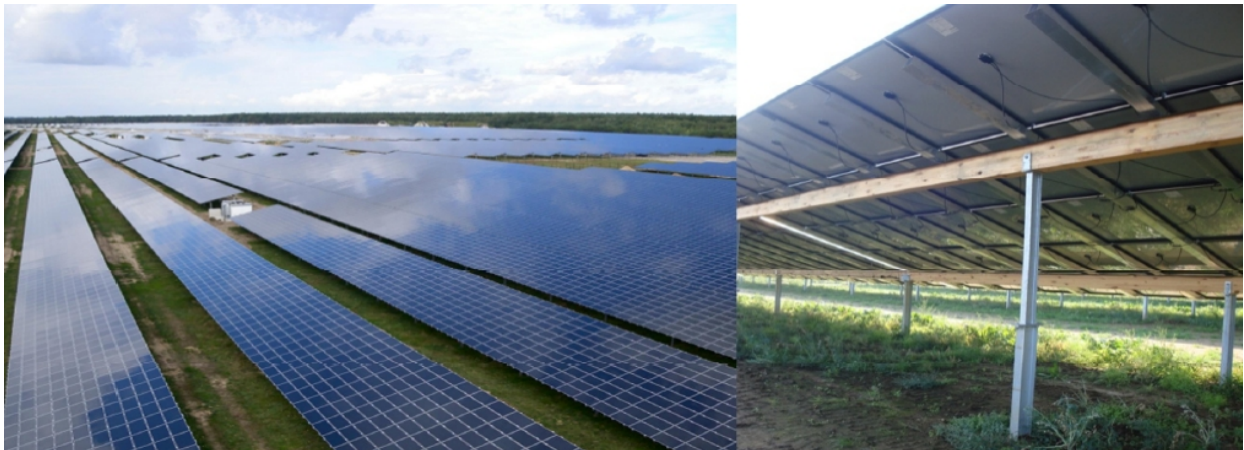
Figure 3: Typical single axis PV arrays

The development will consist of solar panels mounted on steel supporting array structures and are configured into a number of sub array systems. The units will be able to tilt up and down but not rotate with the sun. The units will thus always be positioned in a northerly direction.

Site needs some leveling. Expected height 2,4m but maximum height for any structures assumed at 3m above ground. Arrays orientated east-west with horizontal movement north-south

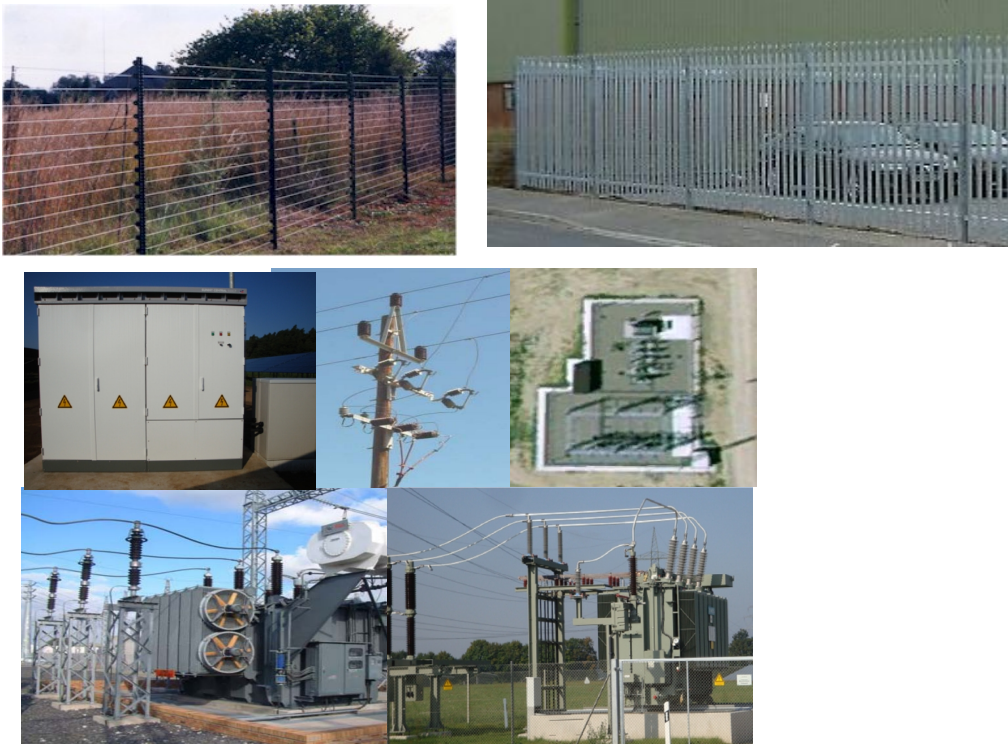
Figure 3: Typical support infrastructure i.e. power lines, substation & switches, fences

Site circumscribed with fire access road and fence. Probably consisting of electrified, galvanized palisade fence of 2,4m in height.

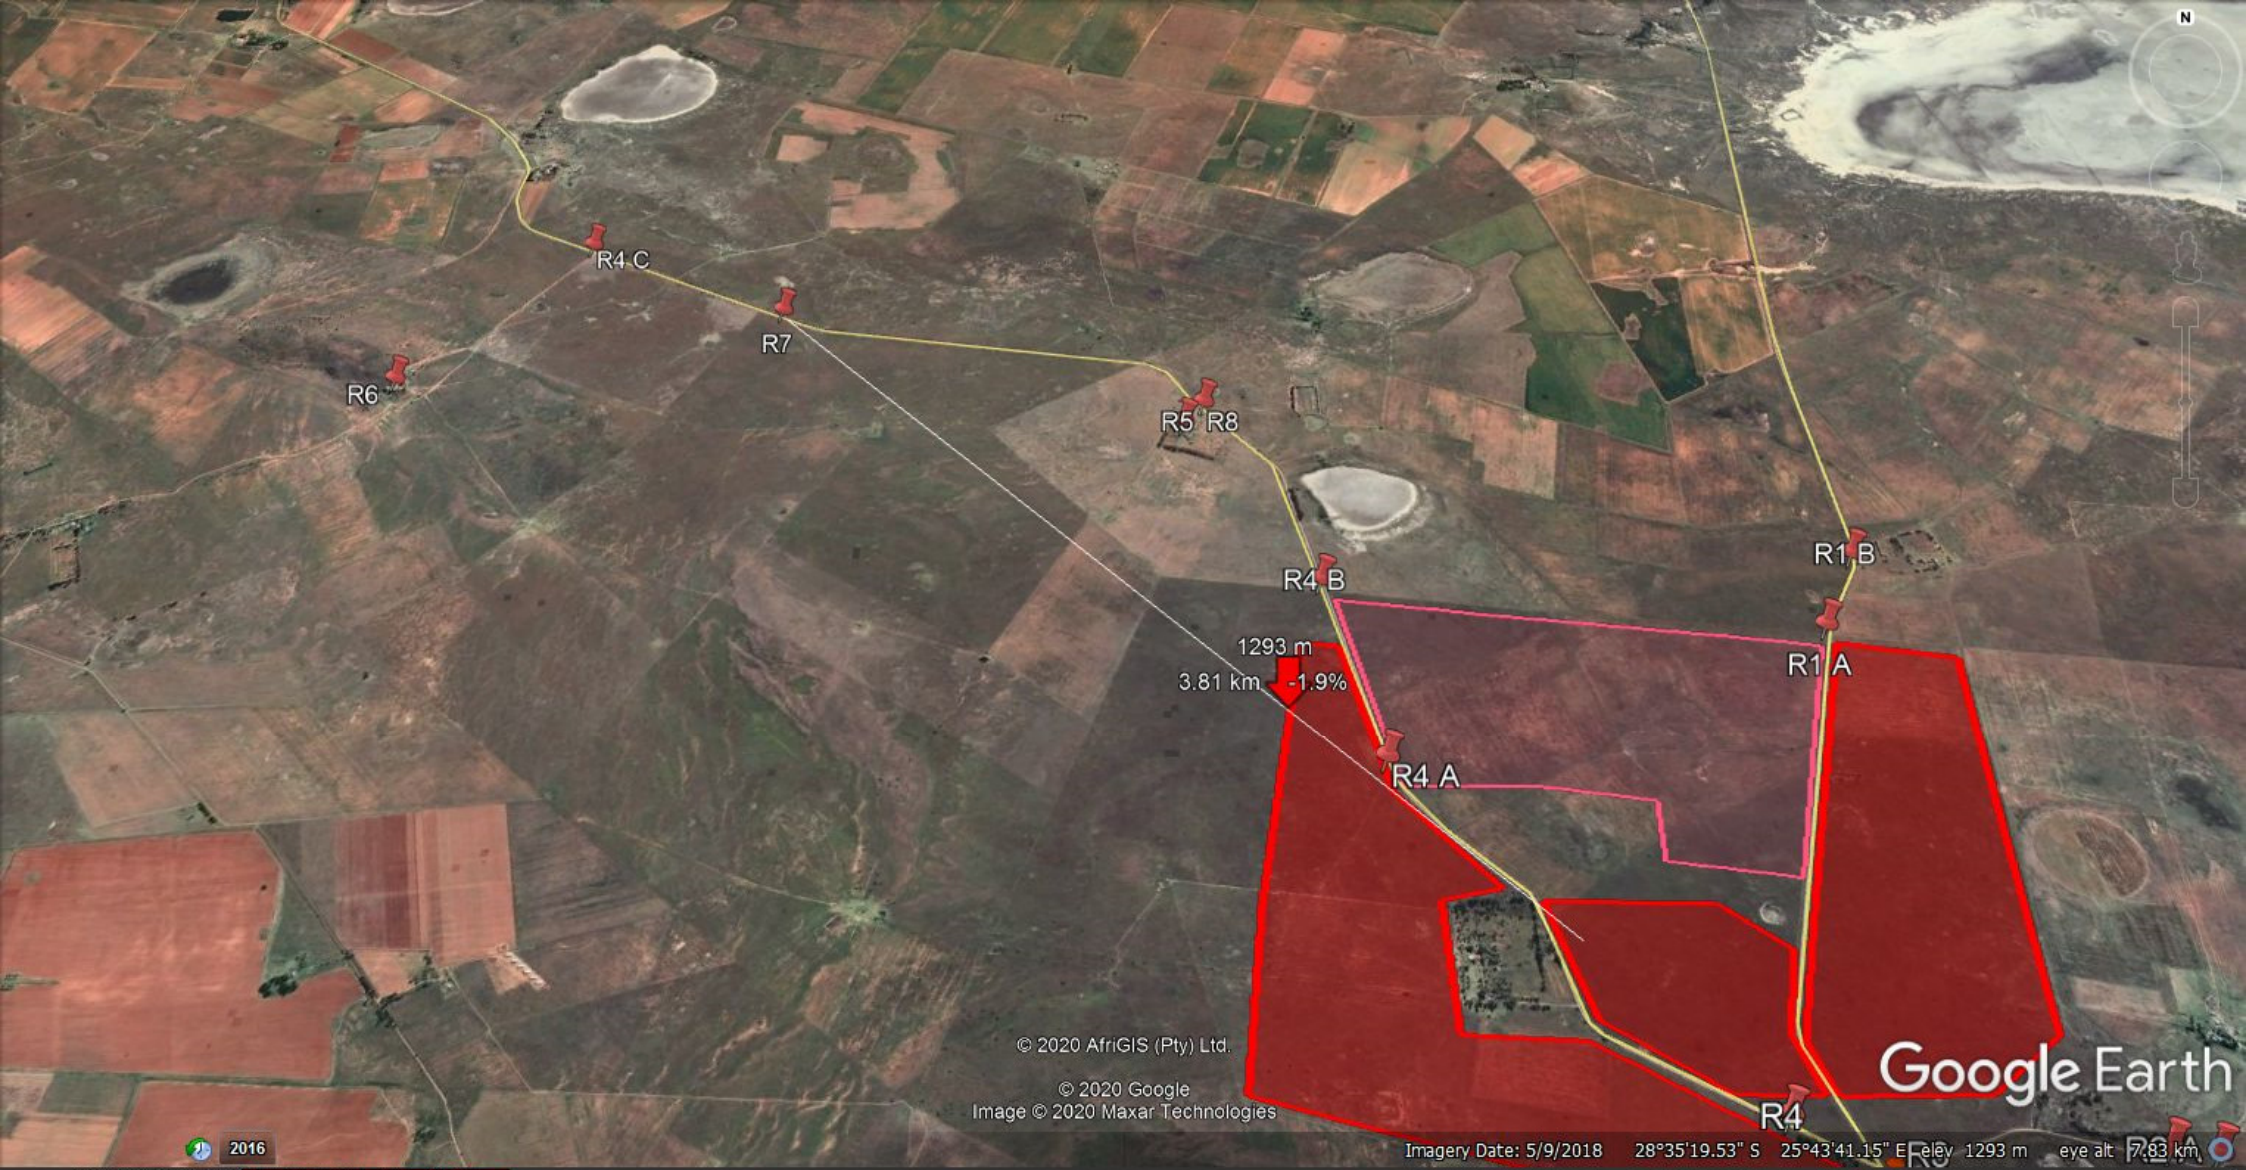
Imagery Date: 5/9/2018 28°33'48.48" S 25°42'06.99" E elev 1305 m eye alt 7.42 km

Graph: Min, Avg, Max Elevation: 1284, 1296, 1305 m
Range Totals: Distance: 5.47 km Elev Gain/Loss: 17.5 m, -38.8 m Max Slope: 4.0%, -3.6% Avg Slope: 0.7%, -1.2%

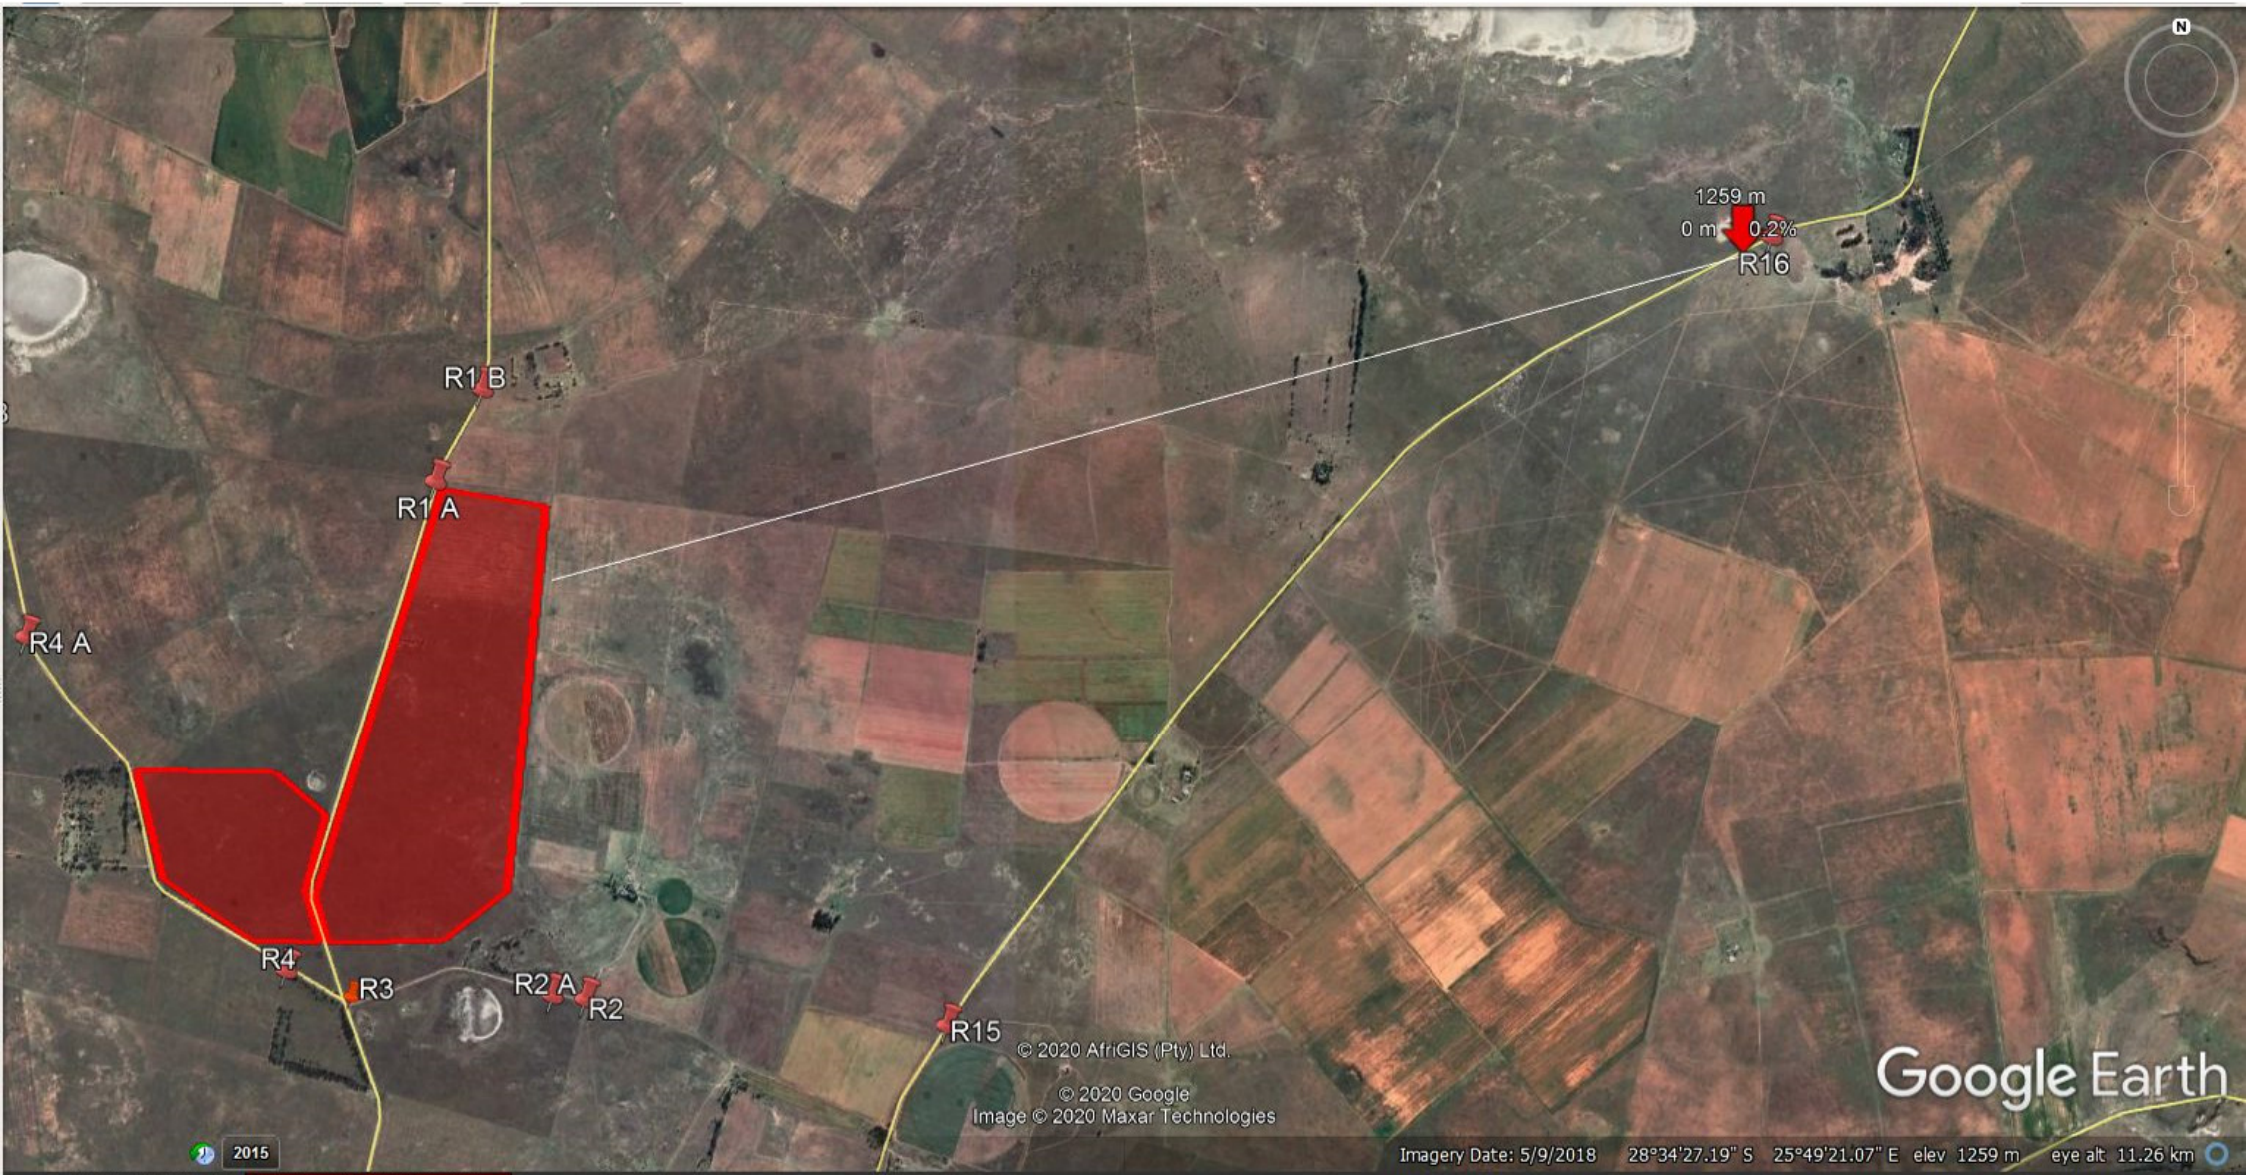
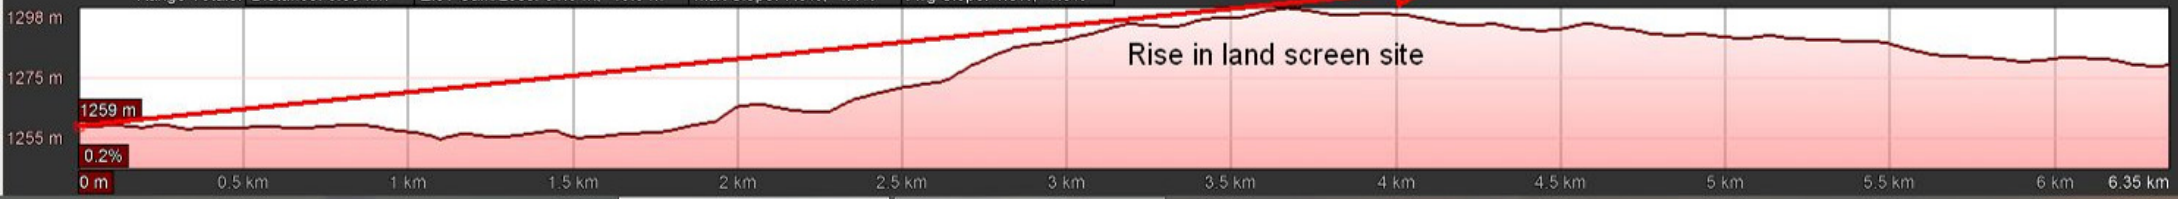
Imagery Date: 5/9/2018 28°37'20.58" S 25°44'54.55" E elev 1281 m eye alt 10.83 km

Graph: Min. Avg. Max Elevation: 1255, 1277, 1298 m
Range Totals: Distance: 6.35 km Elev Gain/Loss: 61.0 m, -40.9 m Max Slope: 7.5%, -4.4% Avg Slope: 1.8%, -1.3%

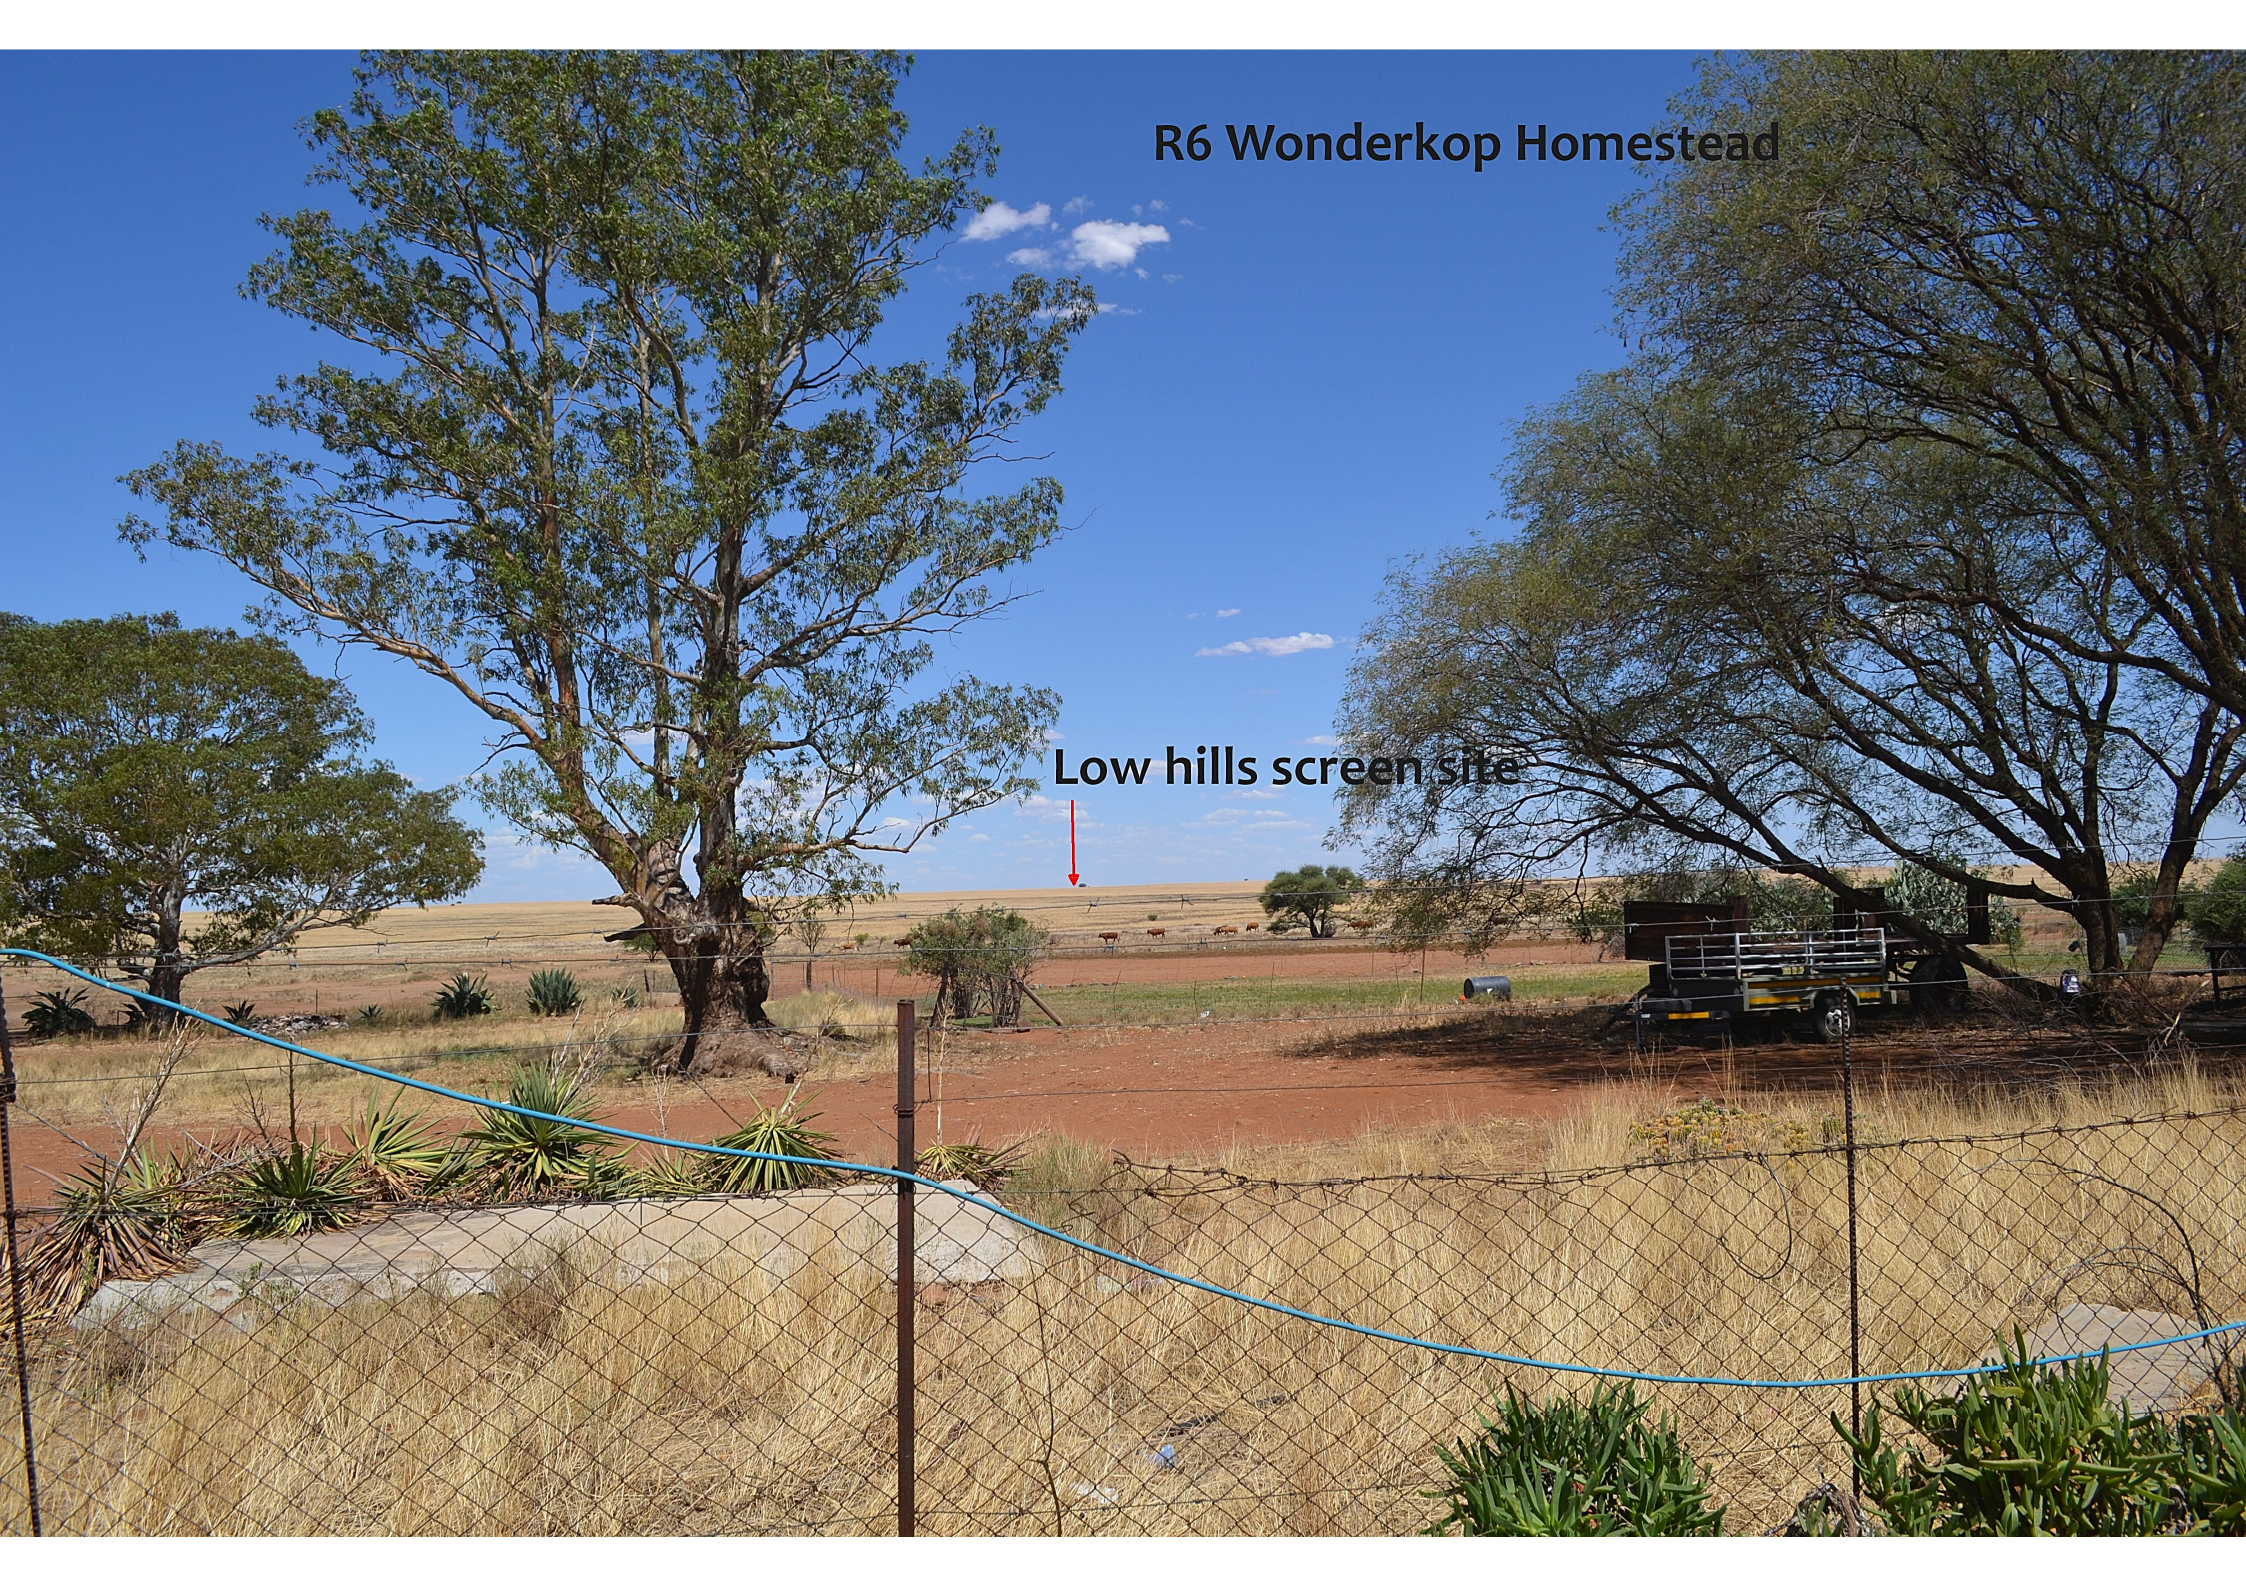
R6 Wonderkop Homestead

Low hills screen site

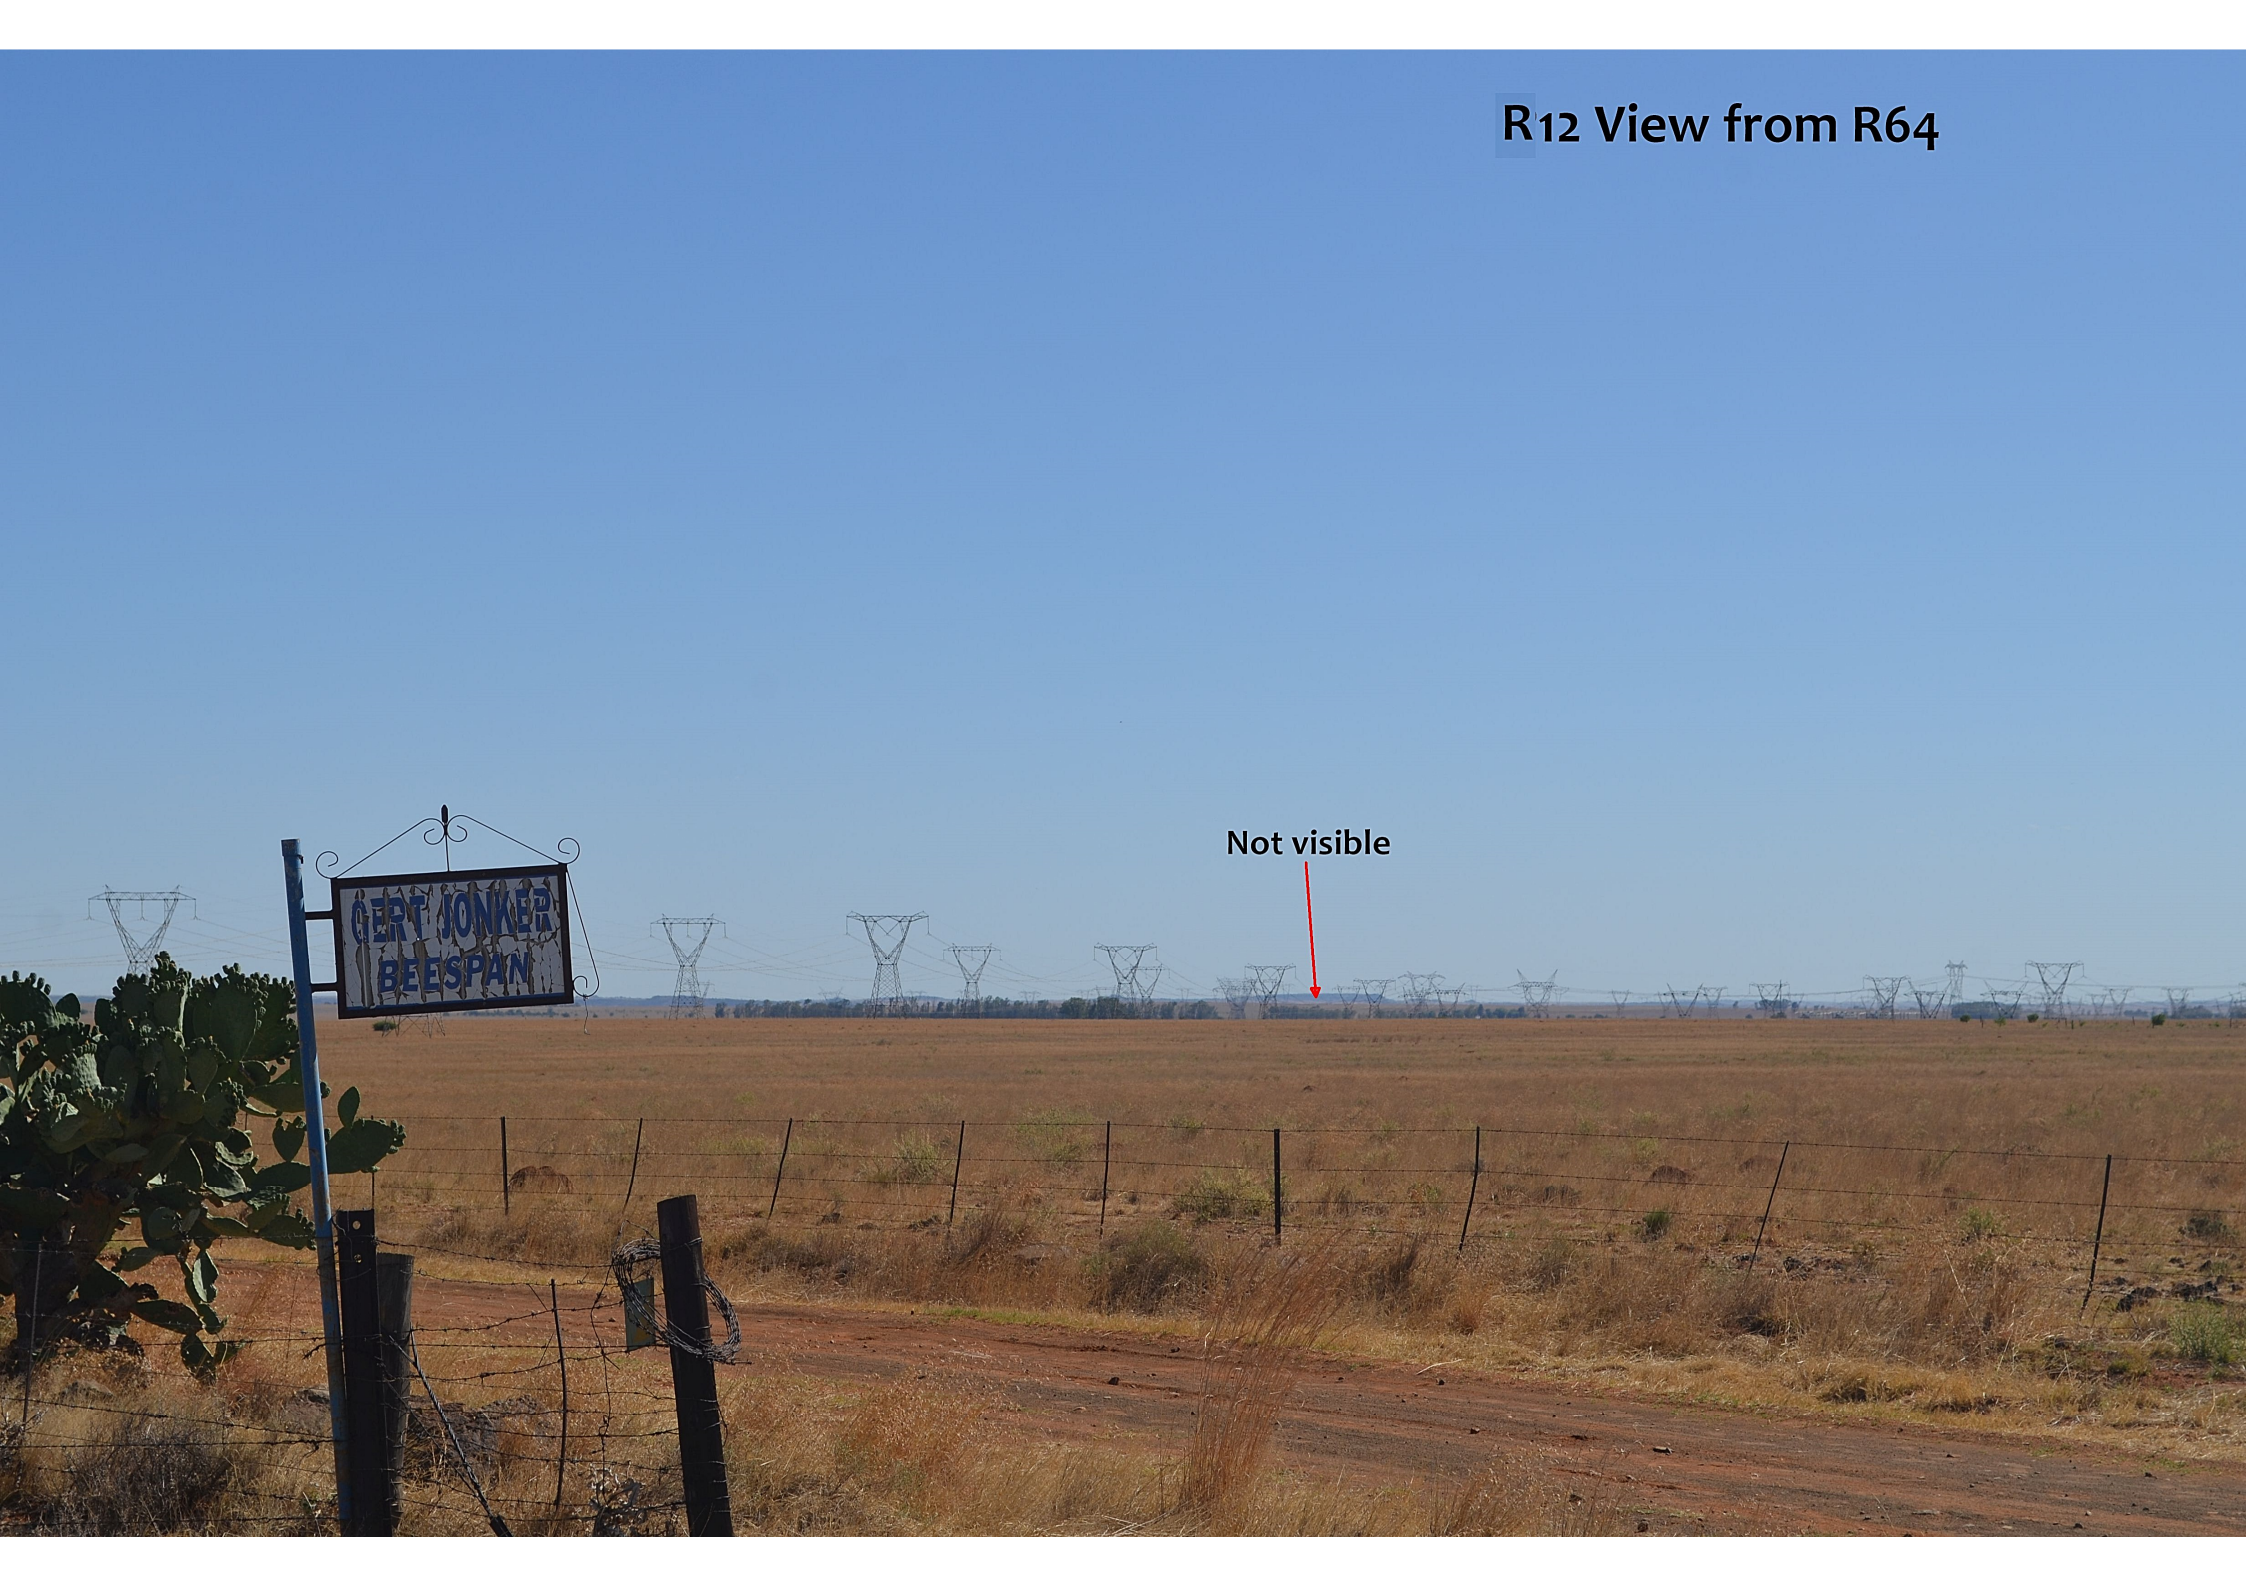
R12 View from R64

Not visible

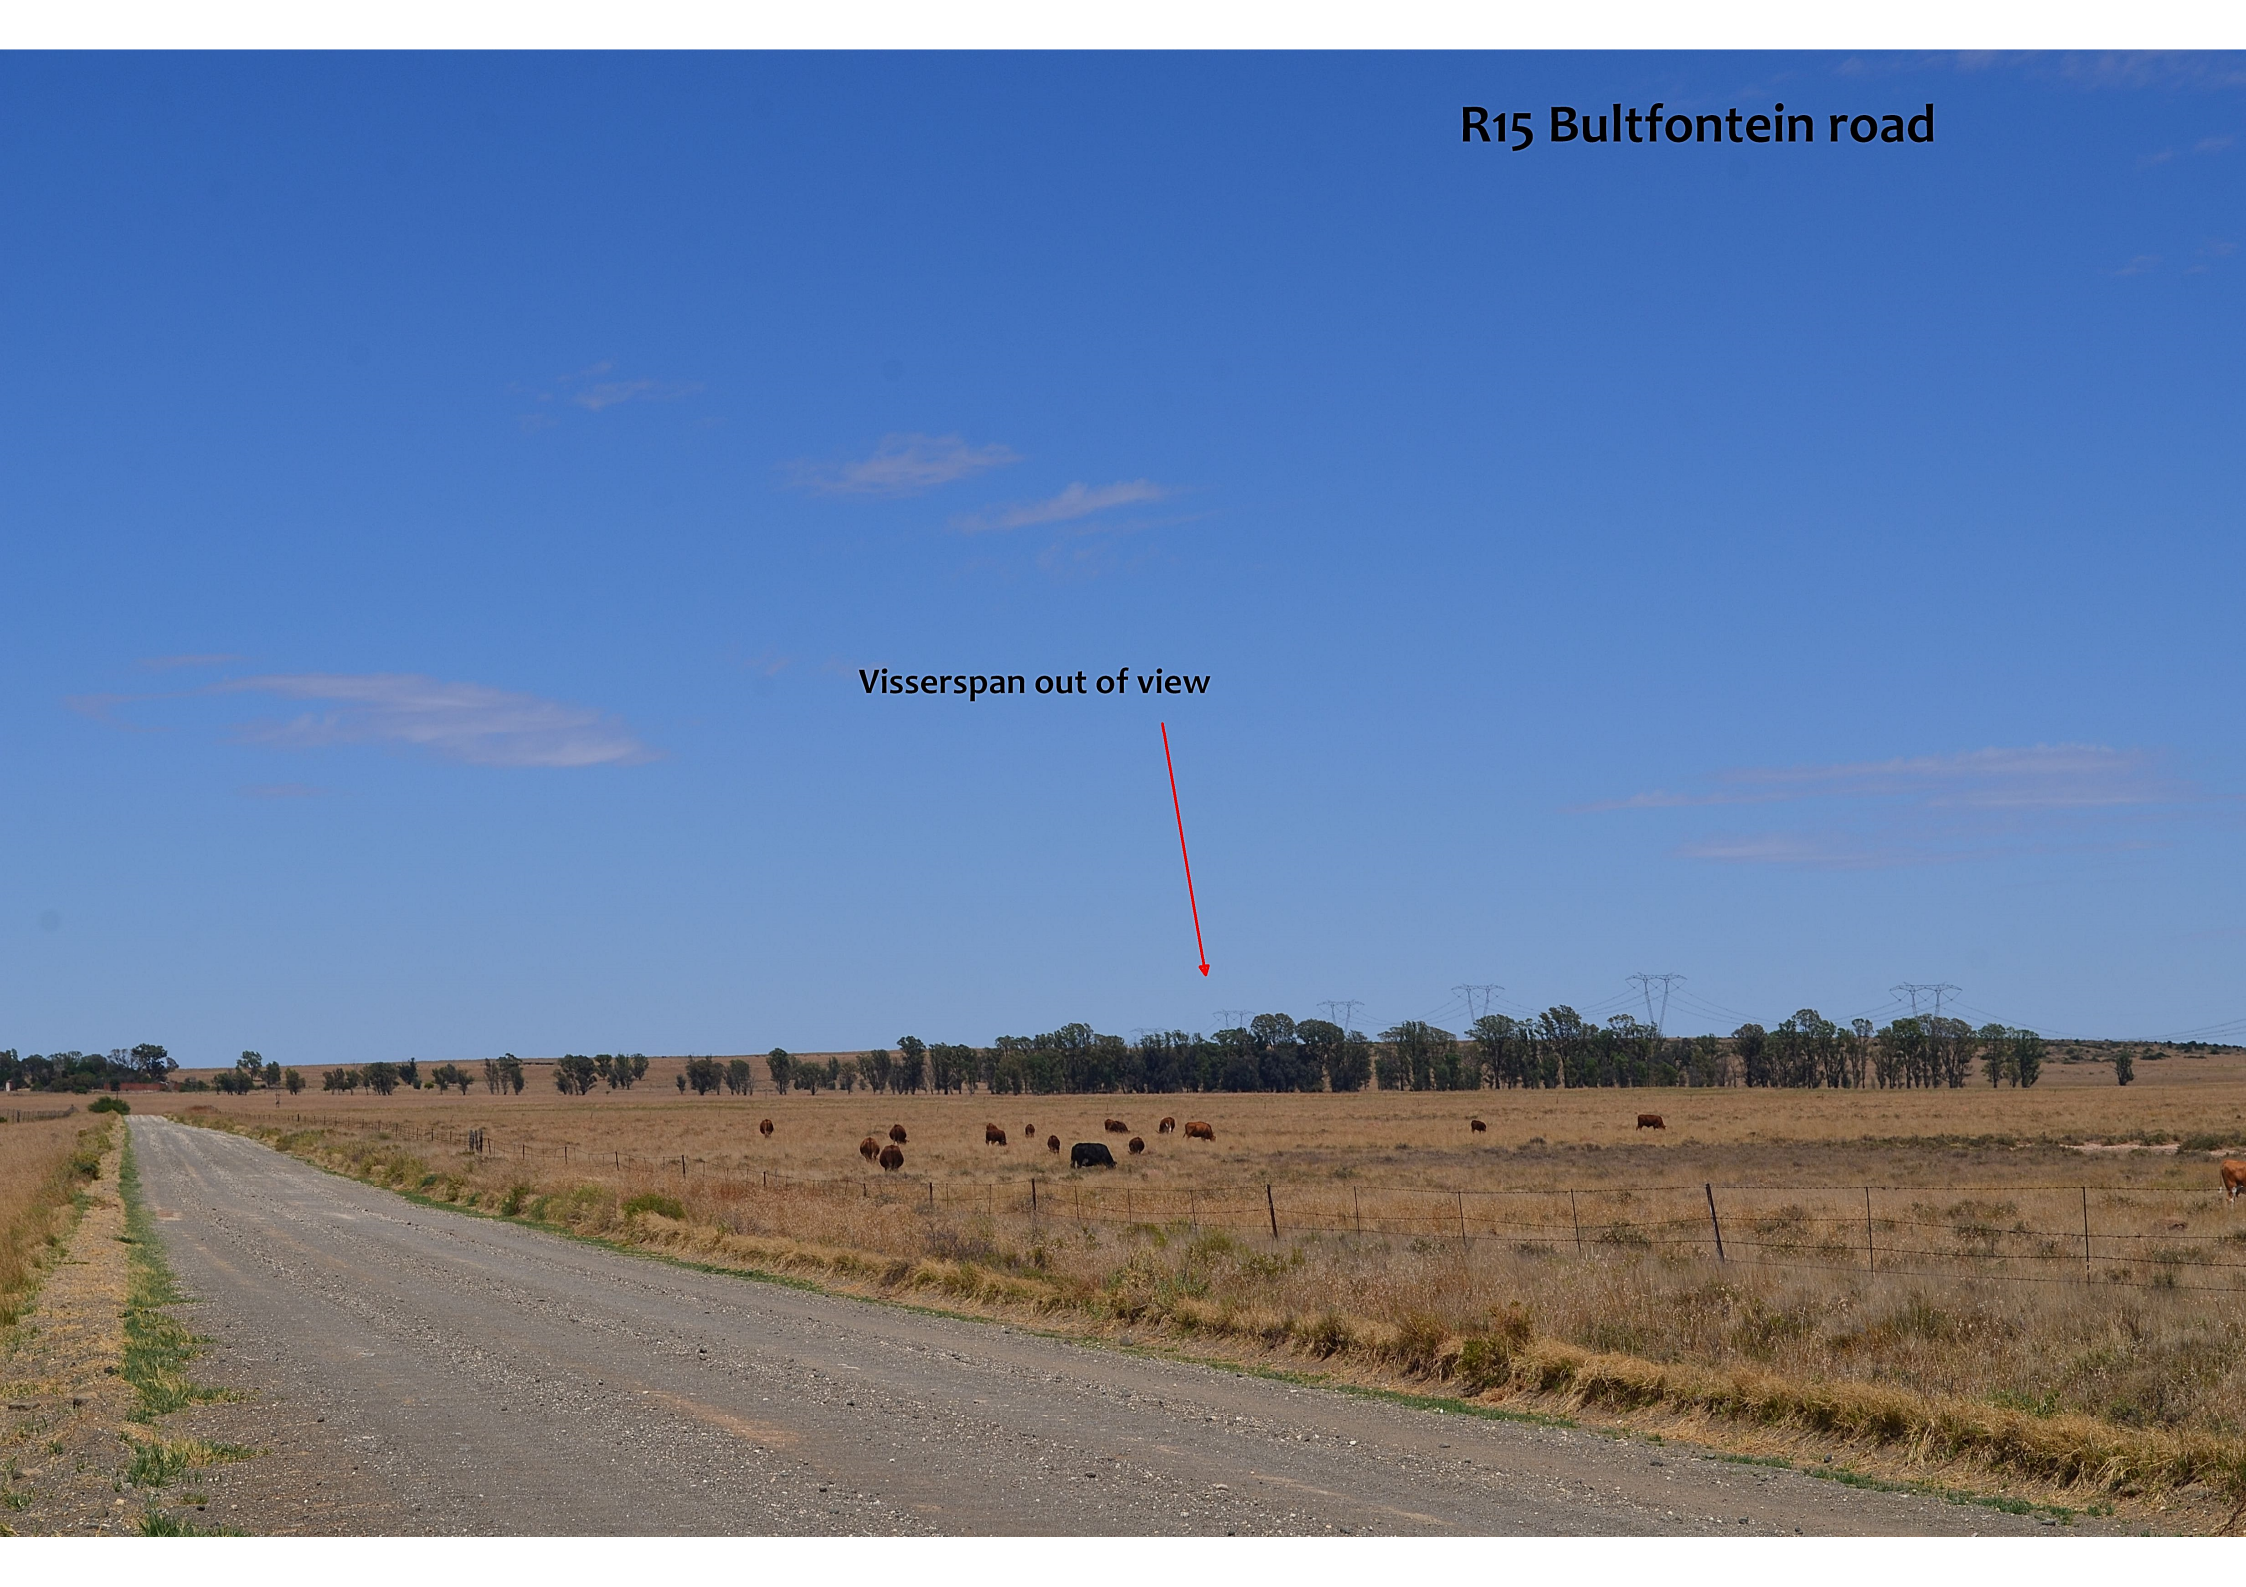
R15 Bultfontein road

Visserspan out of view

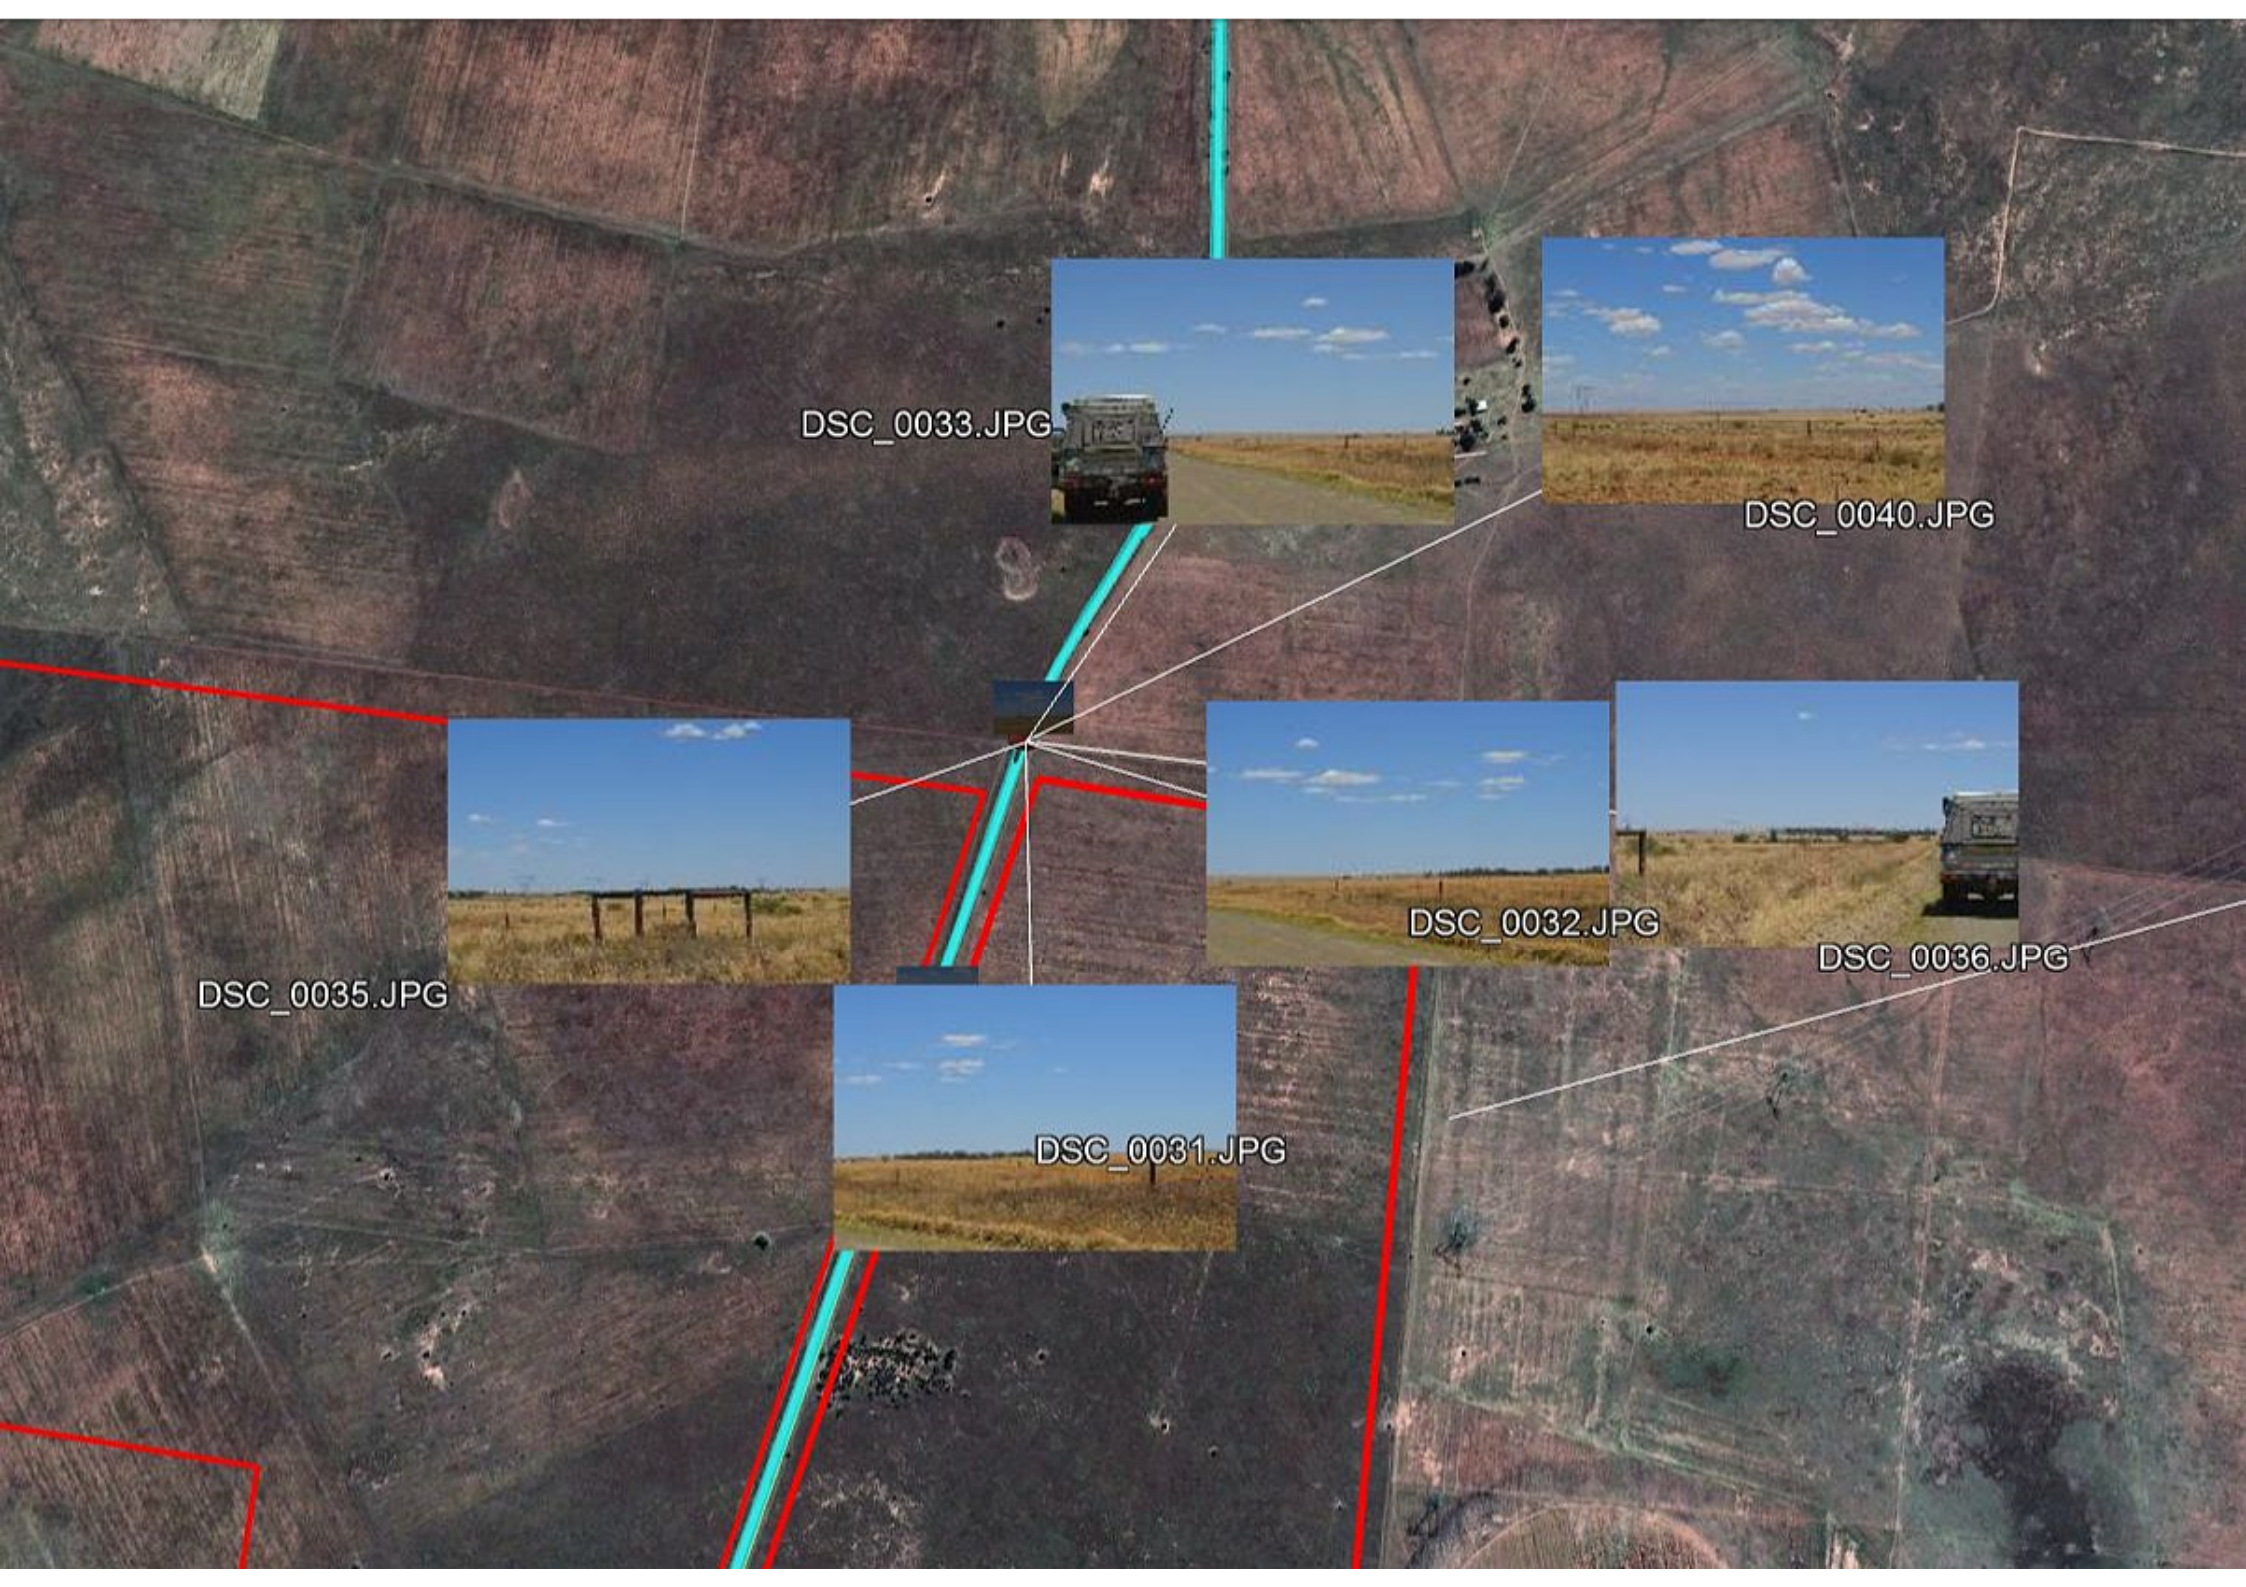
R13

Visserspan in the distance
PV arrays not visible
