**VISSERSPAN PV FACILITY
PROJECT 4
FARM 40, DEALESVILLE, FREE STATE**

VISUAL ASSESSMENT

Final Report

10 Feb 2020

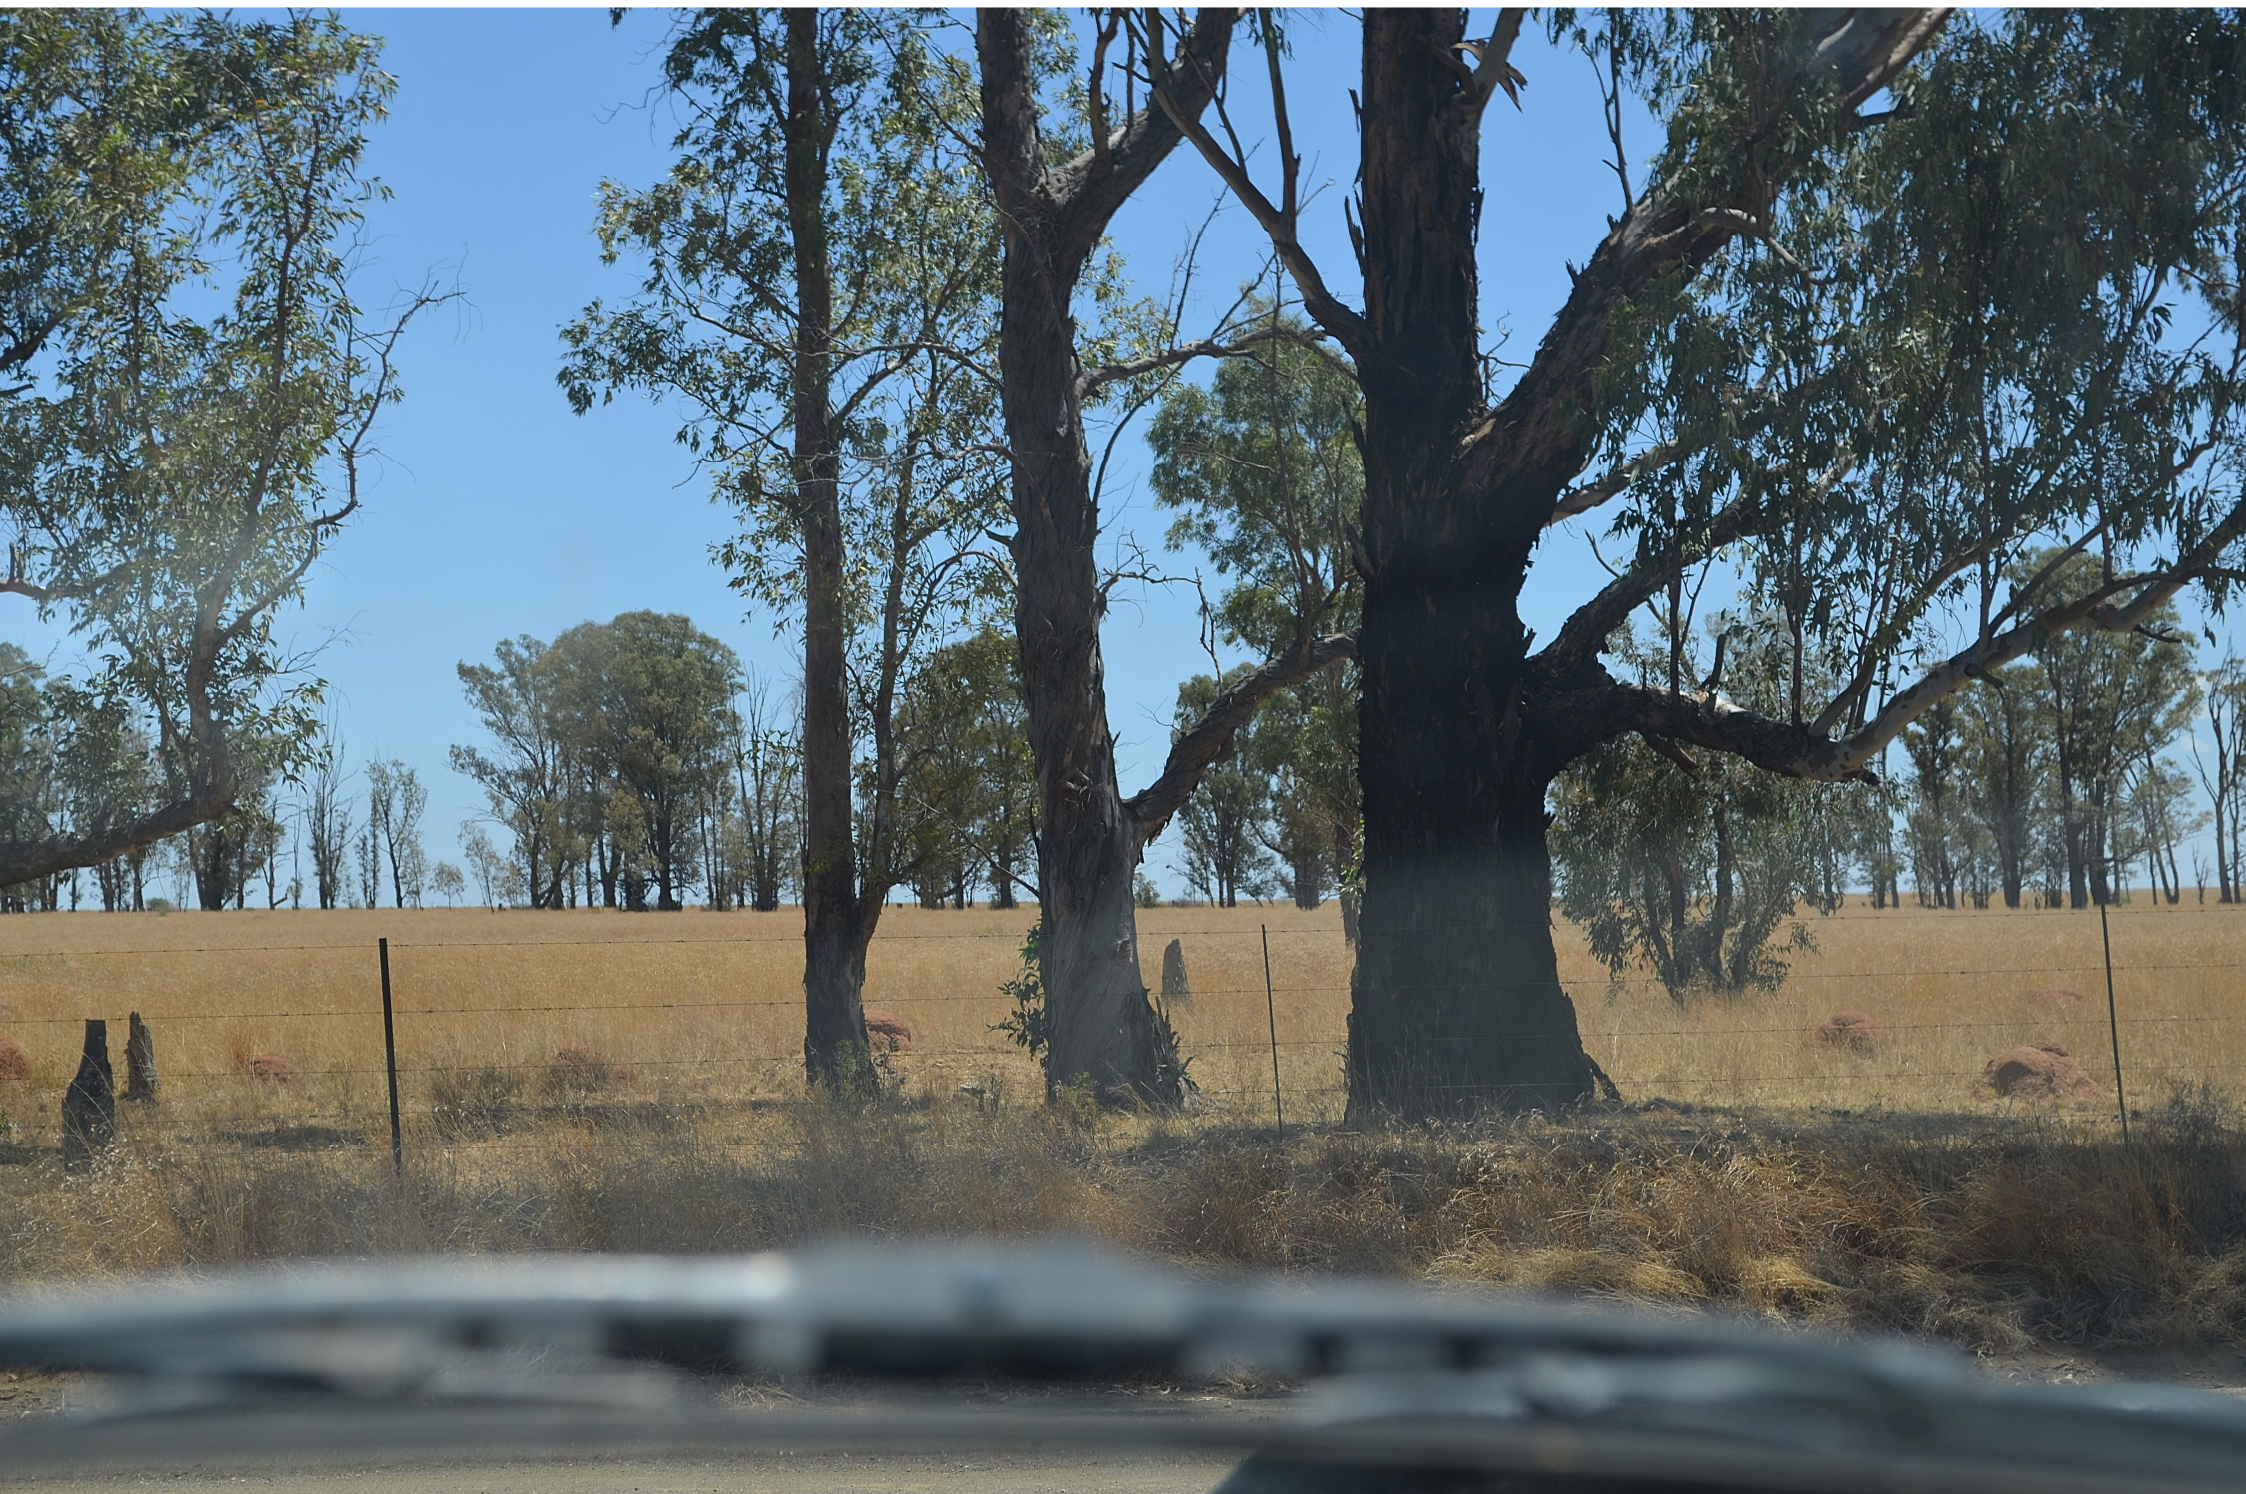
R2 Melsetter gate towards Hertzogville road intersection

Trees to be removed

Sideview of arrays
