# RIVER MAINTENANCE MANAGEMENT PLAN (MMP)

## PROPOSED CONSTRUCTION OF THE JADE HILLS DAM

Portion 26 of Farm Stinkfontein No. 384, Ceres, Western Cape

**MARCH 2021**

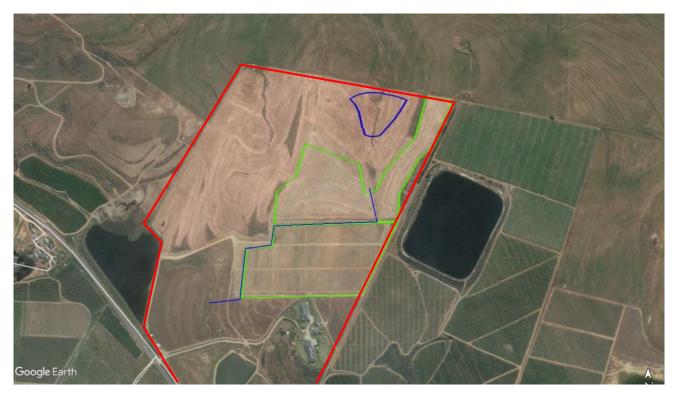
**Figure 1**: Google Earth image showing an overview of the development. The blue polygon is the proposed dam footprint, and the green polygon the proposed agricultural development. The blue line is the proposed pipeline. Portion 26 of Farm Stinkfontein No. 383 is indicated by the red polygon.
