SITE SENSITIVITY VERIFICATION (SSV) REPORT: THE PROPOSED DARLING SOLAR PV DEVELOPMENT, PORTION OF ERF 551, DARLING, WESTERN CAPE

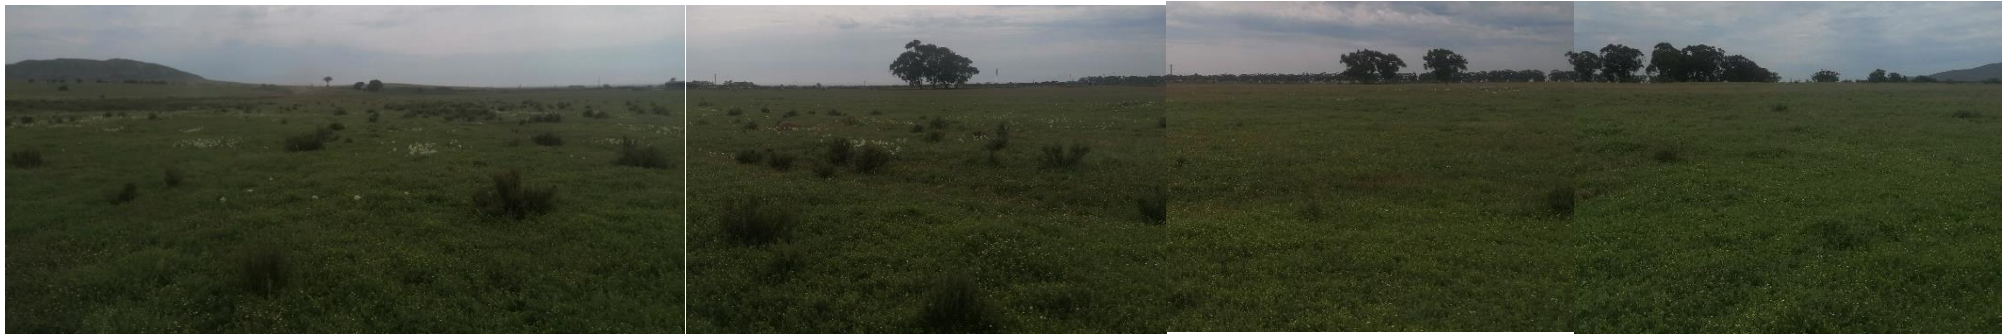
Figure 1. Site overview photographs showing the eastern site portion. Taken from the middle of the eastern portion looking north to south-east.

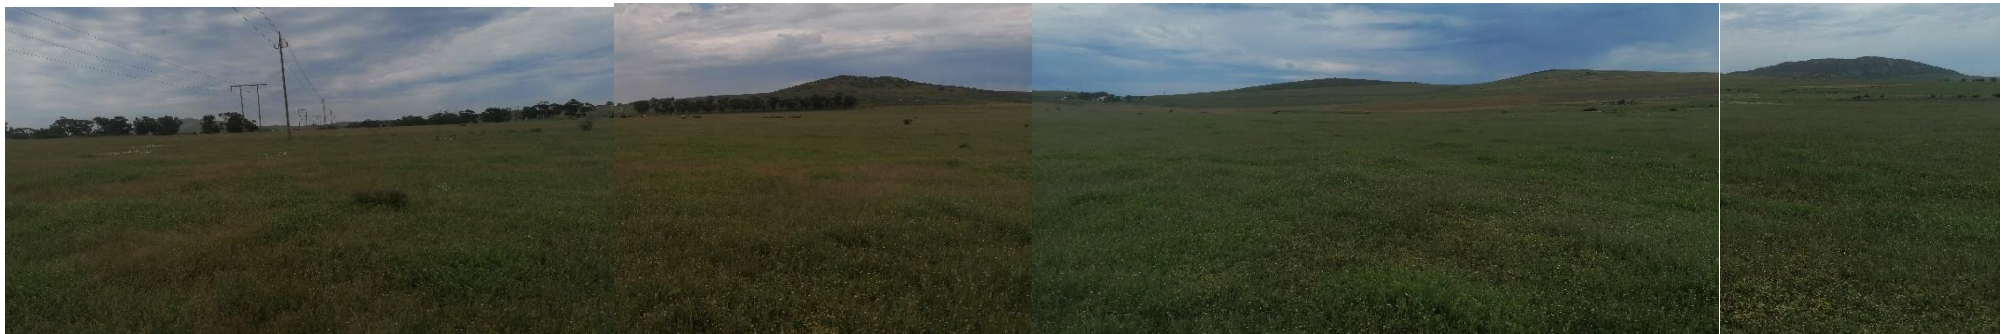
Figure 2. Site overview photographs showing the existing condition of the western site portion. Taken from the eastern boundary below the existing powerlines, looking south to the north-west.

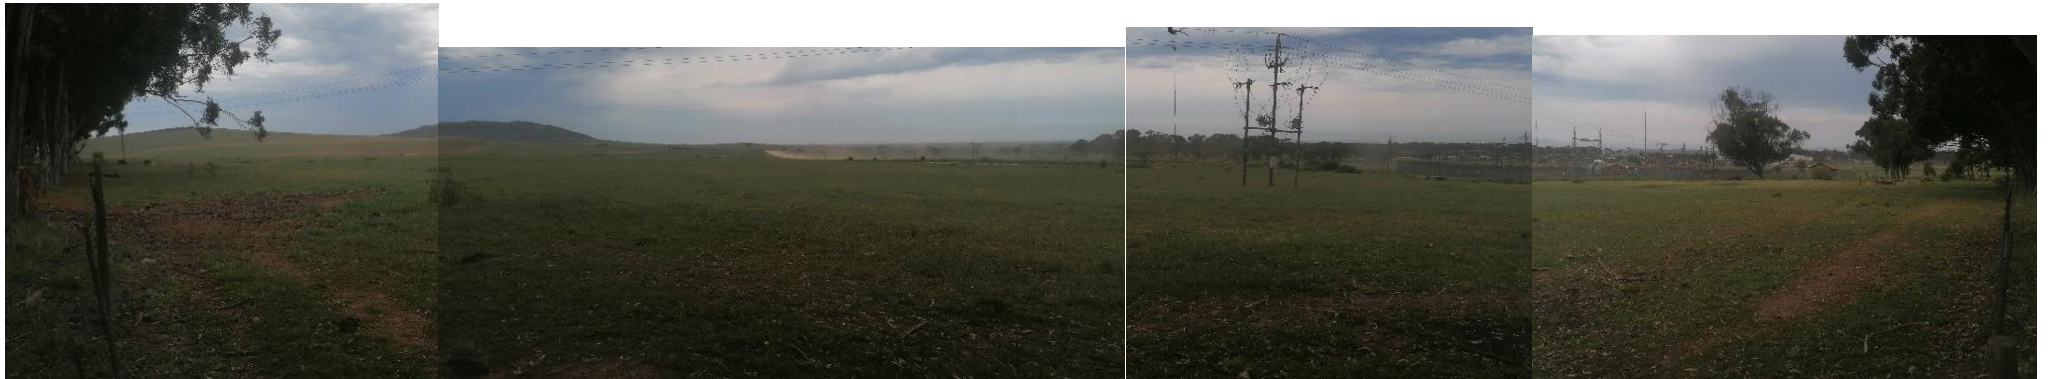
Figure 5. Site overview photographs taken from the southern most boundary of the western portion, looking from the north-west to east towards the existing substation.
