SITE SENSITIVITY VERIFICATION (SSV) REPORT: THE PROPOSED DARLING SOLAR PV DEVELOPMENT, PORTION OF ERF 551, DARLING, WESTERN CAPE

SITE SENSITIVITY VERIFICATION REPORT – DARLING SOLAR PV

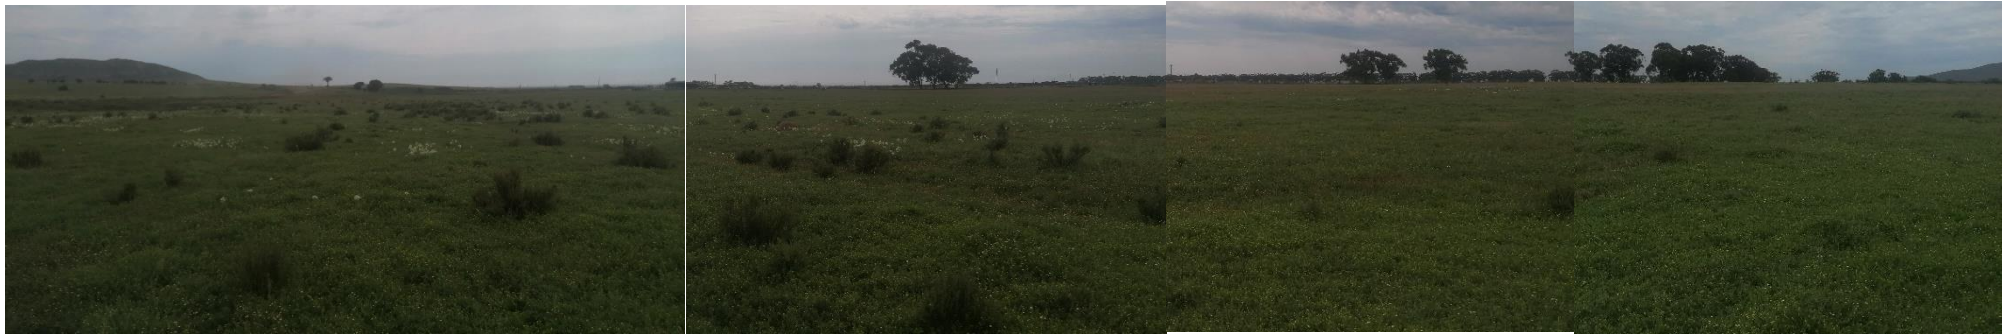
Figure 1. Site overview photographs showing the eastern site portion. Taken from the middle of the eastern portion looking north to south-east.

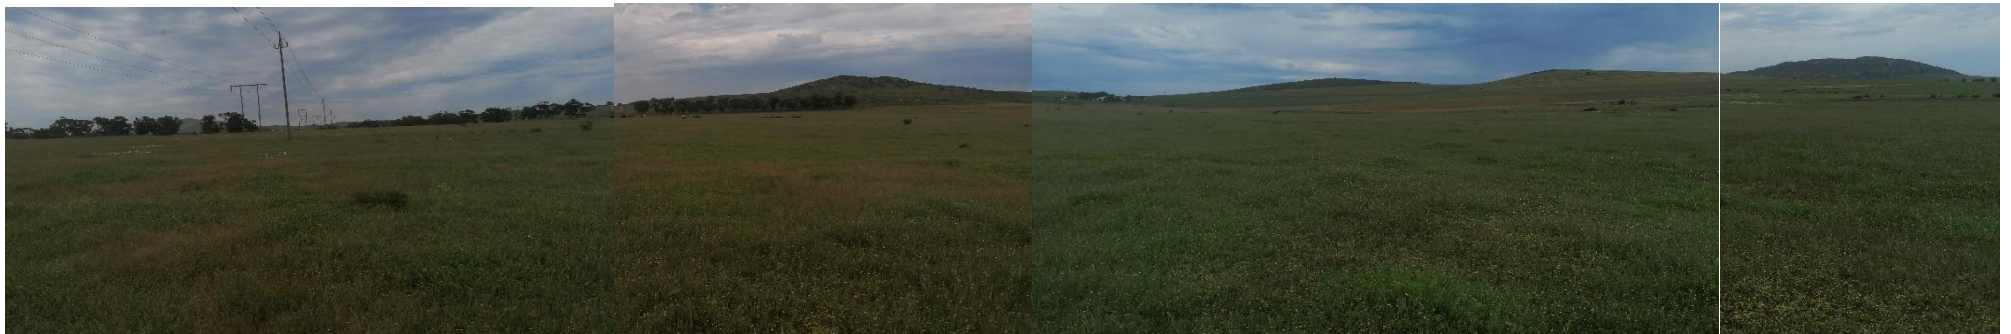
Figure 2. Site overview photographs showing the existing condition of the western site portion. Taken from the eastern boundary below the existing powerlines, looking south to the north-west.

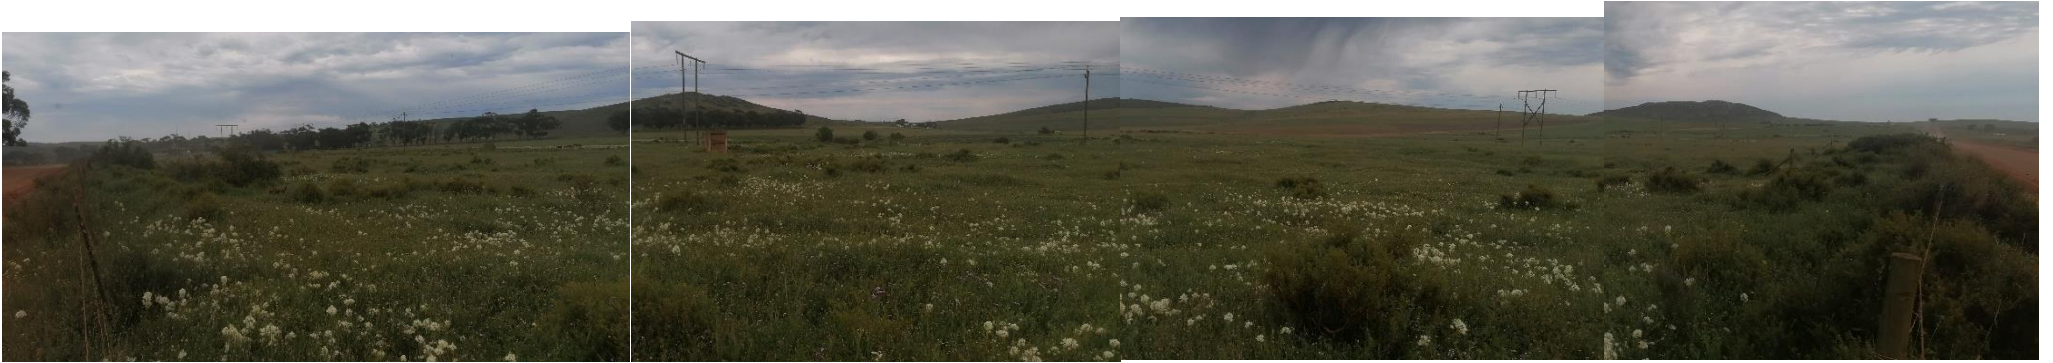
Figure 3. Site overview photographs of the western site portion. Taken from the eastern boundary along the DR1156 dirt road, looking south to the north.

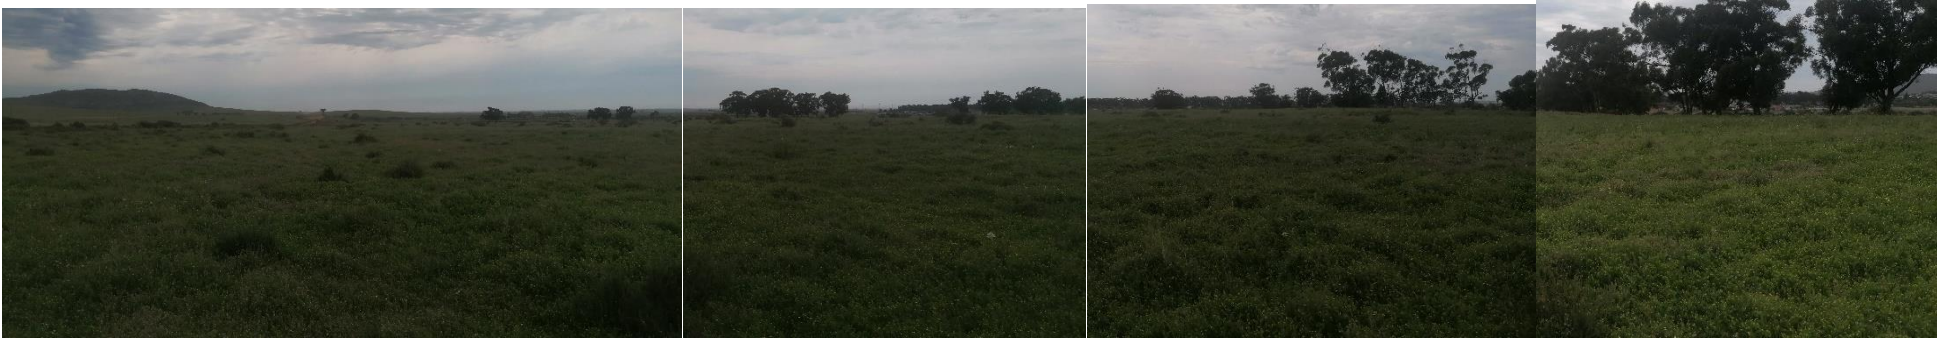
Figure 4. Site overview photographs of the western site portion, towards the south of the site looking north to the south-east

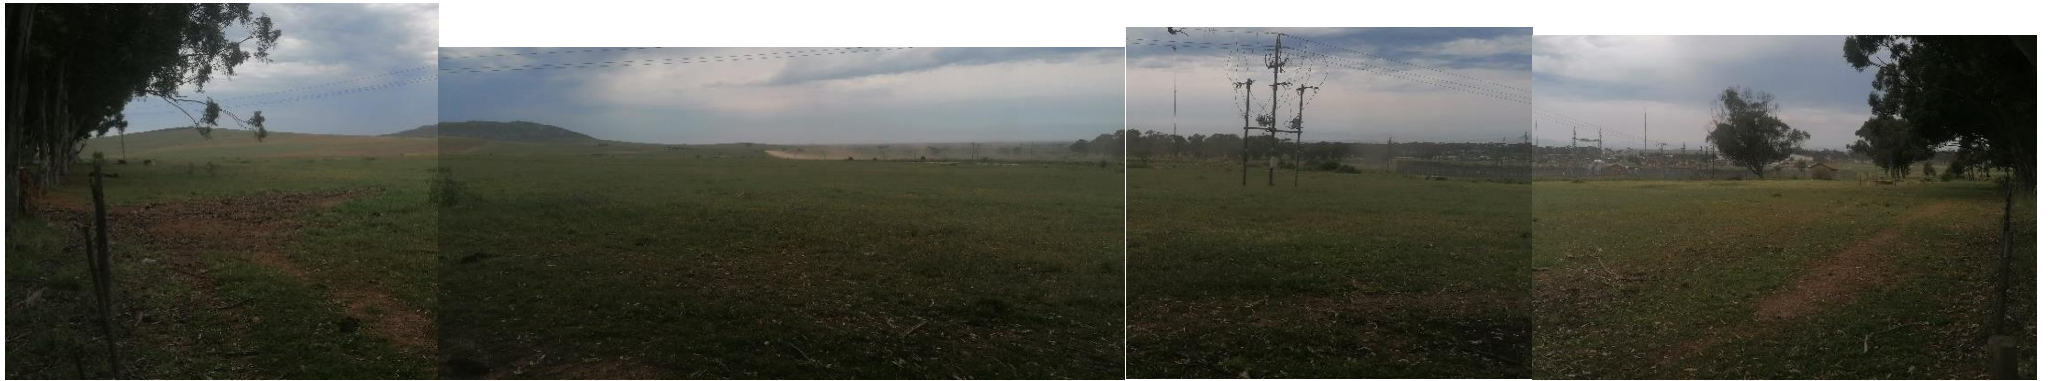
Figure 5. Site overview photographs taken from the southern most boundary of the western portion, looking from the north-west to east towards the existing substation.
